ASBESTOS SURVEY REPORT

A.P. BUILDING (# 98)

E&AS Project #94-260

**PBS Project Number
7045.21**

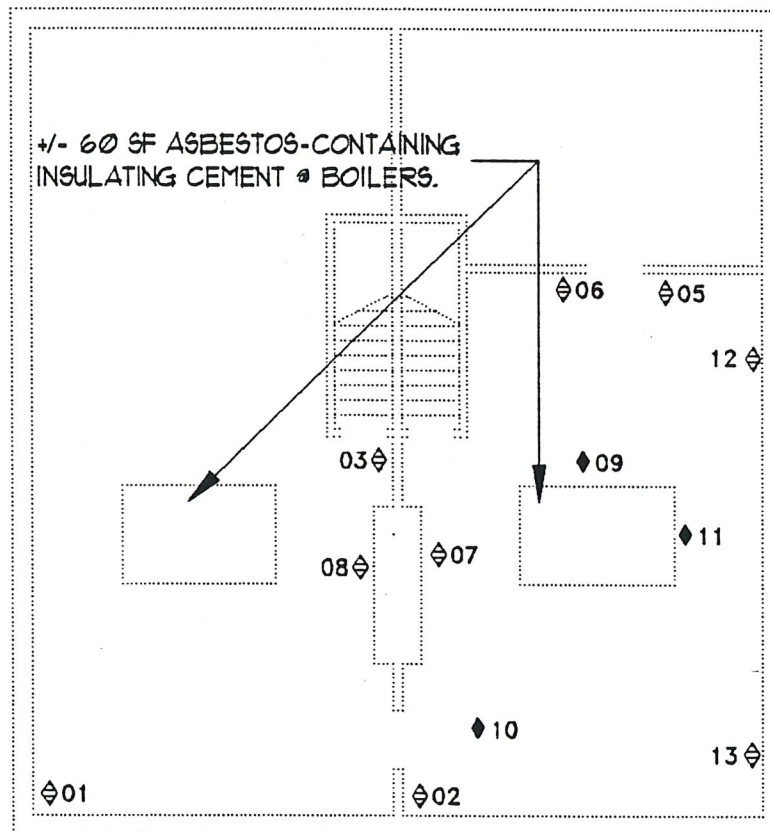
BASEMENT PLAN
SCALE: APPROXIMATELY 1"=10'

- THIS DRAWING IS DIAGRAMMATIC. IT IS FOR GENERAL INFORMATION AND SAMPLE LOCATION.
- ACCESSIBLE SPACES WERE SURVEYED FOR SUSPECT ASBESTOS MATERIALS. SUSPECT MATERIALS FOUND TO BE ASBESTOS-CONTAINING ARE NOTED ON THE DRAWING.
- FOR DETAILED SAMPLE INFORMATION SEE LABORATORY REPORTS, TAB TWO, SECTION FOUR.
- FOR MATERIAL IDENTIFICATION SEE PHOTO DOCUMENTATION, TAB TWO, SECTION THREE.
- +/- 185 LF ASBESTOS-CONTAINING DUCT FELT TAPE EXISTS ON HYAC DUCTS IN BASEMENT.

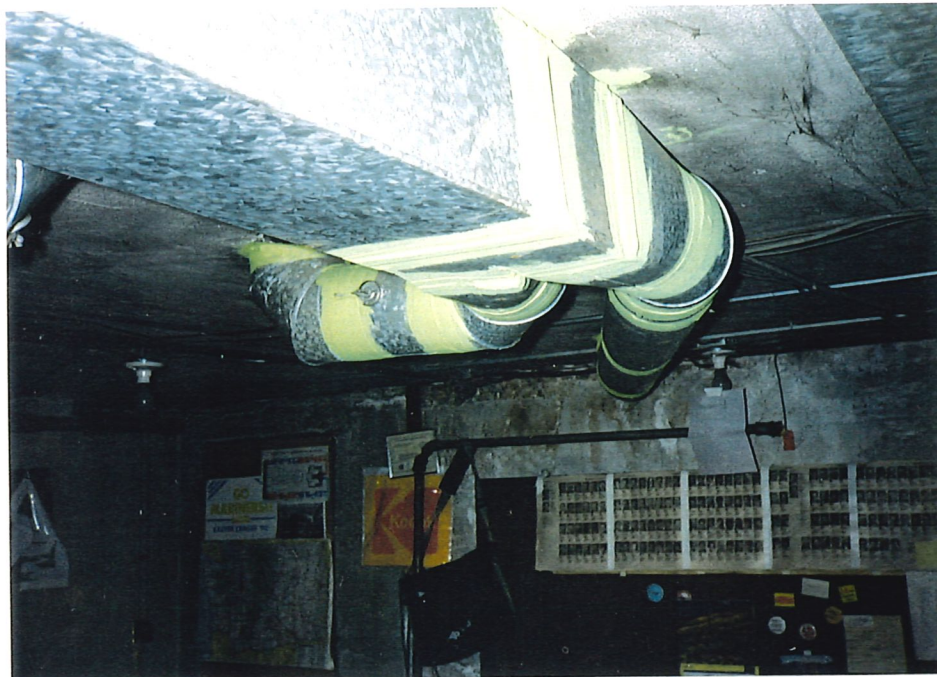
Friable felt duct tape located on ducts in the basement of the building contains asbestos. This material was observed to be in good condition and is of low concern unless damaged.

Accessibility:	LOW	Undamaged Area:	GOOD
Current Damage:	NONE	Damage Potential:	LOW
Friability:	MODERATE	Damage Type:	N/A
Air Plenum:	NO	Damage Cause:	N/A

A. ASBESTOS-CONTAINING DUCT FELT TAPE;
BASEMENT AREA.

Maintain material in good condition and encapsulate accessible material as necessary.

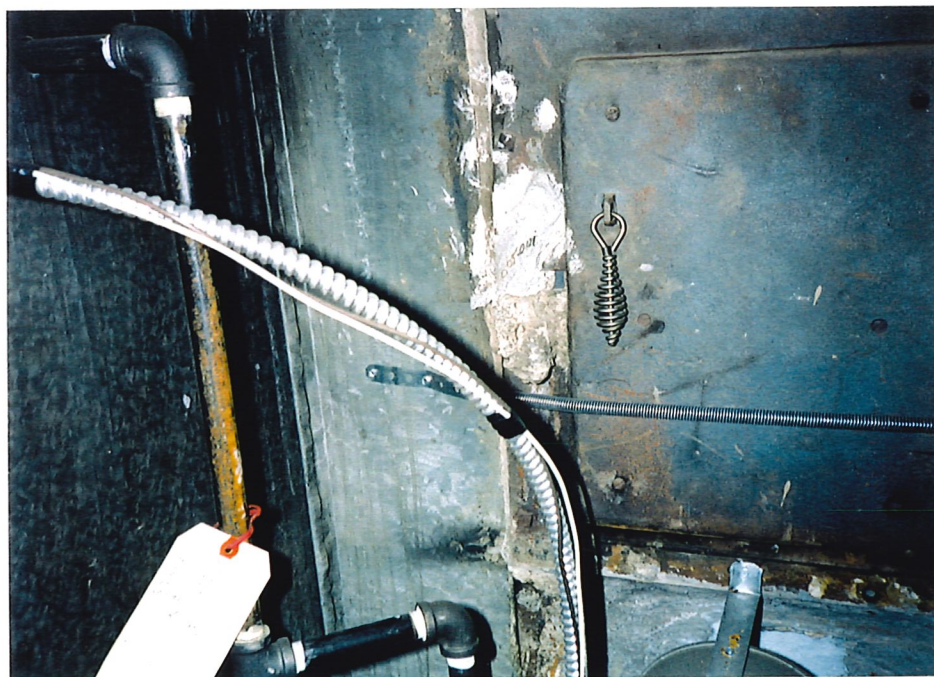
Friable cement located on boiler units in the basement also contains asbestos. This material is hard and plaster-like and is located within the boiler's metal exterior shell. Unless damaged by maintenance or other activities this material is of low concern.

B. ASBESTOS-CONTAINING CEMENT MATERIAL;
BASEMENT FURNACE UNIT.

Maintain material in good condition and encapsulate material as necessary.
