Site Observation Report

Project:	DES Newhouse	Date:	March 22, 2022
Project No:	A21.0033.00/ DES 2021-180 1(A)	Time:	9:30am – 11:00 am
Subject:	Newhouse Building Replacement Existing Newhouse Building Salvage Inventory	Location:	Olympia Capitol Campus

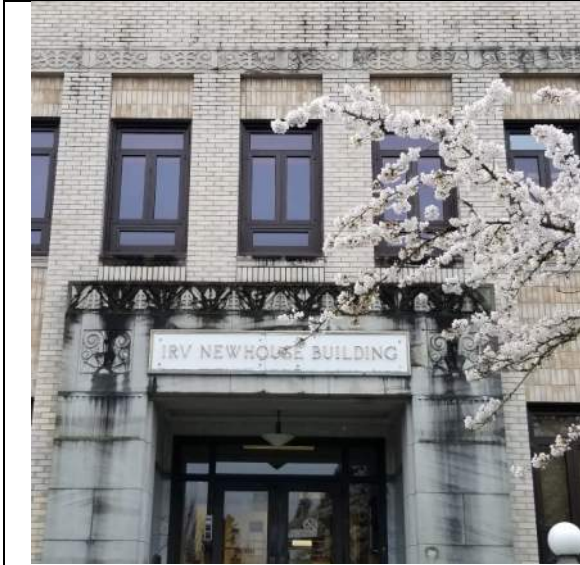
Newhouse Façade entry portal

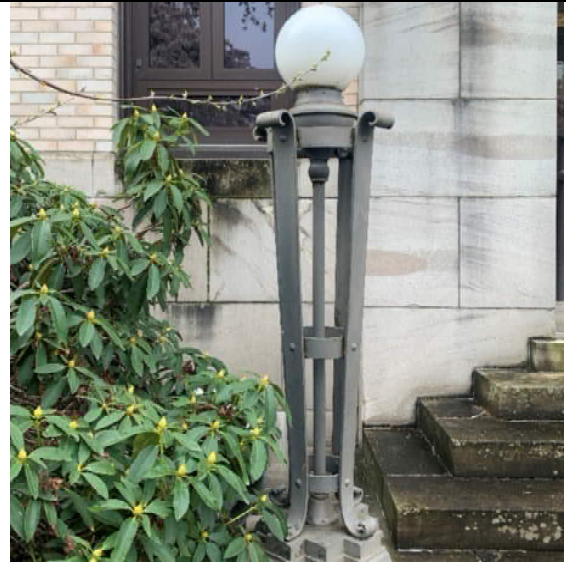
Lamps at the north entry (Quantity: 2)

- Brick clay is lighter in color
 - The Newhouse windows are not historically significant but can be salvaged, recycled, or repurposed
 - The lamp posts (4) at the north and south entrances should be restored and reinstalled. There is quite a bit of rust on metal bases, could be stripped down for repair and recoated, rewired.

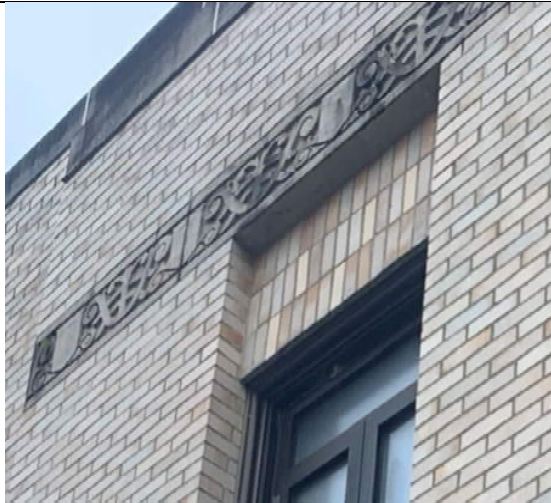
Carved Sandstone and glazed brick

- Material can be salvaged by cutting the joints carefully starting from top of wall to bottom
 - The carved sandstone details/ motifs at the front entrance and around the façade should be salvage for reuse on site or in building interior, or potentially sourced for new artwork

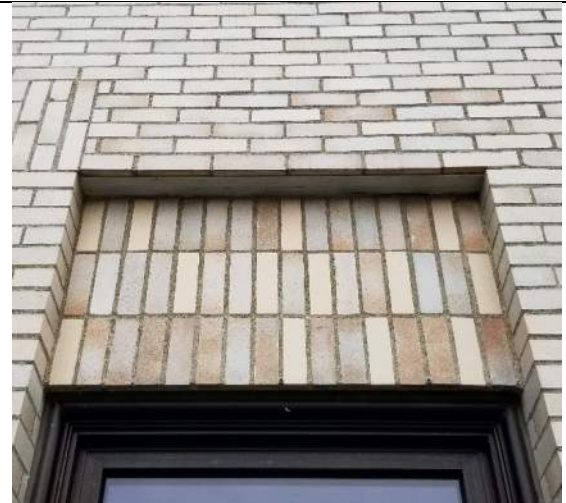
Variegated glazed brick

- The variegated glazed brick is a unique and valuable local material on the façade that should be considered for salvage.
 - Variations in tone and color – the brick glaze is a mix of light and dark bricks in about five different shades of cream, mauve-beige, and orange-brown colors.

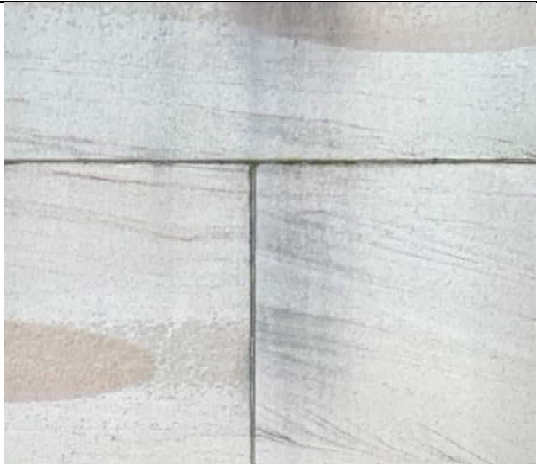
Wilkeson Sandstone smooth panels at building base

- Inventory:
 - Wilkeson Sandstone on the façade is the highest value material, locally sourced. Both smooth and carved Sandstone façade panels are valuable, irreplaceable, and should be salvaged.

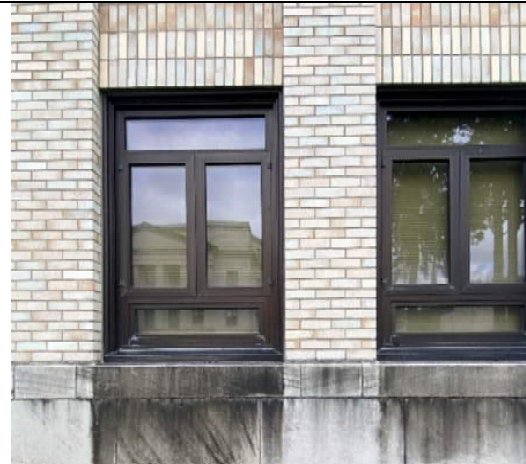
Aluminum Windows and Wilkeson Sandstone sills

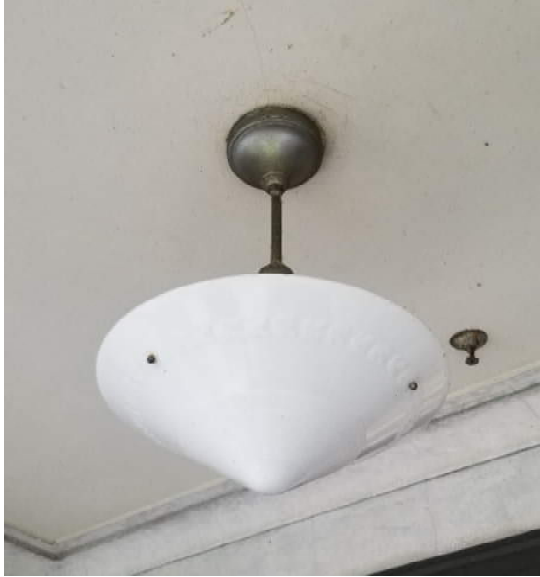
Light pendant at north entry

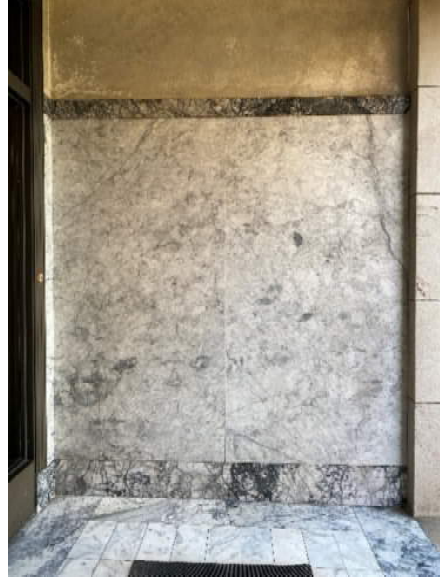
Marble panels at north entry walls and floor

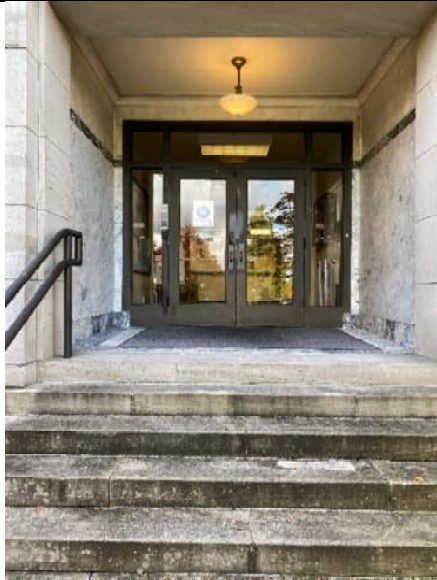
North Entry doors, sandstone steps

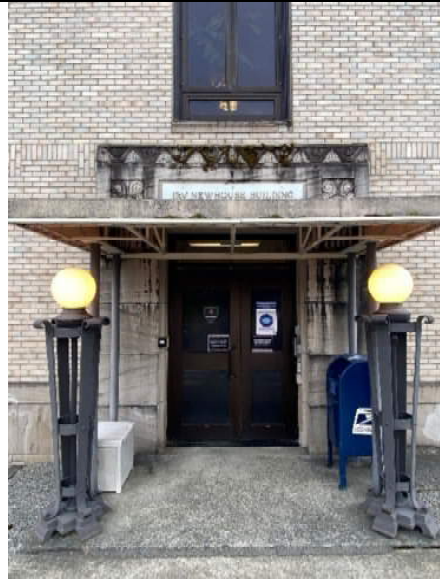
South Entry doors, sandstone surround, variegated glazed brick, lamps (quantity: 2)

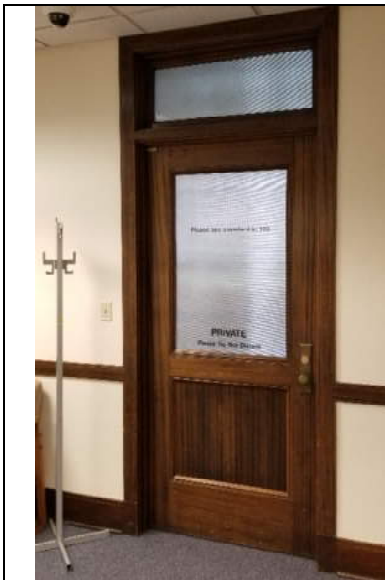
Mahogany Door and Frame with Operable Transom

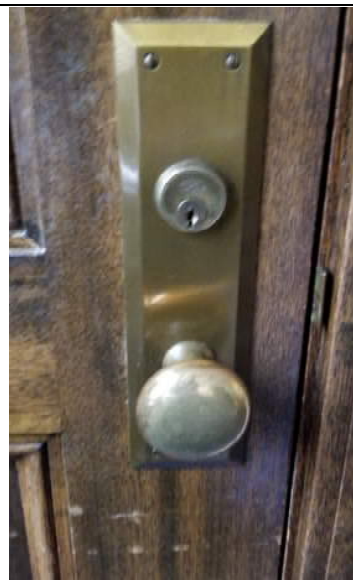
Bronze Door Hardware

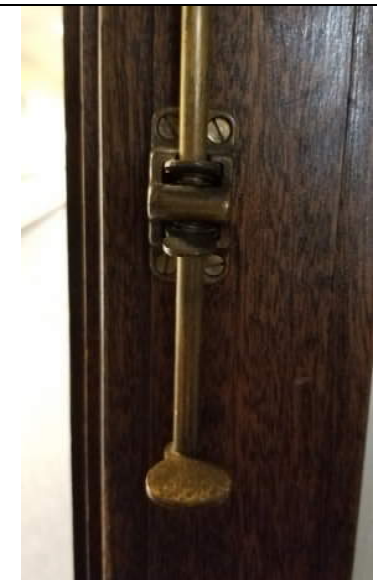
Bronze Transom Hardware

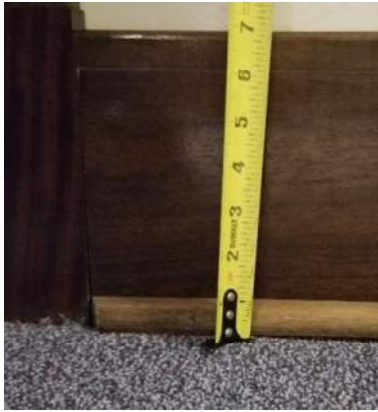
Mahogany Wall base

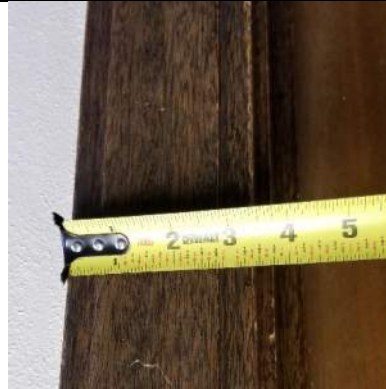
Mahogany Door Frame

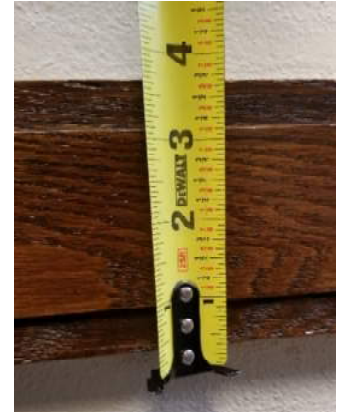
Mahogany Dado Rail

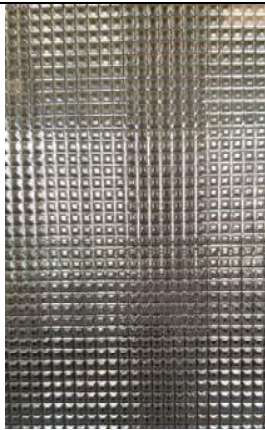
Glass detail in door panel

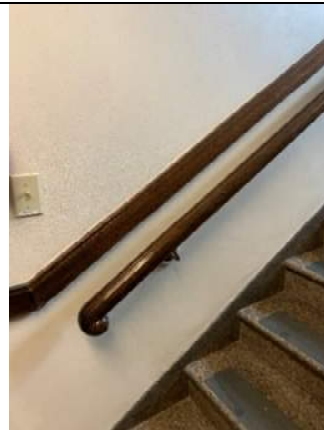
Mahogany trim and handrail

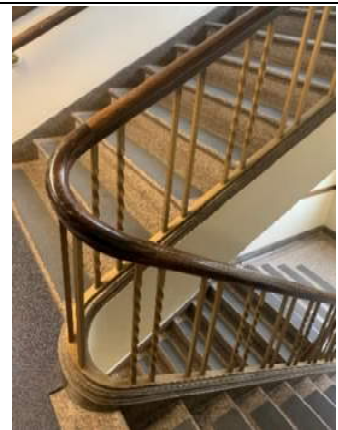
Wood and Brass center handrail

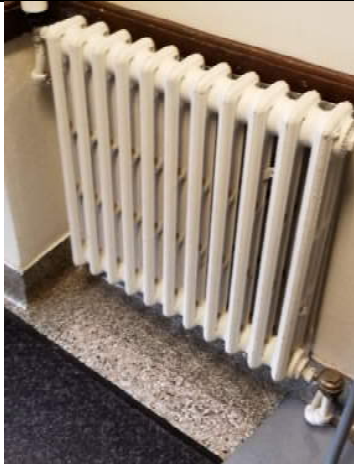
Cast Iron Radiator

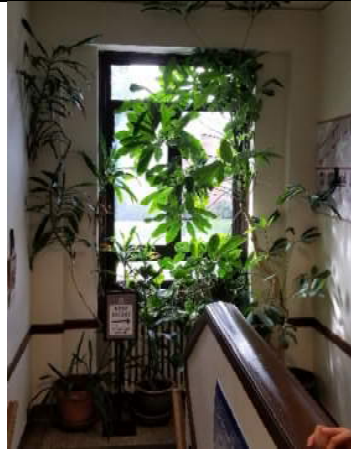
Biophilic Stair landing

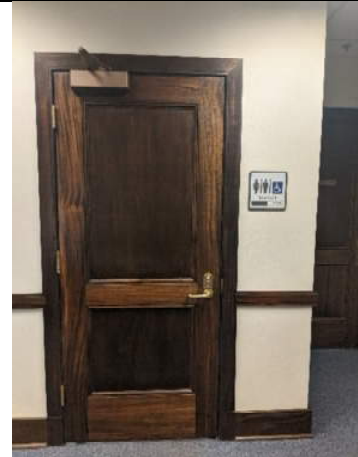
Solid Wood Door
