Capitol Lake Dam Preservation
Project Number: 2016-931

Comprehensive Assessment Report

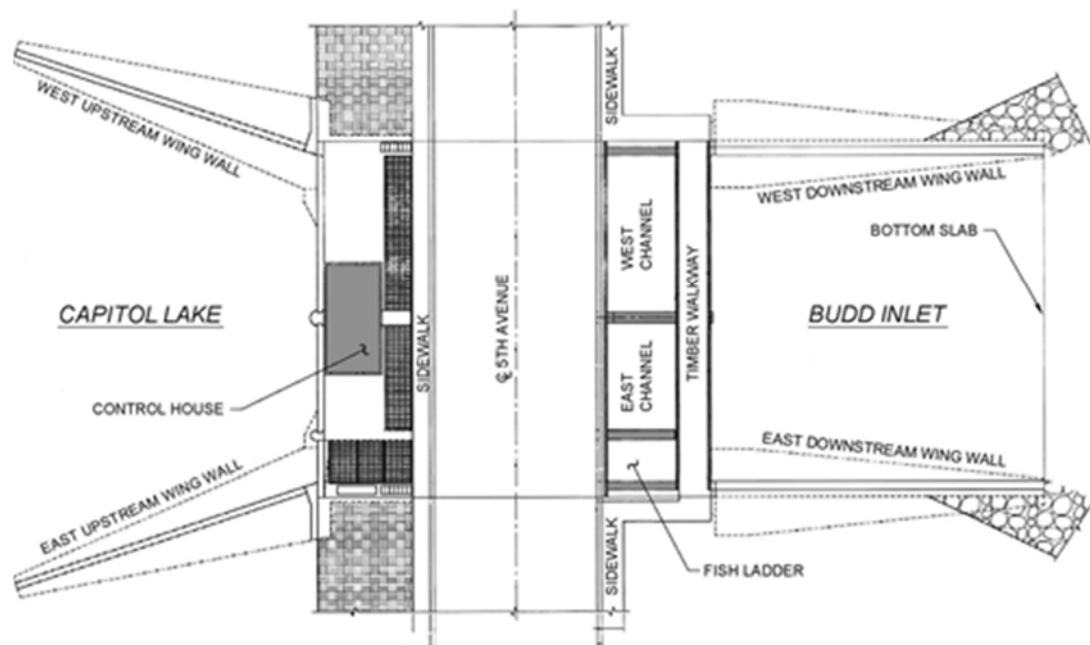
Figure 2: Capitol Lake Dam Spillway Plan View

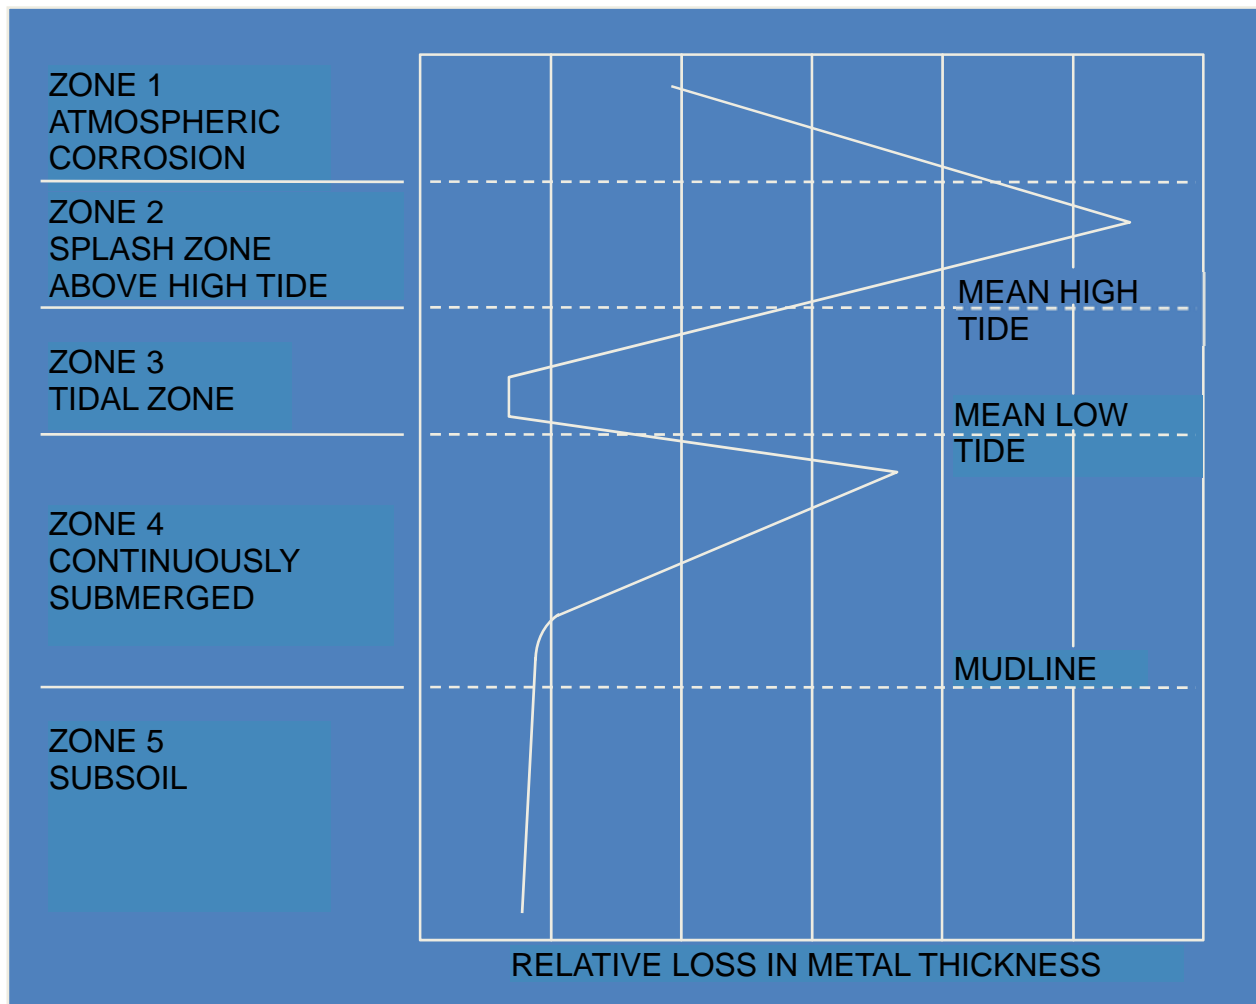
Figure 6: Relative Loss in Metal Thickness at Elevation Ranges

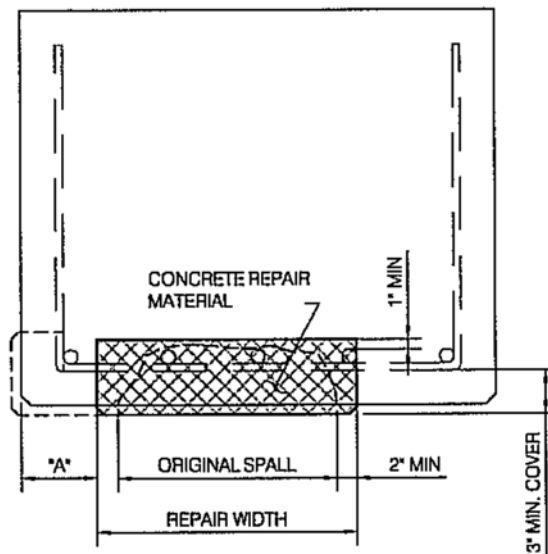
Figure 7. Patch Repair General Section

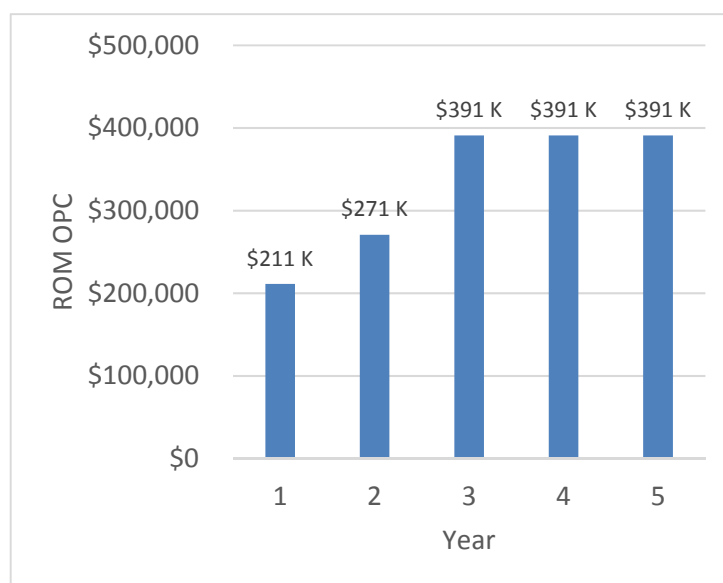
Figure 8: Estimated repair costs by year

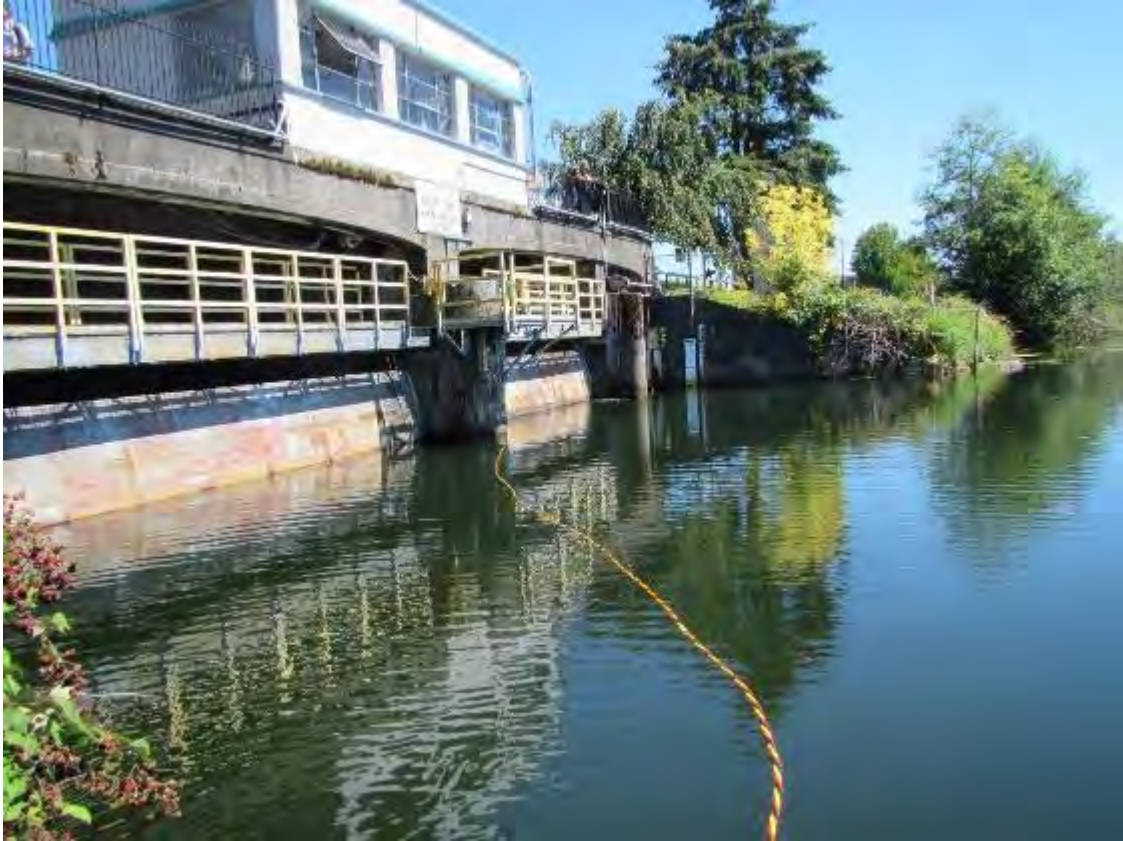
Project Name: Capitol Lake Dam Preservation
Project Number: 2016-931
Structural Condition Assessment Report

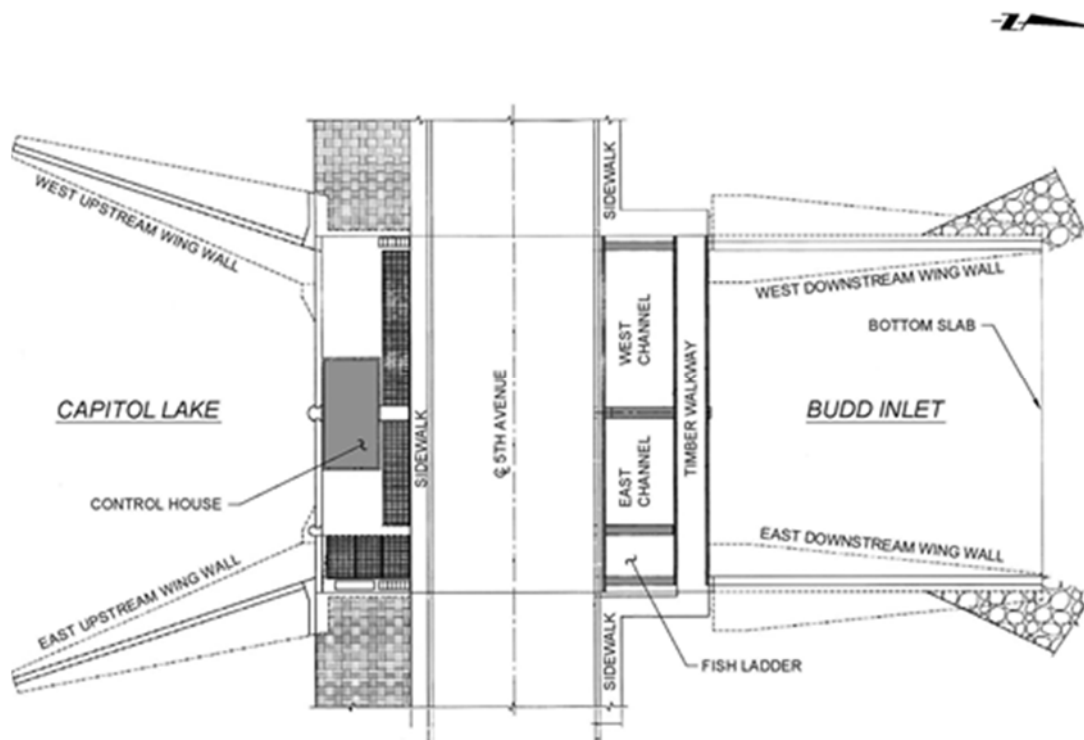
Figure 1: Capitol Lake Dam Plan View

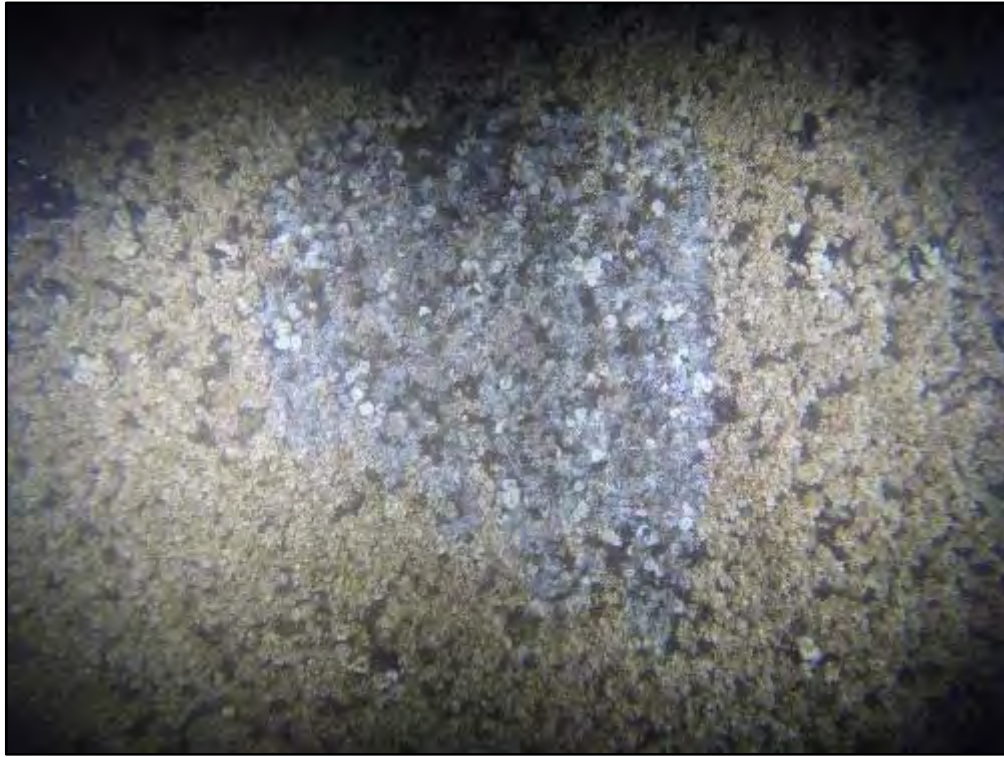
Photograph 4: Typical Abutment Surface at Level II Cleaning Location

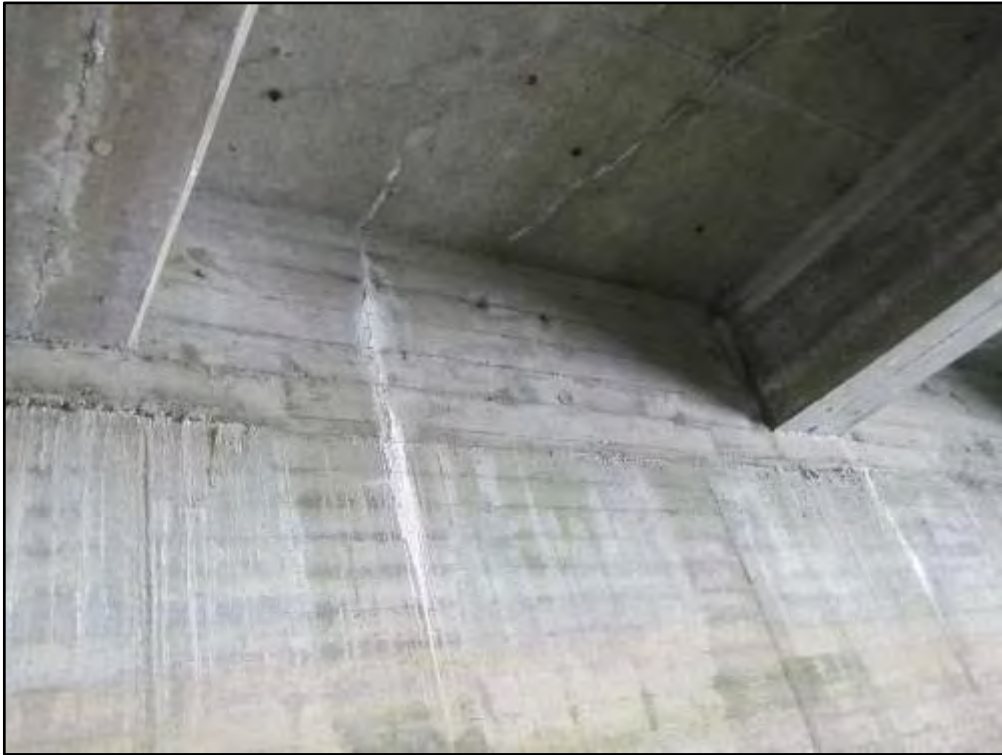
Photograph 5: Efflorescence on West Abutment

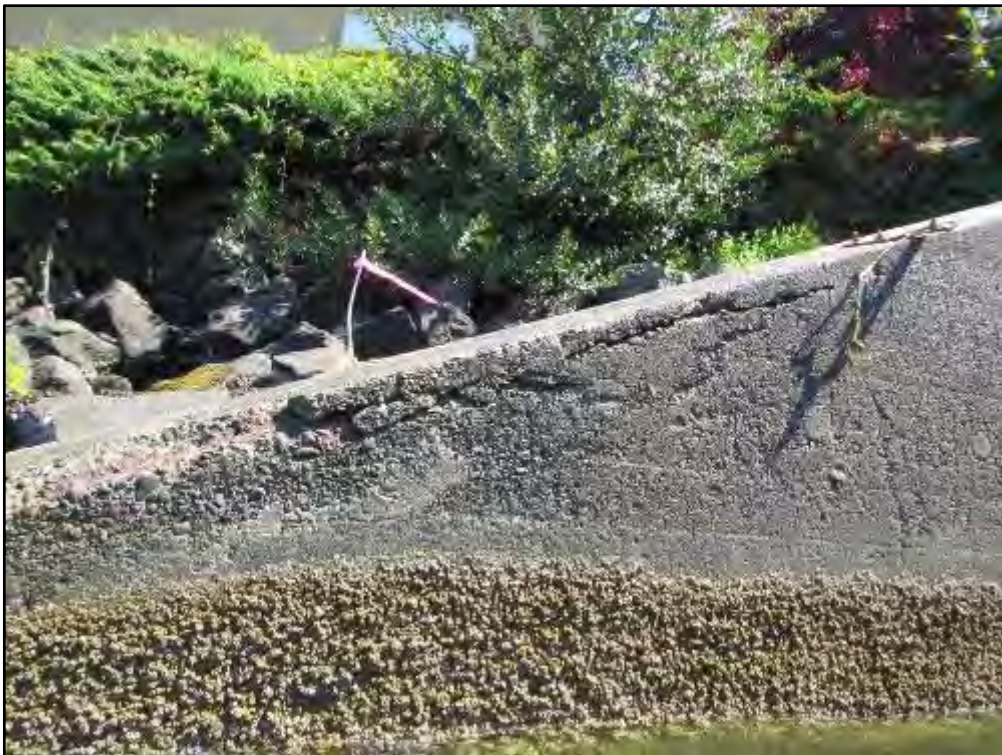
Photograph 6: Open Corrosion Spall on East Downstream Wingwall

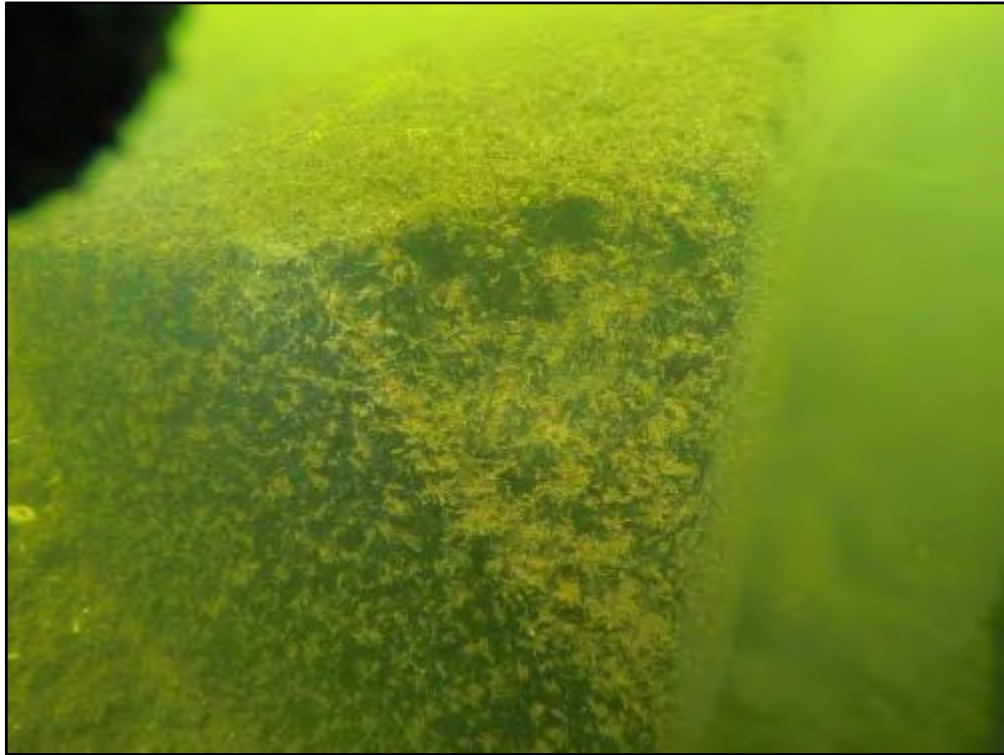
Photograph 7: Impact Spall on West Upstream Wingwall

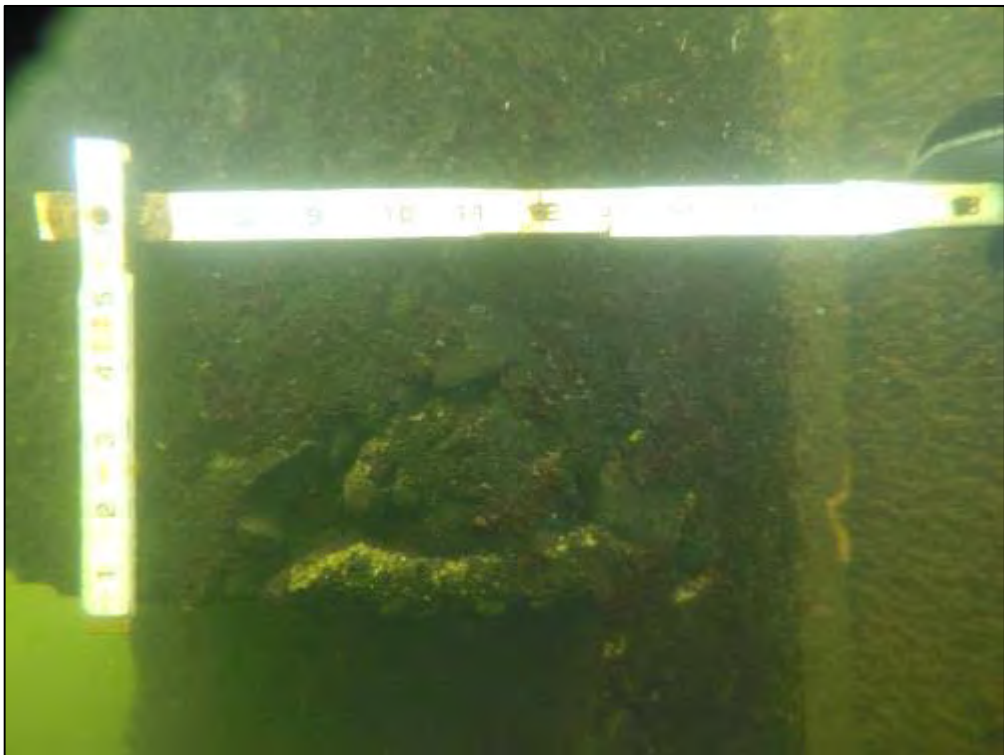
Photograph 8: Poorly Consolidated Concrete on the Upstream End of the Pier Wall Between the East and West Spillway

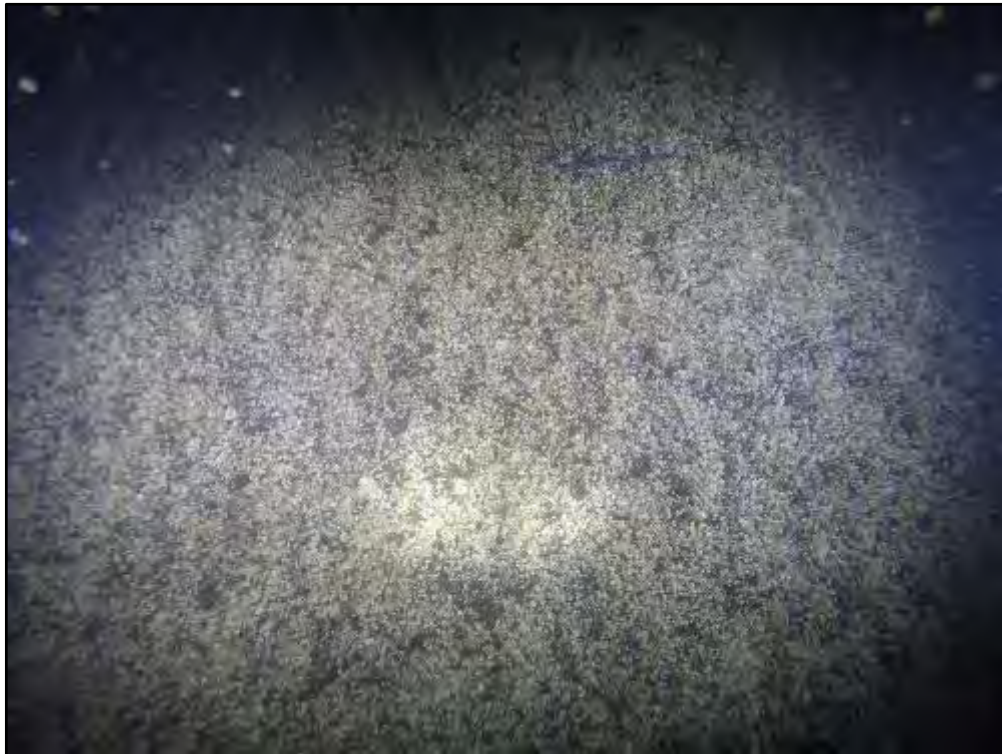
Photograph 9: Typical Marine Growth on Concrete Surfaces Underwater

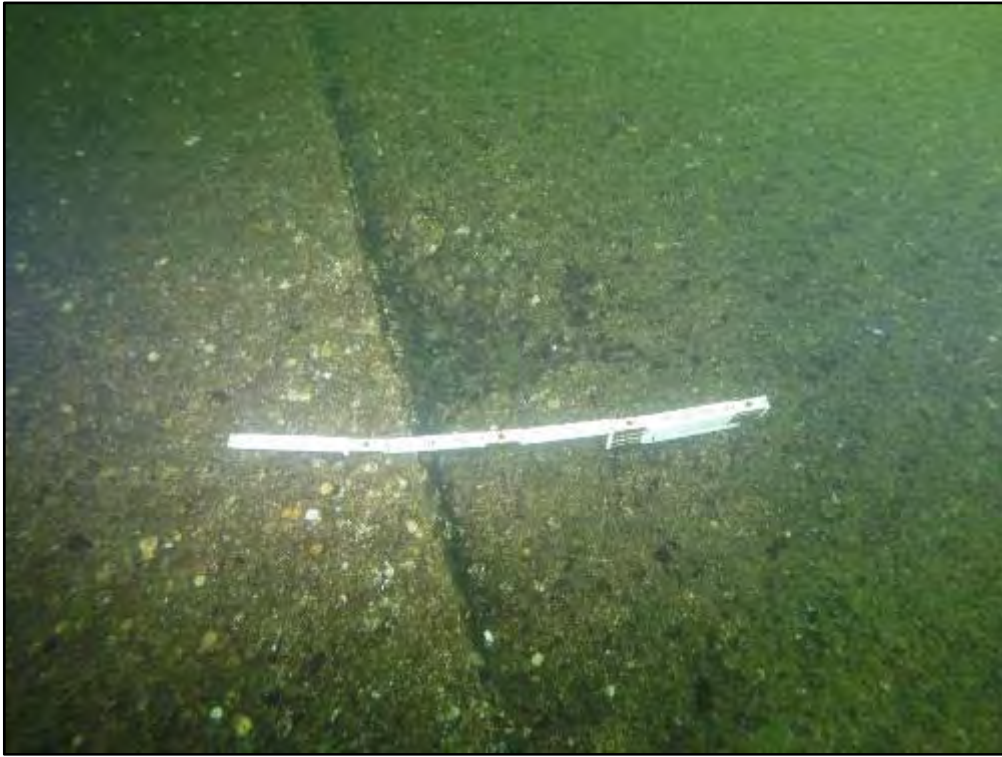
Photograph 10: Spall on Bottom Slab at Expansion Joint

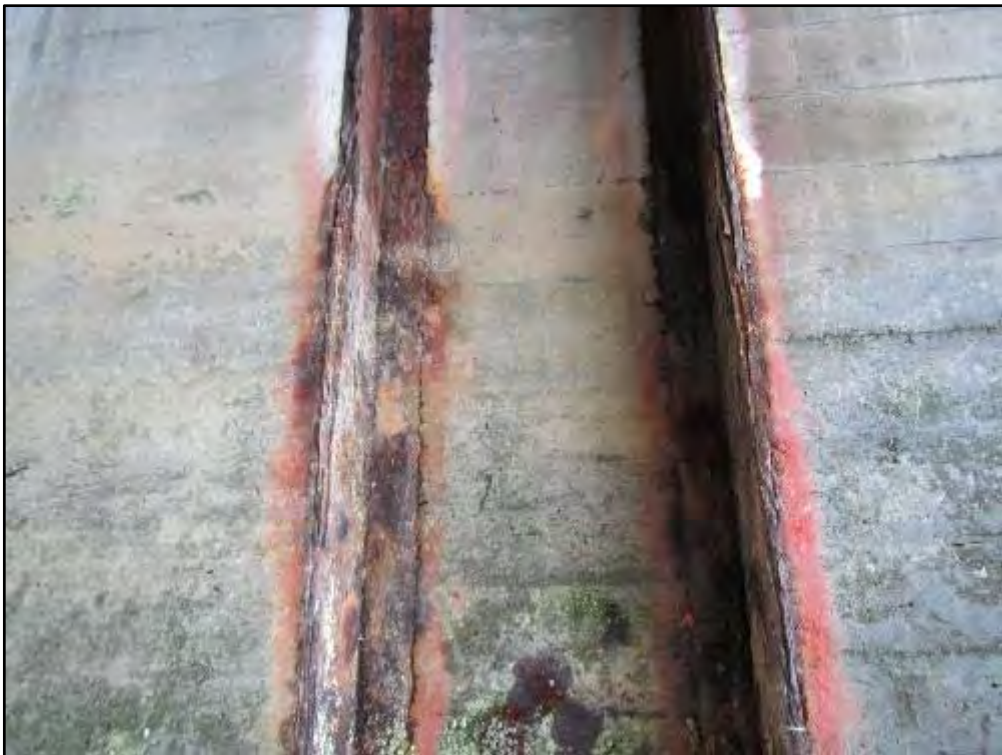
Photograph 11: Stoplog Cutout with Moderate Corrosion

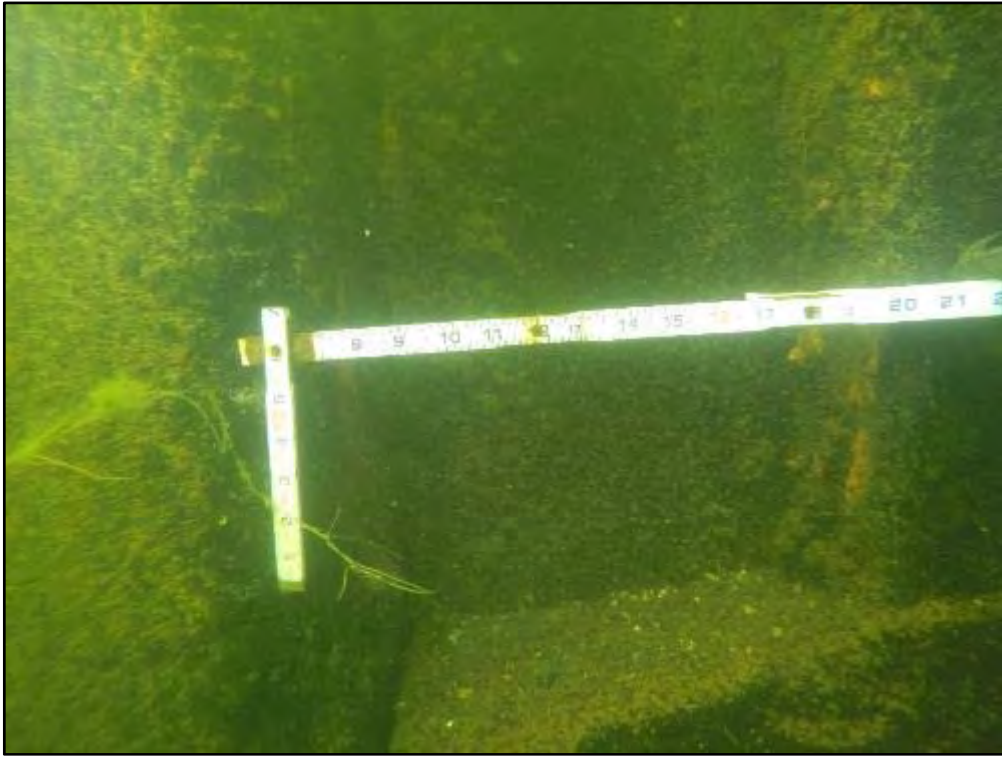
Photograph 12: Typical Stoplog Cutout Underwater on Upstream Side

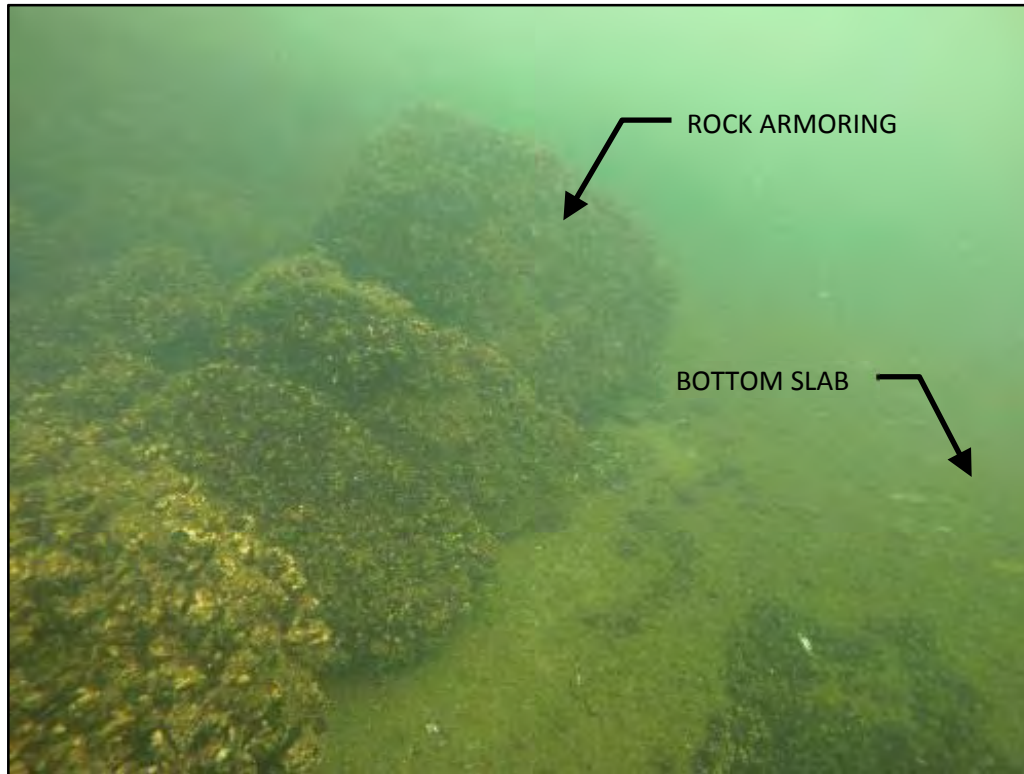
Photograph 13: Typical Rock Armoring along Downstream Edge of Spillway

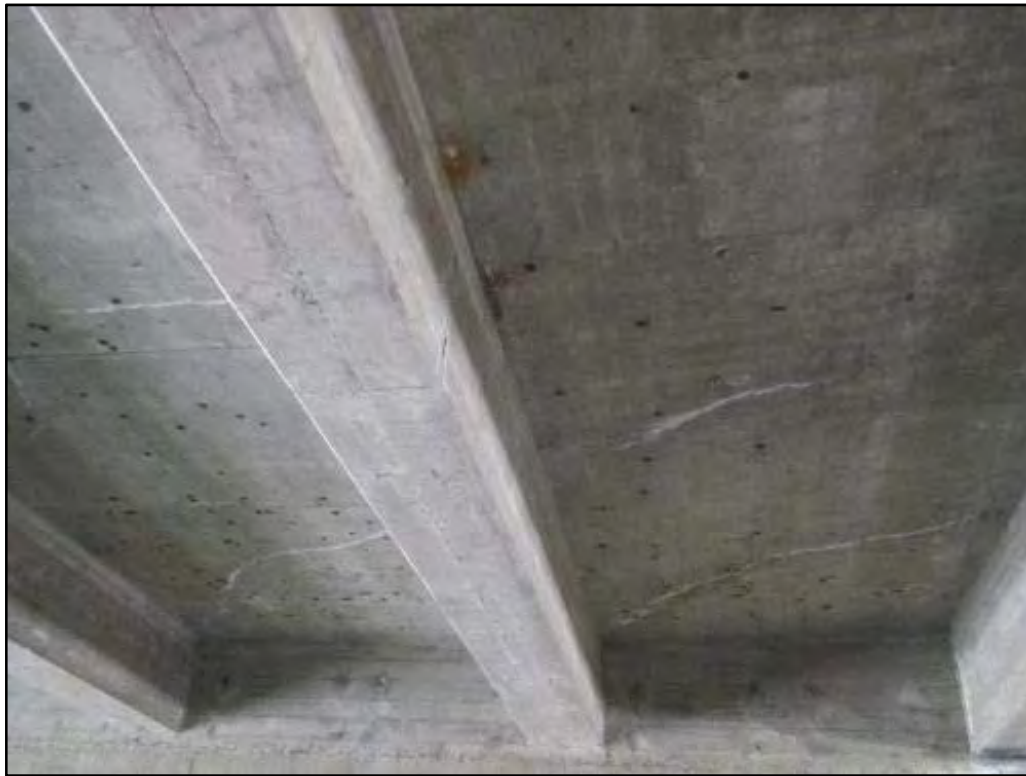
Photograph 15: Typical Girders and Deck Soffit – West Channel

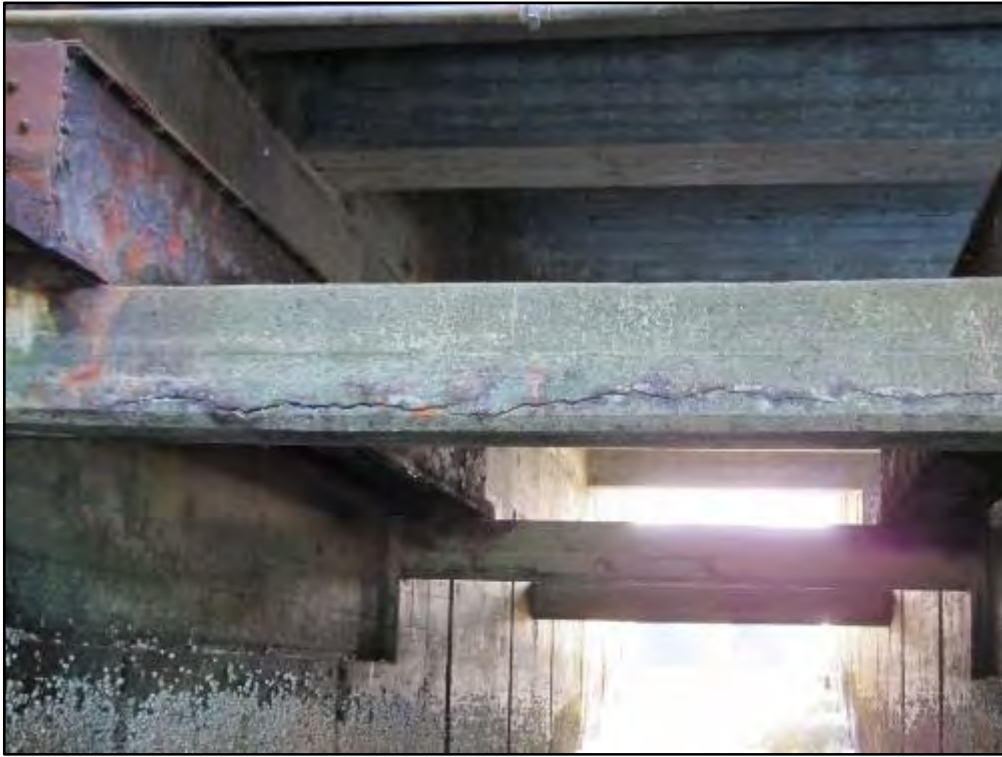
Photograph 17: Typical Closed Corrosion Spall on Fish Channel Crossbeam

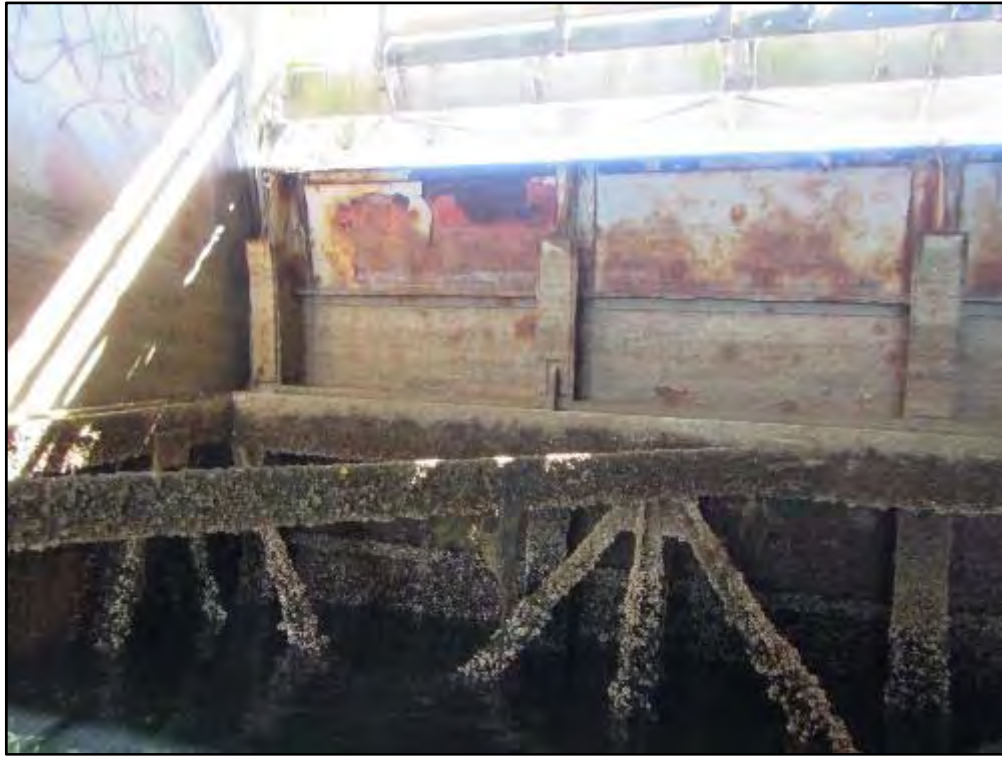
Photograph 19: Inlet Side of West Radial Gate.

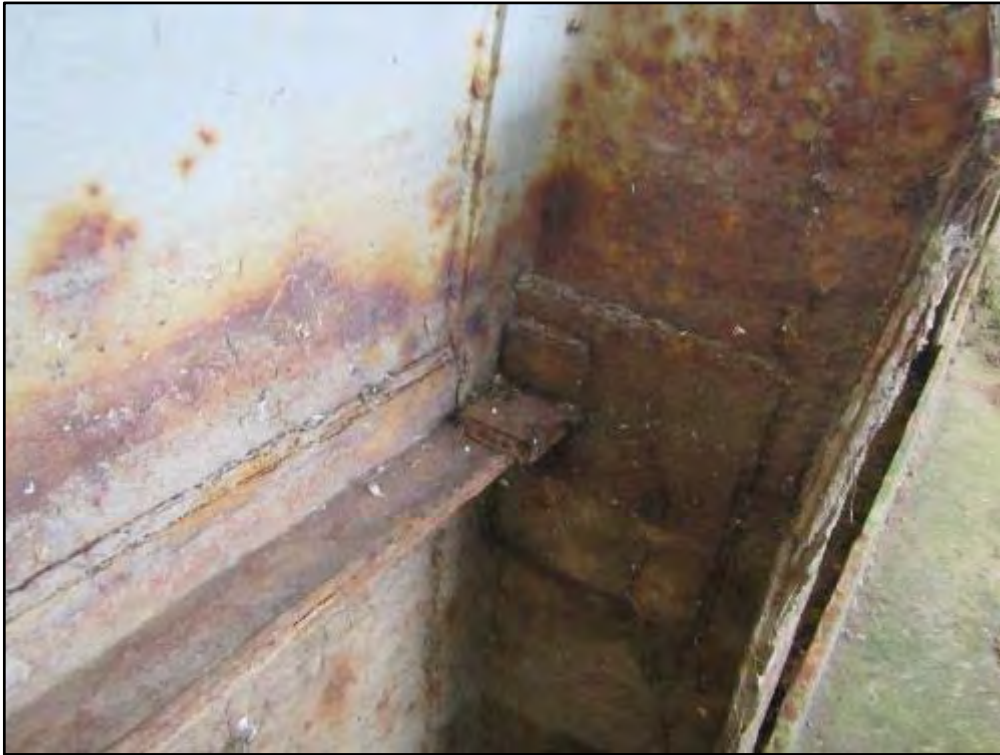
Photograph 20: Moderate Corrosion on Radial Gate Above Water

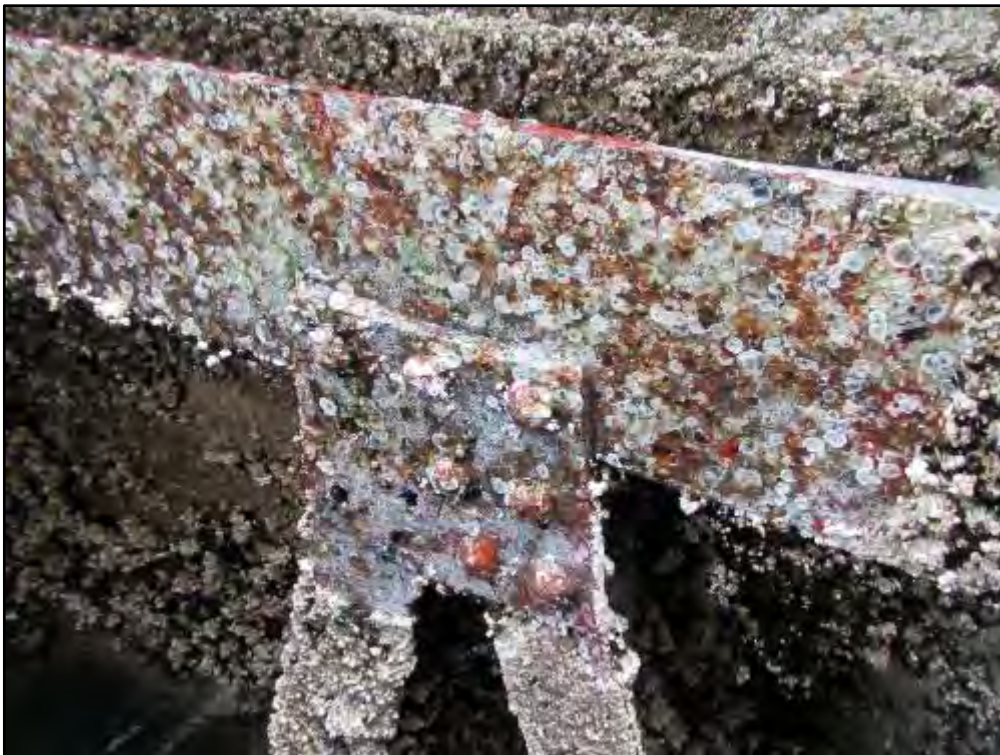
Photograph 21: Minor Corrosion on Radial Gate in Intertidal Zone

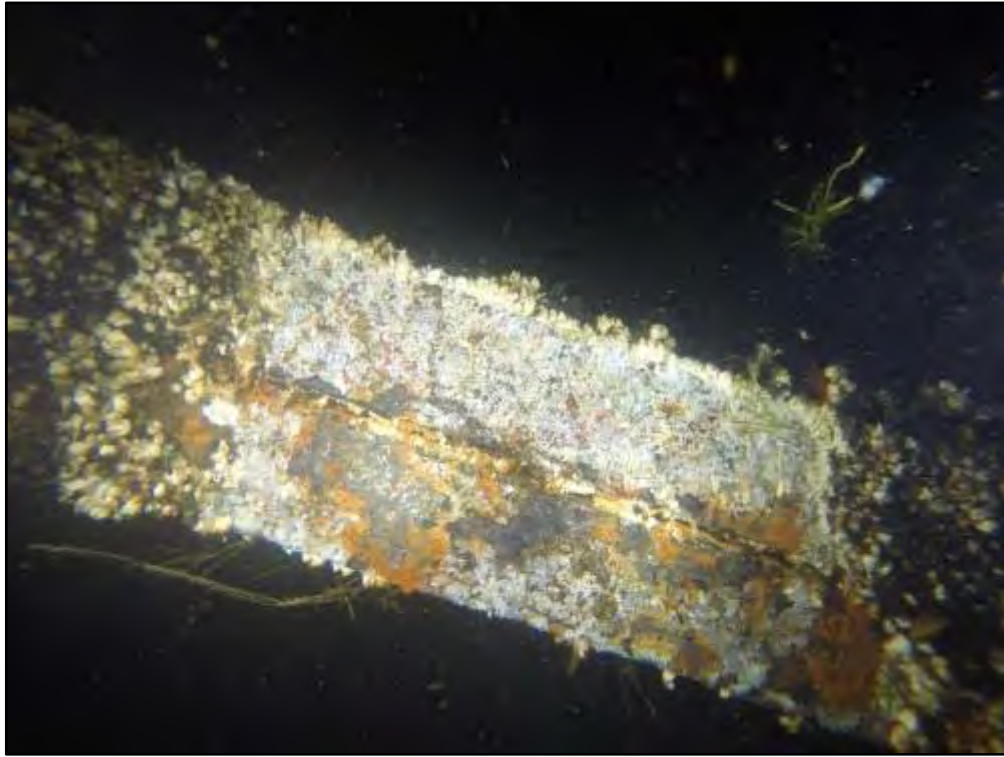
Photograph 22: Minor Corrosion on Radial Gate Underwater

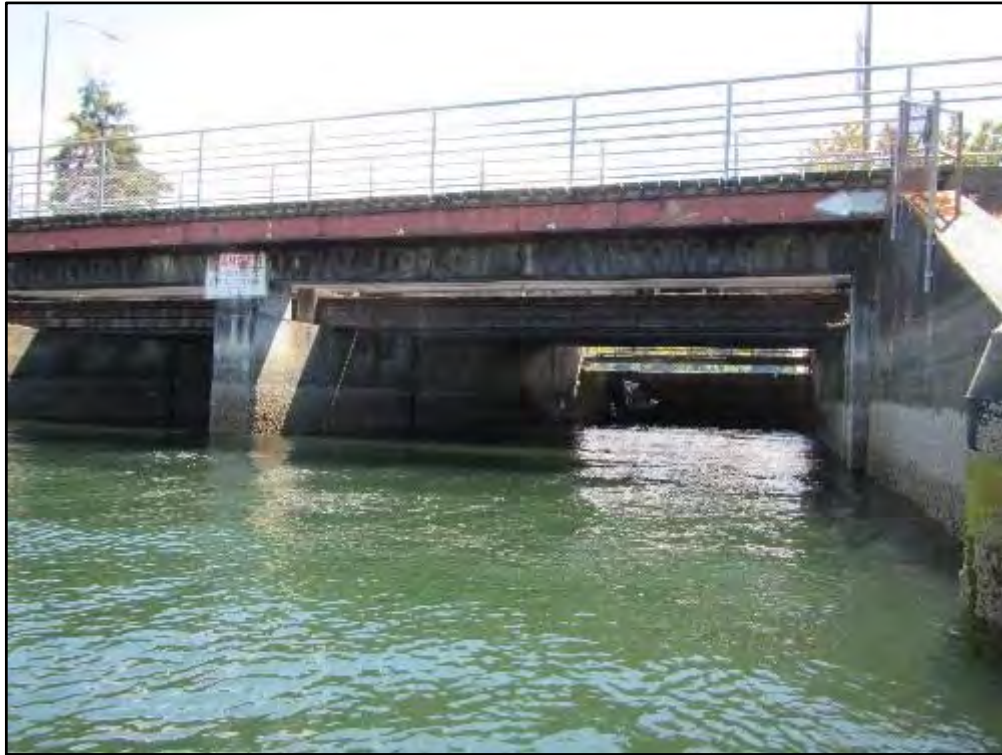
Photograph 23: Elevation of the Walkway, Looking South

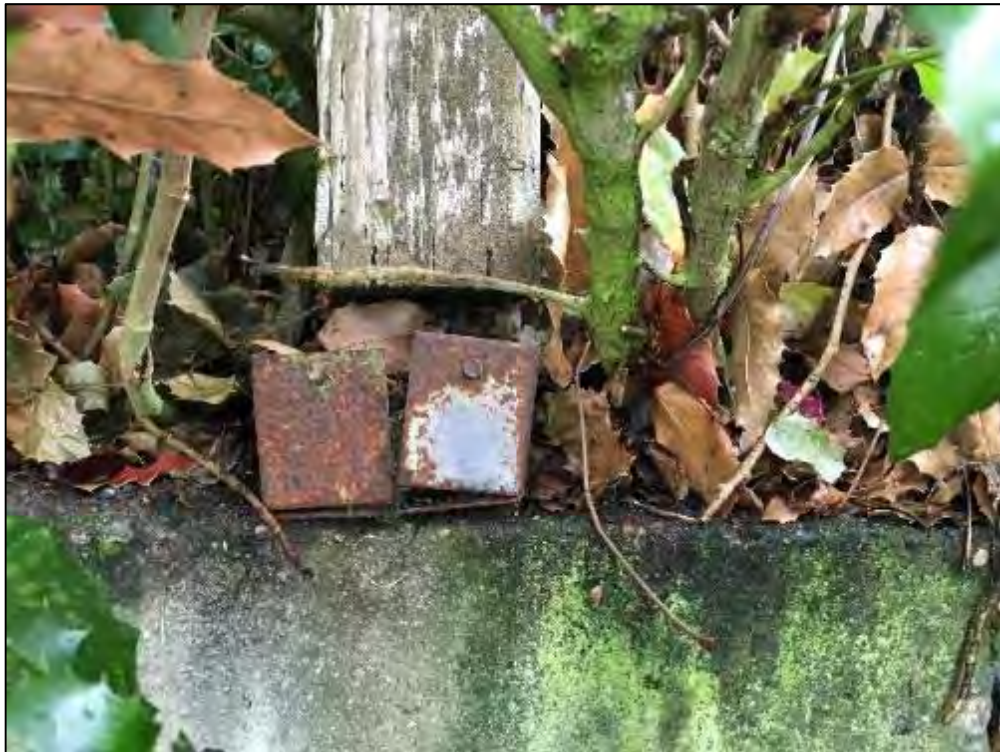
Photograph 26: Timber Post Exhibits Rot and Section Loss and the Steel Connection is Corroded and Deformed

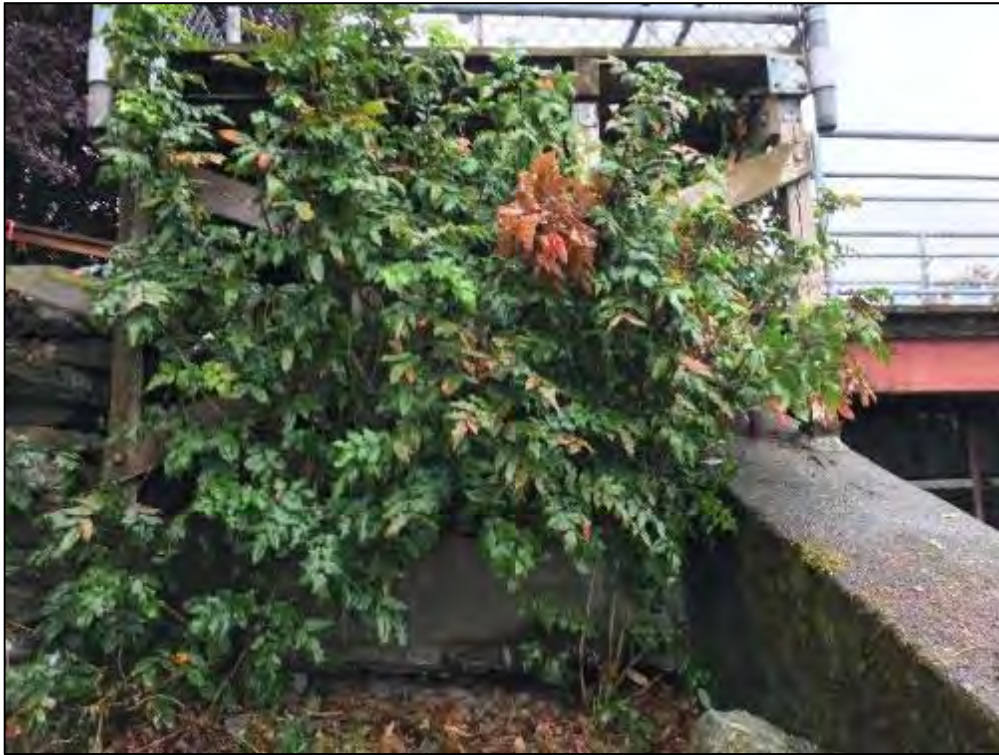
Photograph 27: The Concrete Retaining Wall Supporting the Walkway Exhibits Moderate Undermining

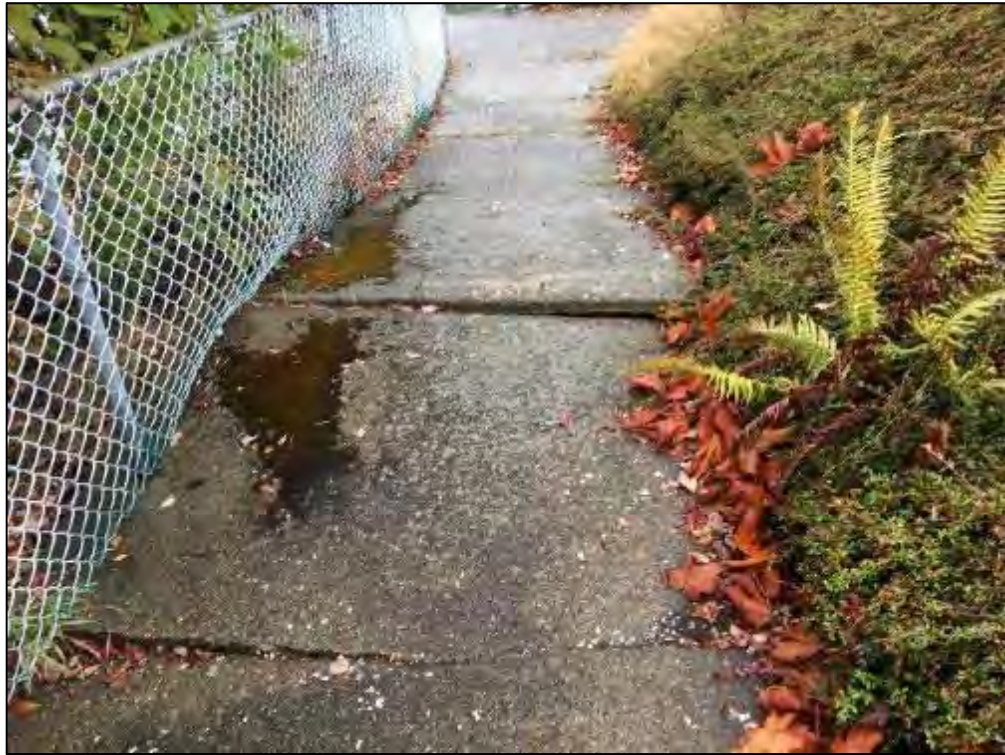
Photograph 28: The Concrete Ramp Exhibits a Large Bump Extending Approximately 10 Feet and has a Vertical Differential of Approximately 12 Inches.

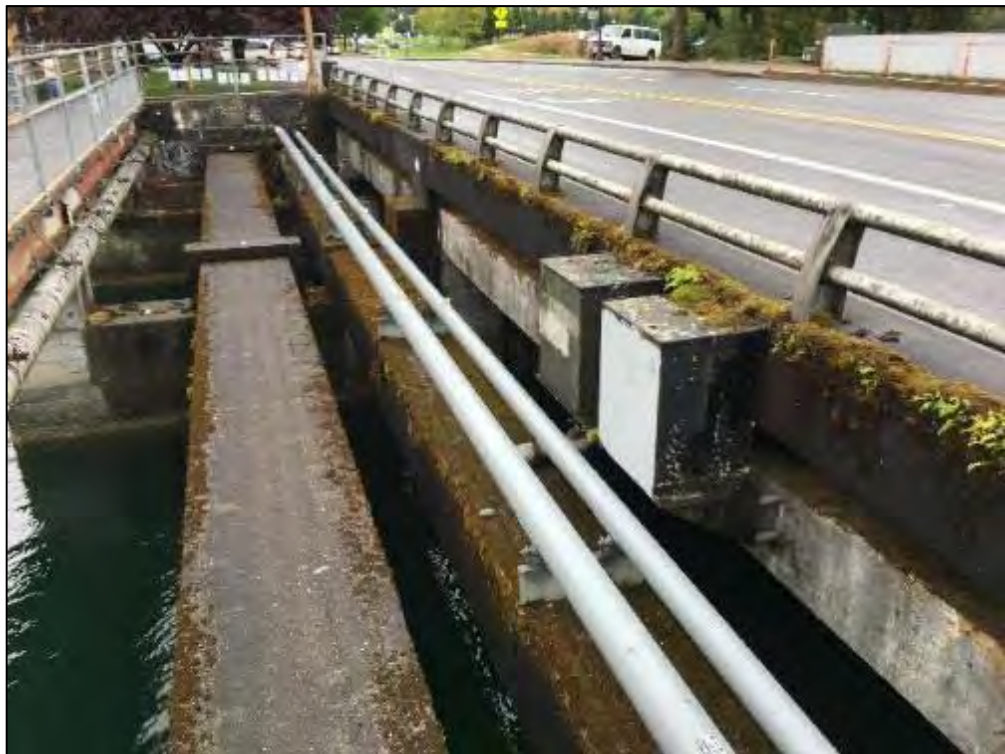
Photograph 29: Typical Condition of the Utilities Crossing the Dam

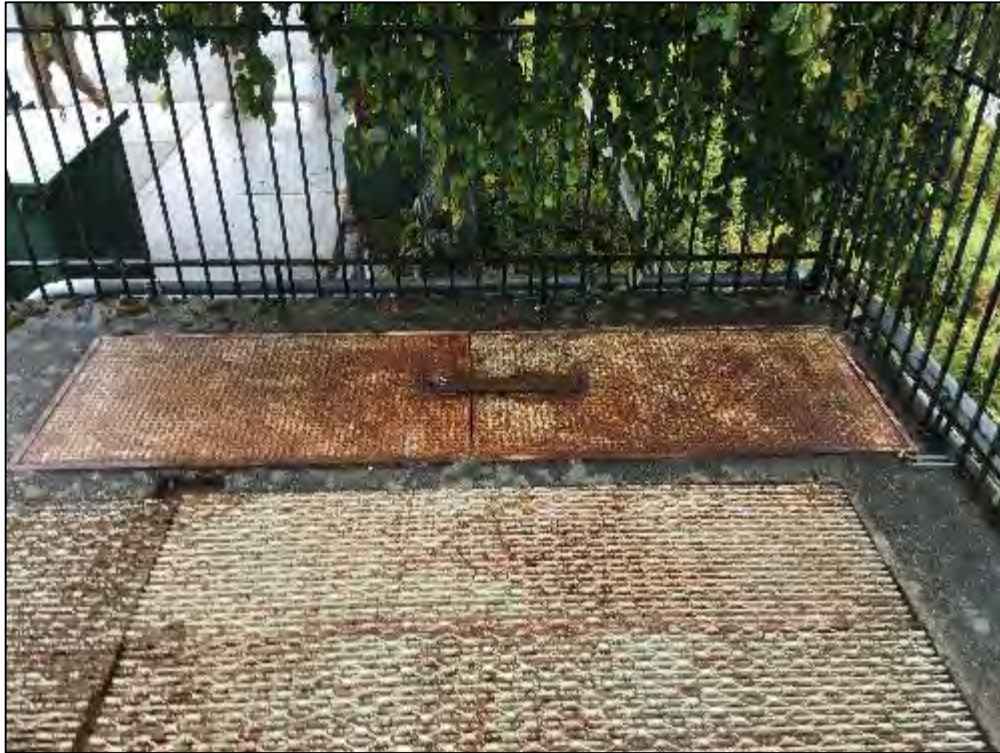
Photograph 30: Condition of the Stillwell Hatch Cover

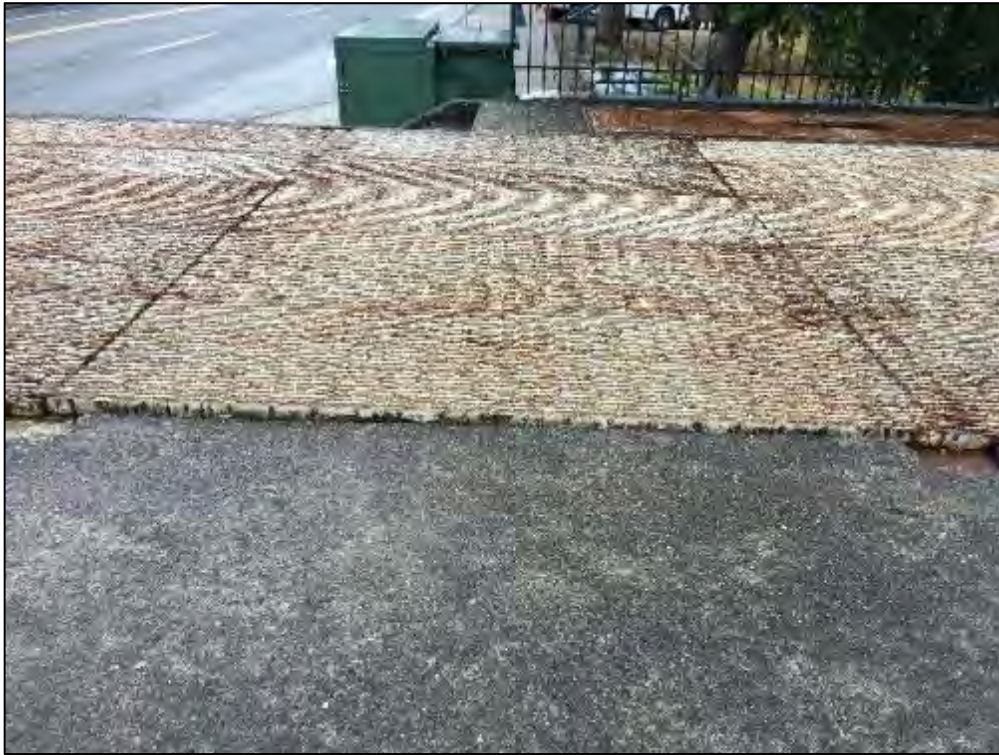
Photograph 31: Typical Condition of the Steel Grating on the Elevated Platform

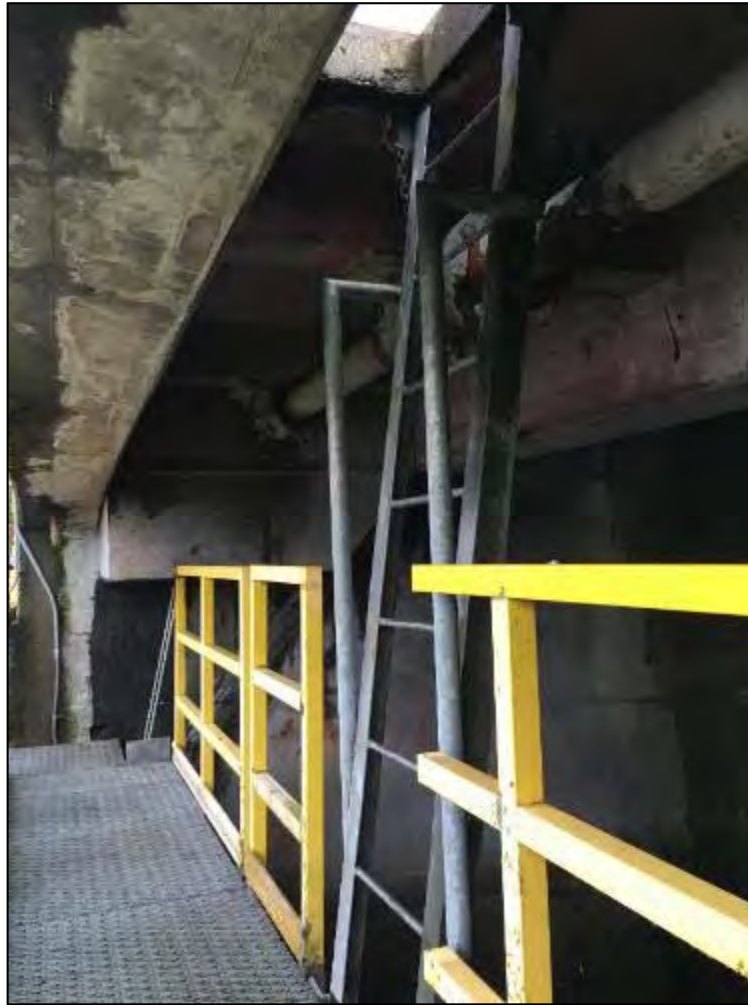
Photograph 32: Condition of the Catwalk Access Ladder
