Capitol Lake Dam Preservation
Project Number: 2016-931

Comprehensive Assessment Report

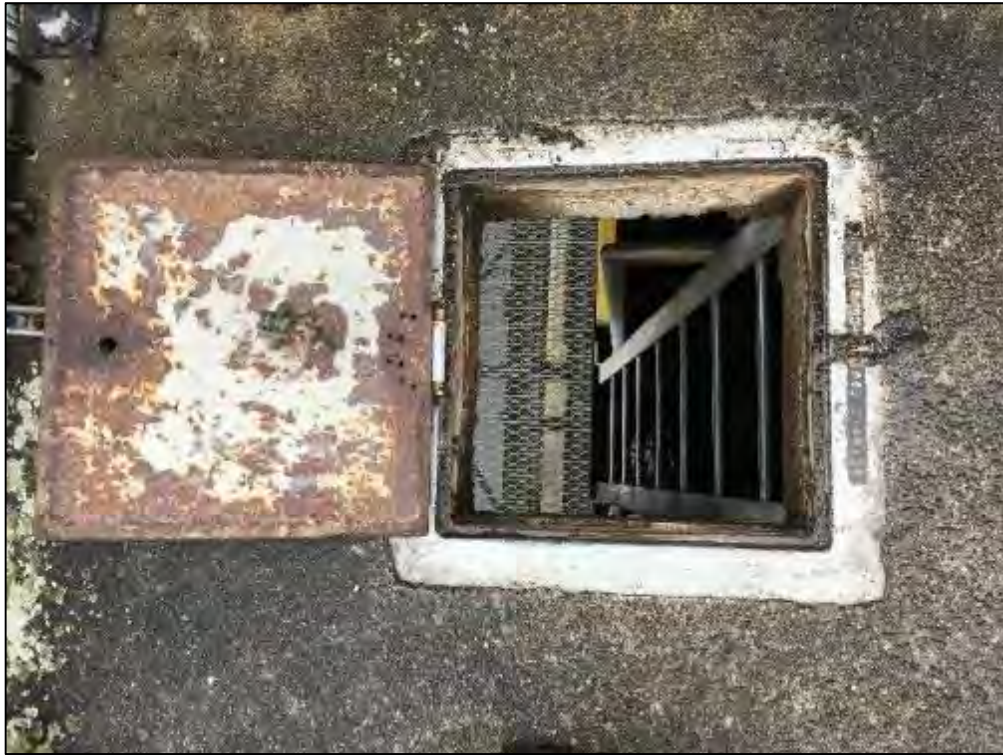
Photograph 33: Catwalk Access Ladder Opening

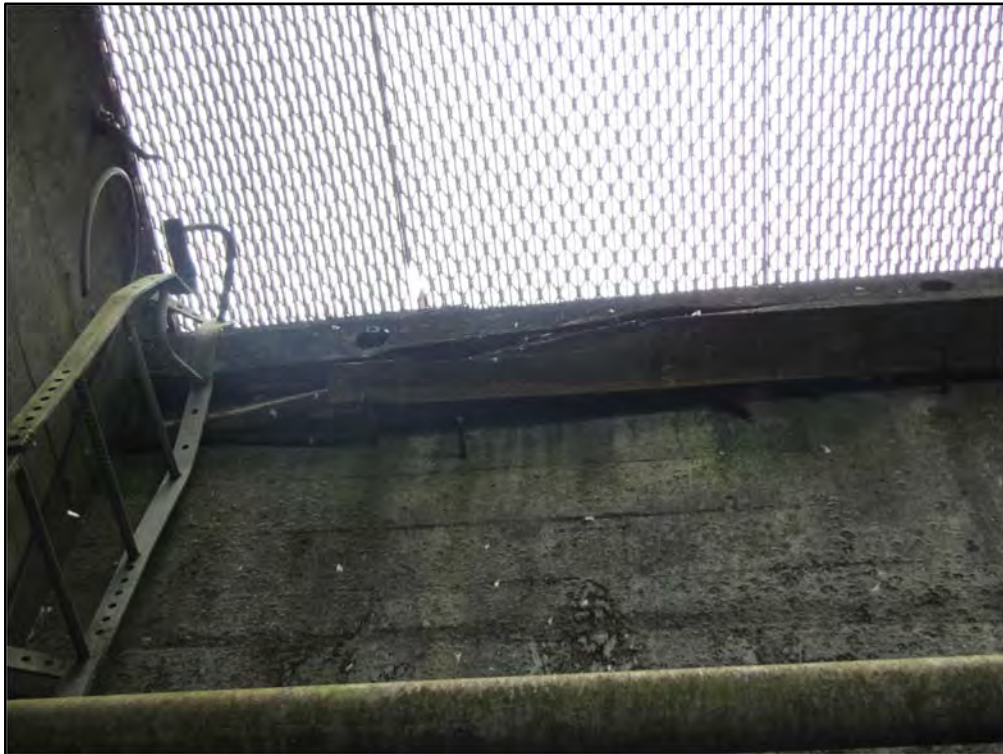
Photograph 34: Crushed Timber Cushion and Deformed Radial Gate Access Ladder

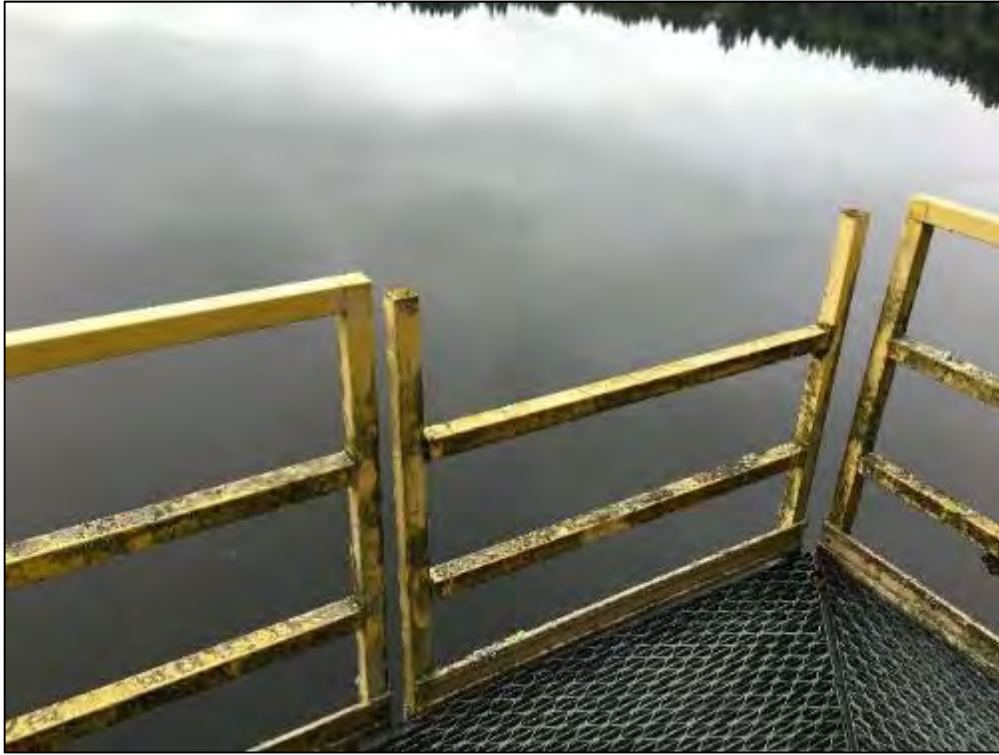
Photograph 35: Missing Top Rail Near the Center of the Catwalk

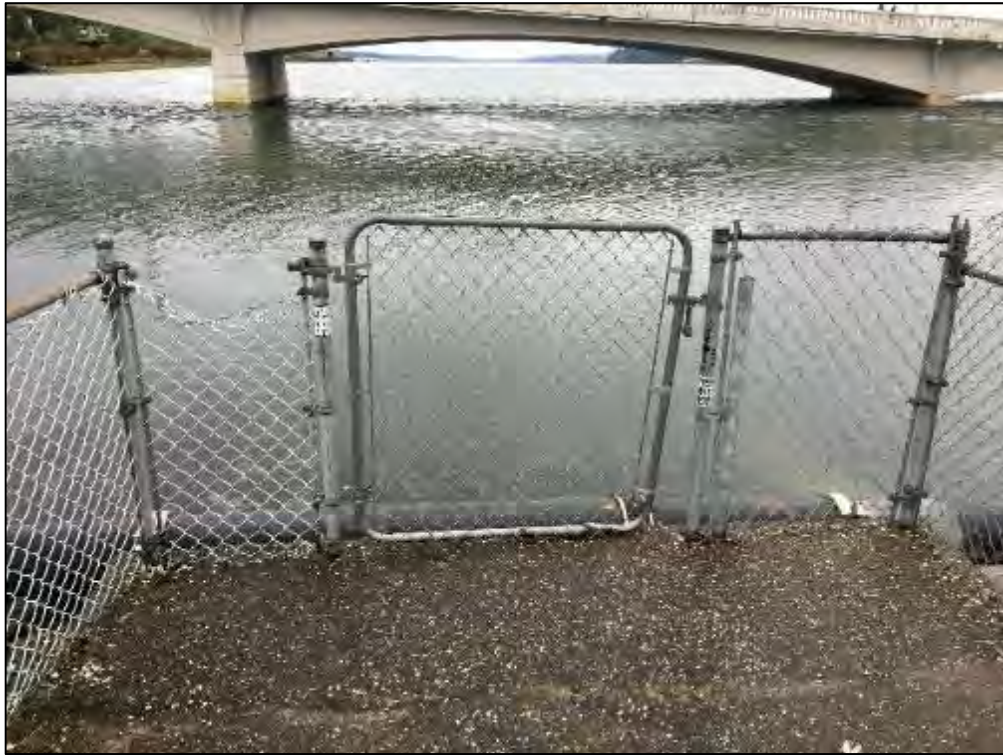
Photograph 36: Missing Top Rail on the Concrete Ramp

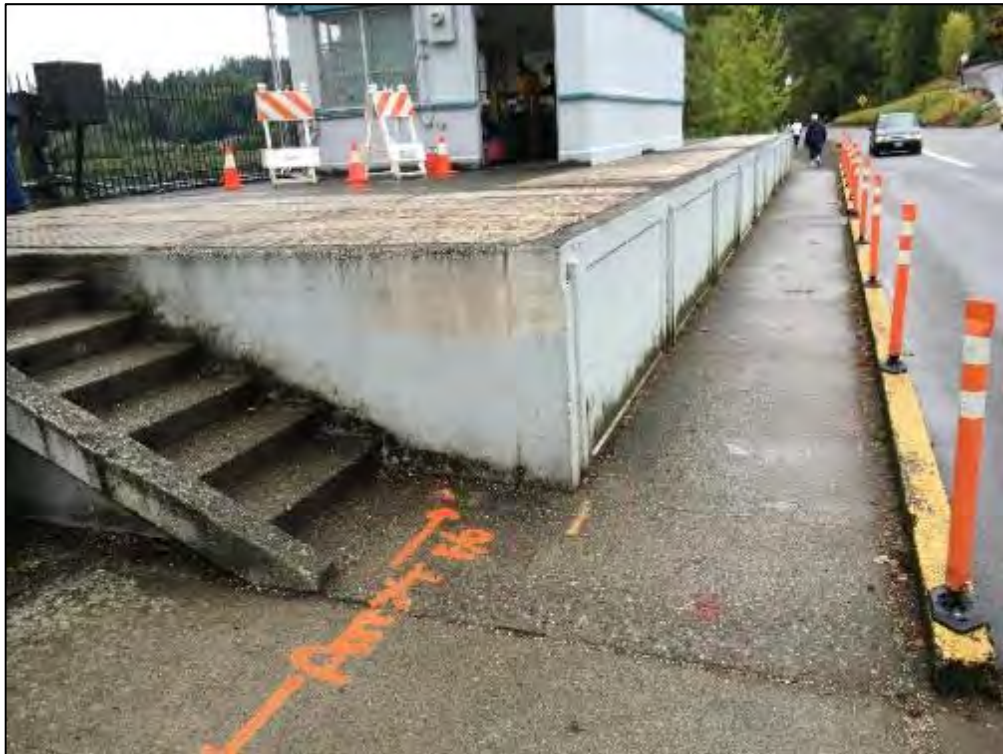
Photograph 37: No Handrail Along the Edge of the Elevated Platform and Steps

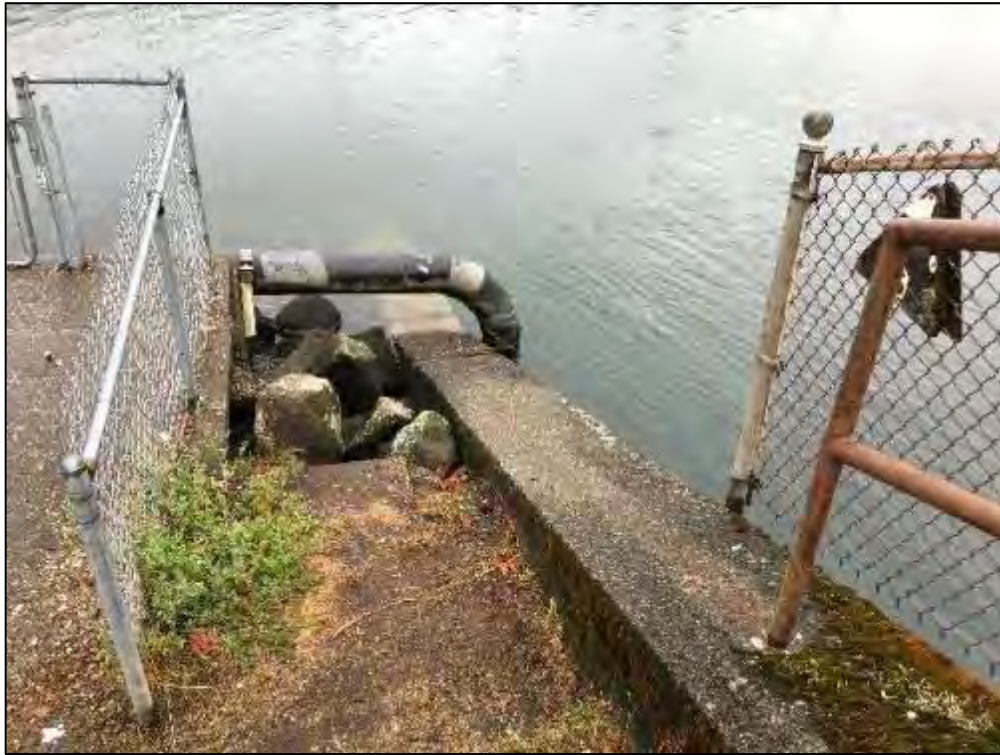
Photograph 38: No Fence Between Concrete Ramp and Wingwall Fence

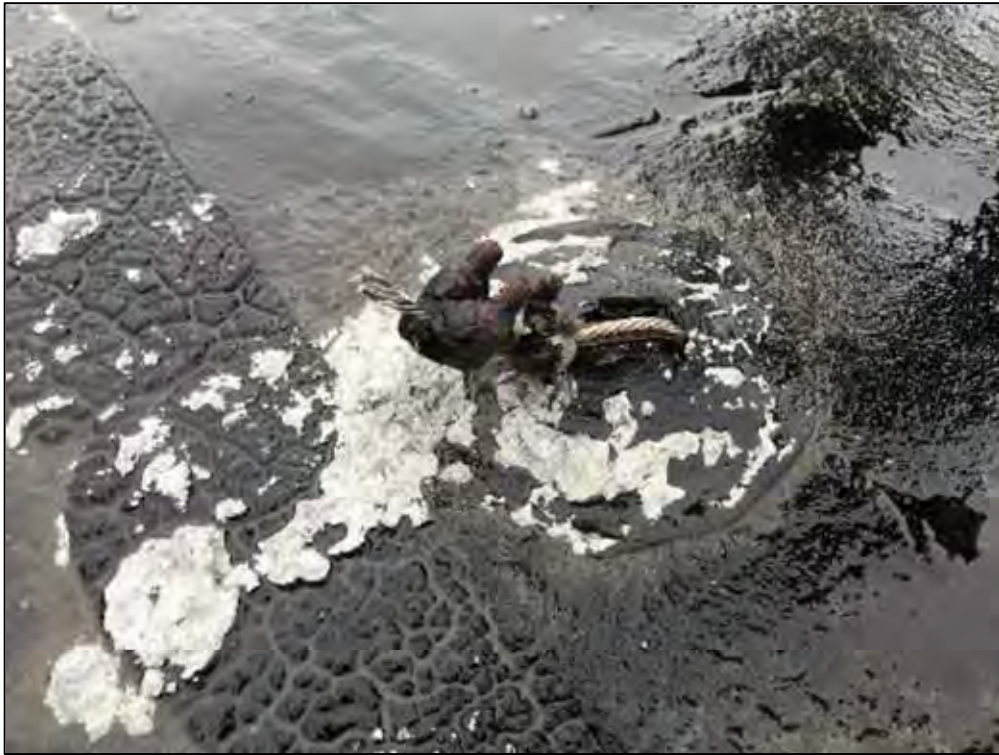
Photograph 39: Alligator Cracking of the Control Room's Roof Membrane and a Failed Fall-Protection Anchor Point

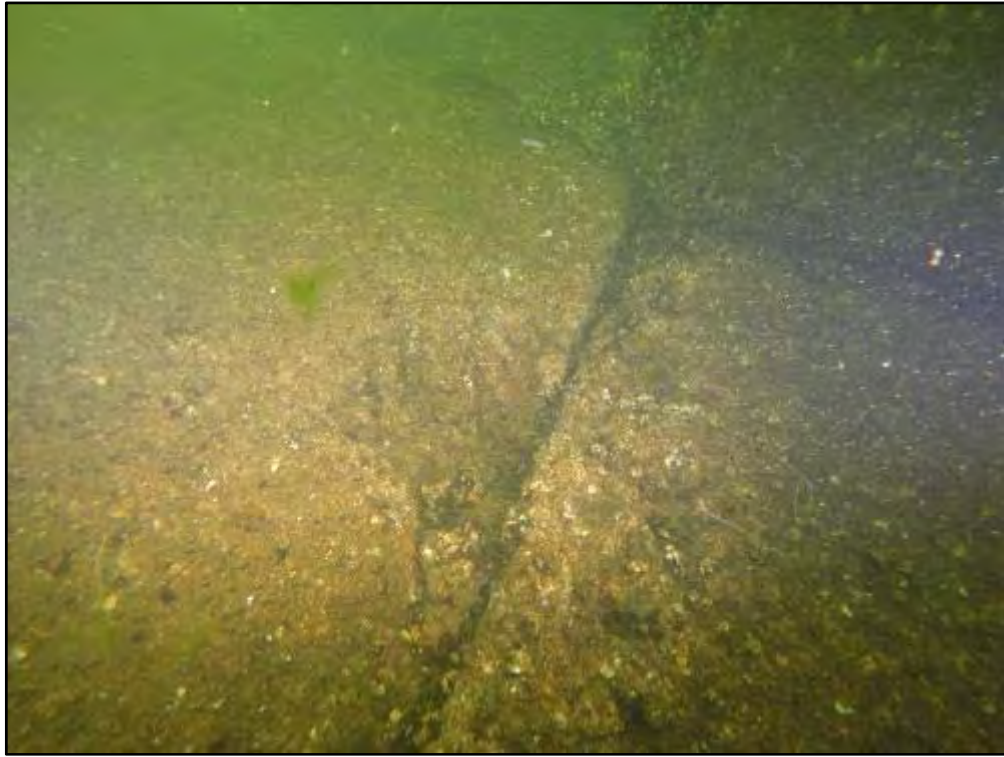
Photograph 46: Spall on Bottom Slab at Expansion Joint

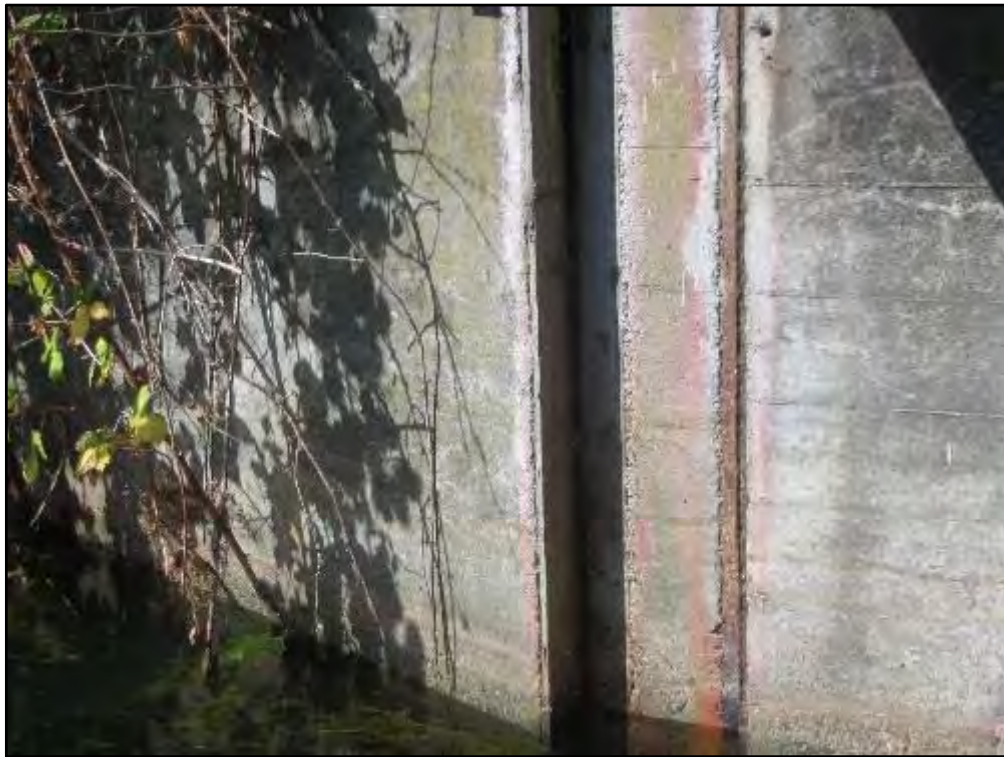
Photograph 47: Stoplog Cutout on West Upstream Abutment

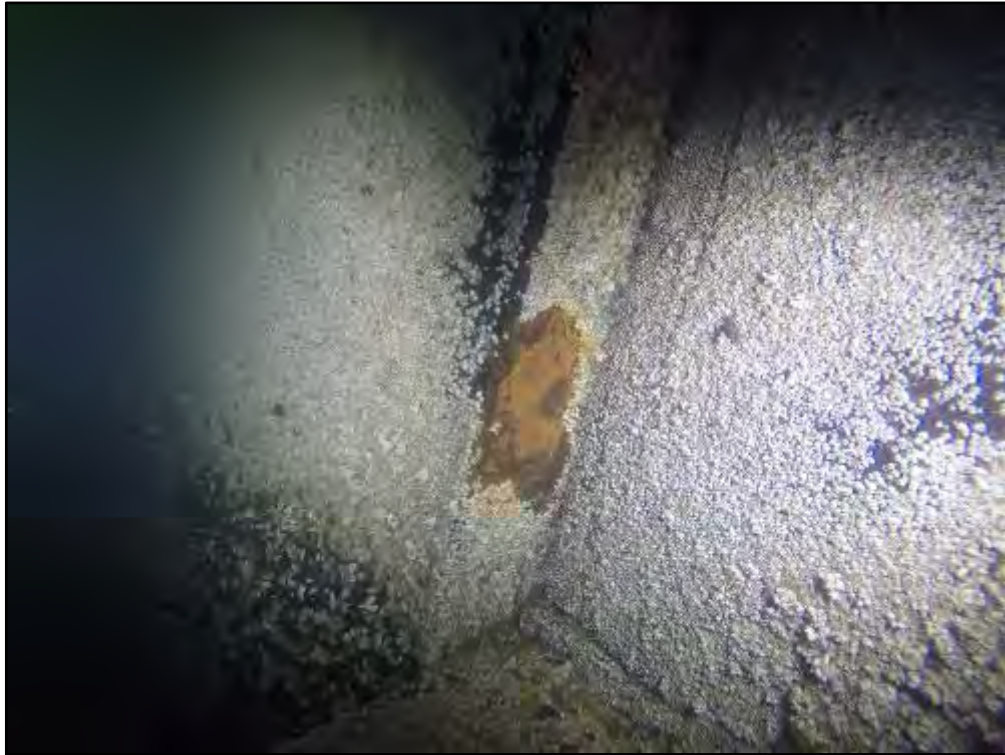
Photograph 48: Moderate Corrosion on Stoplog Cutout on Downstream Side

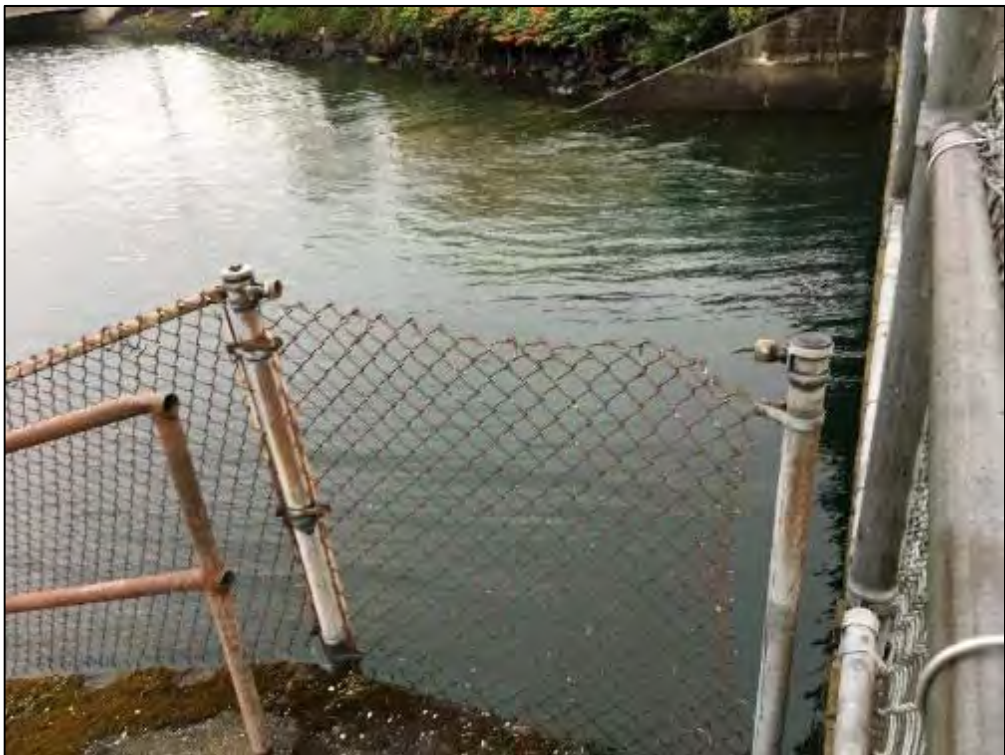
Photograph 49: Missing Top Rail on the Northwest Wingwall Fence

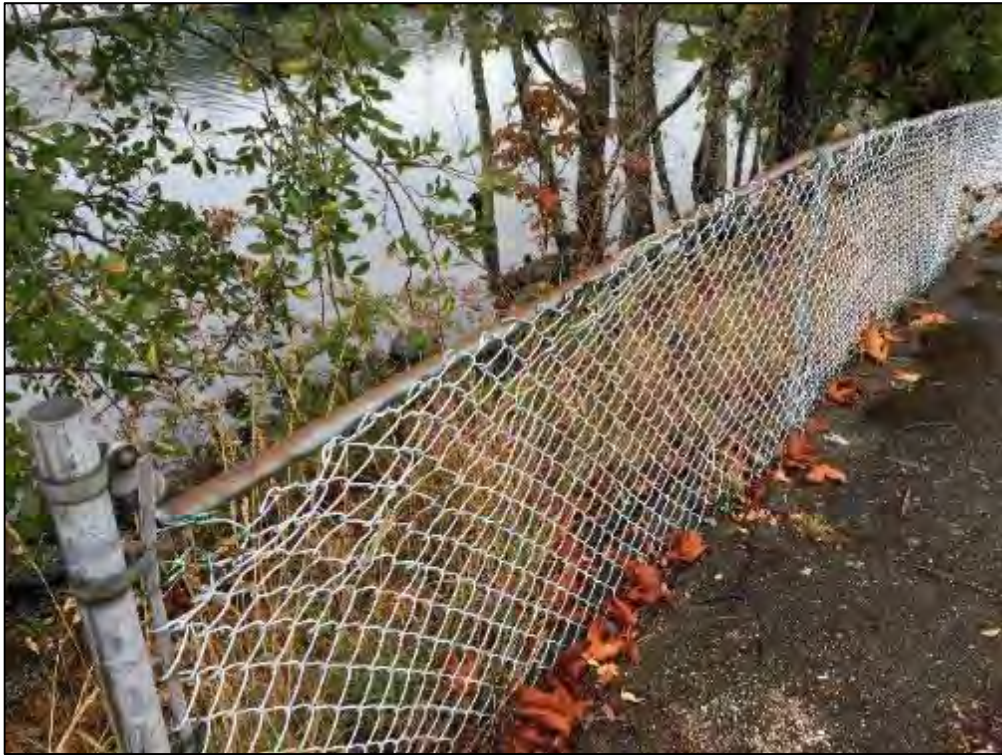
Photograph 50: Disconnected Top Rail at the West end of the Concrete Ramp

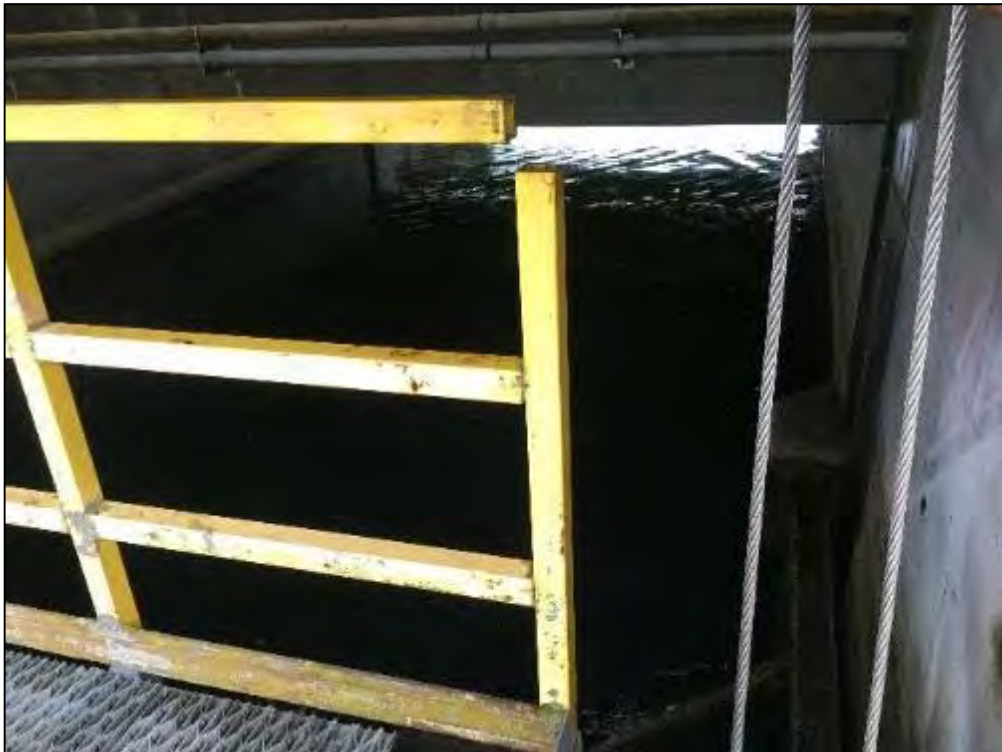
Photograph 51: Missing Catwalk Guardrail Elbow on the East Side of the West Spillway

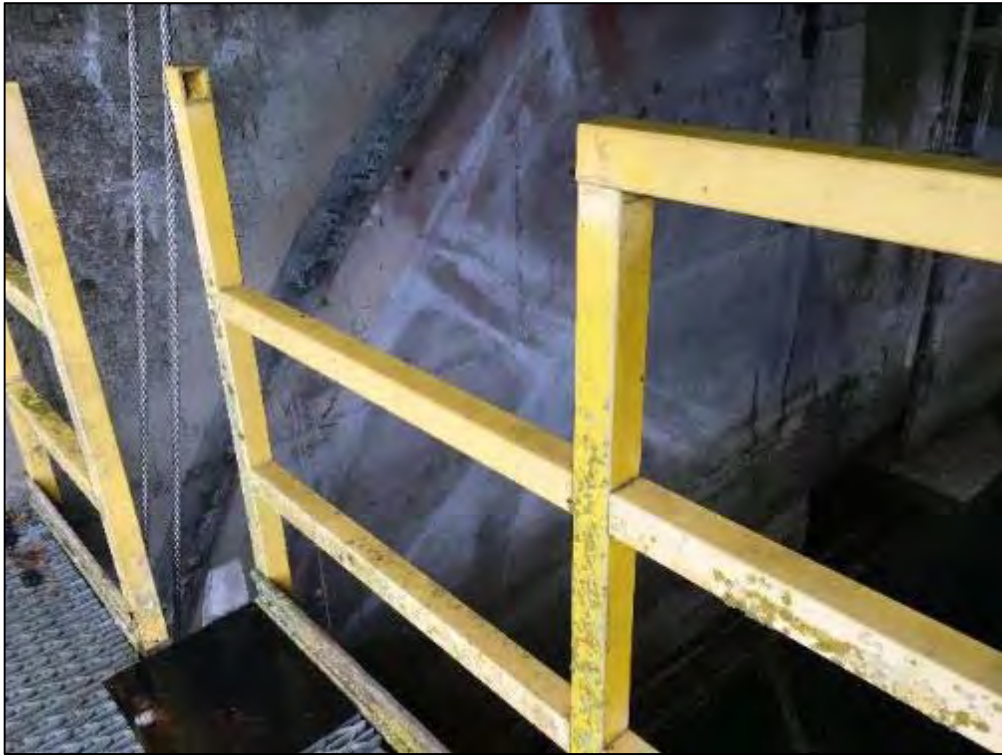
Photograph 52: Missing Catwalk Guardrail Top Rail on the West Side of the West Spillway

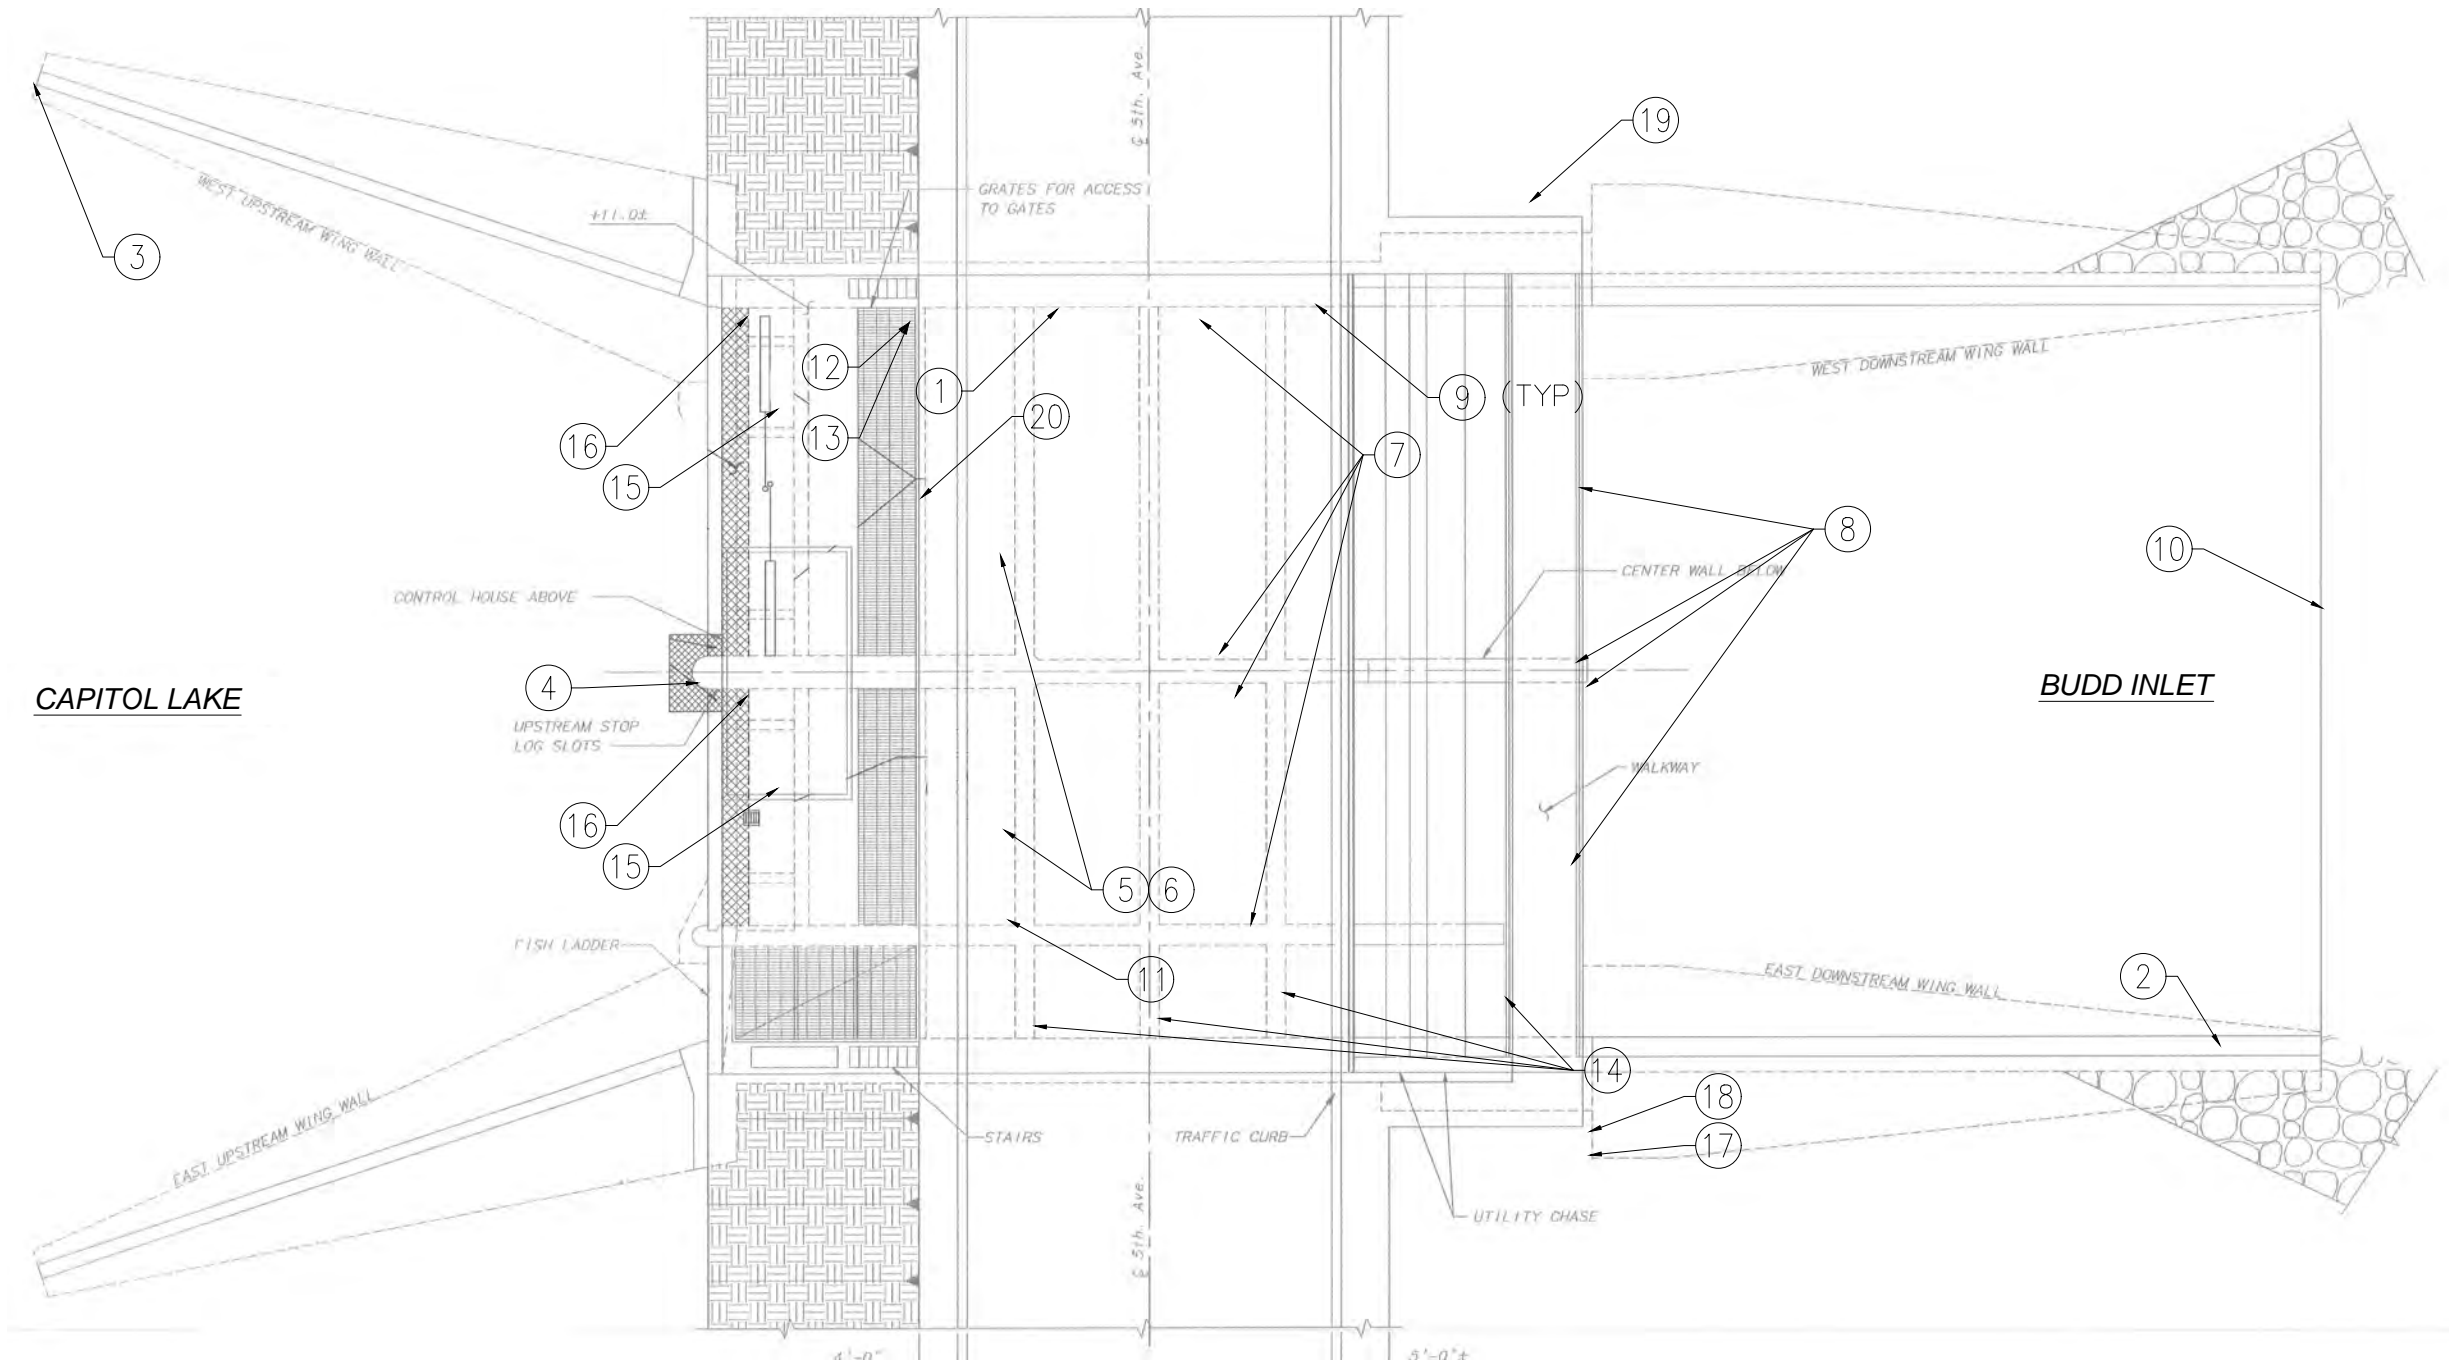
1 PLAN
FIG-01 SCALE: 1" = 10'

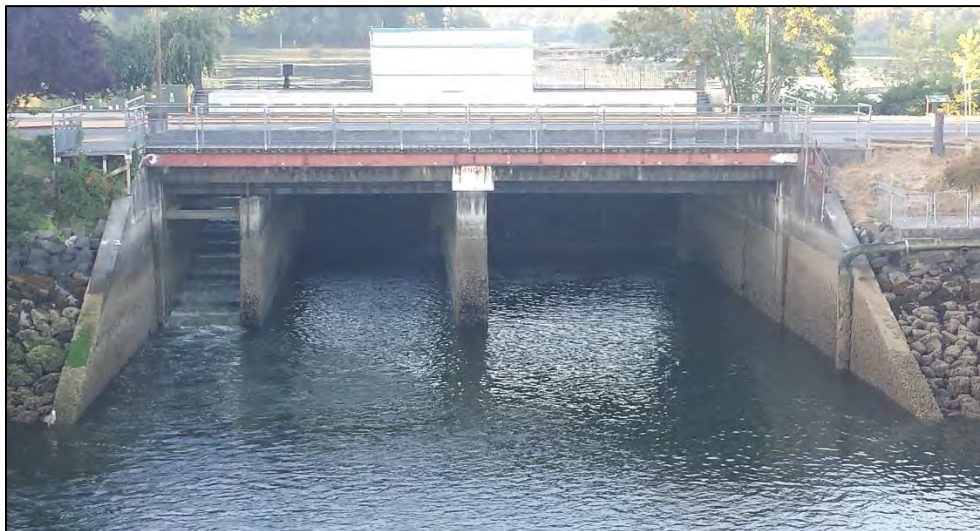
Figure 1: Overview of Dam from the Budd Inlet Side

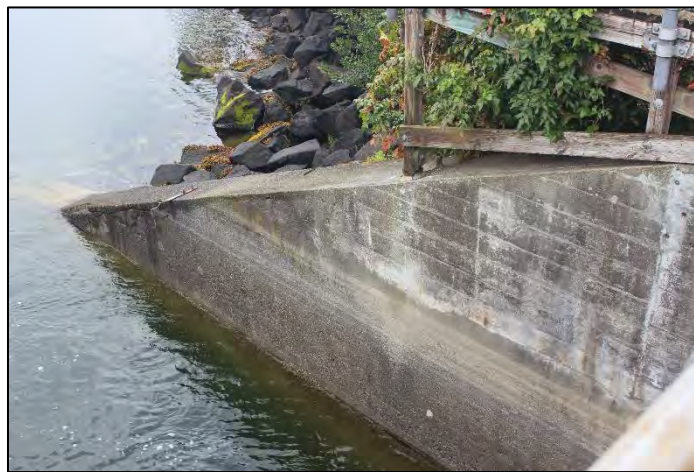
Figure 2: East Wing Wall – Budd Inlet Side

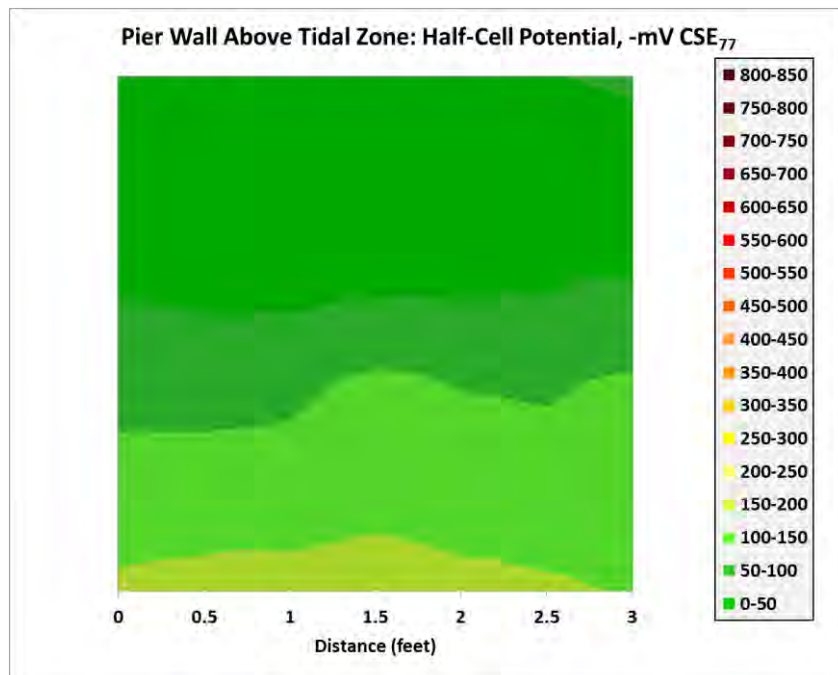
Figure 16: West Channel Pier Wall – Above Tidal Zone – 3’ x 3’ Grid

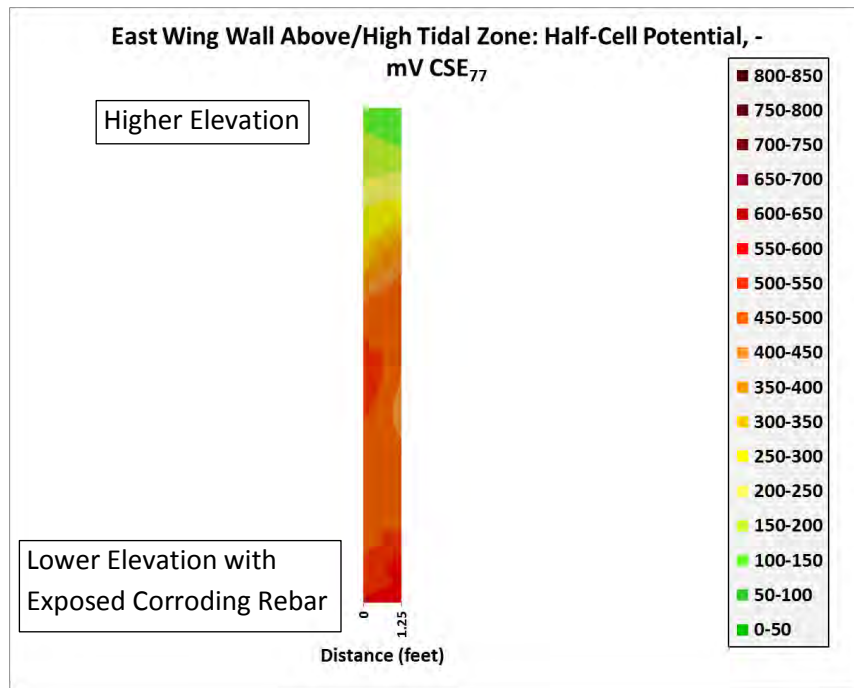
Figure 21: Budd Inlet – East Wing Wall Top Surface – Above/High Tidal Zone – 1.25' x 12.5' Grid – Exposed Rebar Exhibiting Corrosion

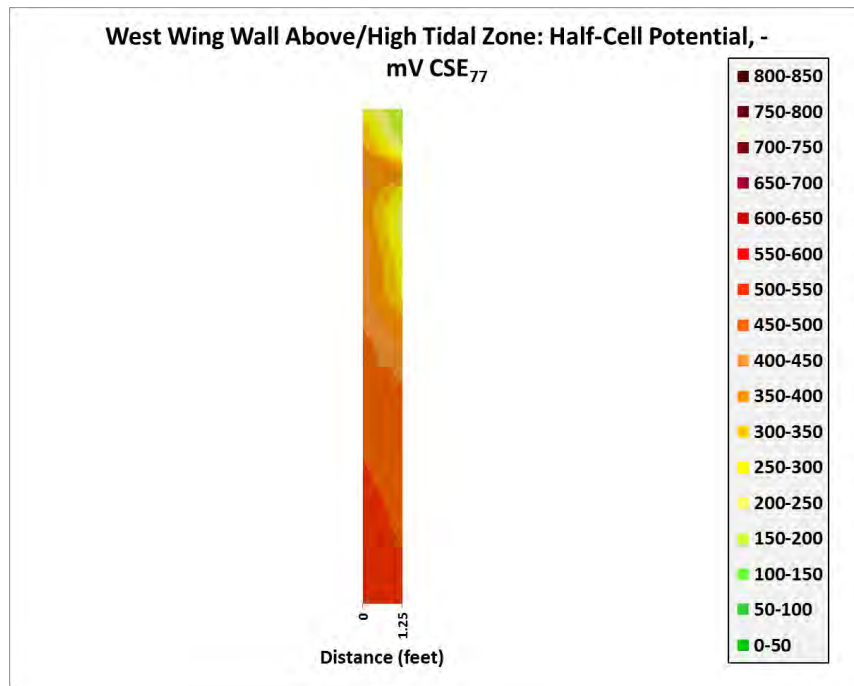
Figure 22: Budd Inlet – West Wing Wall Top Surface – Above/High Tidal Zone – 1.25' x 12' Grid

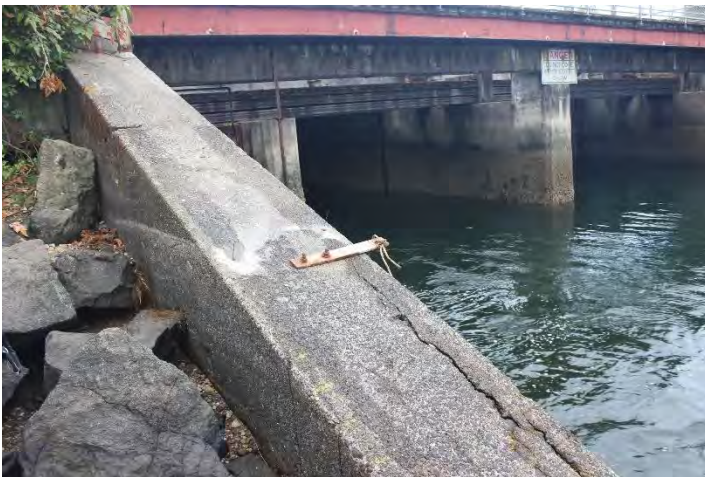
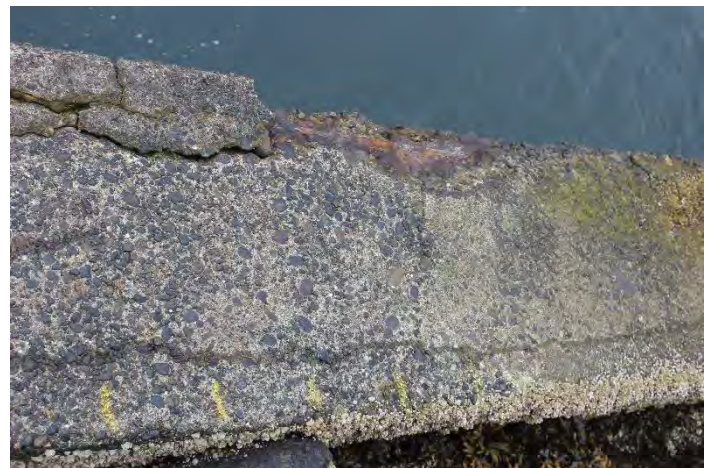
Figure 24: Half-Cell Potential Survey Site (East Wing Wall With Exposed Corroding Rebar)

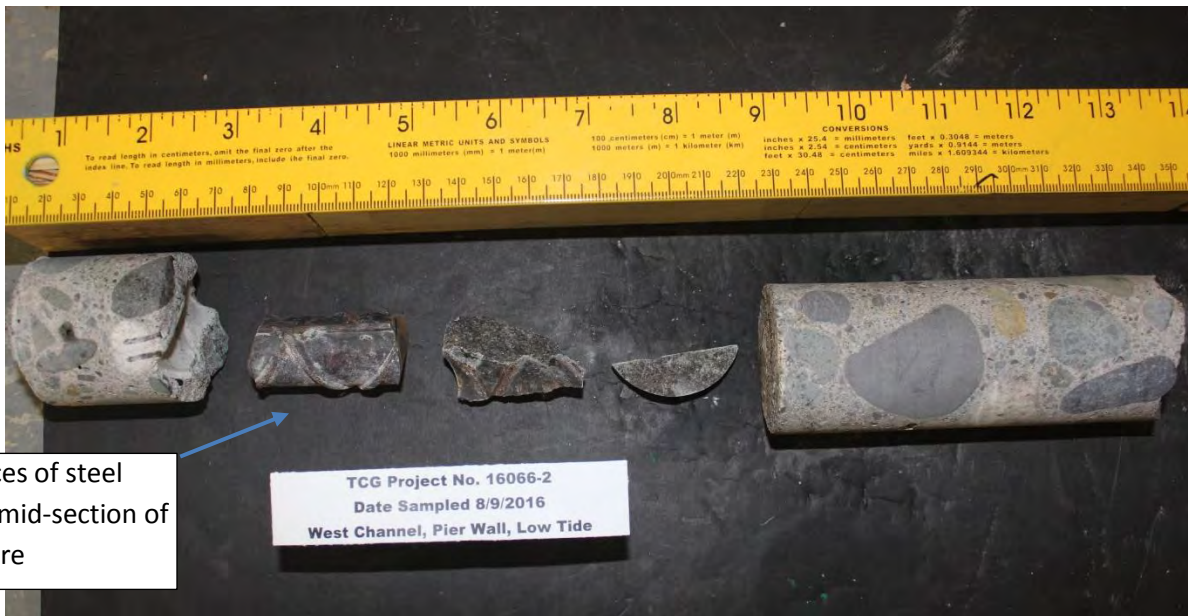
Broken pieces of steel rebar from mid-section of concrete core

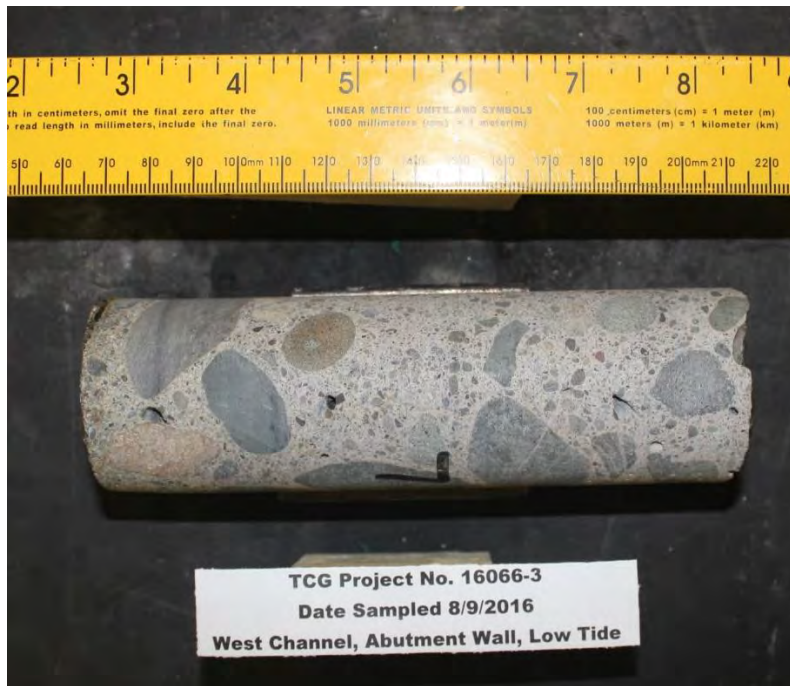
Figure 27: Sample 3 – Abutment Wall Low Tide

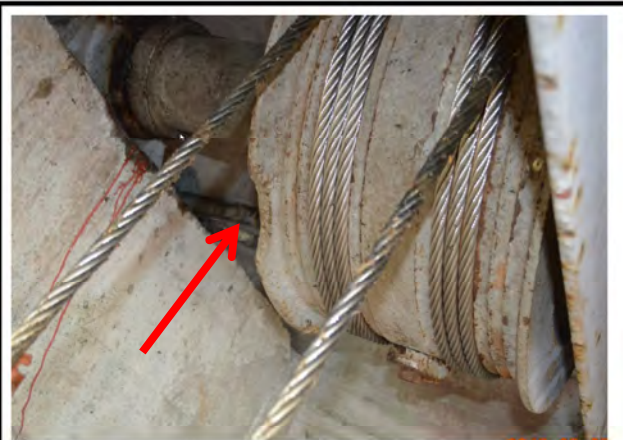
Figure 2-3 Drum Flange – West Gate

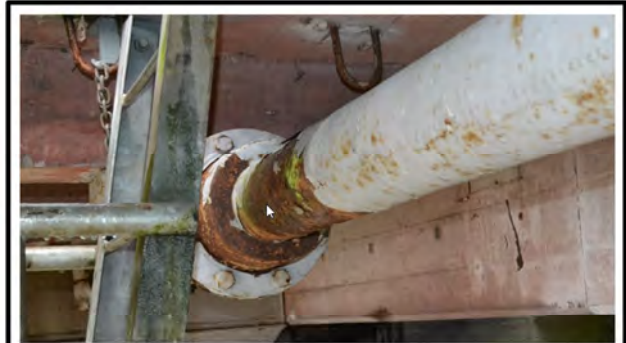
Figure 2-2 Shaft and Coupling Paint Degradation – East Gate

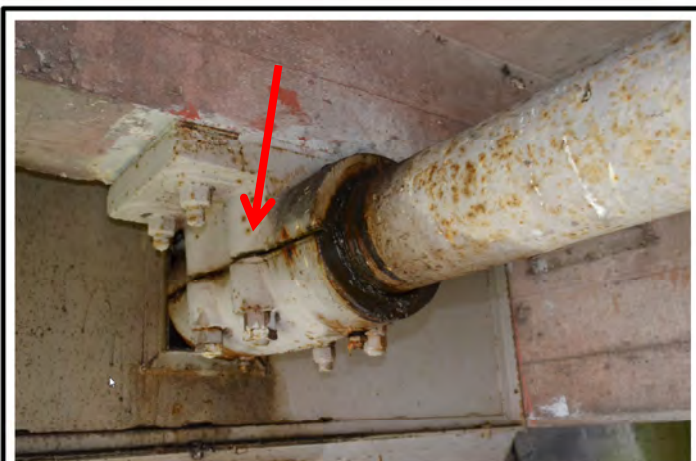
Figure 2-4 Bearing – Split Line Gap

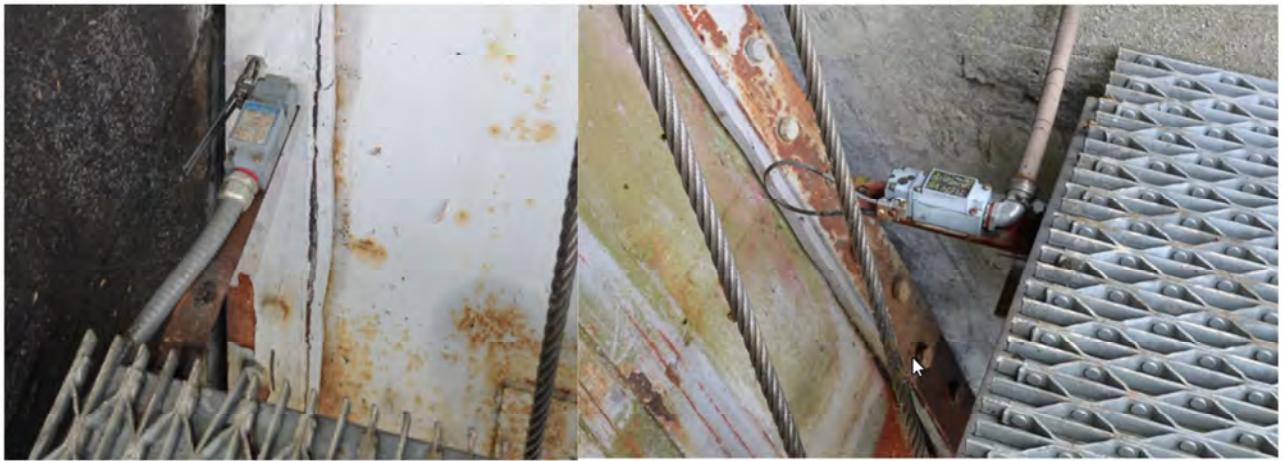
Figure 2-5 Back-up Limit Switches – Tide Gates

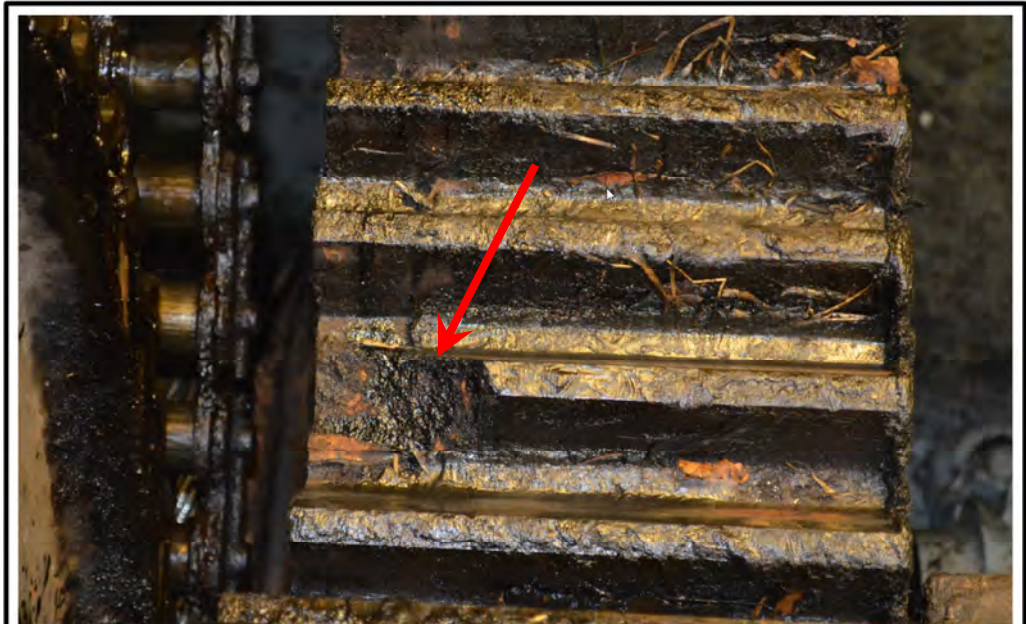
Figure 2-6 Broken Tooth – Pinion Gear – East Tide Gate

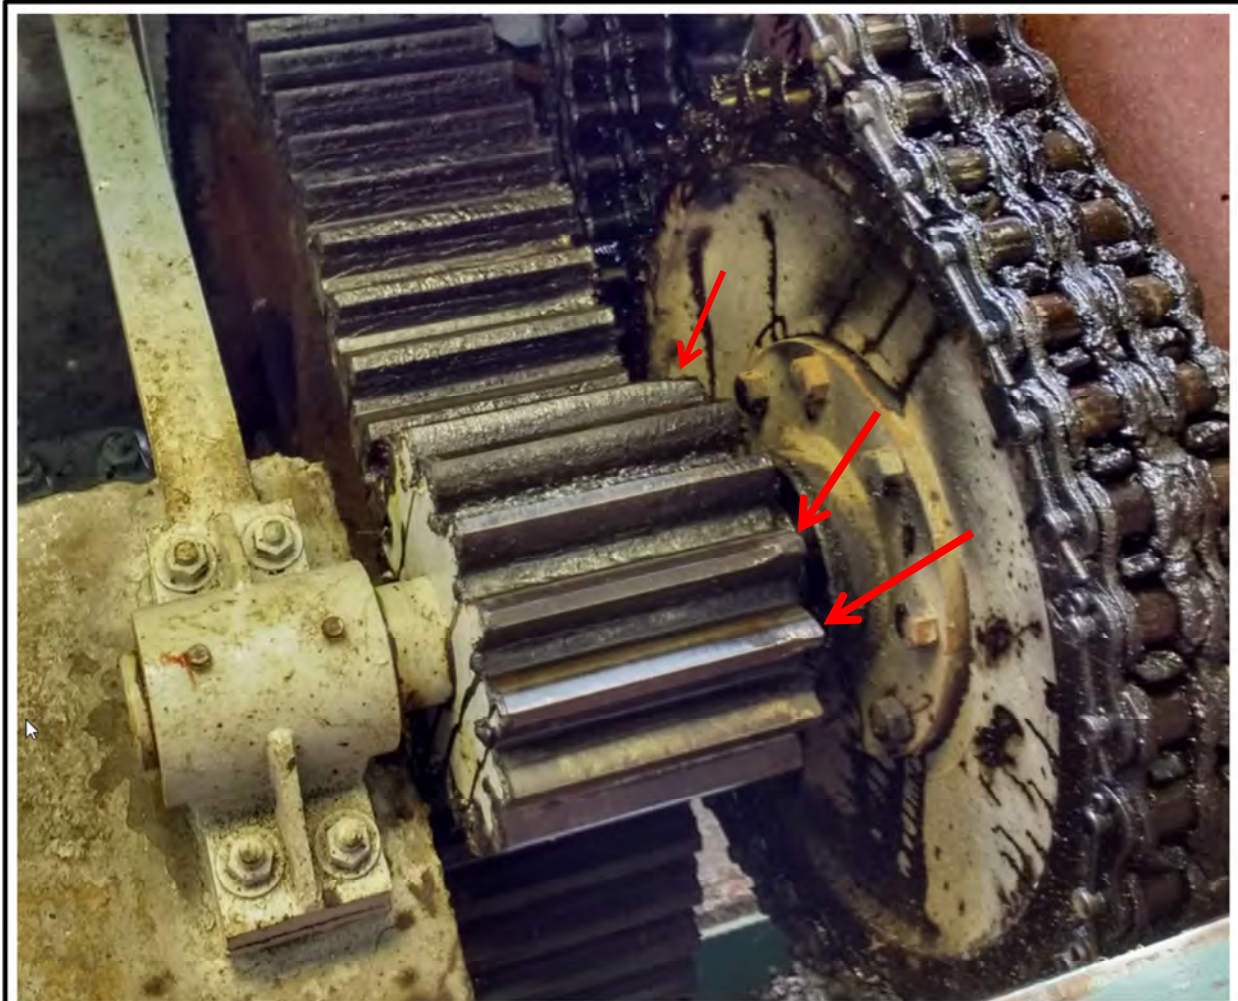
Figure 2-7 Pinion Gear – Worn Corners – West Tide Gate

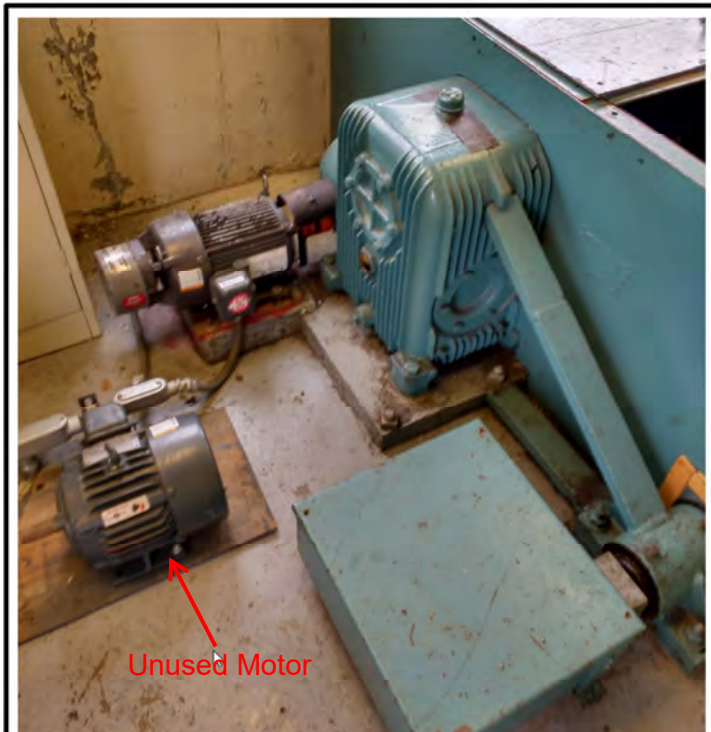
Figure 2-8 East Gate Drive Components

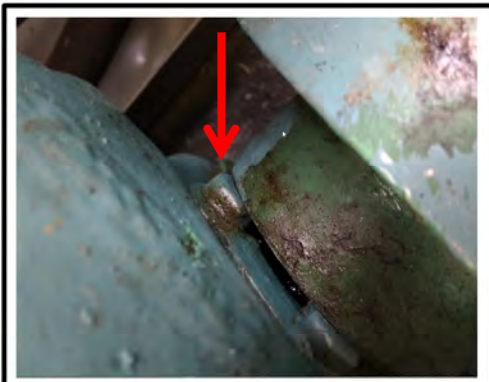
Figure 2-11 Coupler Proximity to Gearbox –West Gate

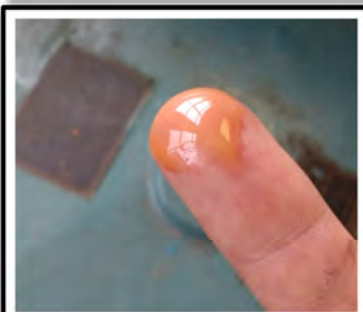
Figure 2-15 Oil Color – West Gate

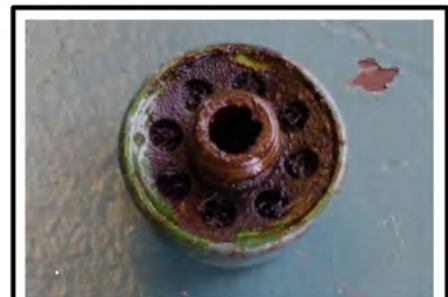
Figure 2-12 Gearbox Breather Plug-Typical Condition
