Capitol Lake Dam Preservation
Project Number: 2016-931

Comprehensive Assessment Report

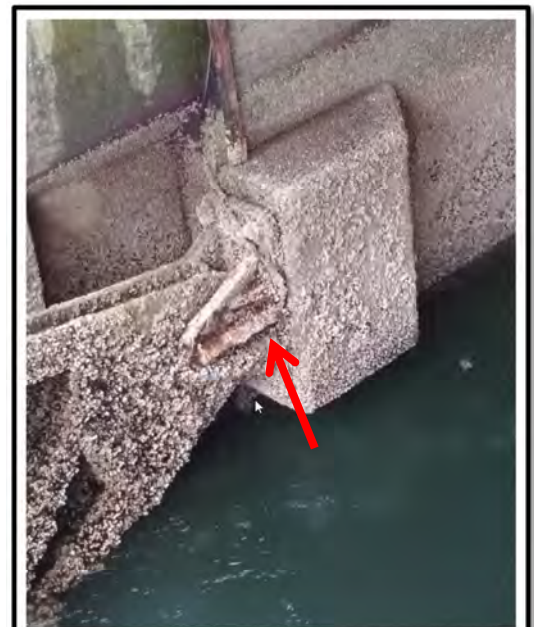
Figure 2-13 Gate Trunnion Connection – Typical Condition

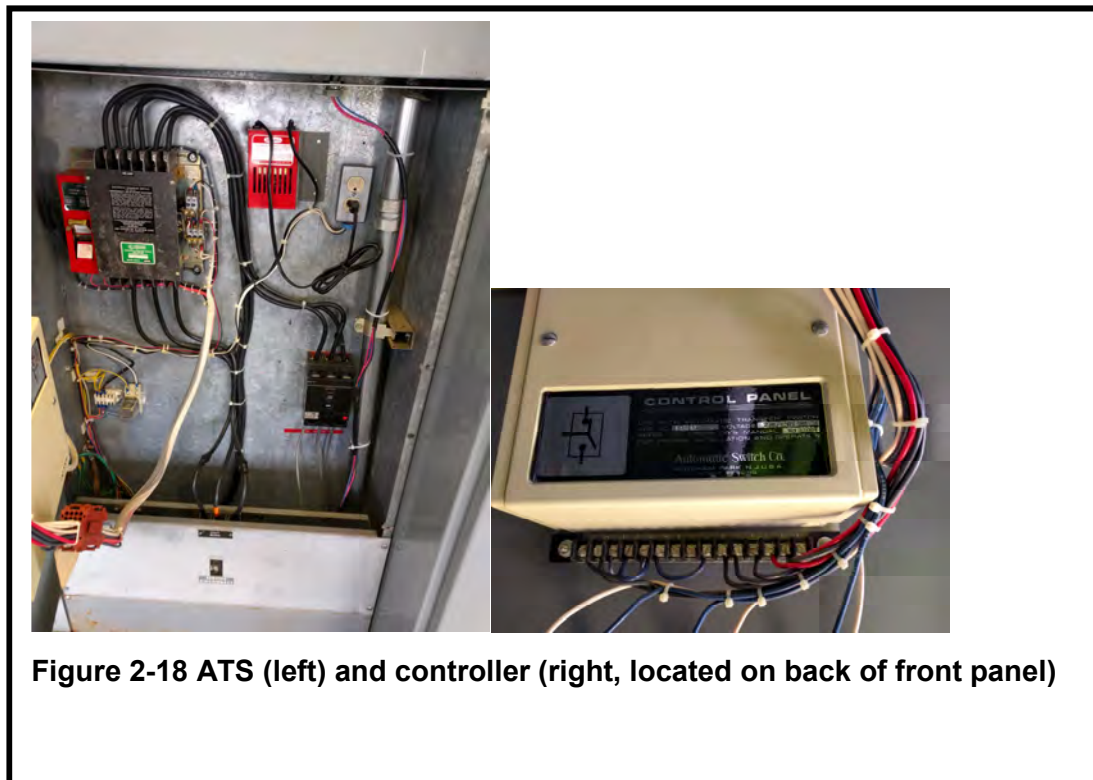
ATS: The ATS is manufactured by the ASCO with a controller by Automatic Switch Company, model 4200. It appears to be from the original MCC installation. The controls on the front panel of the ATS for testing generator operation are not functioning. However, Mr. Bristol reported that this equipment is maintained by a generator servicer and is functional. All components appear to be in good physical condition.

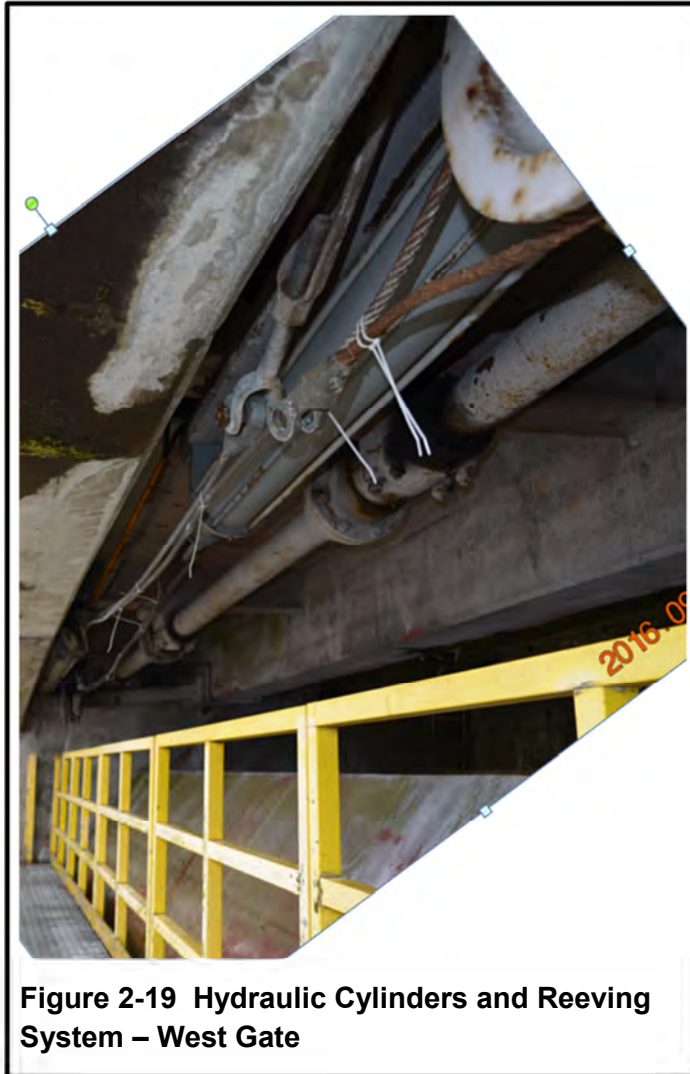
Figure 2-19 Hydraulic Cylinders and Reeving System – West Gate

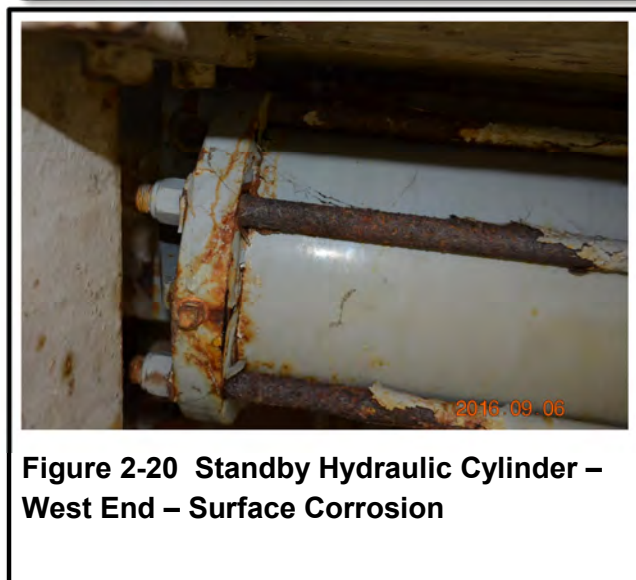
Figure 2-20 Standby Hydraulic Cylinder – West End – Surface Corrosion

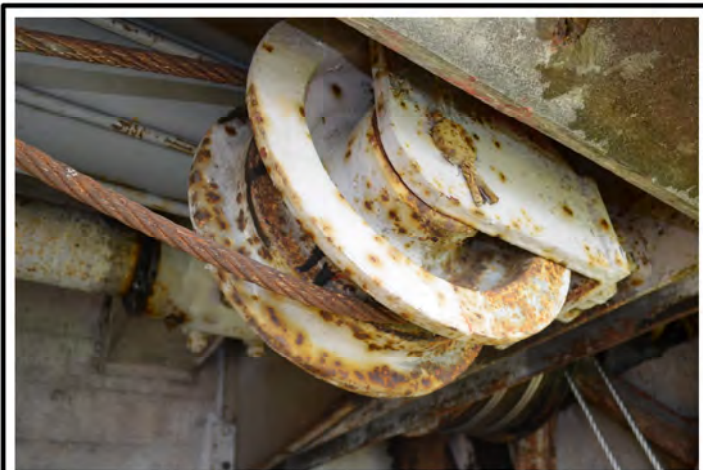
Figure 2-21 Rope and Reeving – Standby Hydraulic System

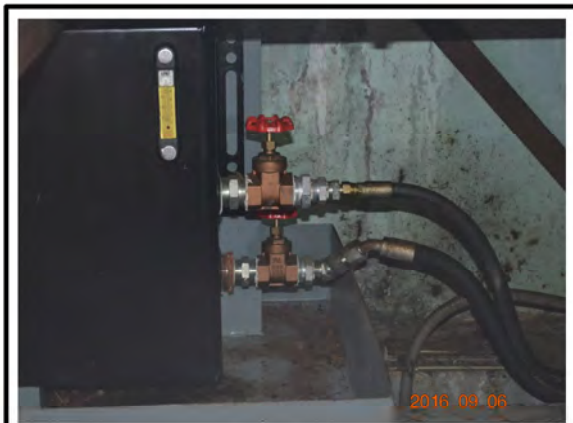
Figure 2-22 Reservoir

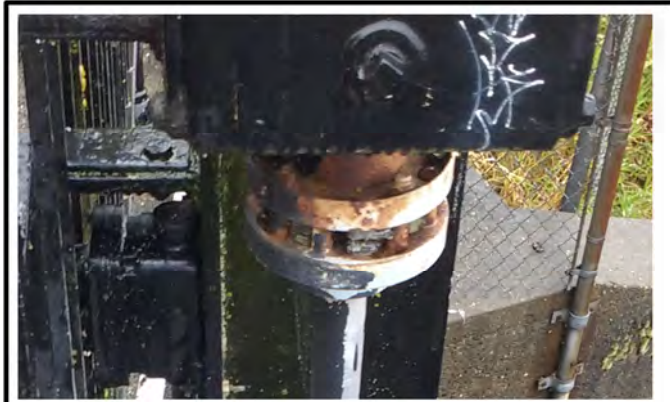
Figure 2-27 Exposed Coupling with Degraded Elastomer

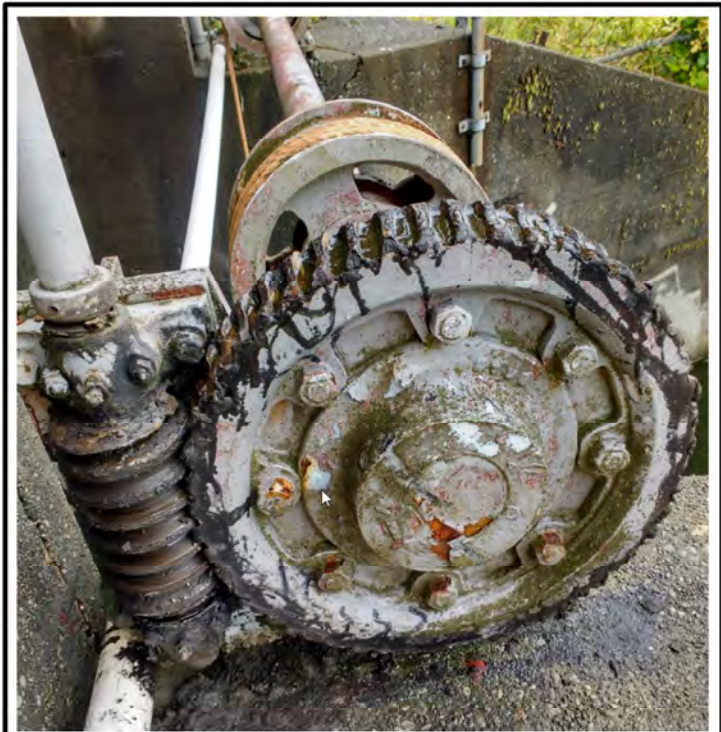
Figure 2-28 Worm Gear Drive

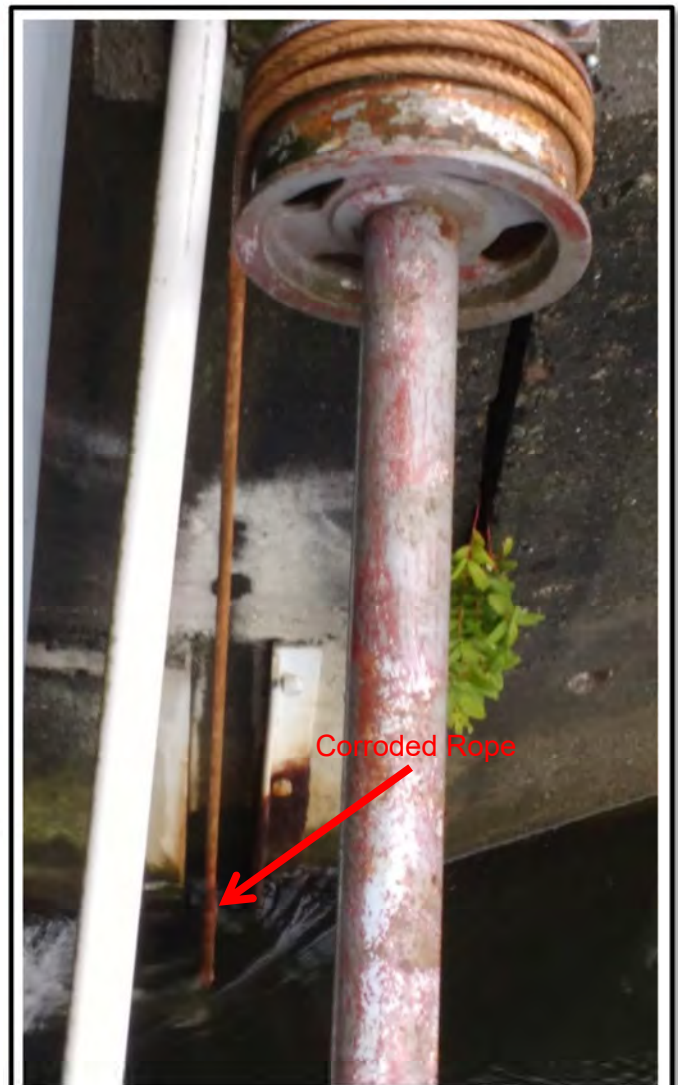
Figure 2-29 Hoist Drum and Rope

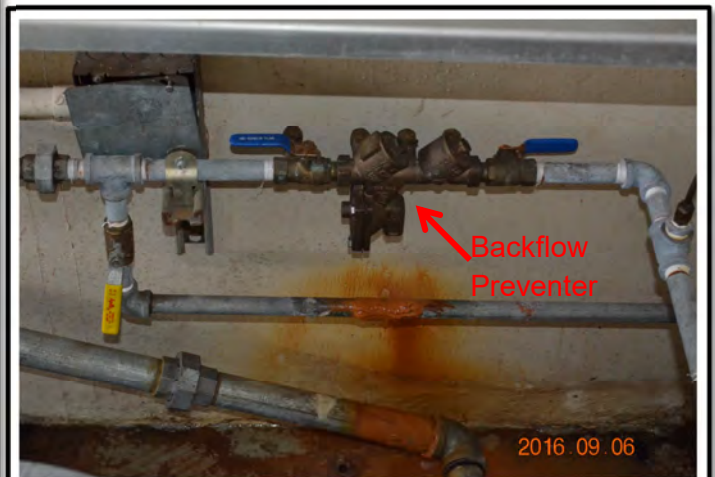
Figure 2-30 Siphon System – Leaking Backflow Preventer

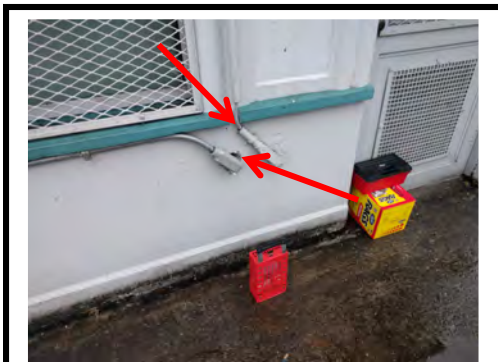
Figure 2-32 Water ingress via conduits

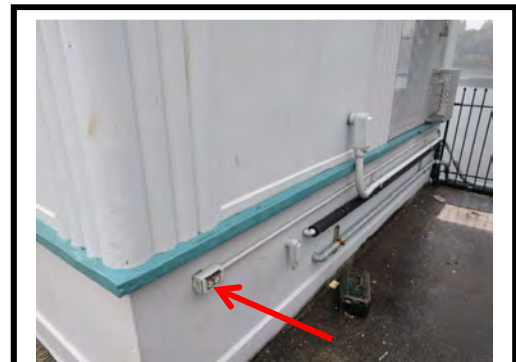
Figure 2-33 Electrical Shock Hazard, Energized Parts Exposed to Public

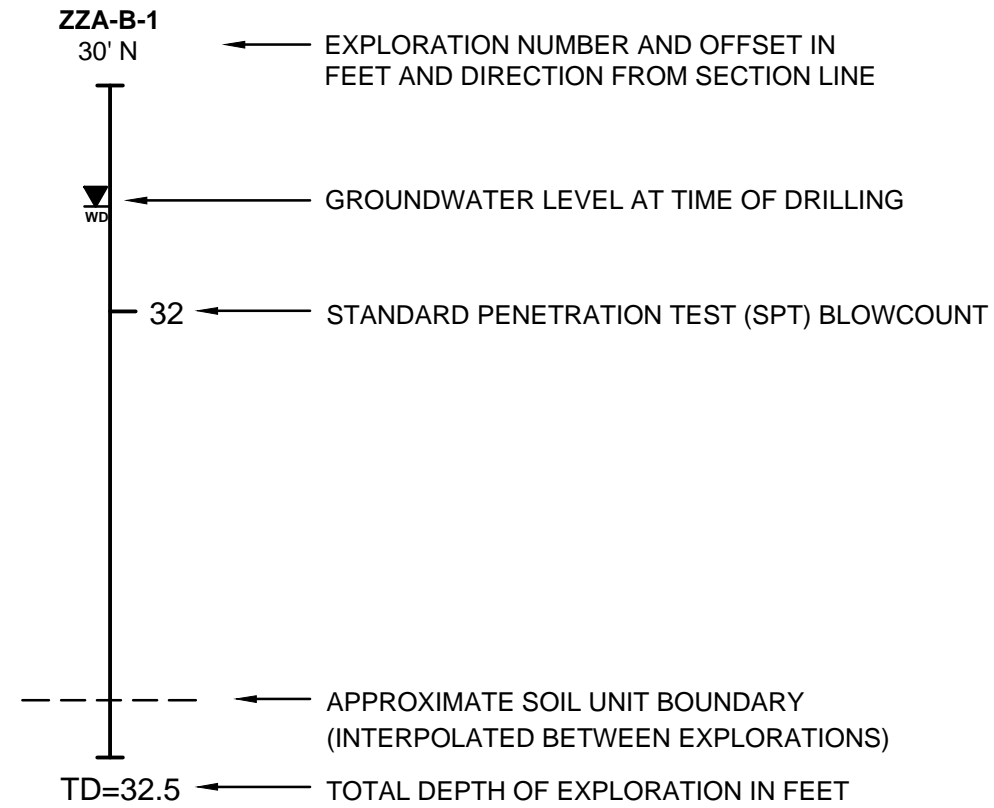
PLAN AND GENERALIZED SUBSURFACE PROFILE NOTES:

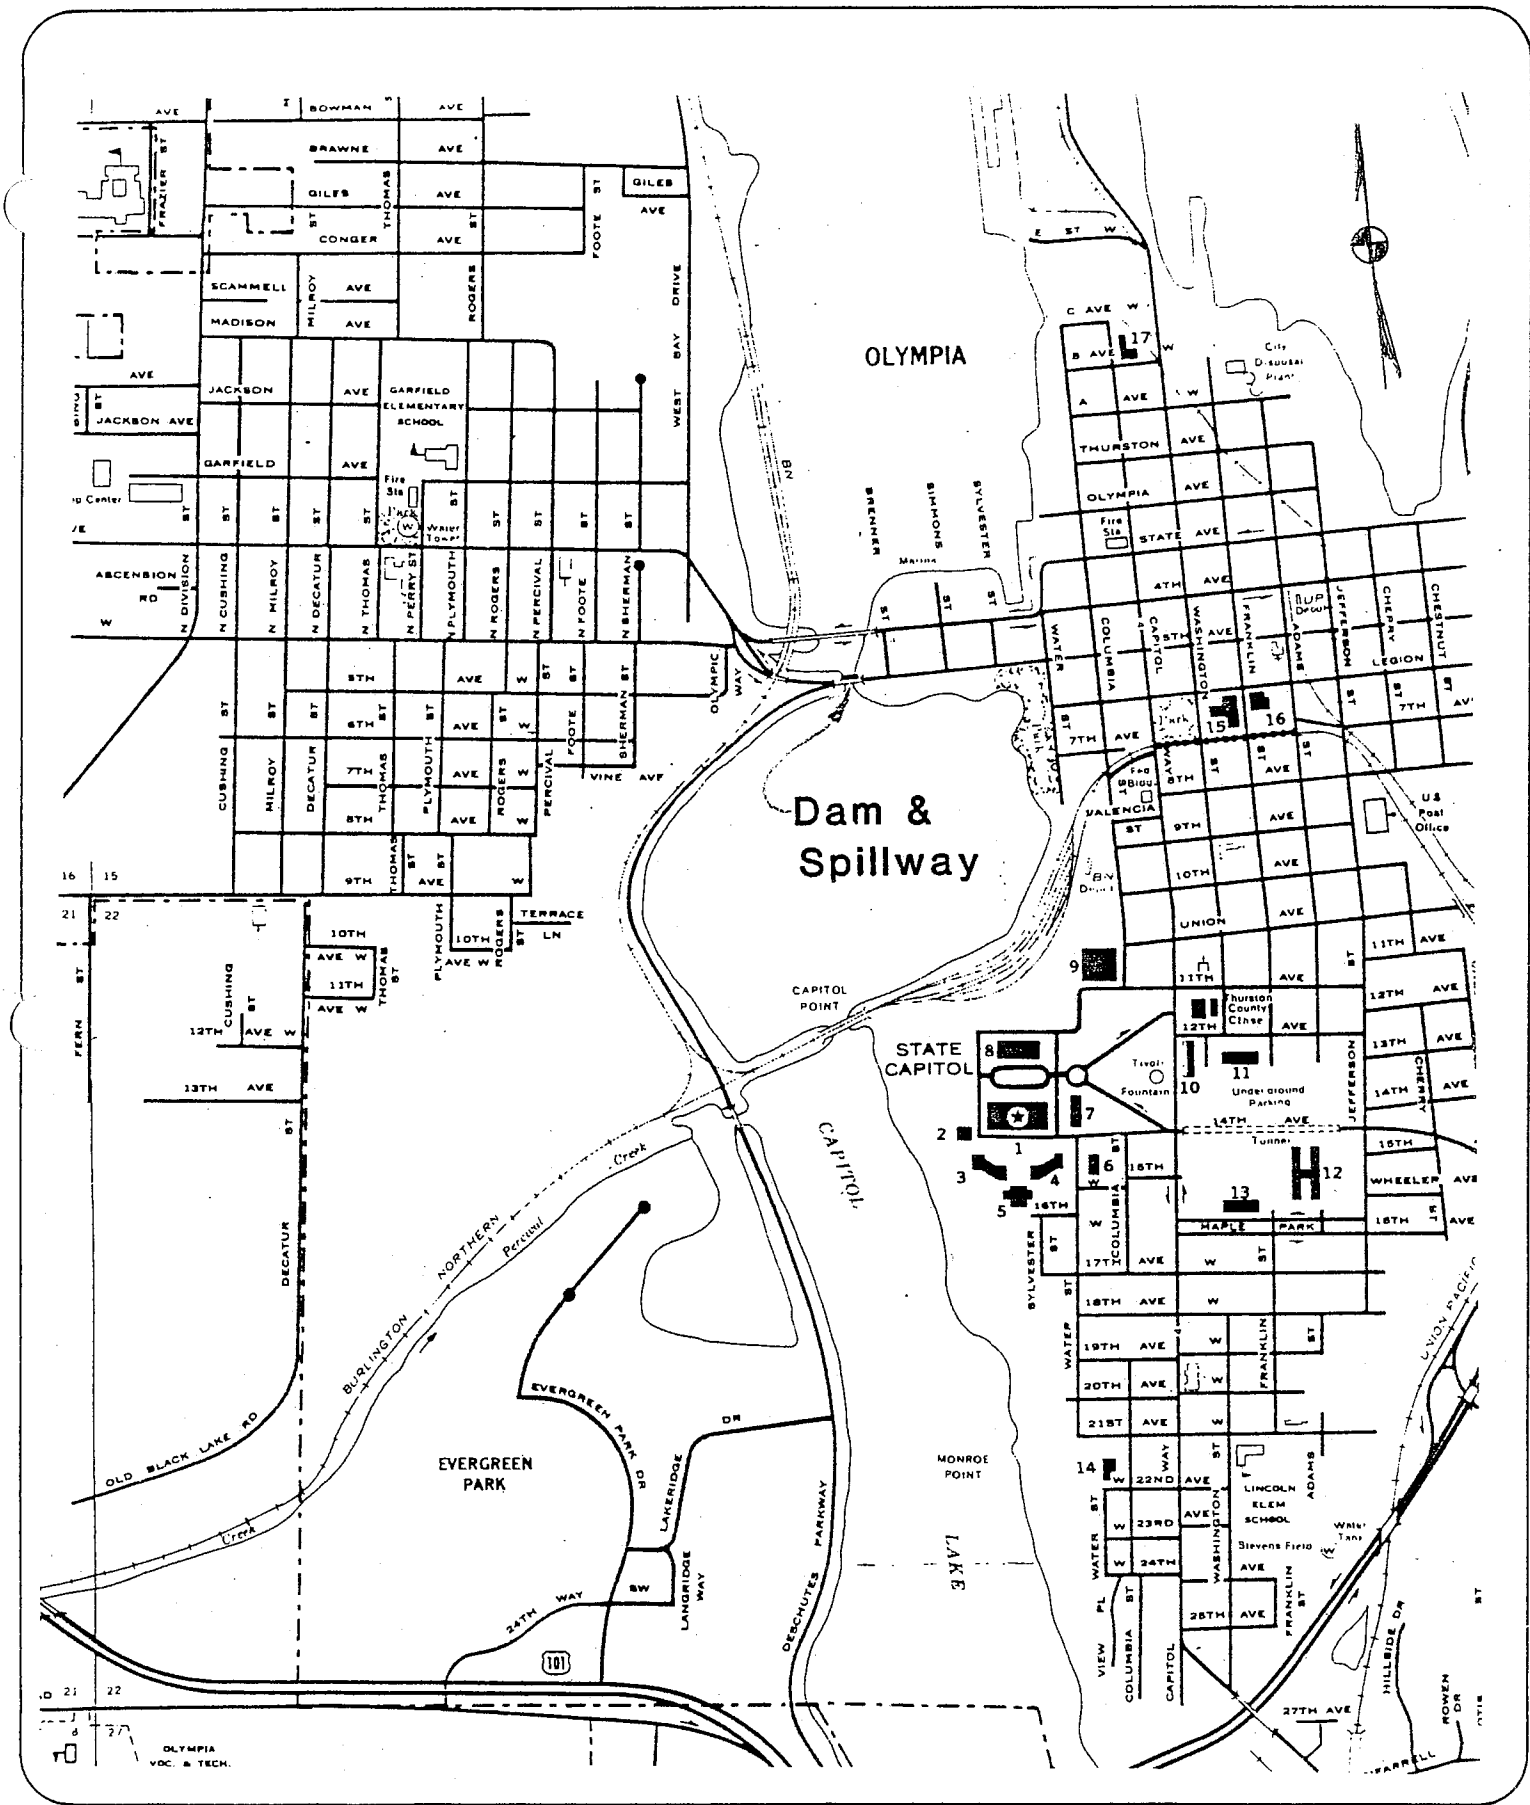
CAPITOL LAKE DAM LOCATION MAP

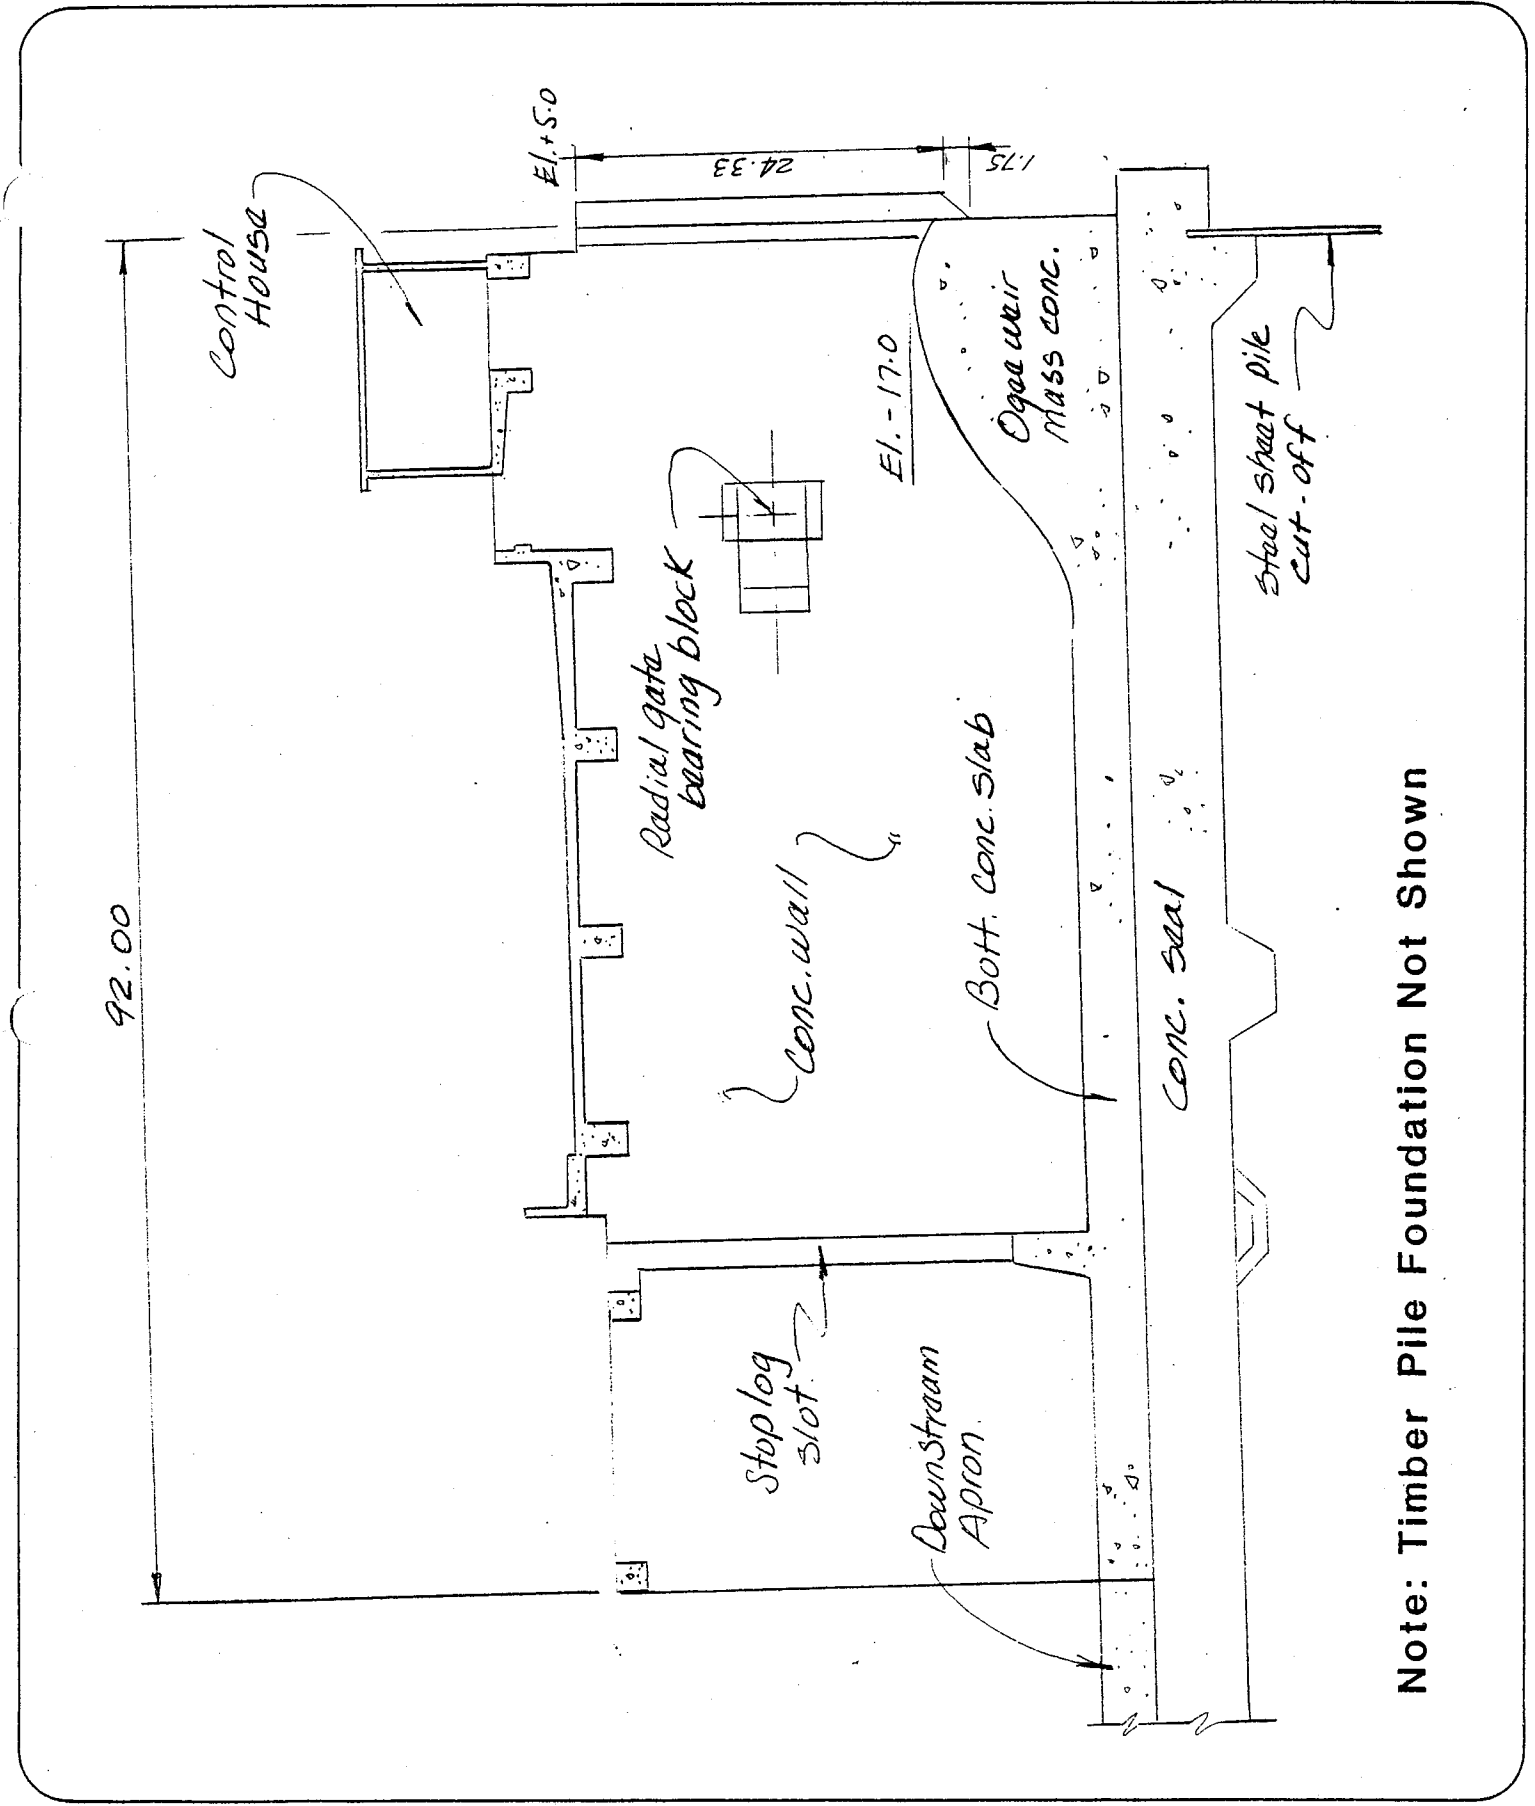
Note: Timber Pile Foundation Not Shown

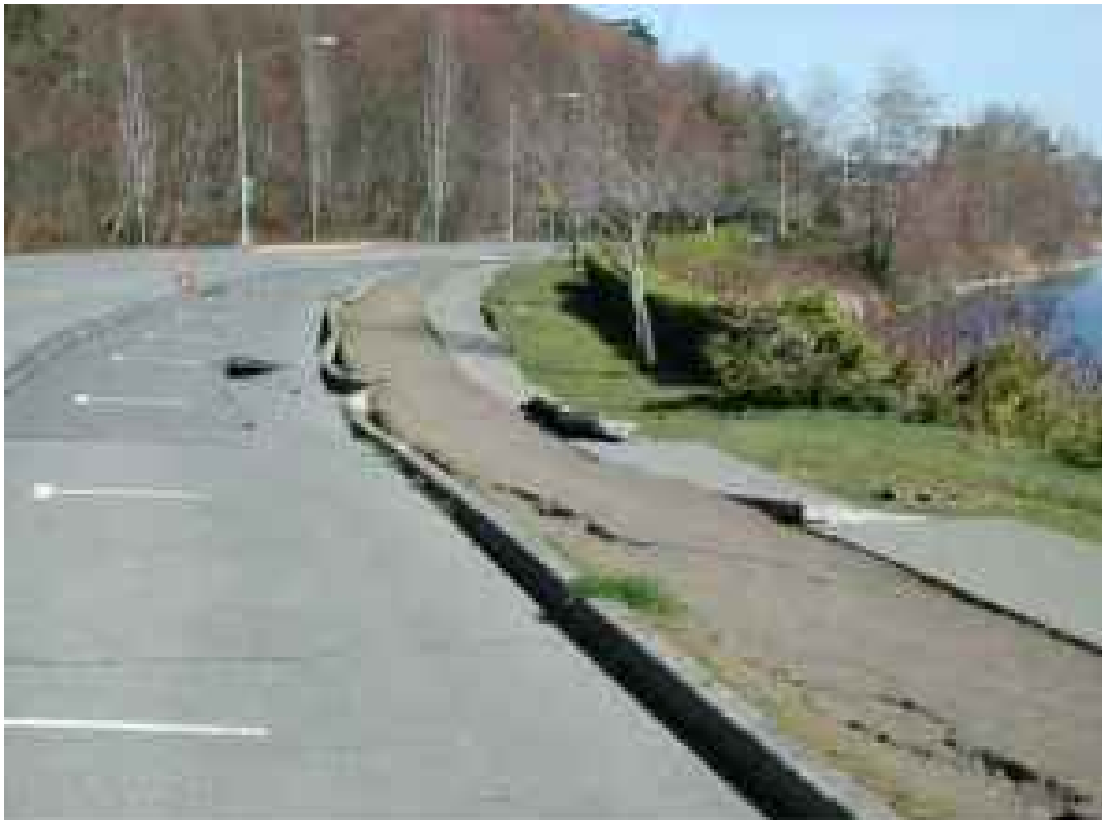
LIQUEFACTION-RELATED DAMAGE FROM (a) THE 1965 SEATTLE-TACOMA EARTHQUAKE (b) THE 2001 NISQUALLY EARTHQUAKE (KRAMER 2008). NOTE THAT BOTH PHOTOGRAPHS WERE TAKEN AT ABOUT THE SAME LOCATION ALONG DESCHUTES PARKWAY SW.

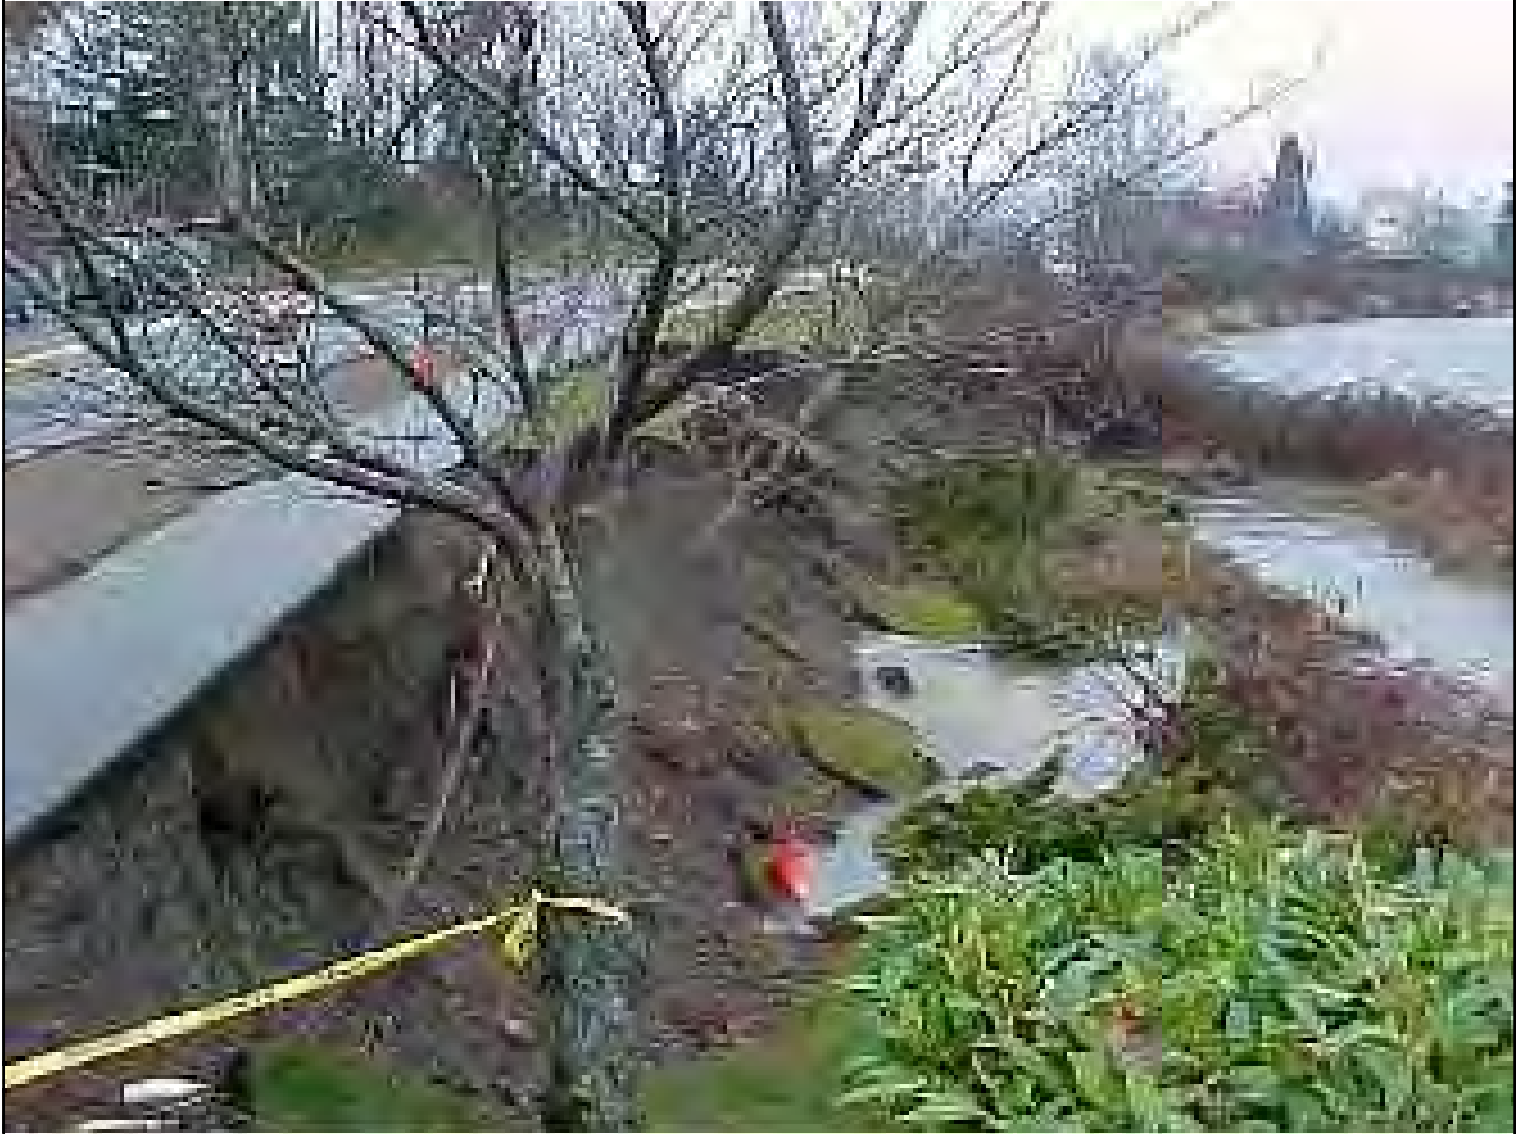
LIQUEFACTION-RELATED DAMAGE FROM THE 2001 NISQUALLY EARTHQUAKE
AT THE END OF DESCHUTES PARKWAY SW (BRAY ET AL., 2001)

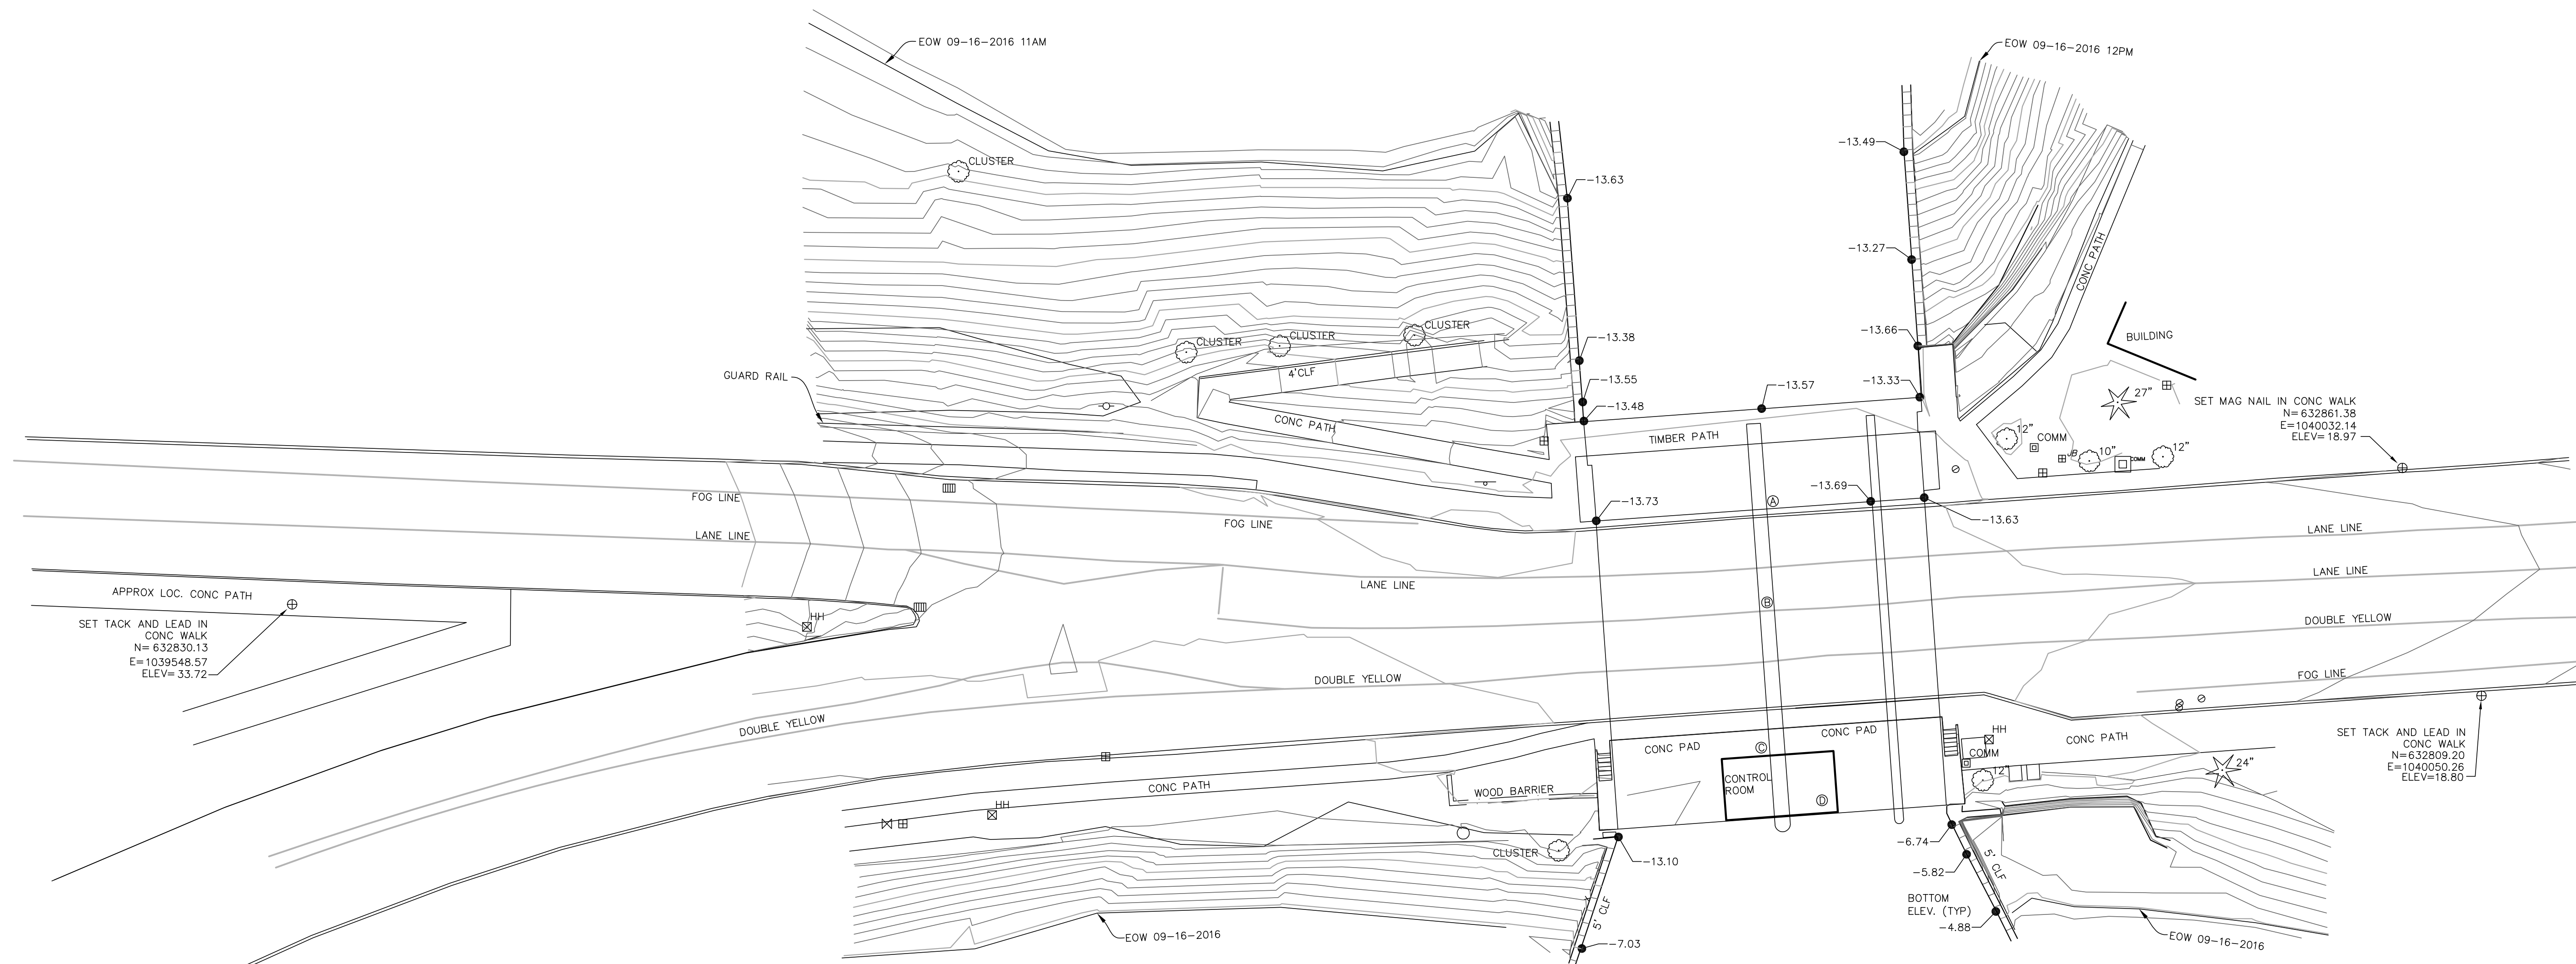
DATUM CONVERSION CHART PER ABAM DRAWING TITLED "CAPITOL LAKE TIDE GATE REPAIRS PROJECT NO. 92-263H" AND NOAA STATION AT BUD INLET
