CONDITION REPORTING AND PRE-CONSTRUCTION RECOMMENDATIONS
JOEL M. PRITCHARD BUILDING ARTWORKS – WASHINGTON STATE CAPITOL COMPLEX

Prepared for: Erica Ceder, Architect | Principal
DLR Group
51 University Street, Ste. 600
Seattle, WA 98101
eceder@dlrgroup.com
Office: 503-274-2675
Cell: 503-220-1338

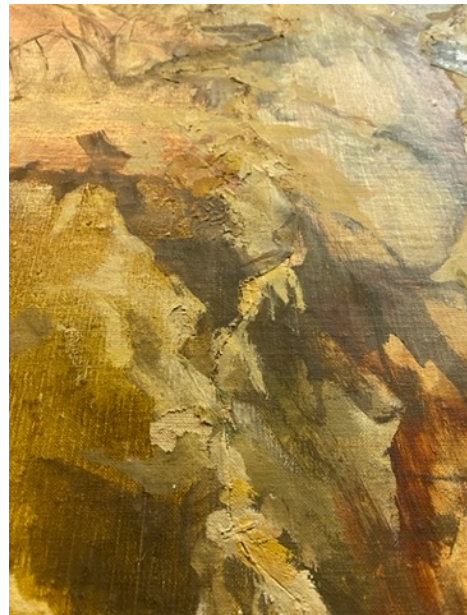
Detail of seam between mural canvas panels with missing surface paint, retouches and staples

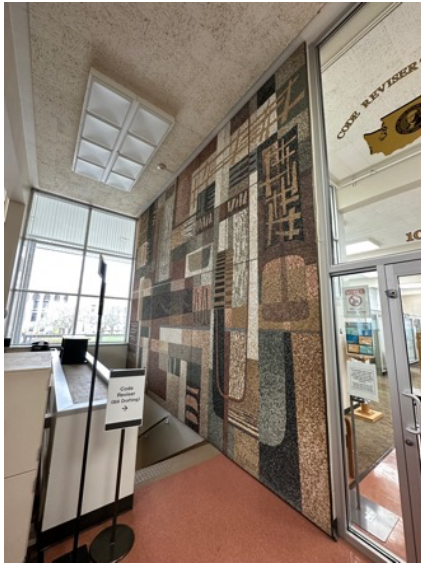
Overall of the mosaic.

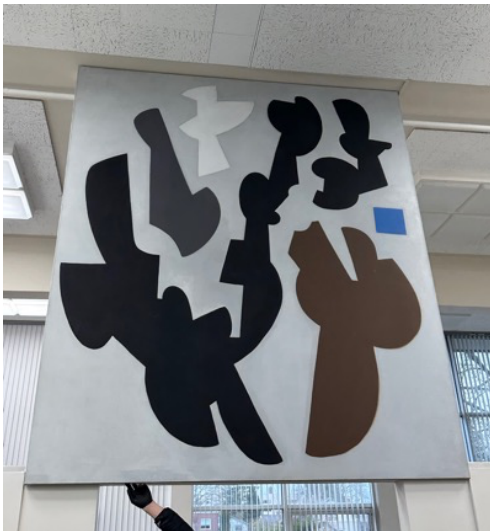
Overall of the painting hung on a French cleat.

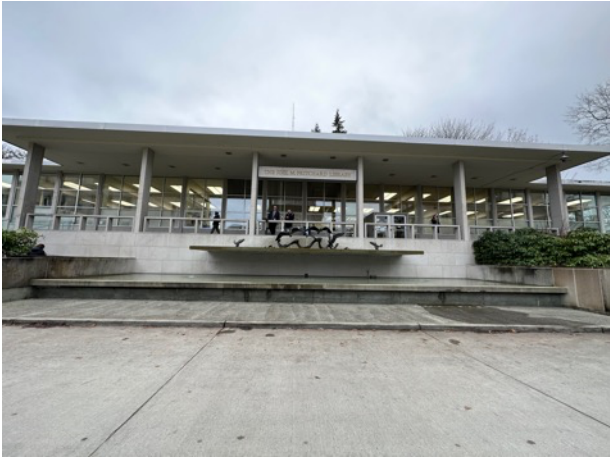
Overall of the whole fountain from the front.

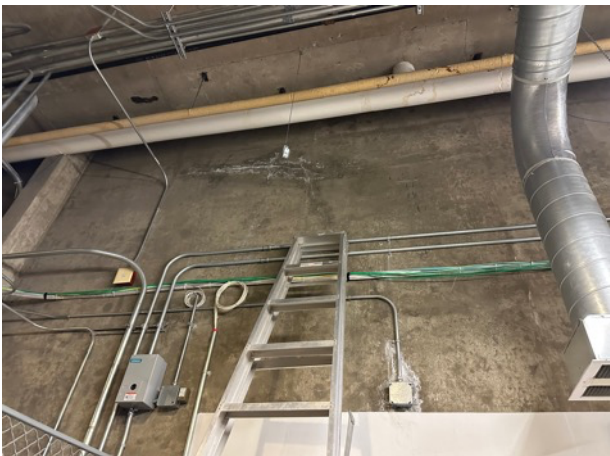
Detail of interior leak caused by the cracks at the exterior basin.

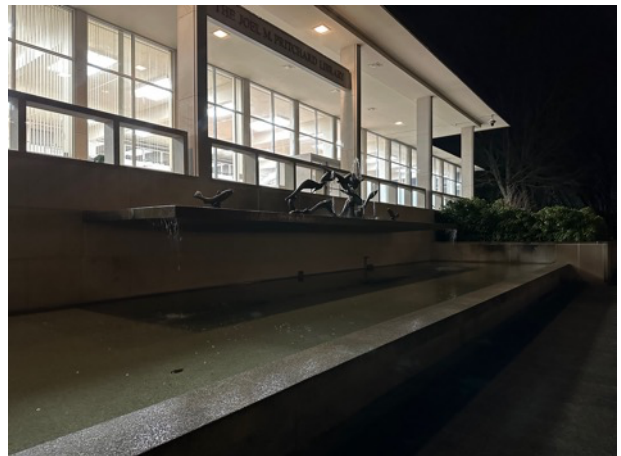
Fountain at night with no lighting operative.
