DES OLD CAPITOL ROOF REPLACEMENT STUDY

Pre-Design
June 2017

EXECUTIVE SUMMARY

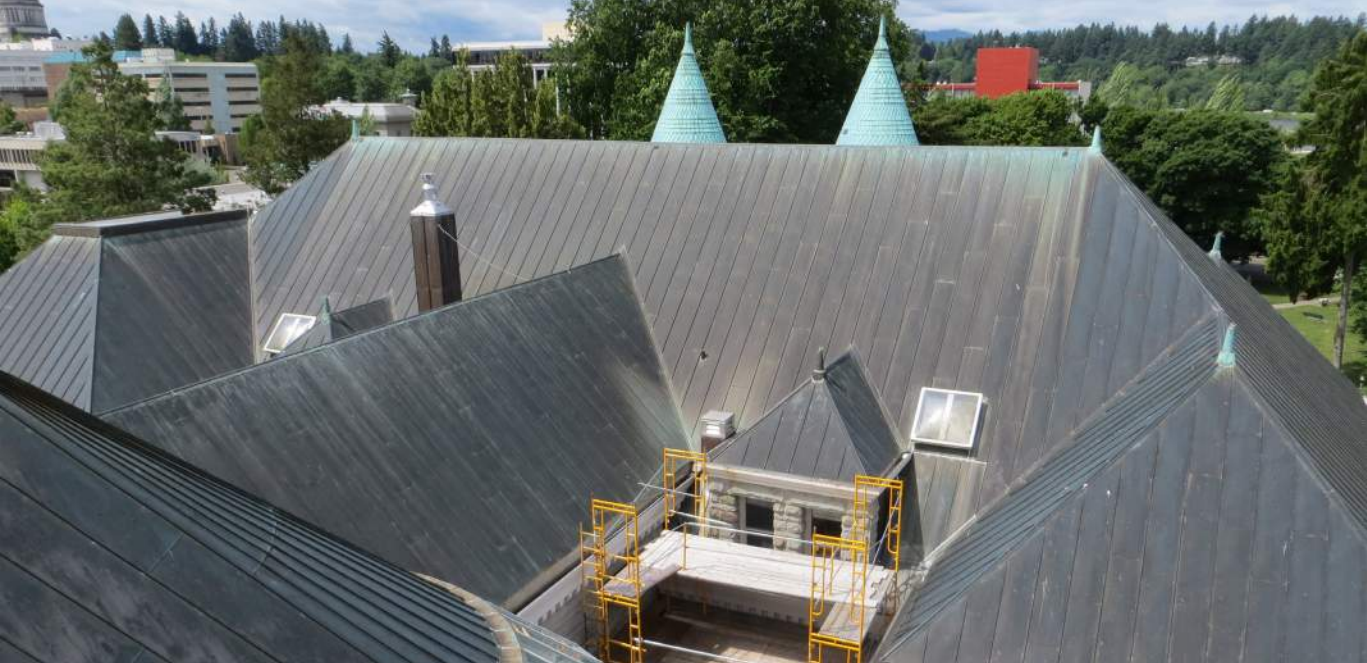
Figure 1. 1892 Building

Water infiltration is ongoing and has been made evident by previous repair projects and interior plaster damage at the eaves. This can be attributed to a number of deficiencies in the copper roofing, detailing, and underlayment.

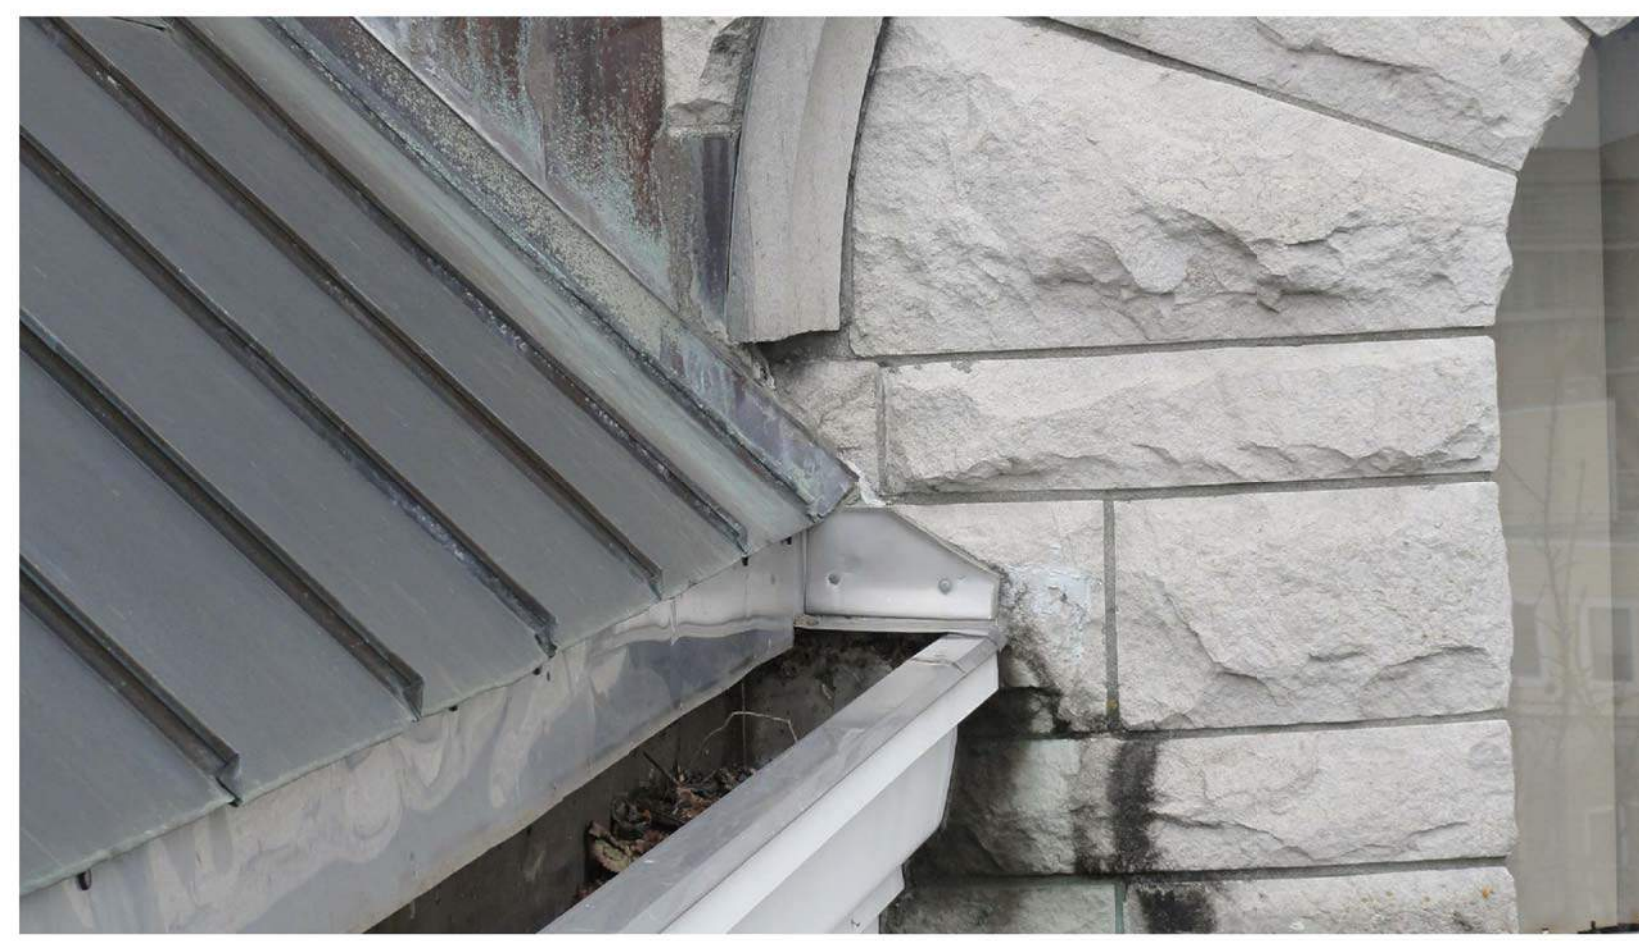
10 East Tower Gutter
Existing Conditions

11 East Tower Gutter Flashing Repair
Section
0 3' 6' 1'

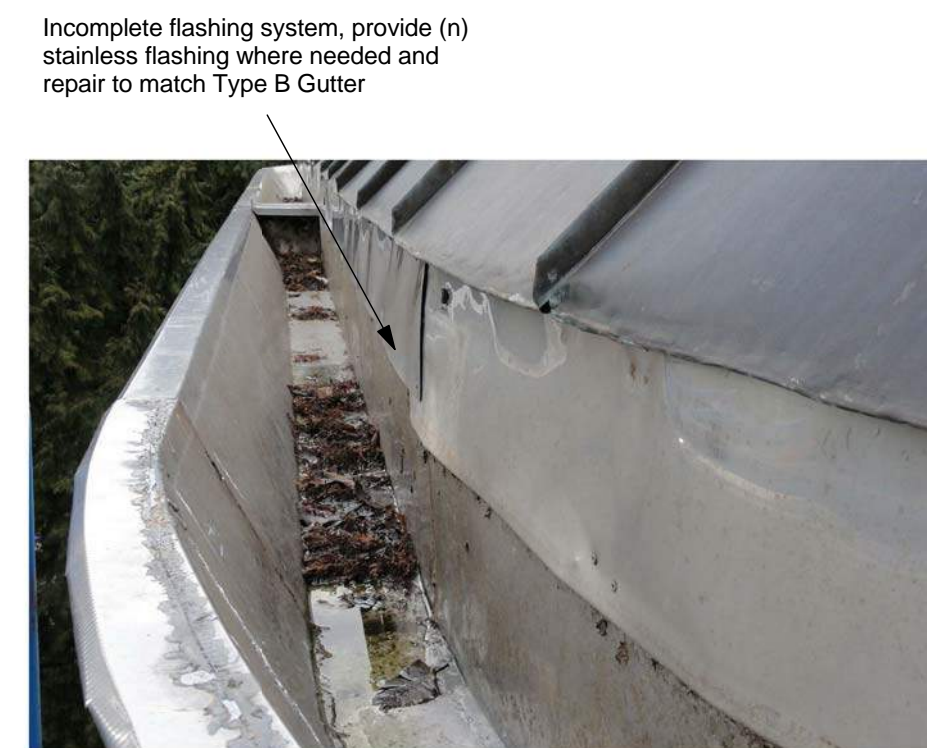
14 West Wing Gutter Flashing - South Elevation
Existing Conditions

Incomplete flashing system, provide (n) stainless flashing where needed and repair to match Type B Gutter

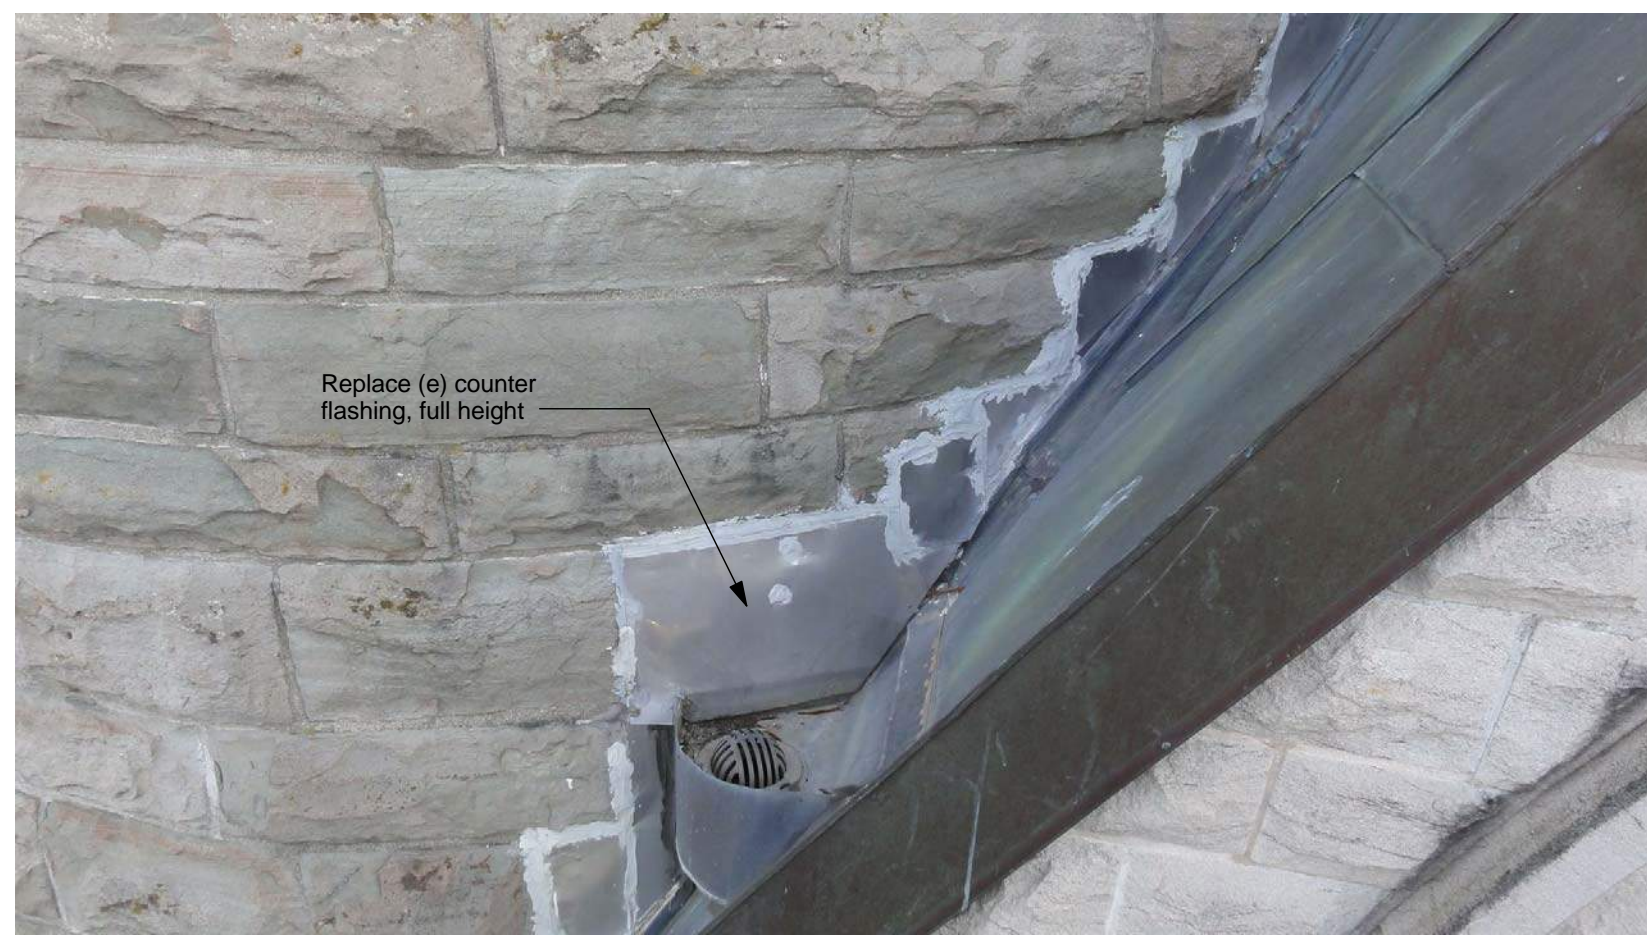
14 West Tower Drain
Existing Conditions **Alternate No.2**

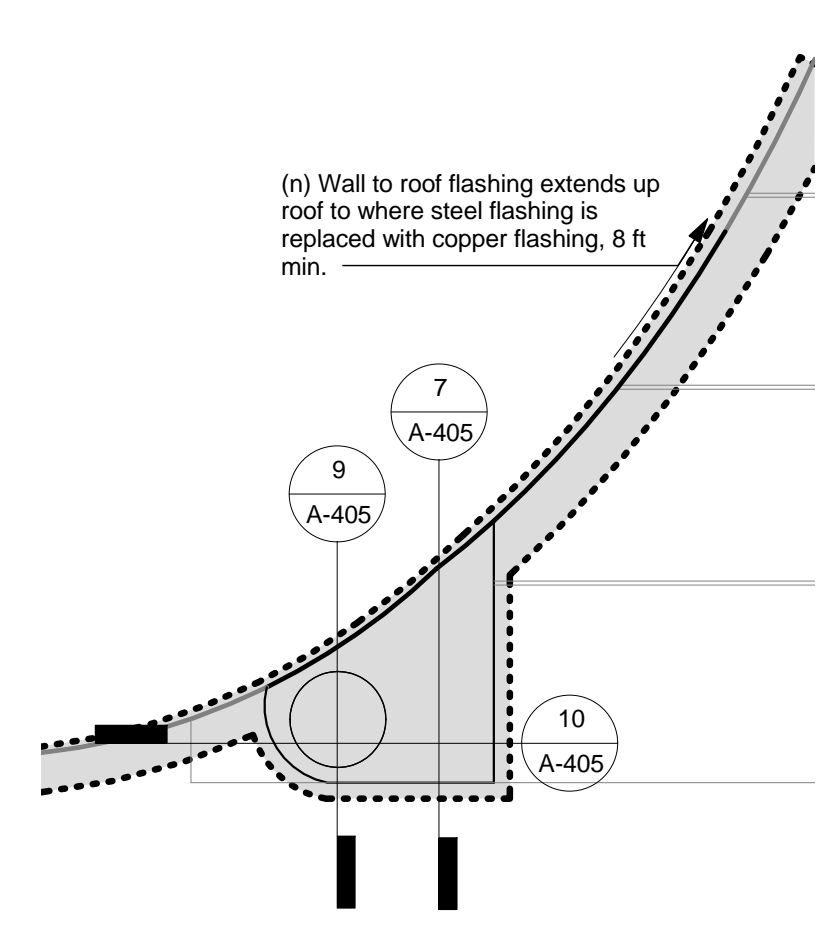
6 West Drain
Existing Conditions **Alternate No.2**

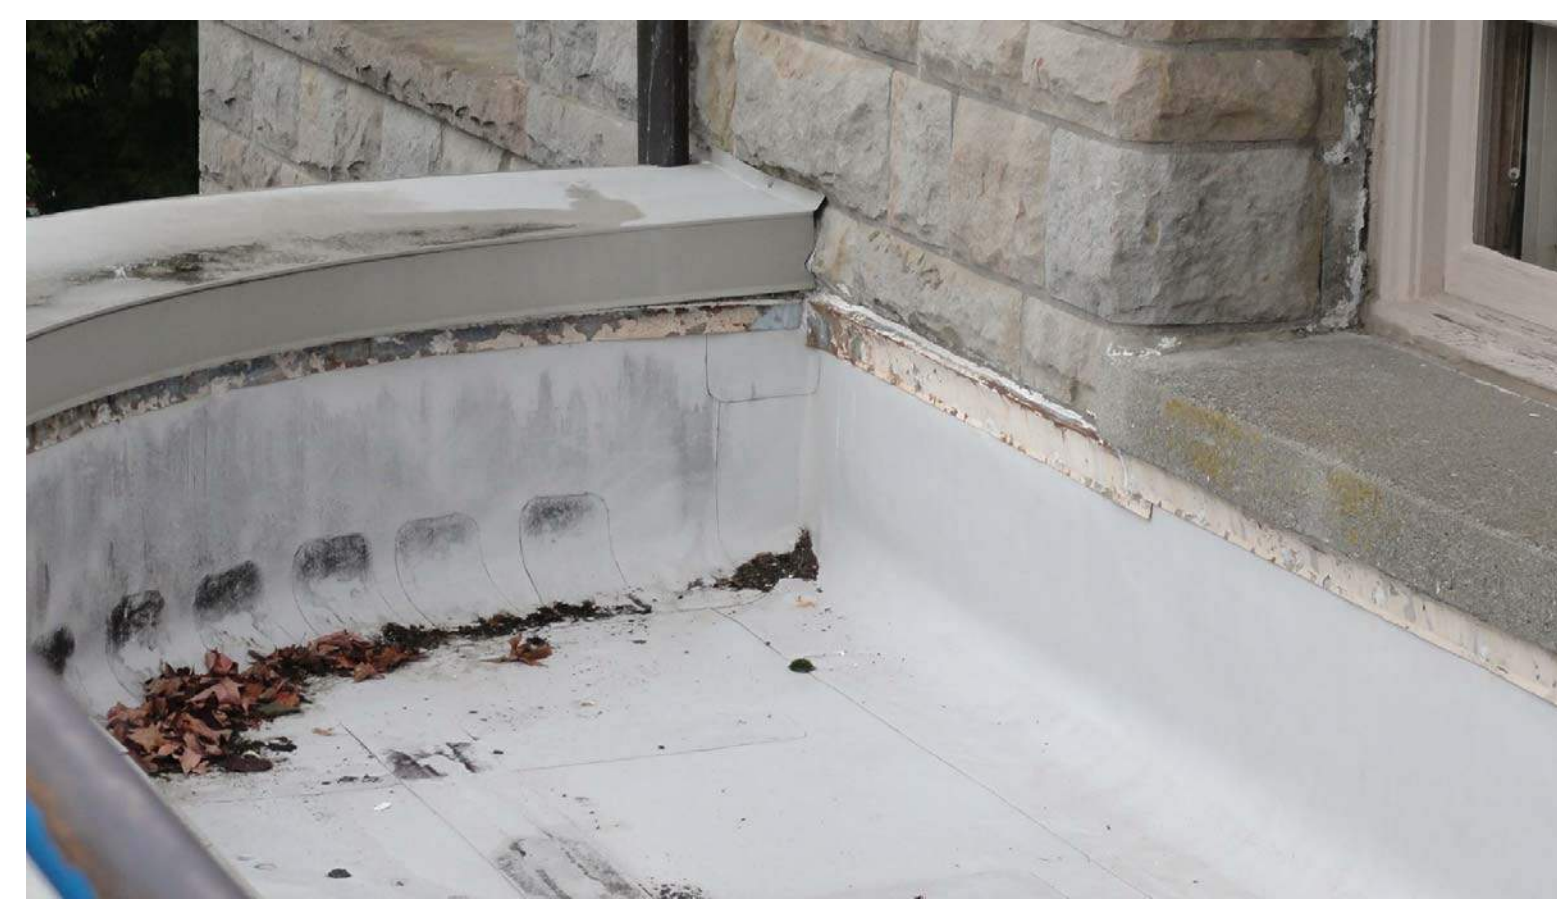
1 Balcony Flashing
Existing Conditions

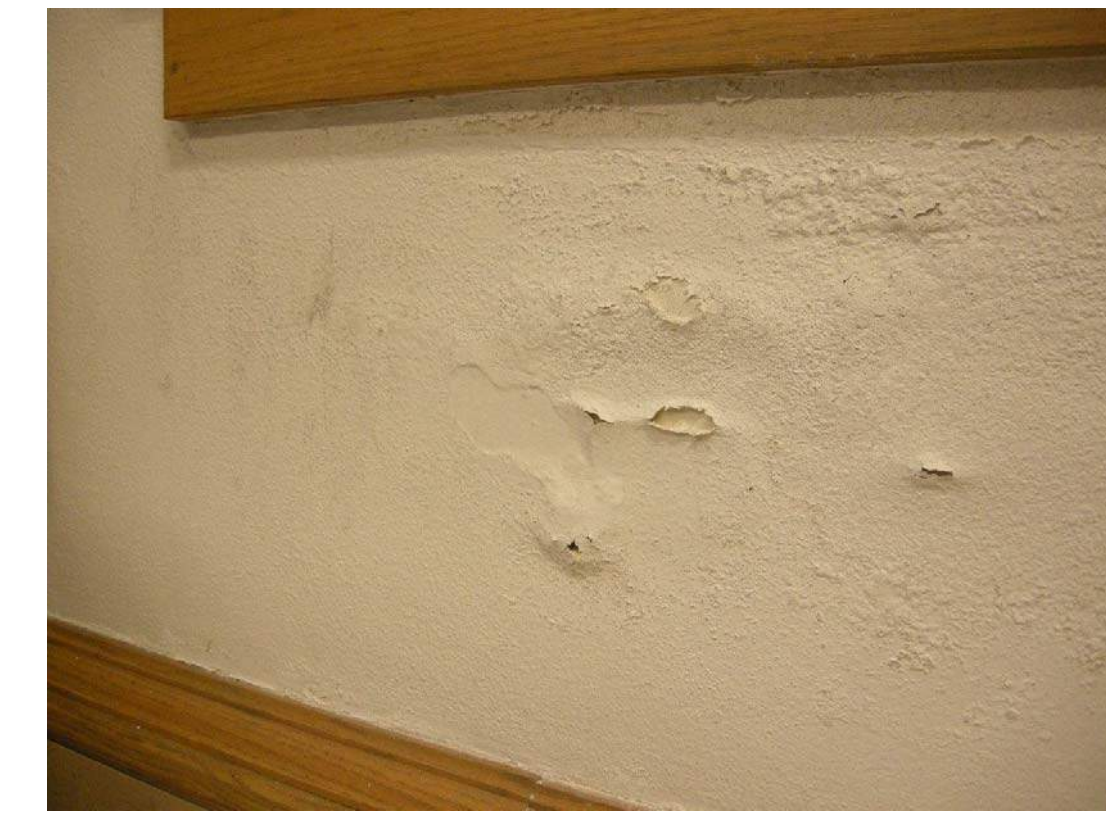
15 (e) Condition - Damaged Plaster

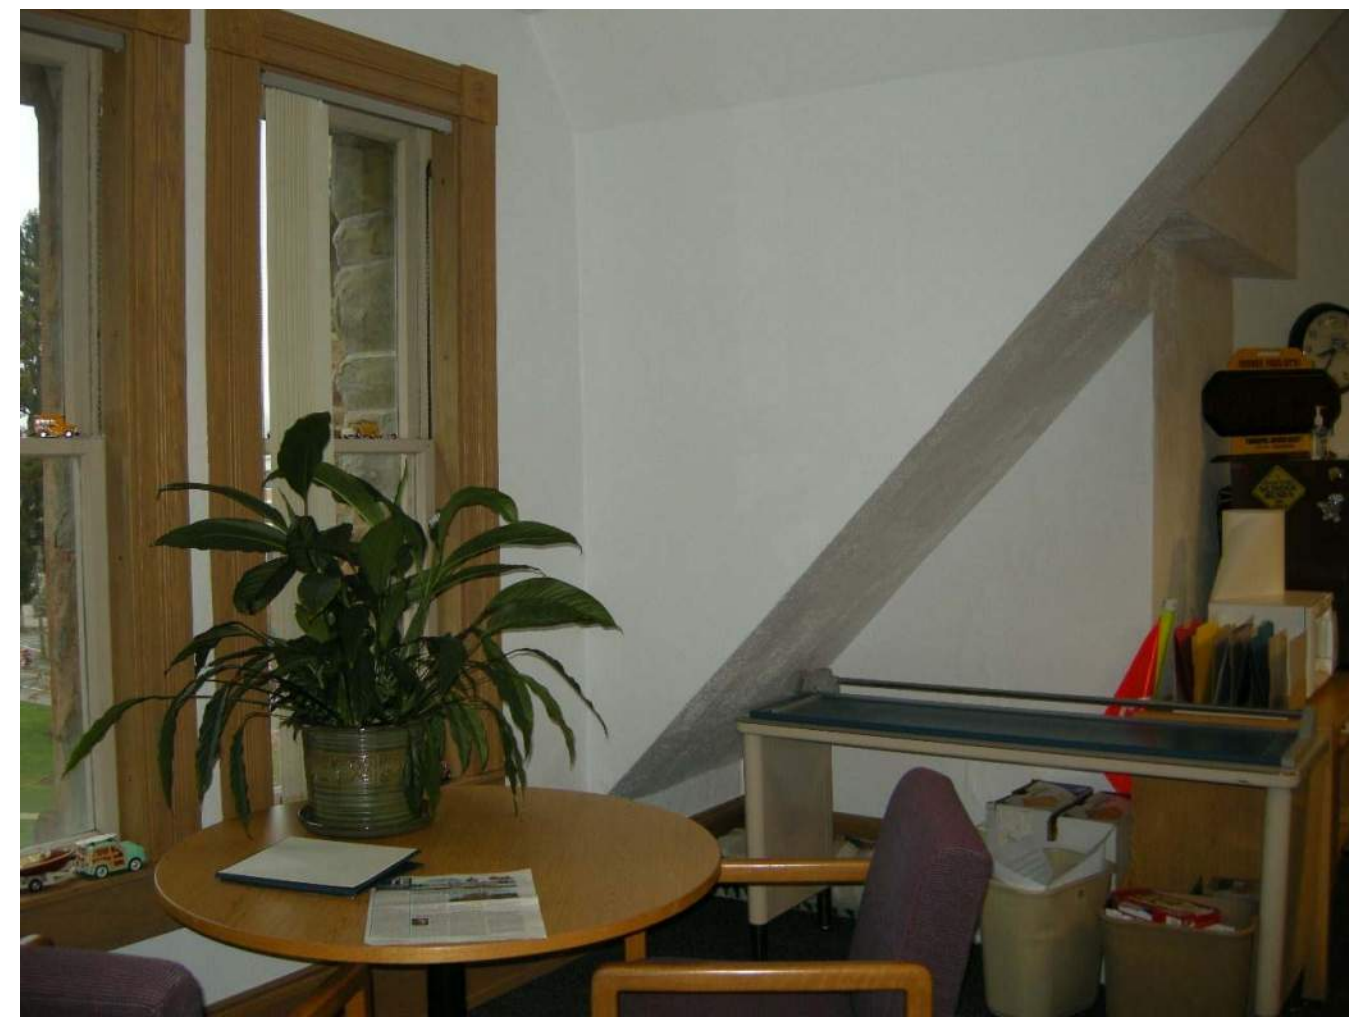
7 (e) Condition - Damaged Plaster at Dormer

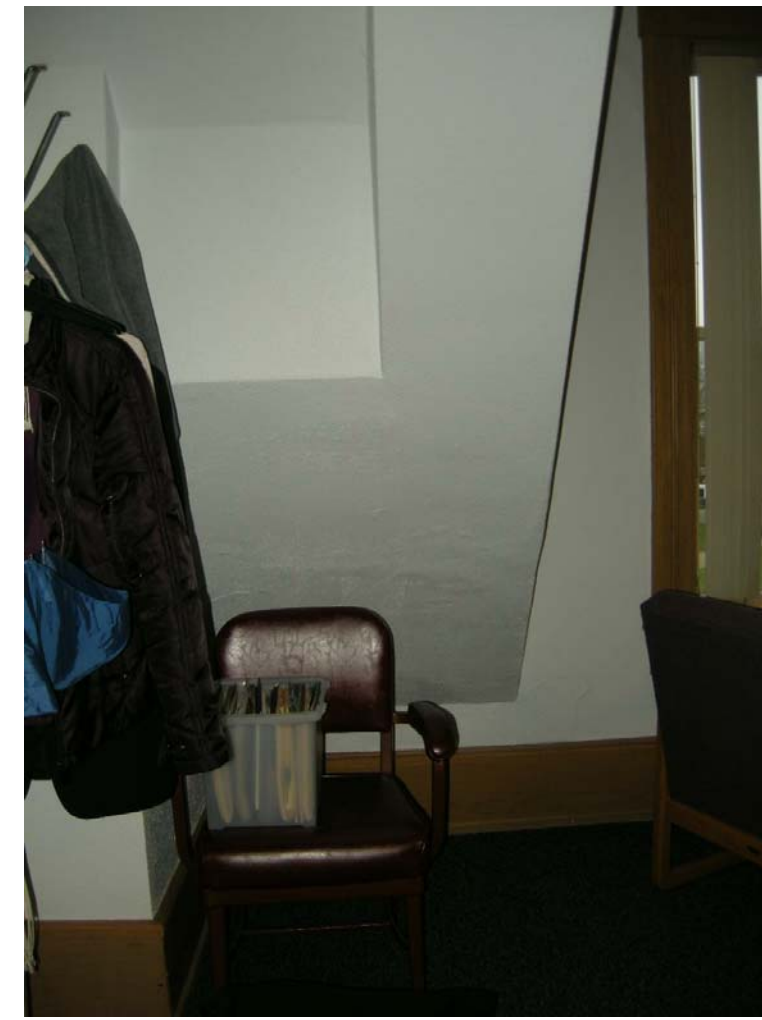
4 (e) Condition - Damaged Plaster at Dormer

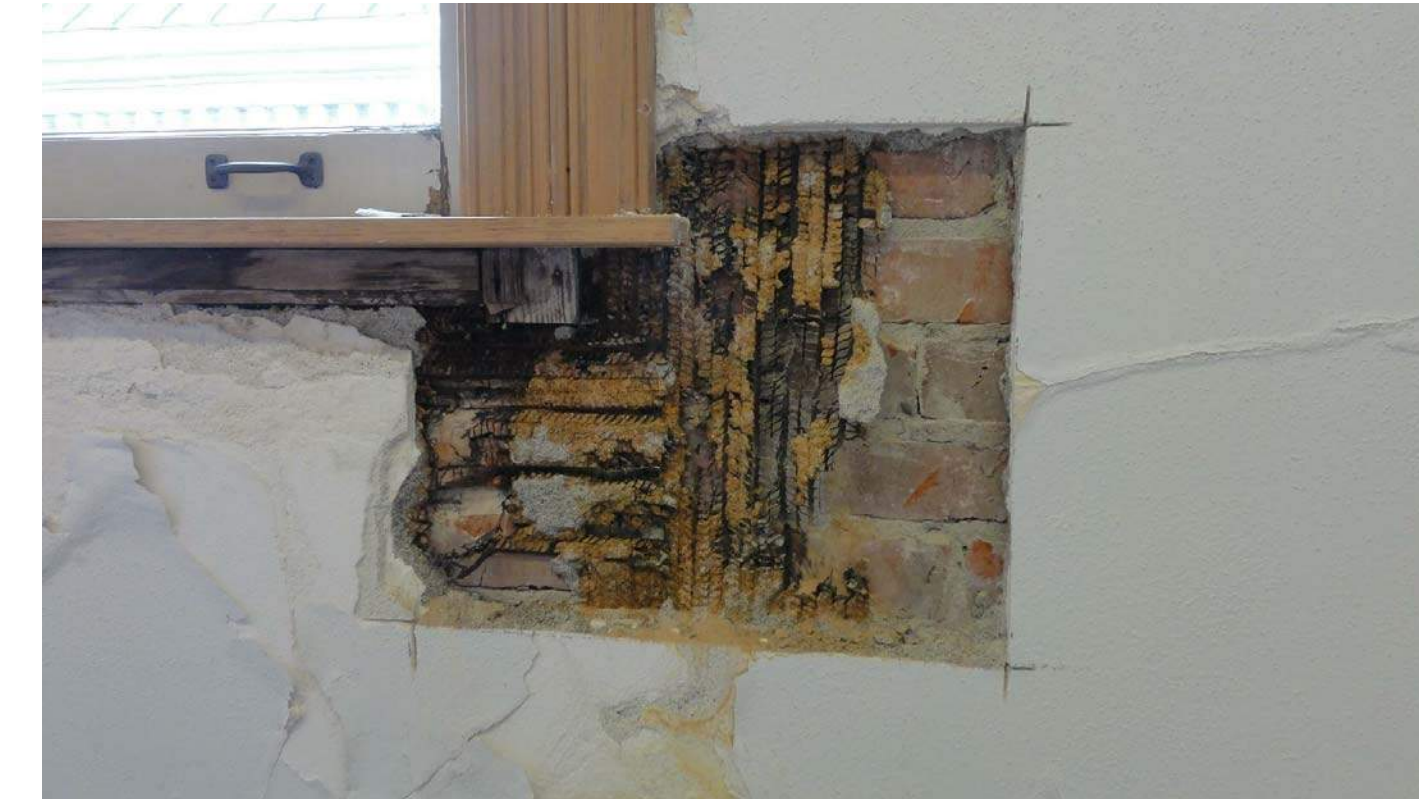
1 (e) Condition - Cut Plaster at Stairwell
