Legislative Chambers Skylight Restoration Feasibility Study

Washington State Legislative Building

Washington State Department of Enterprise Services

April 4, 2017

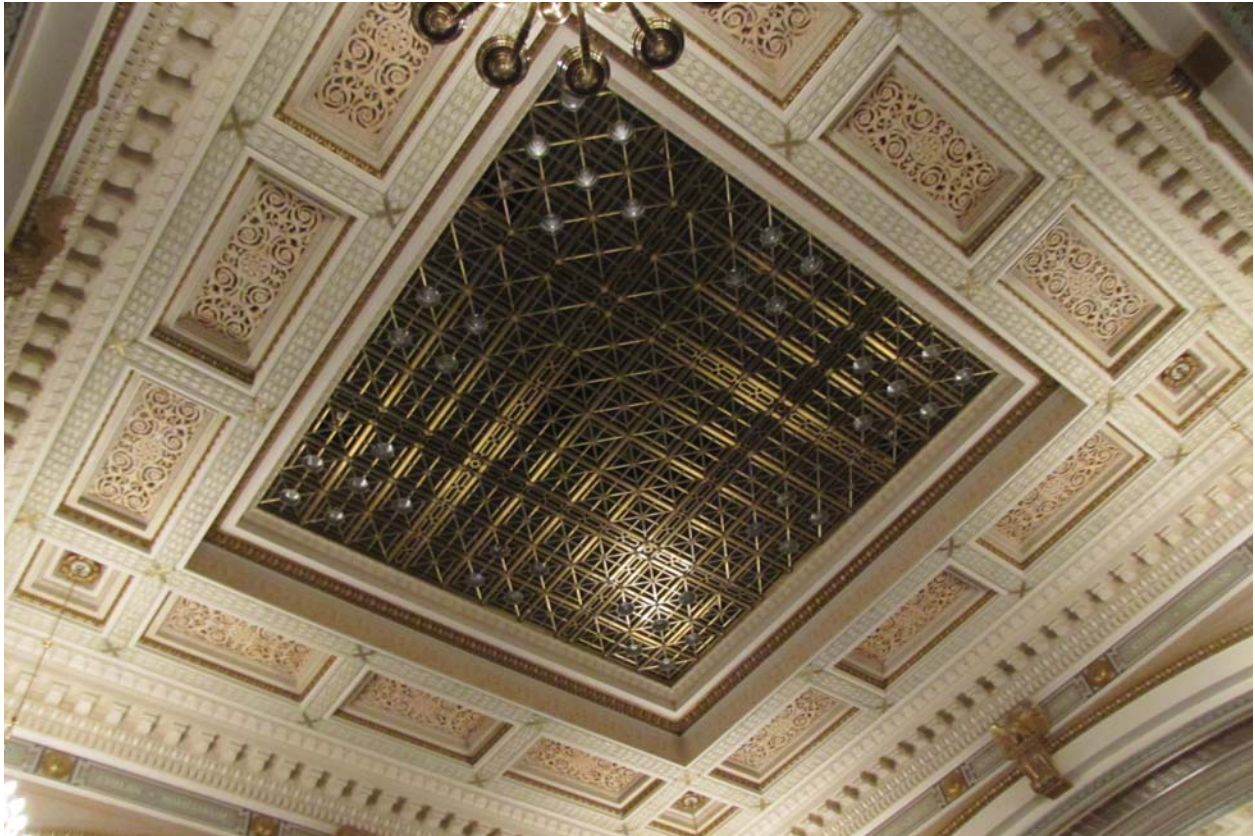
Figure ES03: House bronze ceiling laylight

- 40 light fixtures which have been replaced and upgraded with new lamps to meet changing demands of videography in the Chamber spaces (1930-2003).
- A smoke detector (2003).
- A security camera (2003).
- 2" thick acoustical insulation in lieu of the original opalescent glass panels - partially due to safety concerns of a seismic event as well as for acoustical improvement (1967).

- Restore the 20 laylight bronze panels that once held light fixtures back to the original ornamental pattern.
 - Replace the existing security camera with a smaller security camera, carefully locating it on the fretwork in the least obtrusive location.

- Replace the smoke detector with a smoke sampling system connected to the existing fire alarm system that will be installed above the laylight. Conduit to run tight to the framework for the laylight to eliminate shadowing. Number of air sampling ports to be determined with the Fire Marshall during design.

- Remove and replace the insulation panels that block the openings in the laylight with either historically appropriate 1/8" amber-tinted opalescent glass with a safety film OR light-transmitting resin panels.

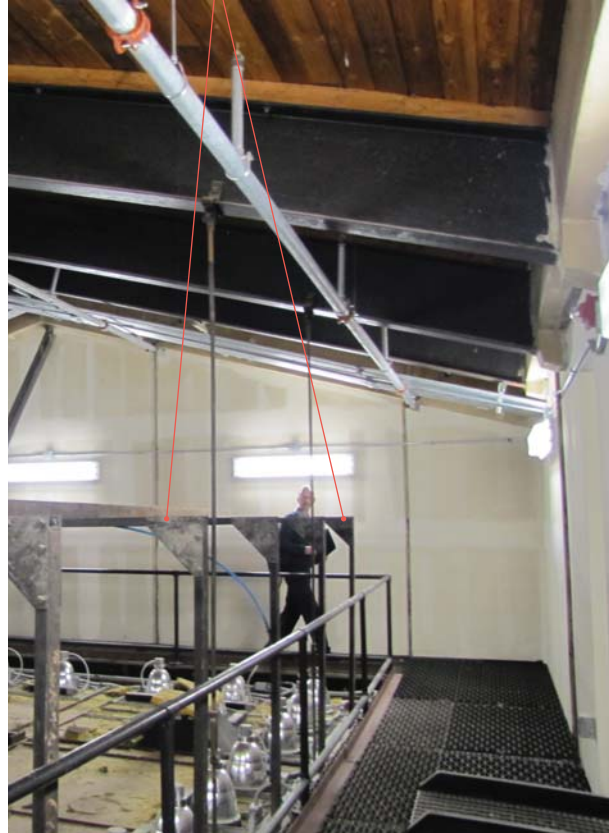
Figure 28: Catwalk and pipe rail around ceiling laylight

The metal framework that was utilized as the support system for the original 20 light fixtures above the ceiling laylight is still present (see Figure 28).
