CAPITOL LAKE DAM CONDITION ASSESSMENT AND LIFE EXPECTANCY

October 31, 2008

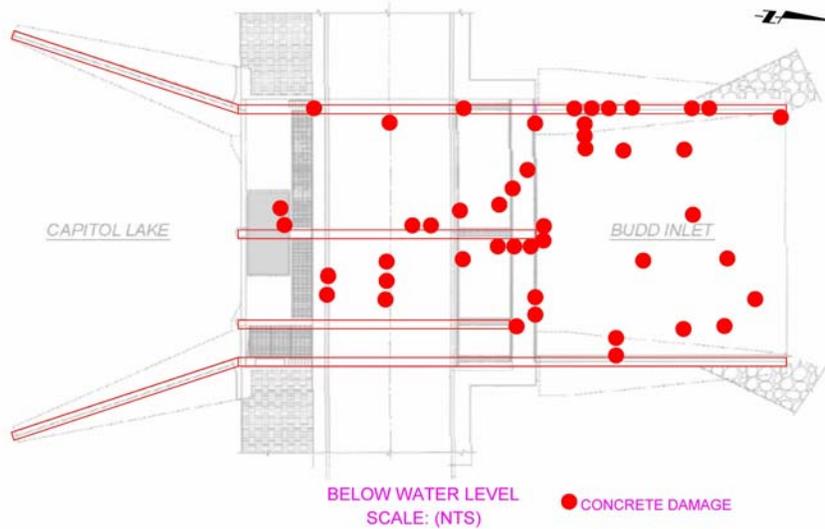
Figure 5. Concrete Damage Concentration Map (Underwater)

The general vicinities of the damage noted in the dam's concrete are displayed in Figures 5 and 6. The two figures are intended to convey a general understanding where the concrete damage is concentrated, and should not be used as repair plans. Figure 5 shows (in plan view) the damage observable below water. Similarly, Figure 6 indicates damage noted above water.

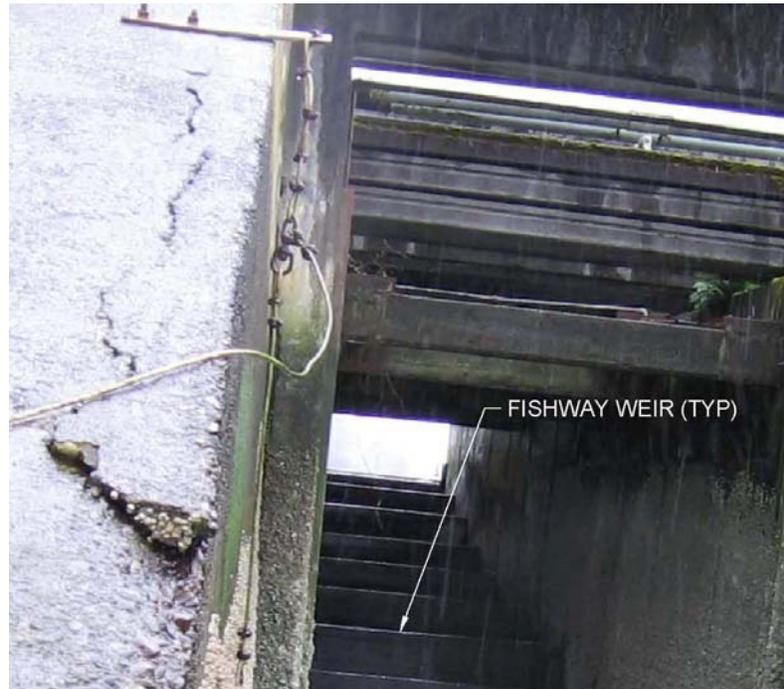
Figure 7. Spalled Downstream Wing Wall

Efflorescence and minor spalls and cracks were observed in various locations around the wing wall elements. The wing walls also exhibit occasional instances of significant localized delamination, spalling (see Figure 7), and cracking. Dywidag bars that were used during construction to support falsework were observed protruding out from the concrete of the entire inner face of the westerly abutment (see Figure 8). Most of the occurrences exhibit light spalling with what appears to be corrosion spreading to the surrounding concrete.

The deep spalling exhibited on the wing walls and pier walls is primarily localized near the bottoms of the walls, although section losses generally appear incidental and should not significantly affect the serviceability of the structure. The spalls may become larger and more susceptible to damage over time if they are not repaired, especially those that exhibit exposed steel, which could initiate corrosion of the surrounding concrete and significantly escalate the damage. The bottom slab itself exhibits similar spalling, potentially compromising the behavior of the design flow through the concrete channel.

The concrete abutments/wing walls, pier walls, and bottom slab elements are all in fair condition and repairs are recommended, but with low priority. The damage consists of spalling and cracking. Suggested repair measures include cleaning the spalls and patching with a non-shrink epoxy mortar and epoxy-injecting the crack openings. Good preparation and installation technique are essential to a long-lived repair. For spall repairs, particular attention should be paid to the properties of the mortar when selecting a repair material. An example of a patching material is SikaRepair[®] 223 (see Appendix E). The properties of the selected mortar should be comparable to the properties of the concrete.

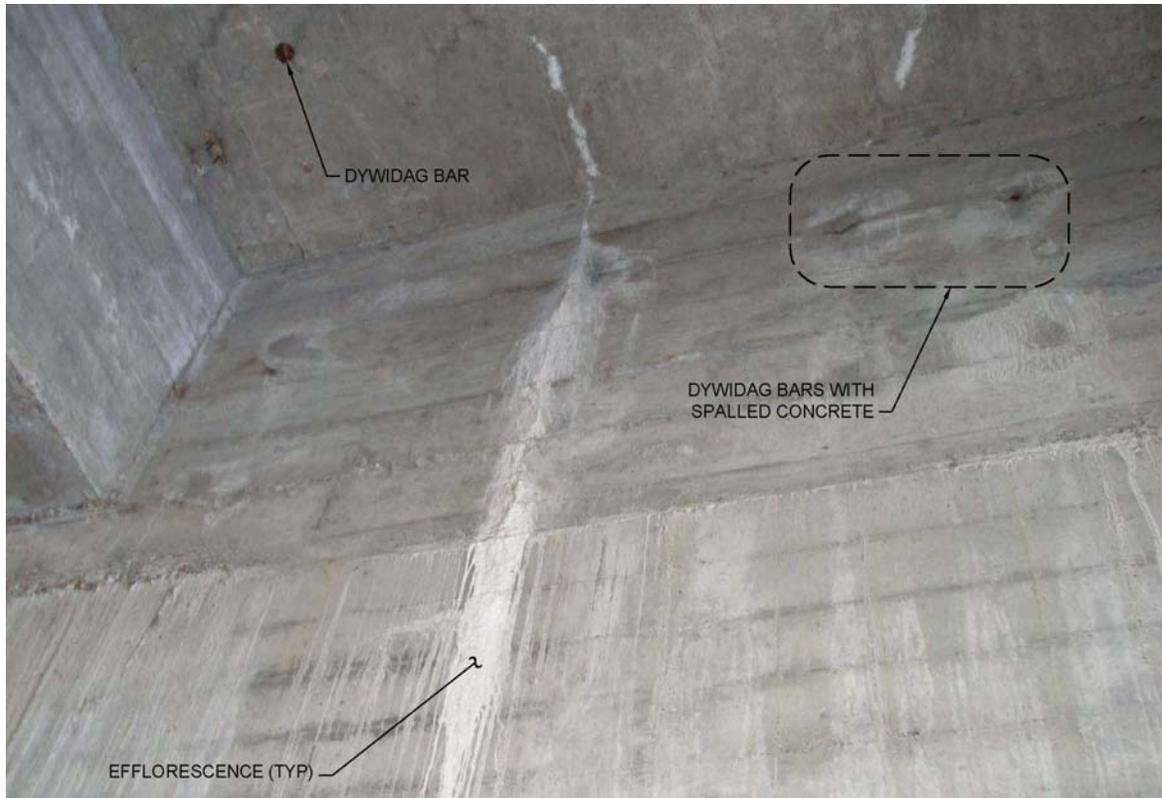
Figure 8. Defects and Efflorescence Observed on Walls and Deck Soffits

Spotted efflorescence is visible on the soffits and in areas adjacent to abutments and pier walls, indicating seepage of water through the concrete. Minor tension and compression cracking is visible on the girders supporting the bridge structure.

Above-water inspection revealed the presence of dywidag bars scattered throughout the deck soffits, along with various buildups of efflorescence and superficial cracking, typically near corners between the girders and abutments supporting the roadway (see Figure 8).

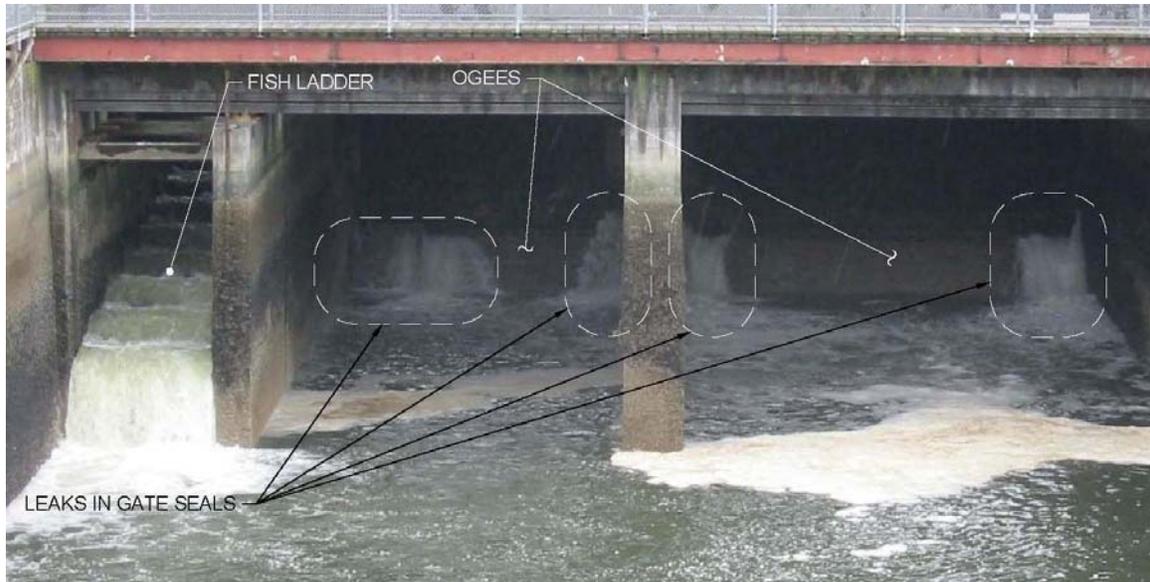
Figure 9. Radial Gates As Seen From Budd Inlet Side During Low Tide

The steel faces of the gates are shown in Photographs 2 and 4 of Appendix A, and exhibit minor to medium deterioration, although section loss is not severe. Underwater inspection revealed leaks in the seals around all sides of both gates. During low tide, leaks in the seals were verified upon visual inspection (See Figure 9). Refer to Appendix D for findings associated with the tide gates machinery and controls.

The damaged seals on the radial gates are in poor condition. This has the ability to affect flow through the dam, but does not yet significantly affect the dam's performance. However, the leaks in the seals compromise the integrity of the surrounding (and still intact) seals by initiating small currents, or flows of water through the openings. The localized points of pressure caused by the

ongoing currents make the surrounding seals more susceptible to failure by being torn or becoming separated altogether from the gates near the openings.

The seals around the radial gates are in poor condition and should be replaced in full. The radial gates exhibit localized areas of moderate section loss and no repairs are required. However, the gates should be monitored for further section loss during routine inspections. According to the Capitol Lake Tide Gates Machinery and Controls Assessment in Appendix D, the noisy shaft bearing on the west gate should be replaced immediately. Furthermore, it is imperative that a limit switch be added to the East Gate to detect the full up position.
