Washington State  
CENTER FOR CHILDHOOD DEAFNESS  
& HEARING LOSS

DES Project # 2018-713 B (2)

# PRE-DEMOLITION STUDY

4 FEBRUARY 2019

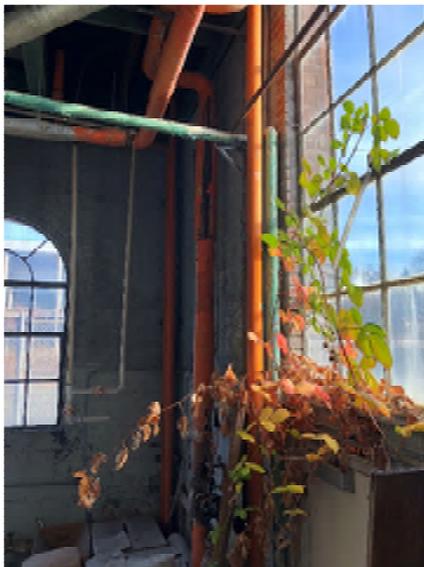
The condition of the exterior wall is very poor. Mortar is soft and loose at places and there are several areas where the masonry has cracked, particularly at the building corners. The condition of the windows and doors are equally poor with some of the glass being missing. Plants have grown up and through one of the windows on the south elevation.

*Boiler House interior with plant growth*

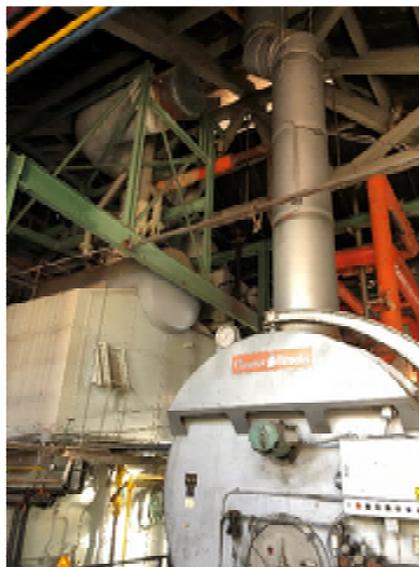
*Boiler House equipment and interior structural frame*

- The condition of the load-bearing walls and the need to do significant abatement followed by deconstruction and removal of the old boilers and their supporting structure will require temporary shoring and bracing of the structure prior to full demolition.
- In addition to usual building demolition of the building, the scope will include removing the shallow utility trench and piping
- The existing generator and transfer switch location in/adjacent to the building will need to be replaced prior to demolition

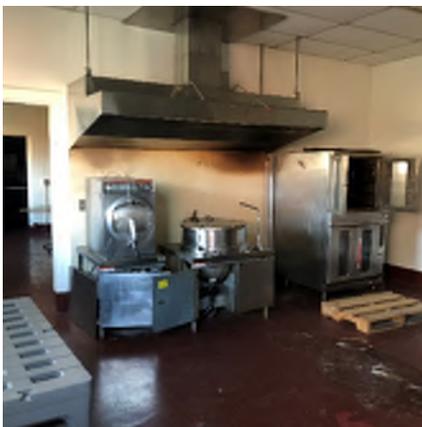
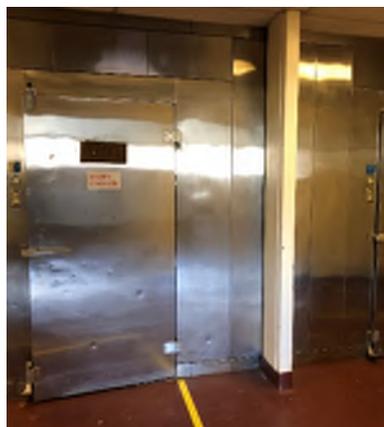
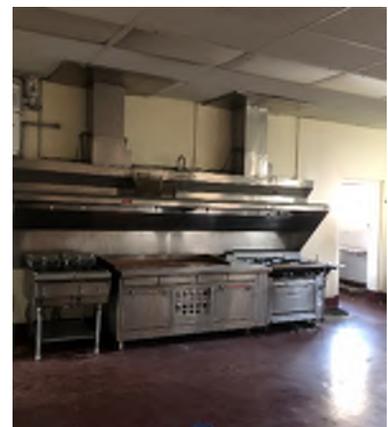
The Kitchen/Cafeteria houses a large inventory of pre-fabricated refrigeration and kitchen equipment which has been abandoned. There are considerable quantities of pipe runs in the crawlspace/utility tunnels. There is a considerable quantity of hazardous materials which must be abated in order to demolish/remove the equipment and its serving utilities.

*Interior kitchen equipment to be removed*

- In addition to usual building demolition of the building, the scope will include removing the shallow utility trench and piping
- There are several walk-in refrigeration rooms which will need to be cleared of residual freon or other controlled gasses.
- There is a cast-in-place concrete grease separator in the crawlspace below the kitchen which may require special handling.

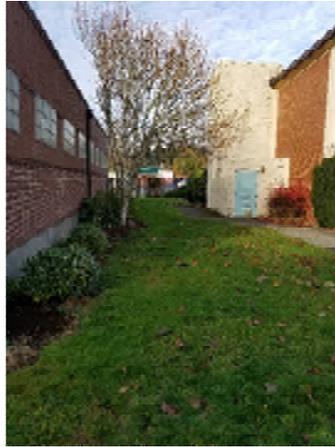
service enters the campus from East Evergreen Boulevard and is routed between the Epperson Middle School/Vocational Training and Divine High School buildings to serve Divine High School. Care will need to be taken to not damage or reroute the section of piping passing between the Epperson Middle School/Vocational Training and Divine High School buildings as this leg may be in the demolition zone.

*Gas pipe between Divine HS and Epperson*

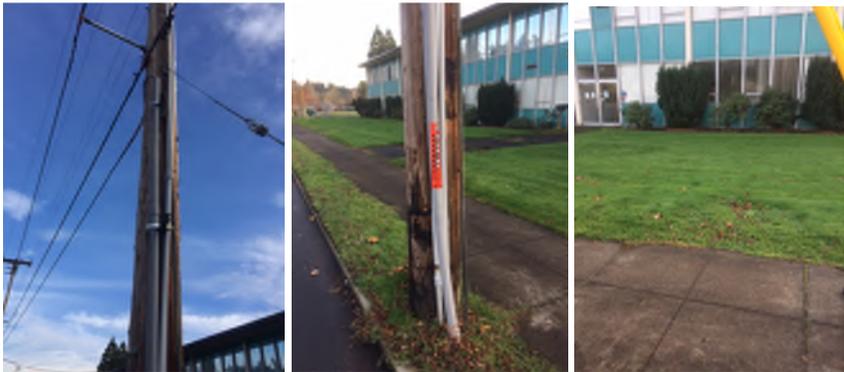
The cable on East Evergreen Boulevard appeared to go into/under the Epperson Middle School/Vocational Training building. The location of the cable termination and the route of the cable to the termination point were not identified.

It appears that the cable on North Grand Boulevard would not be impacted by building demolition activities. However, it appears that the cable on East Evergreen Boulevard would be impacted by demolition activities and the school would need to contact the telecommunication service provider for coordination and their re-routing of the cable into Clarke Hall.

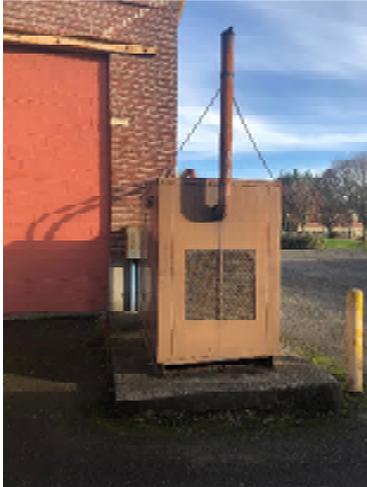
Emergency power generation for the different buildings on campus is provided from multiple sources. Kastel has its own exterior emergency diesel generator. The cottages and Northrup Elementary School are provided with local emergency battery backed up light fixtures. The rest of the buildings are served by an exterior emergency diesel generator located to the west of the Boiler building which is being torn down. The Boiler building generator appears to be old and past it's useful life.

*Boiler Building Generator*

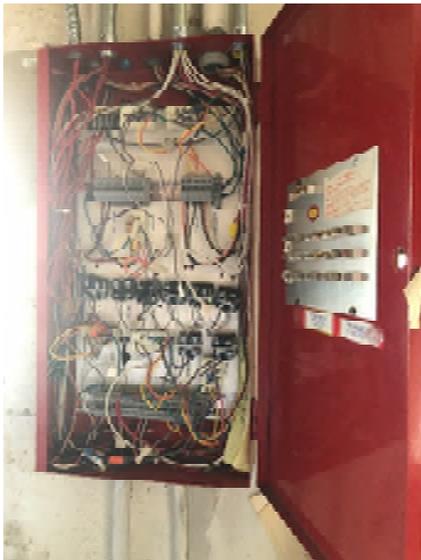
The campus standard fire alarm system manufacturer is Simplex. There are various different types of Fire Alarm Control Panels located in the different buildings. Fire alarm circuits from Clarke Hall and the cottages are routed through the Maintenance/Warehouse Fire Alarm Cabinet which is being torn down.

*Maintenance/Warehouse Fire Alarm Cabinet*
