Roof SURVEY REPORT

Limited Roof Survey and Leak Investigation

Rainier School Building 2010

Buckley, Washington

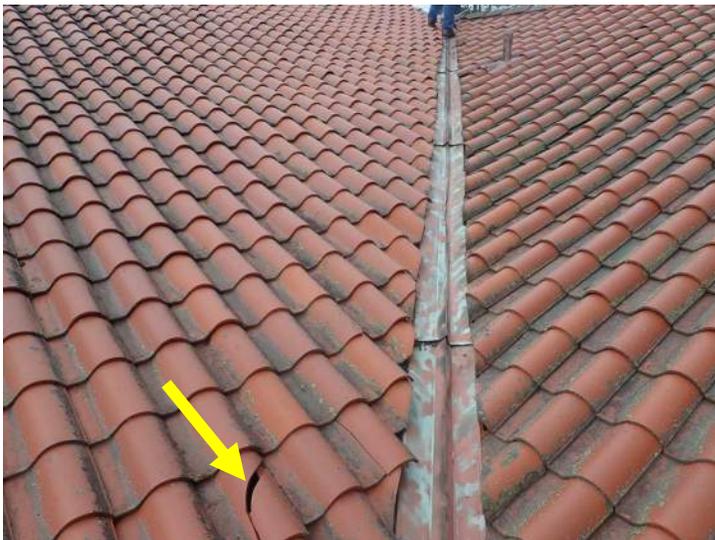
Photo No. 11 - Observations at Typical Valley

The copper valley flashing liner is in poor condition at this time. The center rib has been creased and pressed down flat in several locations and should be replaced with a new sheet metal valley as part of a reroofing project. Several cracked, and/or displaced roofing tiles were also identified along the valleys and field of the roof areas.

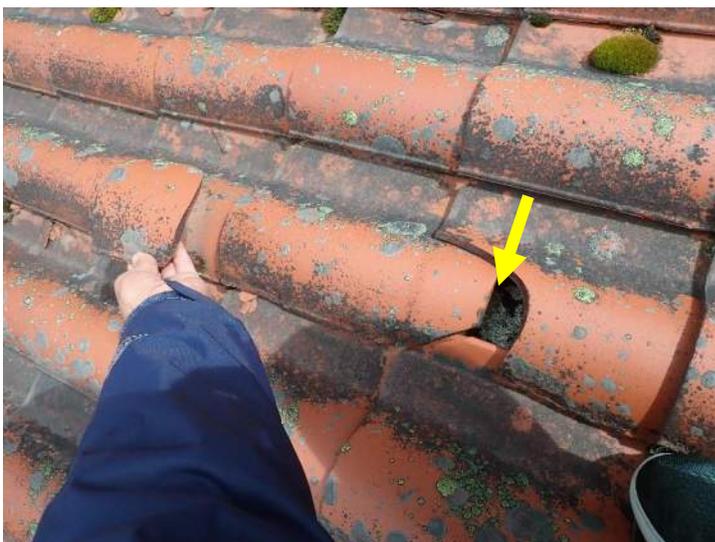
Photo No. 12 - Example of Cracked and Broken Roof Tiles Observed in Field of the Roof Areas

Close-up of typical cracked clay roofing tiles observed at the subject roof areas. The photo shows the exposed 1-ply underlayment beneath the tiles leading to the potential of water intrusion. UV exposure accelerates the aging of the underlayment, causing deterioration and potential failure of the underlayment.

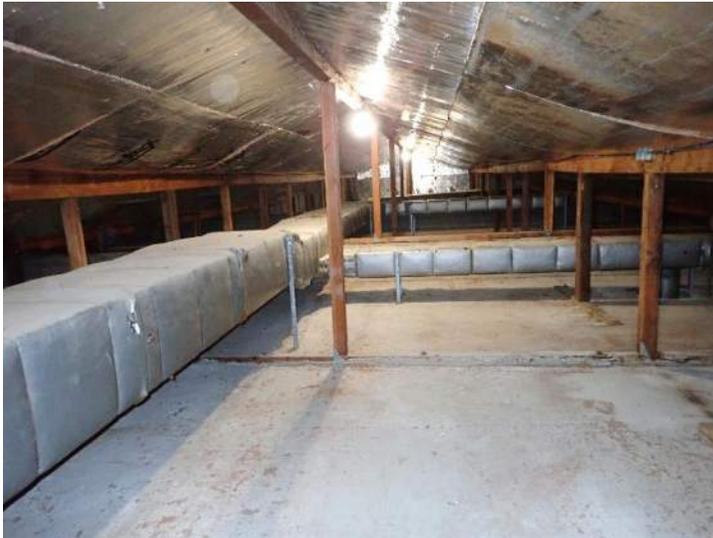
Photo No. 13 - Building 2010 Attic Photo in West Roof Area

Area separation walls within the attic break the overall space into three separate attic sections. This photo depicts existing attic conditions within the west side of the subject roof area looking west. Foil-faced polyisocyanurate insulation is mechanically-attached to the underside of the tongue-and-groove wood roof decking.

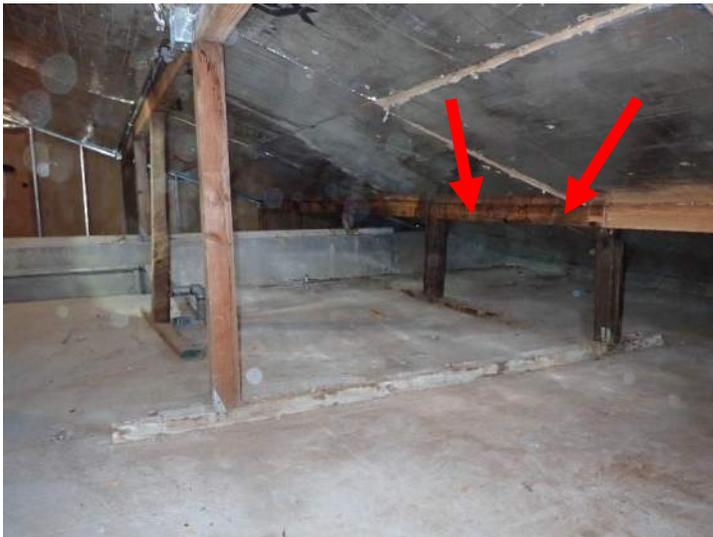
Photo No. 14 - Building 2010 Attic Photo in Center Roof Area

Depicts conditions at the west section of the attic near the area separation wall within the center attic area. The arrows show evidence of water staining on the wood beams. The insulation inhibits identification of leak sources and acts to trap rain water against the wood decking, causing further damage and decay to wood framing components.

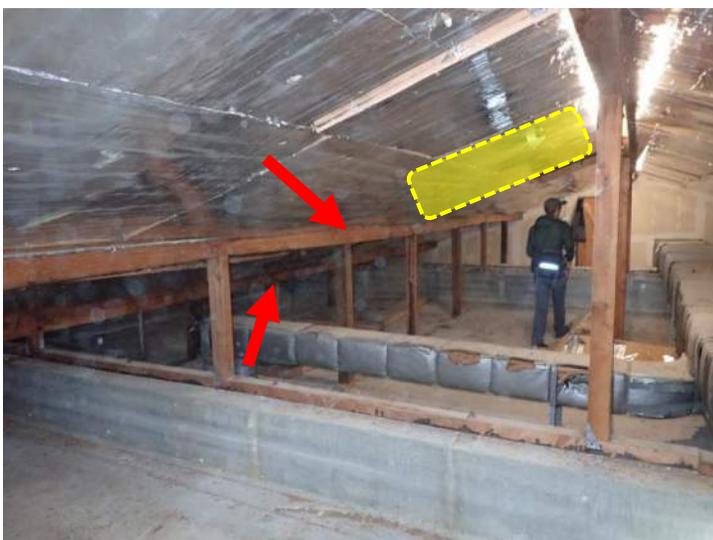
Photo No. 15 - Building 2010 Attic Photo in West Roof Area

The 2x6 T&G wood decking runs parallel with the roof slope and is supported along the ridge line, two intermediate beams that extend the length of the attic and along the downslope eave edge. The two arrows identify the two intermediate beams that have been framed at approximate 10'-3" spacing intervals. The general test opening area is also shown.

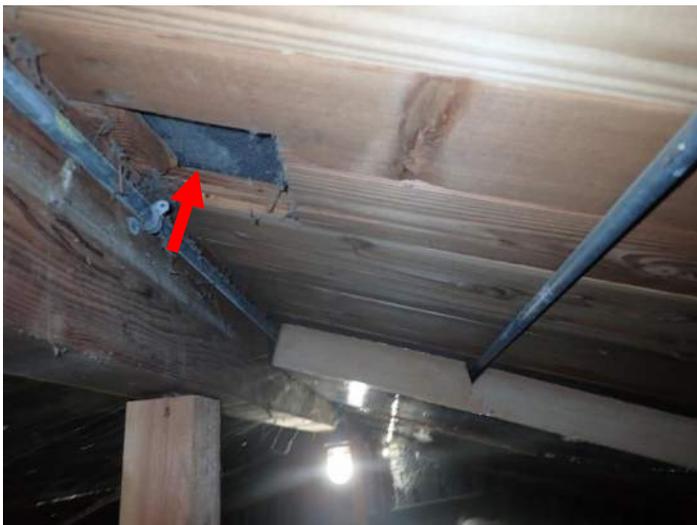
Photo No. 18 - Attic view at Ridge Vent Location

The arrow depicts the cut-out of the wood decking at the location of the small ridge vent that was blocked by the insulation. The wood at the vent appears to be in good, dry condition. Evidence of water intrusion and staining was observed downslope. The following photos depict those conditions.

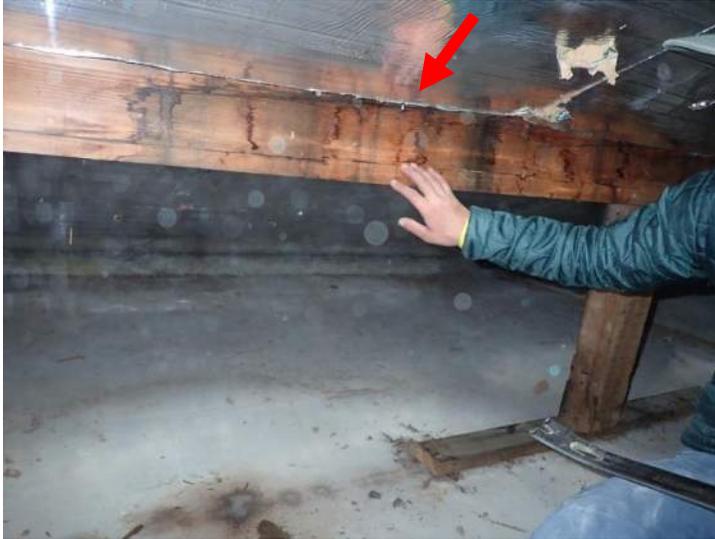
Photo No. 19 - Systemic Water Staining at Attic Wood Beams

Downslope of the ridge vent at the beam located closest to the eave, extensive evidence of water intrusion was observed. As we worked to remove the insulation, water that had been trapped against the wood decking by the 4-inch insulation panels actively dripped onto the concrete below.

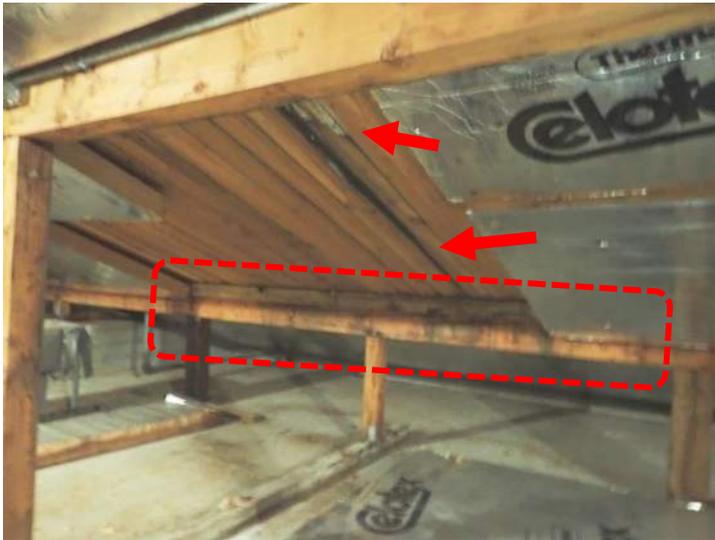
Photo No. 20 - Water Staining at Attic Structural Members

With insulation panels removed, this photo shows water staining running down the roof decking. The arrow at the top of the photo shows an area of biological growth on the wood surface. Water staining was observed along most of the length of the downslope wood beam indicating systemic water intrusion.

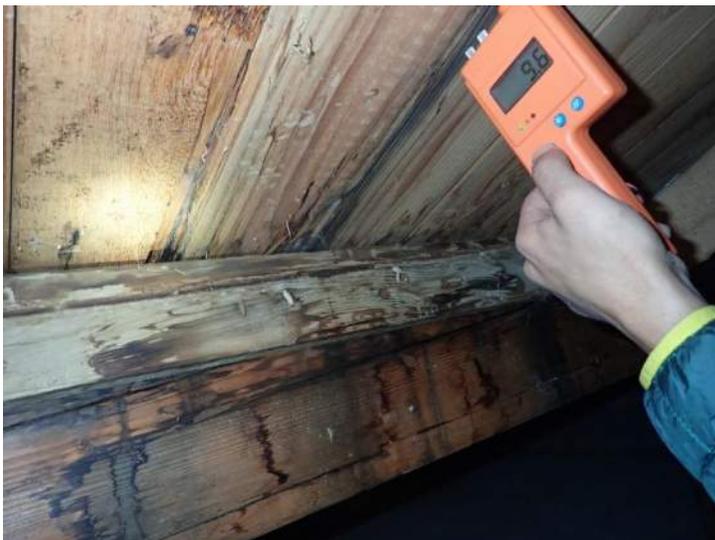
Photo No. 21 - Moisture Meter Readings at Roof Deck

Photo of water staining on the T&G wood decking and 4x10 wood beam. Water staining was observed throughout the attic. The photo shows a Delmhorst BD-2100 Moisture Meter used to measure moisture content of the wood. This photo shows a reading 9.6%, during an unusually on-going dry spring season, while others measured approx. 20%, which is considered significantly elevated and will promote further fungal growth and wood decay.

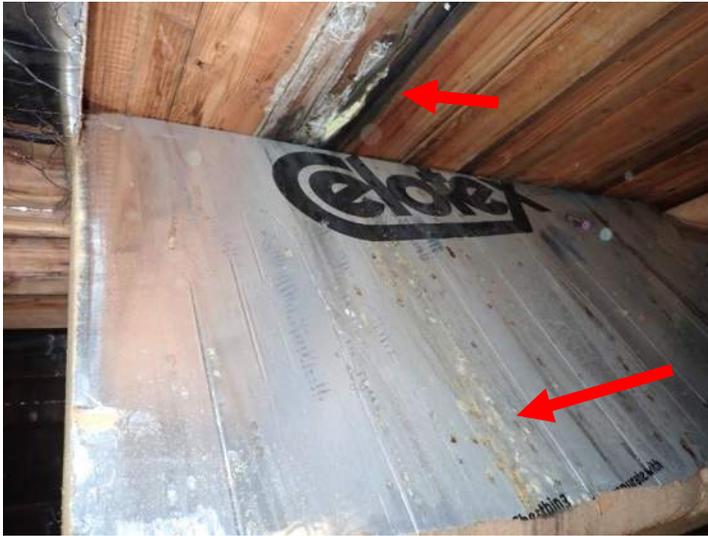
Photo No. 22 - Water Staining and Biological Growth Trapped by Insulation

As other insulation panels upslope where removed, the water staining continued. The white colored substance appeared to be biological growth (i.e. mold). Water staining on the top-surface of the insulation against the wood decking, showed signs of staining on the foil-facer.

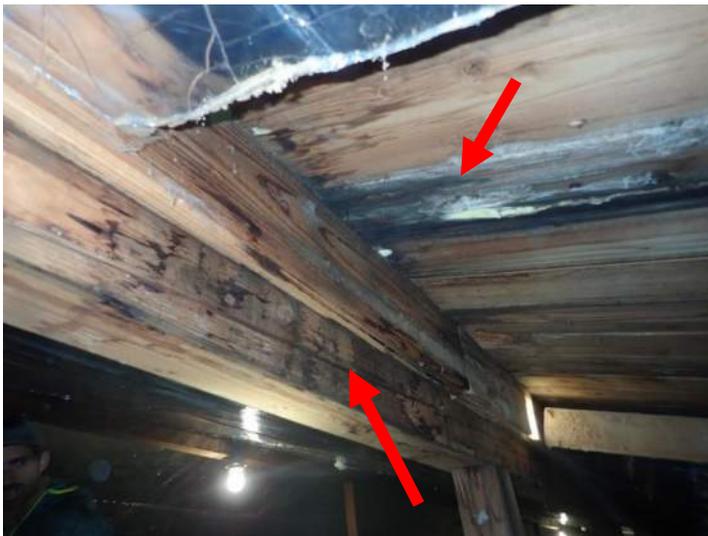
Photo No. 23 - Water Staining and Biological Growth on Wood Structure

Closer photo of water staining and biological growth which had been in contact with the intermediate beam closest to the ridge.

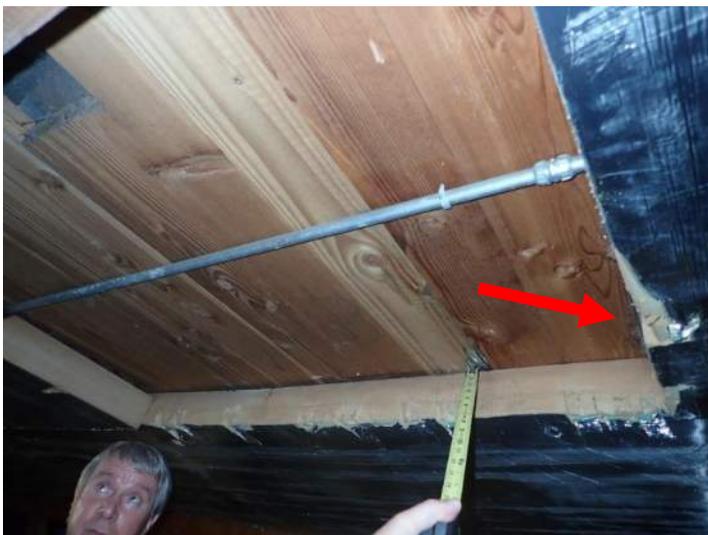
Photo No. 24 - Attic Conditions Downslope from Ridge Vent

The water staining shown in previous photos continued to extend upslope and appeared to originate near the point of the arrow. For reference, the cutout for the ridge vent is shown in the upper left corner.

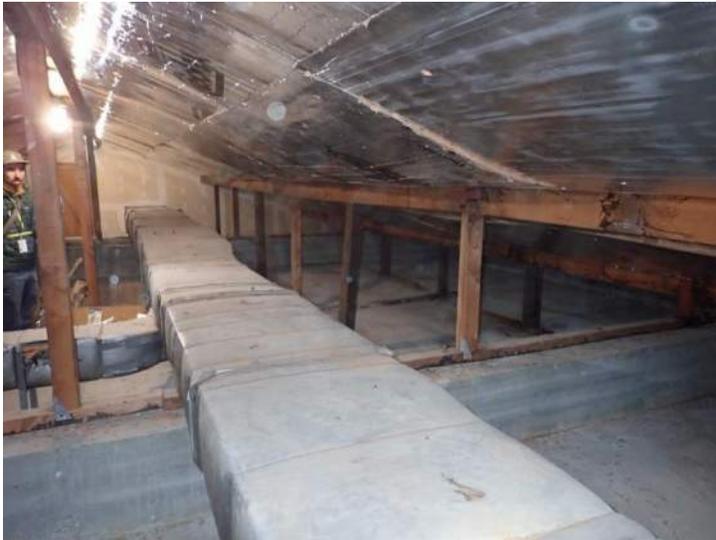
Photo No. 28 - Attic View within West Section of Roof

Photo looking east within the west attic area. The photo shows several areas of water staining along the supporting posts and beams.

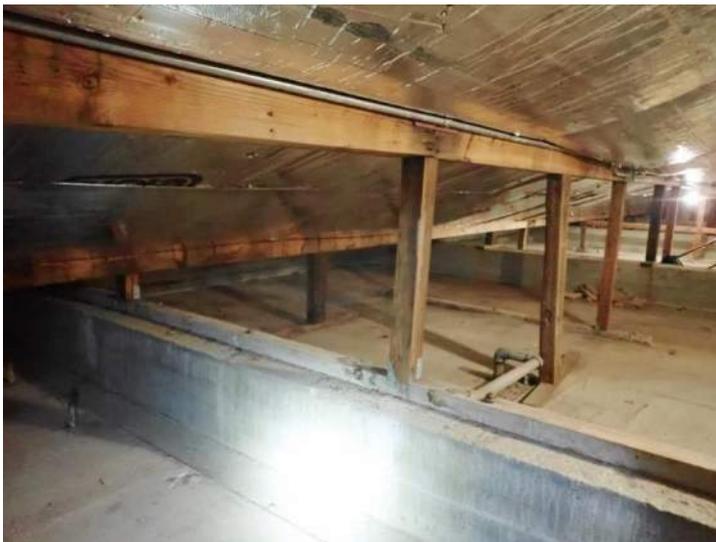
Photo No. 29 - Attic View within Central Section of Roof

Photo near the stair access of the central area in the attic. Again, several areas of water staining on beams were observed.

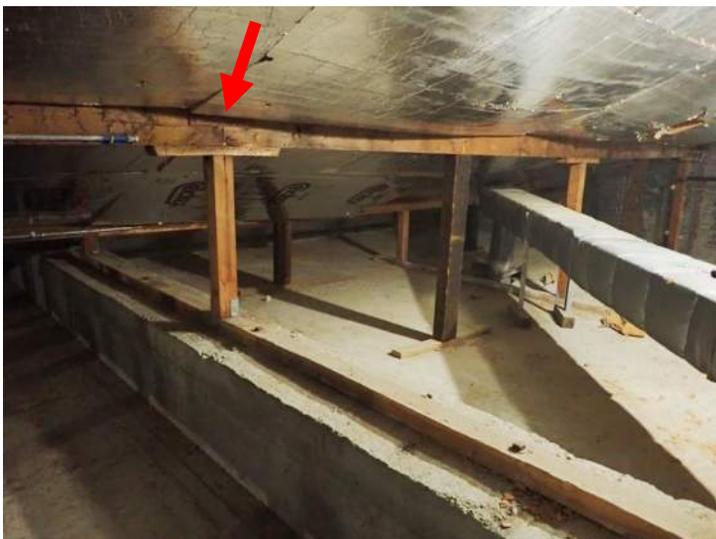
Photo No. 30 - Attic View within East Section of Roof

Depicts evidence of water staining near the east gable end of the east attic area. Please refer to Site Visit Report prepared by Harbor Consulting Engineer's regarding structural components.

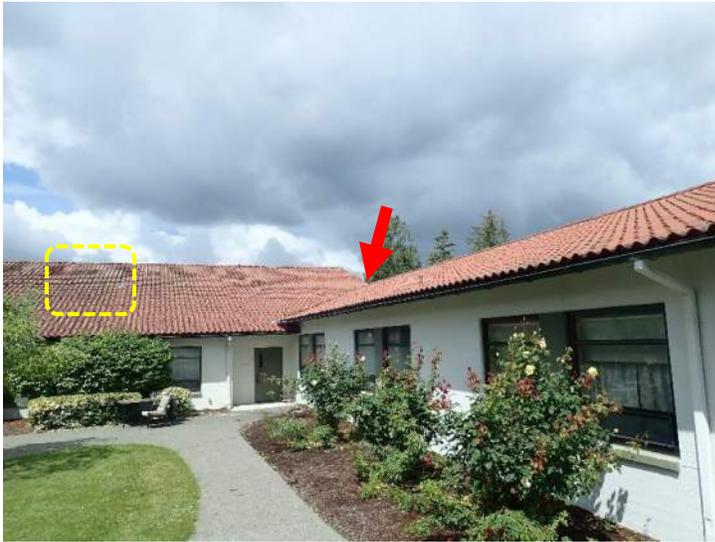
Photo No. 31 - East Courtyard showing Valley at Area of Concern

Following our initial interior observations, we accessed the roof from the central courtyard on the east side of the building, going up the valley identified by the arrow. The yellow box identifies an area of concern at the adjacent roof area where visual signs of sagging of roof components were observed.

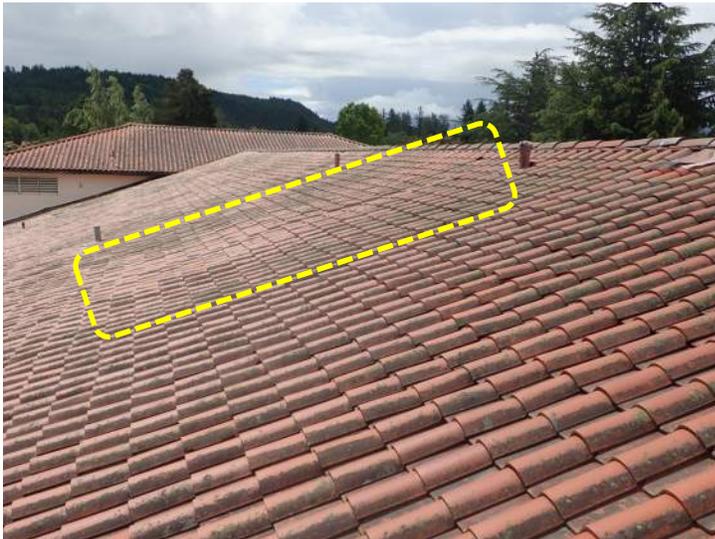
Photo No. 32 - Area of Visual Sagging of Roof Components at Center Wing of Building

View of area of concern as photographed from the valley. A large section of the clay tile roofing appears to be sagging. This area was not part of our initial survey area; however, we recommend additional survey effort take place along with potential emergency repairs to address the noted issues.

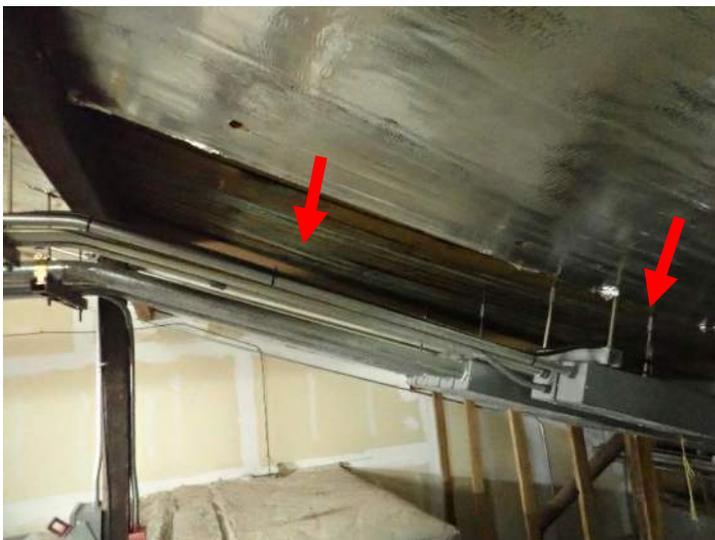
Photo No. 33 - Attic View Below Area of Concern

During our survey we also observed an area of deflected/sagging roof-related components at the center roof area adjacent the valley on the east side of the roof areas. Several large electrical conduits are located below the area and attached to the underside of the roof decking. This area is an area of critical concern and is recommended to be repaired immediately.

At the interior of the area of concern, where deflected/sagging roof-related components were visually observed, several electrical conduits and mechanical services were located and supported by the roof decking. This is an area of critical concern and is recommended to be repaired and corrected immediately.

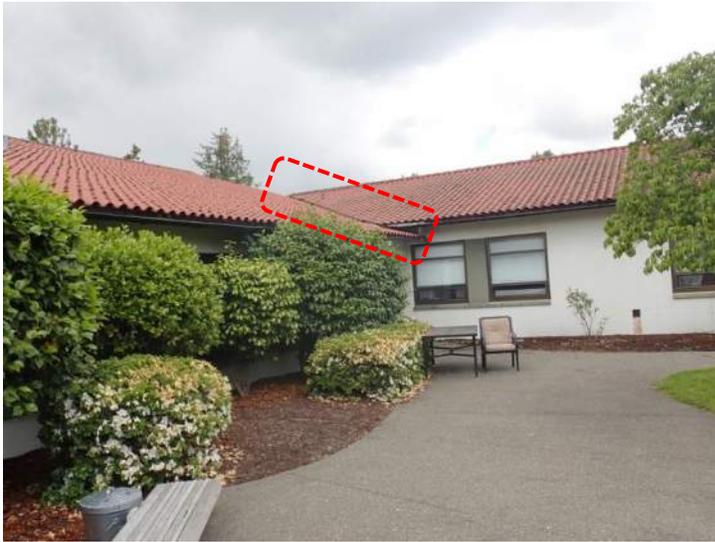
Photo No. 34 - Valley at East Side of Roof Survey Area

Water intrusion was also identified to be problematic at the two valley locations observed during the survey. The valley shown in this photo is located in the courtyard space between the north and center roof sections on the eastern side of the building. The valley flashing was in poor condition and evidence of water intrusion within the attic was prevalent.

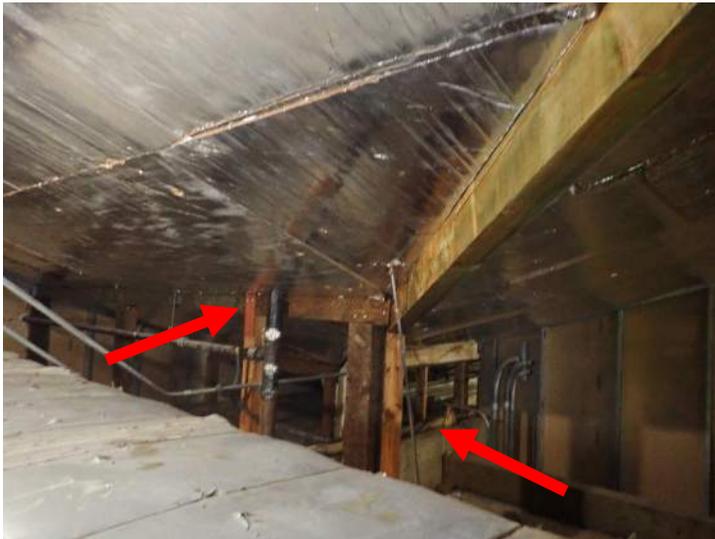
Photo No. 35 - Evidence of Water-Staining at Valleys

Systemic observations of water intrusion were noted along both of the valley's that intersect the north wing roof area. Select wood framing members may also need to be replaced due to water-damage and decay at the valley locations. Evidence of staining on the concrete floor was also evident.

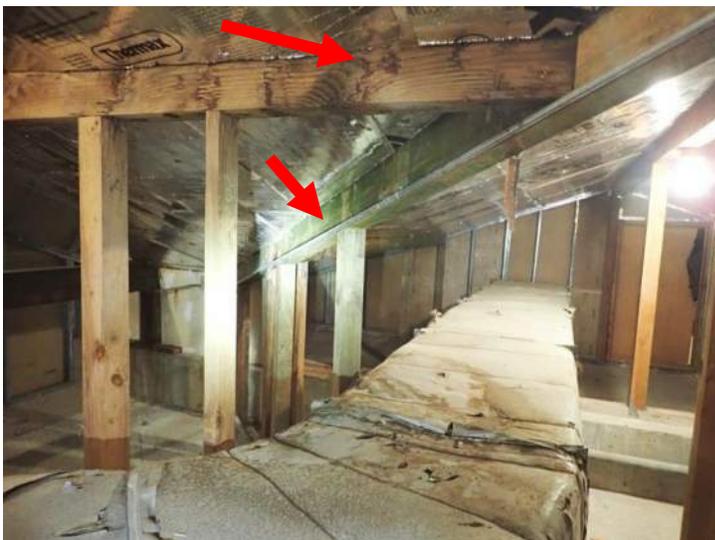
Photo No. 36 - Evidence of Water-Staining at Valleys

The west side valley also showed evidence of water intrusion. On other campus buildings, the existing valleys have been problematic with on-going water intrusion issues. Redesign and retrofit of the valleys and flashing systems is recommended.

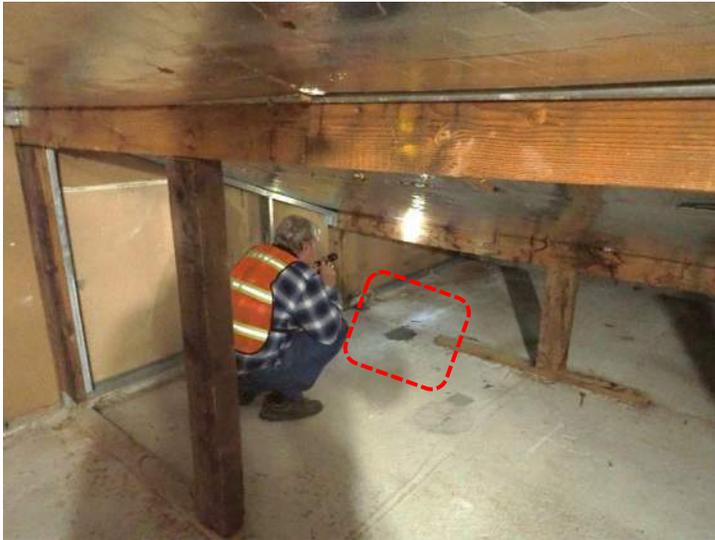
**Photo No. 37 - Rain-water leaks
Following Brief Storm During Survey**

Following a brief, but heavy rainfall during our survey, rain water was observed dripping from the roof at a minimum of three locations observed during a cursory walk through. This is example is located in the central roof area towards the west of the stairs.

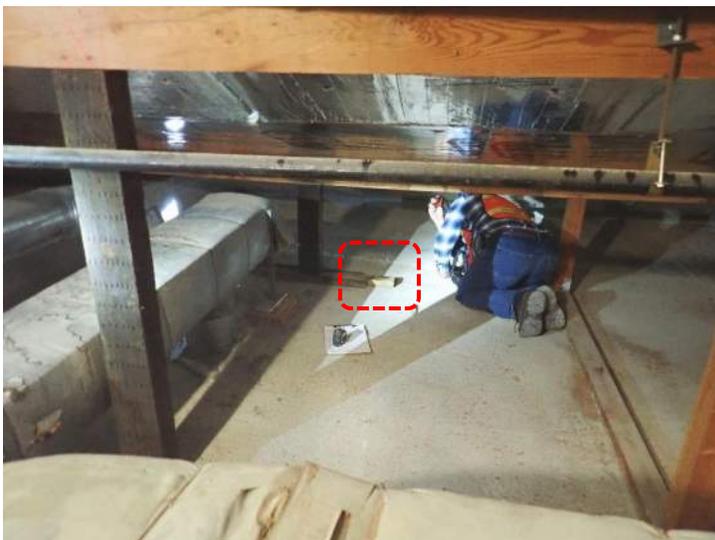
**Photo No. 39 - Rain-water leaks
Following Brief Storm During Survey**

Rain water was also observed dripping from the 4x10 wood beam in the east attic area and dripping on the 2x4 wood sill plate below.

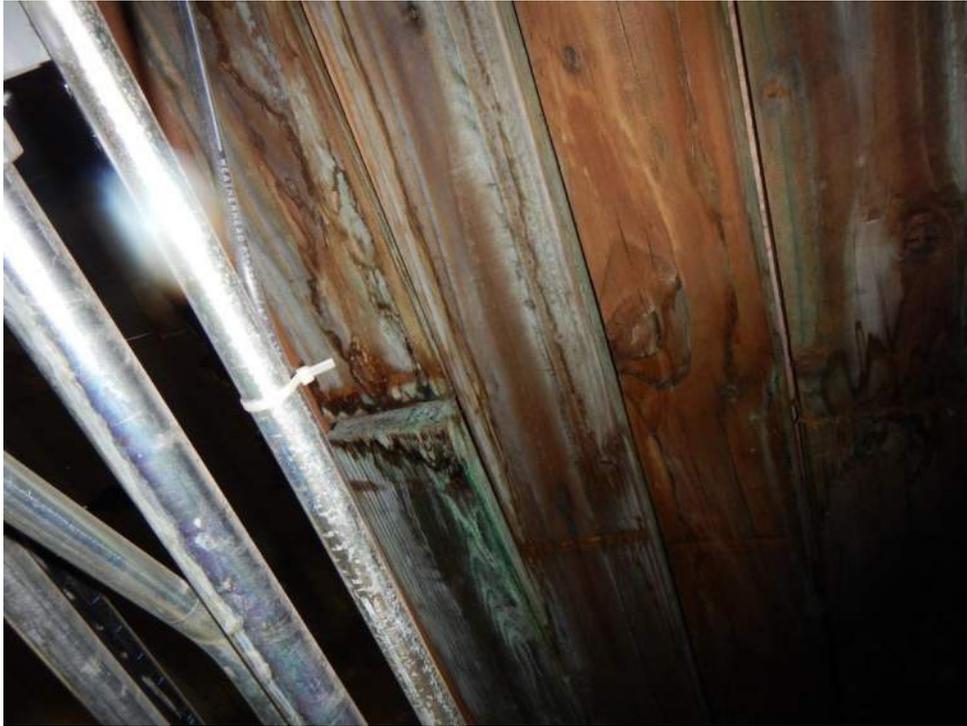
Photograph # 7: Example for water seepage staining on soffit of decking.

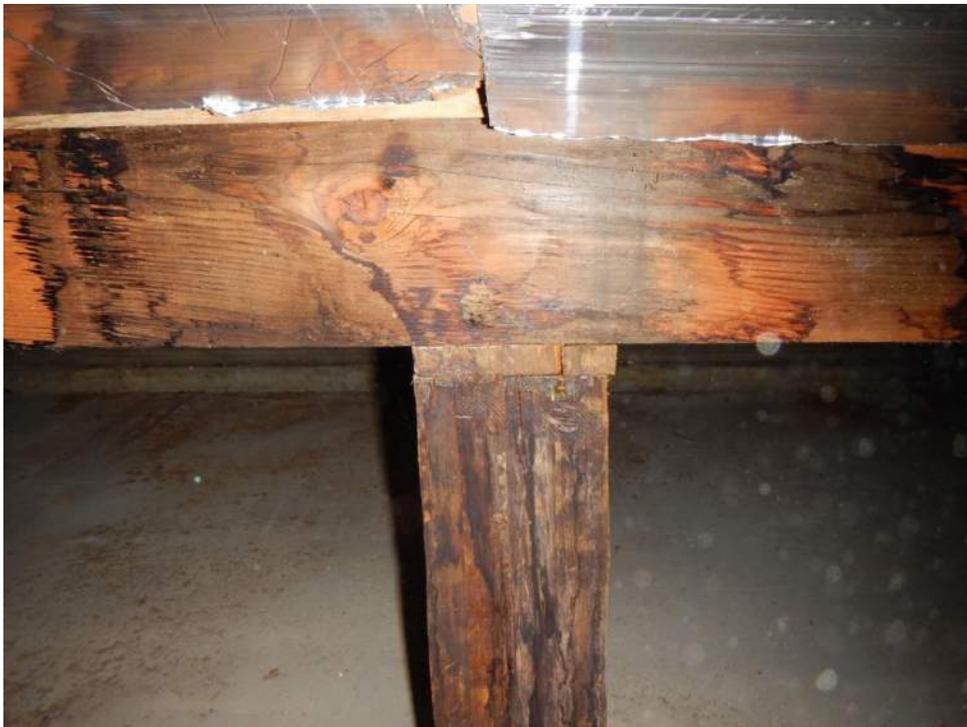
Photograph # 8: Example of water seepage staining on beam and post.

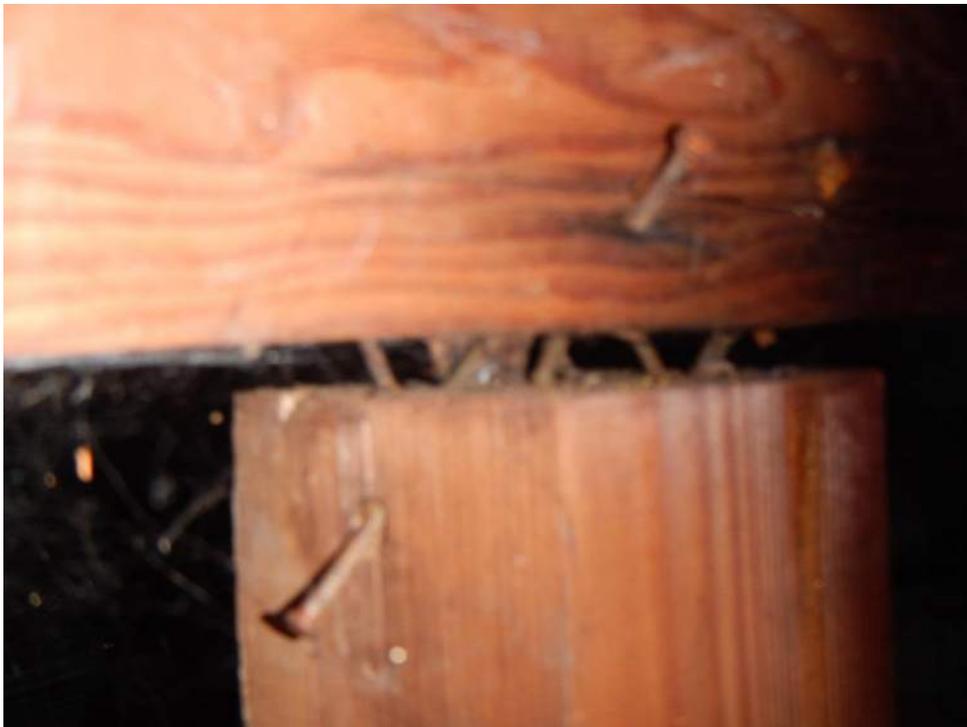
Photograph # 10: Ridge beam not in contact with support post.

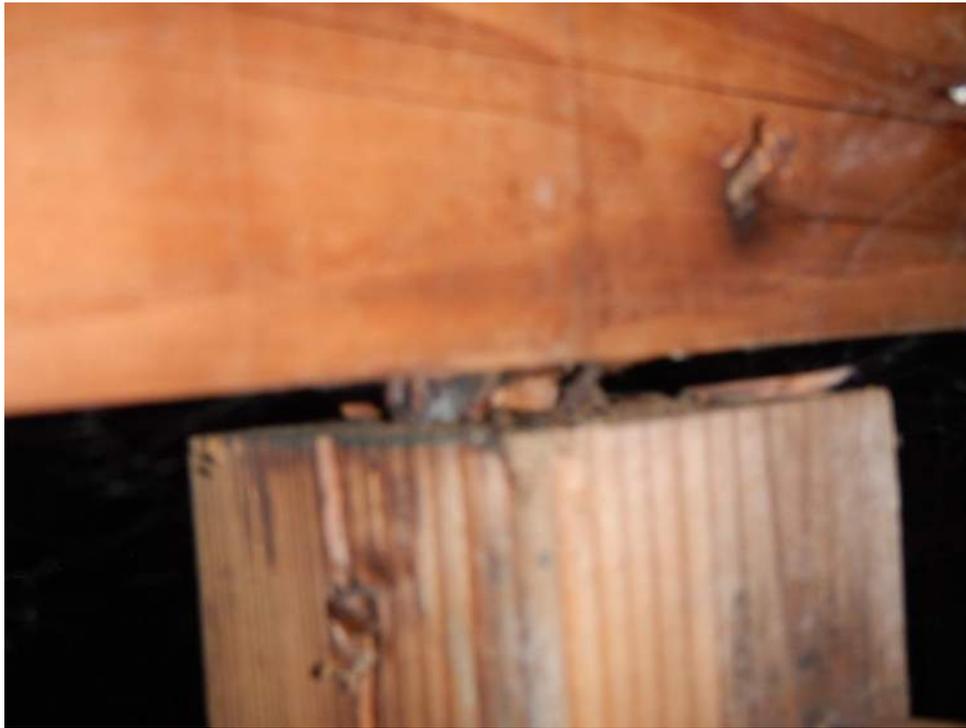
Photograph # 11: Ridge beam not in contact with support post.

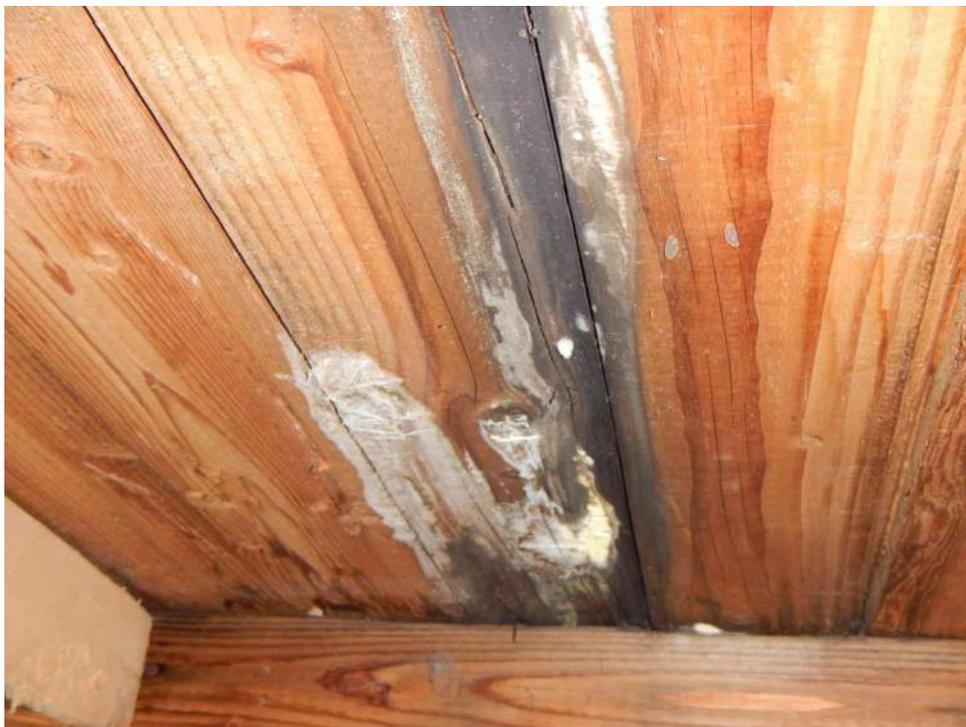
Photograph # 12: Example of timber roof deck decay at soffit.

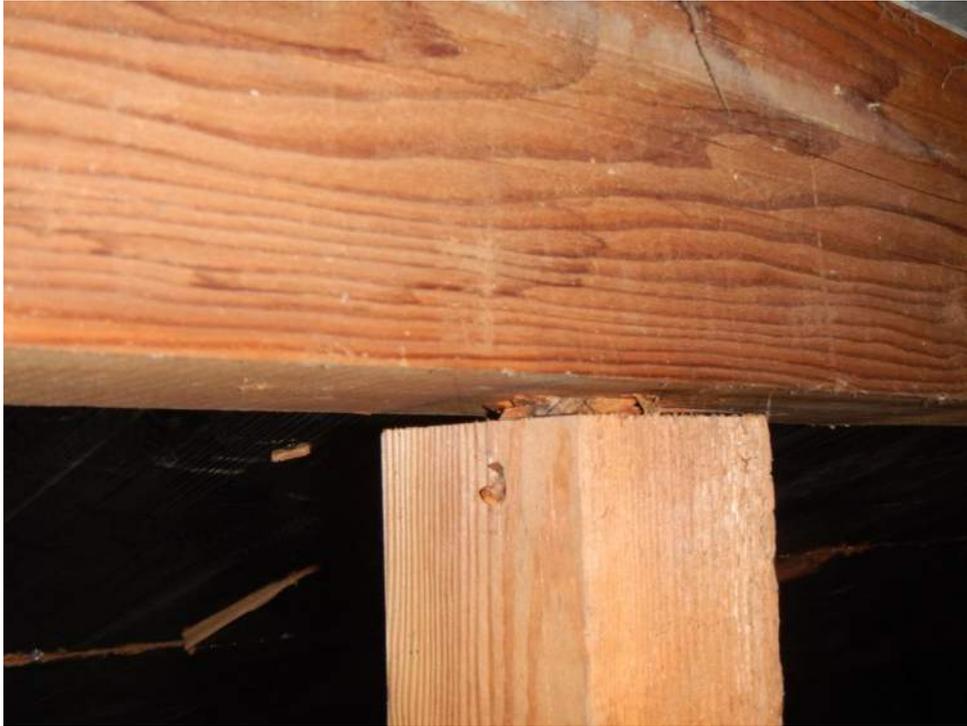
Photograph # 13: Ridge beam not in contact with support post.

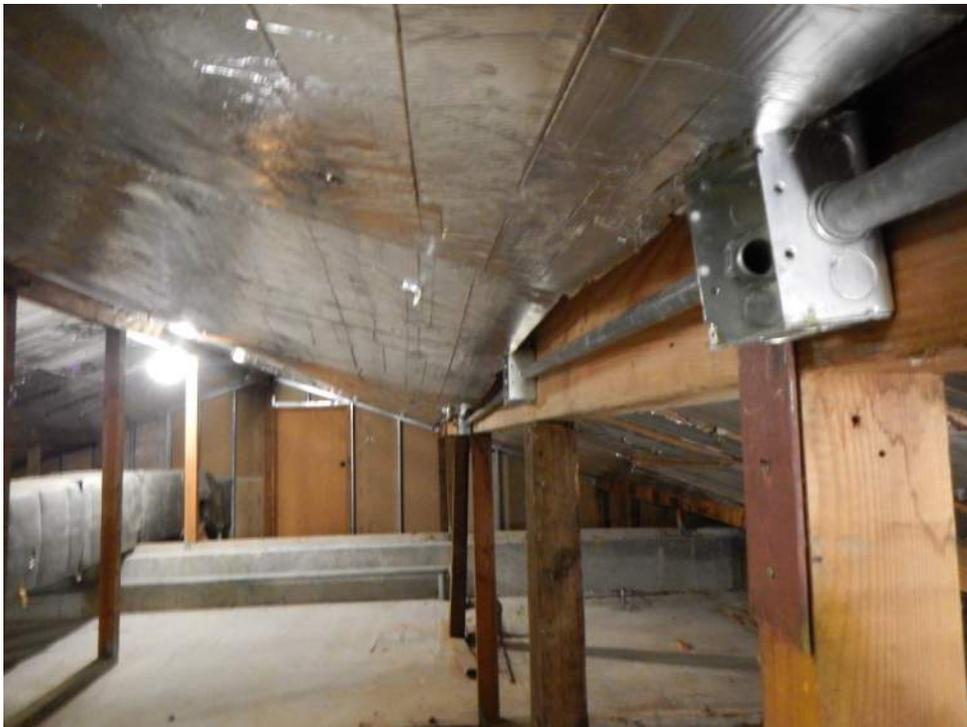
Photograph # 14: View of attic framing with rigid insulation (note non-plumb posts)

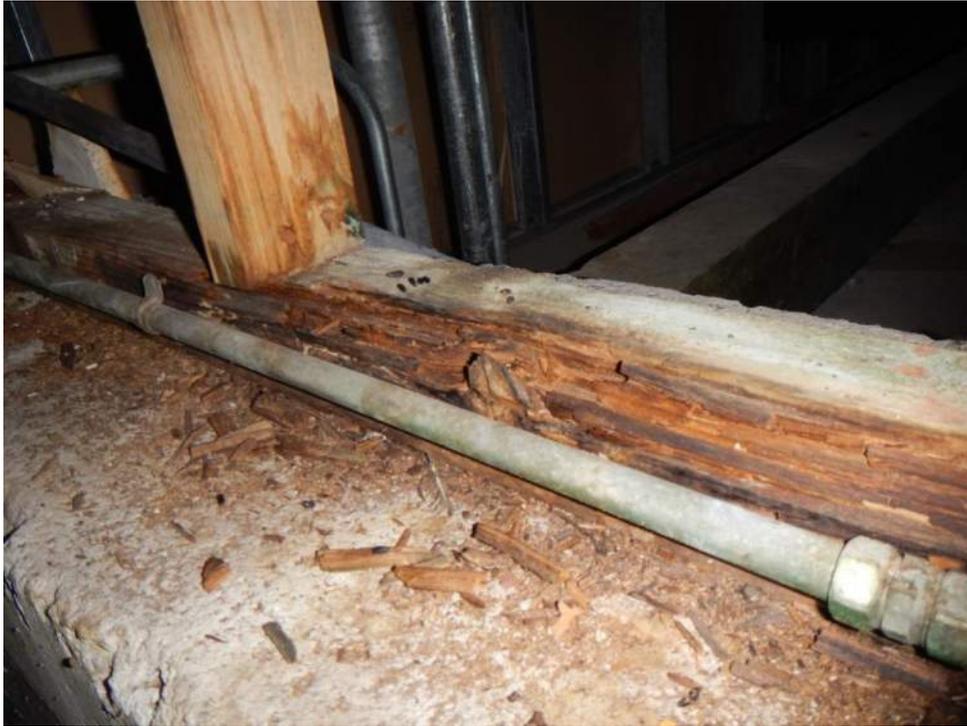
Photograph # 15: Deteriorated wood sill plate below valley on upturned concrete beam.

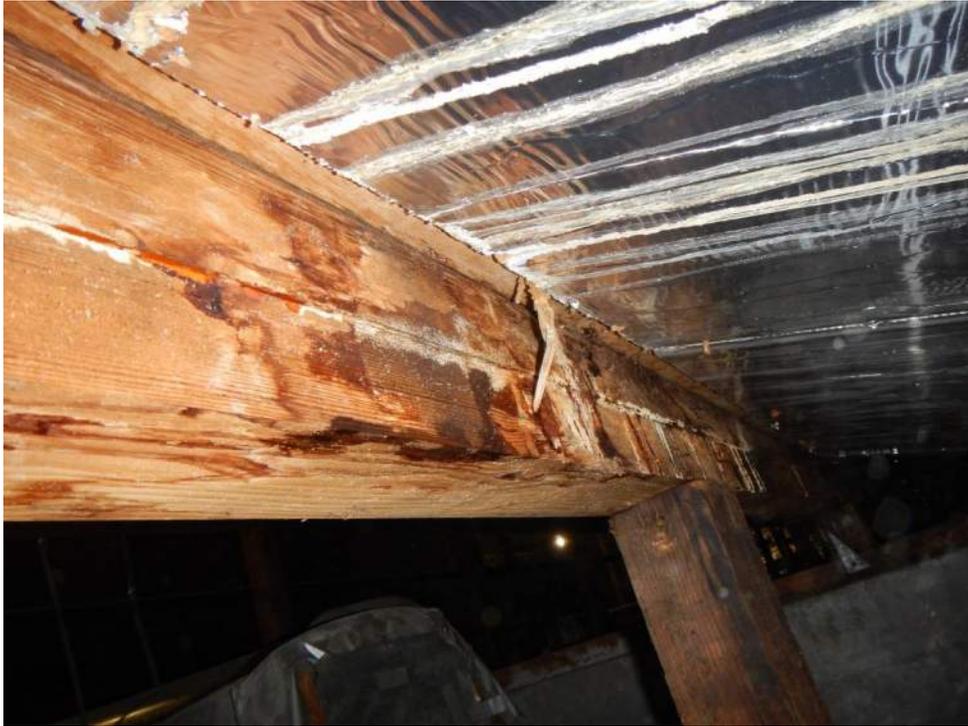
Photograph # 17: Example of seepage staining on soffit of roof decking and support beams.

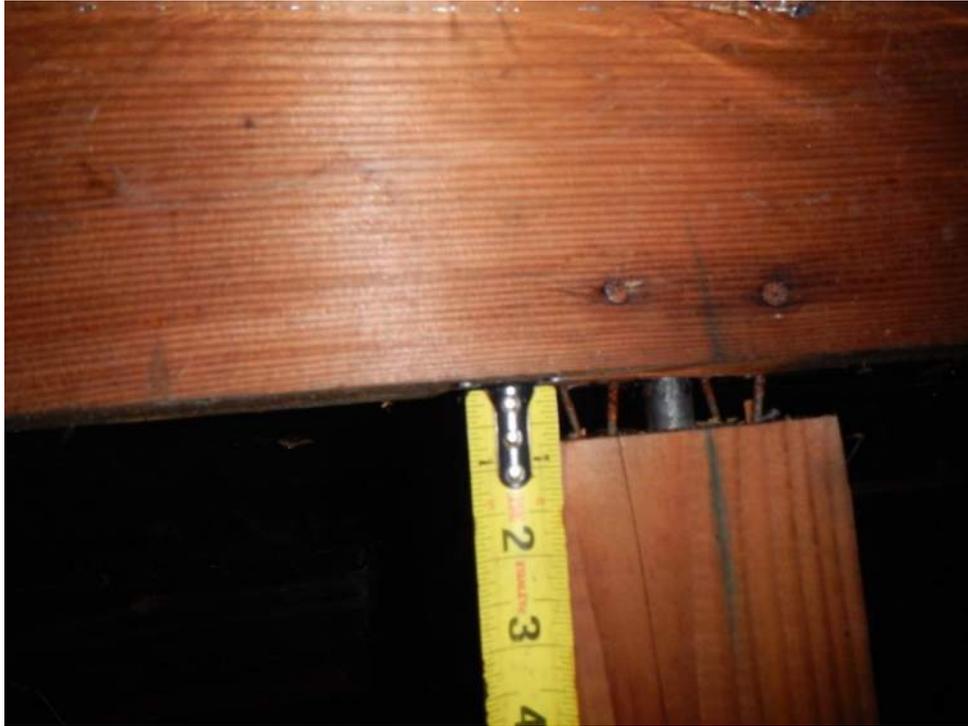
Photograph # 19: High beam separation from post of 3/4 inch.
