LEAK INVESTIGATION REPORT

**Tacoma Rhodes Center
Broadway Building – West Elevation Wall
Tacoma, Washington**

*Job No. 0807-10B
June 24, 2009*

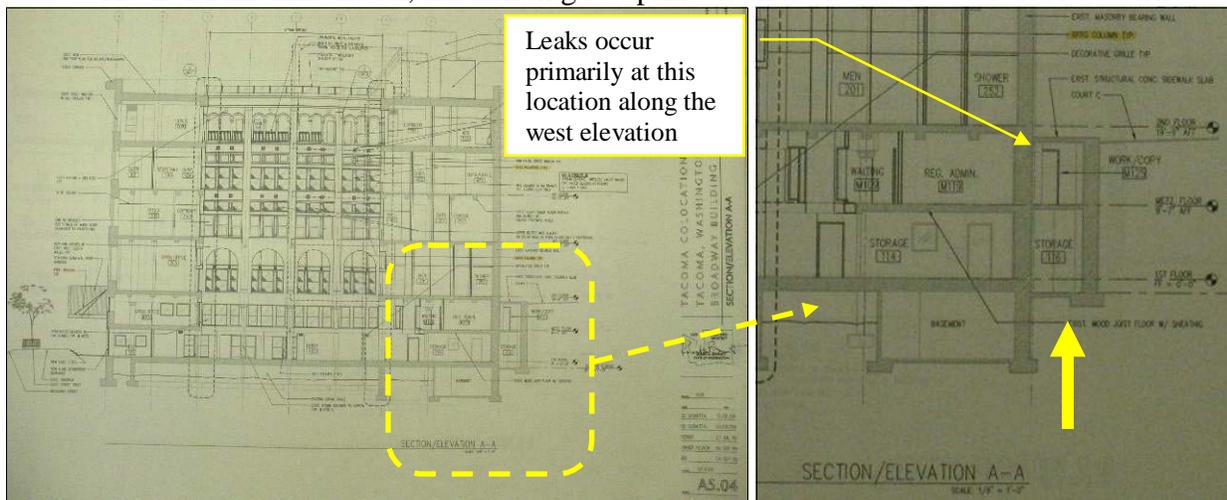
The Mezzanine and First Floor Levels extend under the Court C sidewalk at the west perimeter.

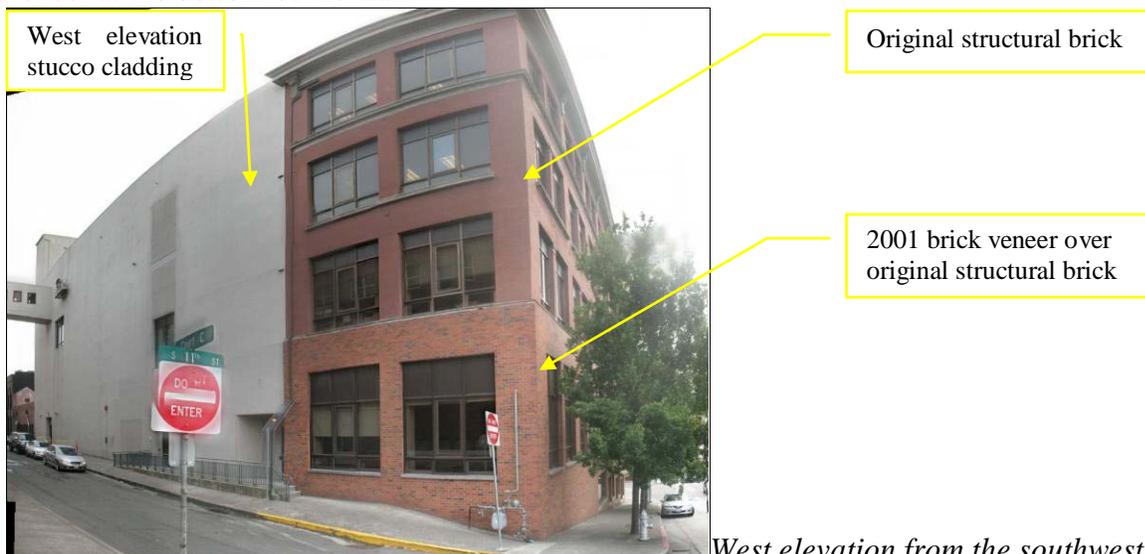
At areas of the brick veneer, no weeps were noted to provide drainage of the space behind the veneer. The adjacent concrete sidewalks appear to have been placed over the face of the brick veneer at the bottom of the wall.

West elevation from the southwest.

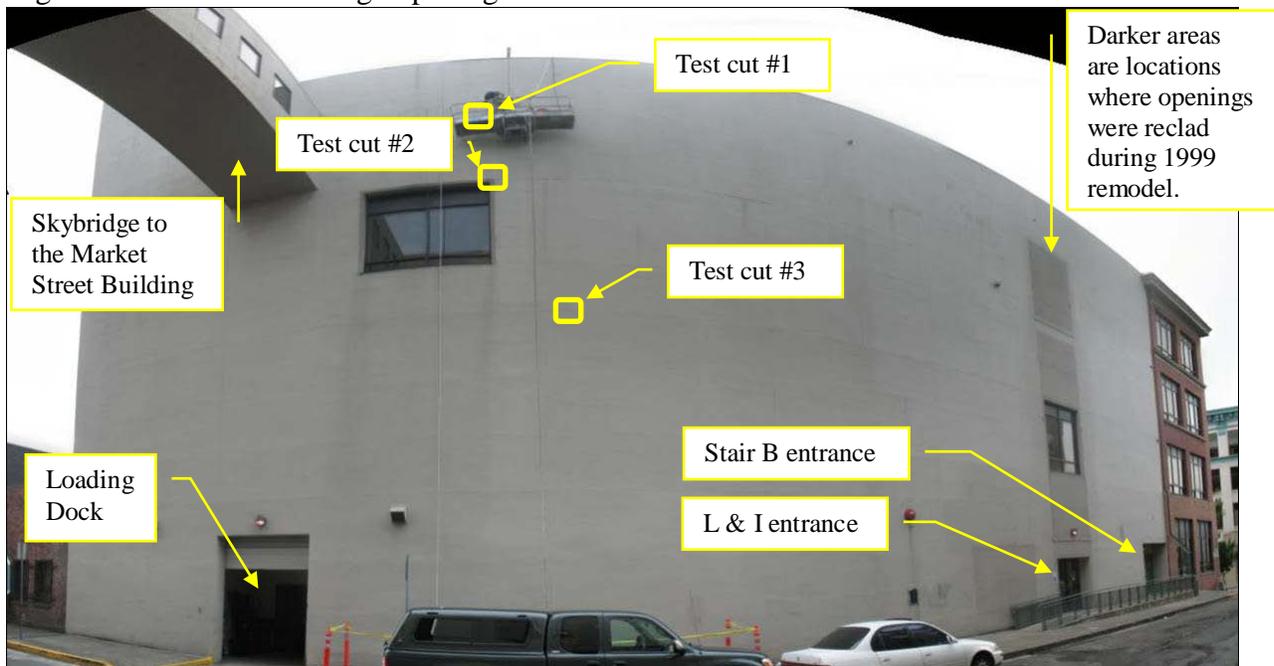
Test cuts were taken on the west elevation exterior wall in three (3) locations. Stucco cladding was installed directly over the original structural brick wall. It appears that many of the original window openings in the structural brick were framed in and eliminated at that time. Where windows were eliminated, steel stud framed wall with batt insulation, 5/8-inch gypsum sheathing, and asphalt saturated building paper was installed prior to installation of the stucco. The building paper does not tie-into the adjacent wall assembly and simply terminates at the edge of the old window rough opening.

Broadway Building west elevation exterior wall and approximate location of test cuts.

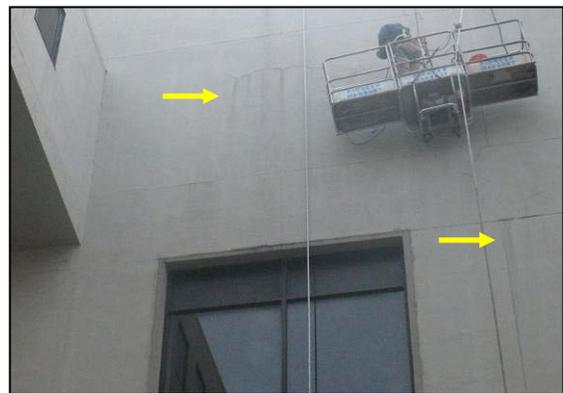
Since there is a lack of a continuous weather resistive barrier (WRB) behind the stucco cladding, water that penetrates cracks and joints in the stucco can migrate down the wall behind the stucco until it either emerges at the interior of the building as leaks or returns through cracks/joints back to the exterior. Evidence of water migration out of cracks is visible where water stains can be seen on the exterior wall (arrows indicate examples in the photo to the right).

During certain wind/rain events, the positive pressure on the west elevation wall may create enough air/water migration to the interior to create the leaking noted by Mr. King at windows. However, without the wind pressure driving the water into the building, water that penetrates the stucco is likely to migrate down the wall until it either reaches the juncture with the sidewalk where it penetrates the building or it exits through another crack in the stucco.

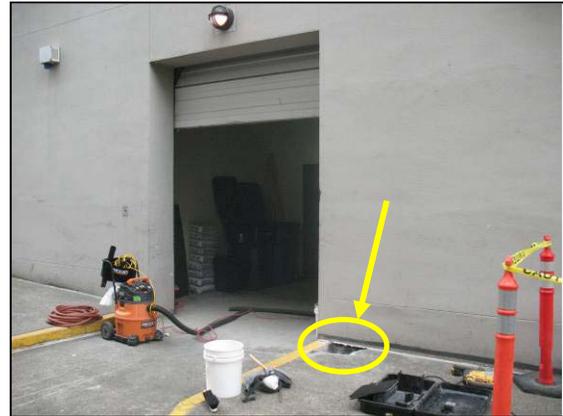
At this location, an asphalt based waterproofing is installed between the structural concrete and the concrete topping slab (sidewalk). There appears to be a rubberized flashing membrane installed on the top of the waterproofing at the juncture with the wall.

The stucco wall cladding extends continuously down the wall below the top of the sidewalk and appears to terminate within ½-inch of the structural concrete lid (over the Mezzanine Level interior space). The waterproofing was applied onto the outside face of the stucco and up approximately 4-inches.

It appears that no protection course was installed over the waterproofing. Steel mesh visible in the test cut appears to have been laid on the waterproofing prior to placement of concrete and damage to the waterproofing at the juncture with the stucco cladding appears probable.

Proper integration of waterproofing and wall cladding would normally include the following: A direct tie-in between the waterproofing and the WRB behind the wall cladding should be created. The wall cladding should terminate above the concrete topping slab. A provision for drainage of migrating water behind the cladding should be created. A protection layer between the waterproofing and the concrete topping slab is strongly recommended in order to prevent damage to the waterproofing and provide a slippage plane.

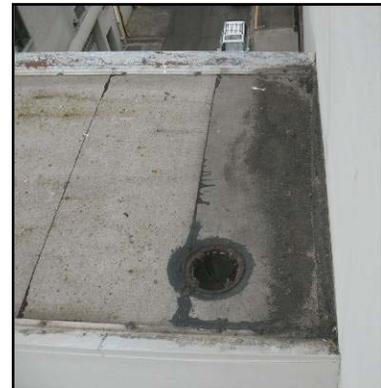
At the Fifth Floor, west elevation of the Broadway Building, a sky bridge connects to the Market Street Building. The sky bridge roof slopes toward the Broadway Building where a drain is located approximately 18-inches away from the wall. There is no opposing slope to provide drainage from the wall to the drain and evidence of standing water is visible. It appears that water builds up against the rising wall and evidence of leakage into the stucco cladding is visible down the wall from these points.

Mr. King indicated that leaks occur inside the sky bridge under this rising wall juncture. In order to address leakage at the sky bridge roof-to-wall juncture, the roof assembly should be modified to provide positive slope from the wall to the drain. Additionally, the configuration of the roof flashing should be modified to raise the level of the flashing minimum 8-inches above finished roof surface integrated in weather-lapped fashion with the wall cladding assembly.

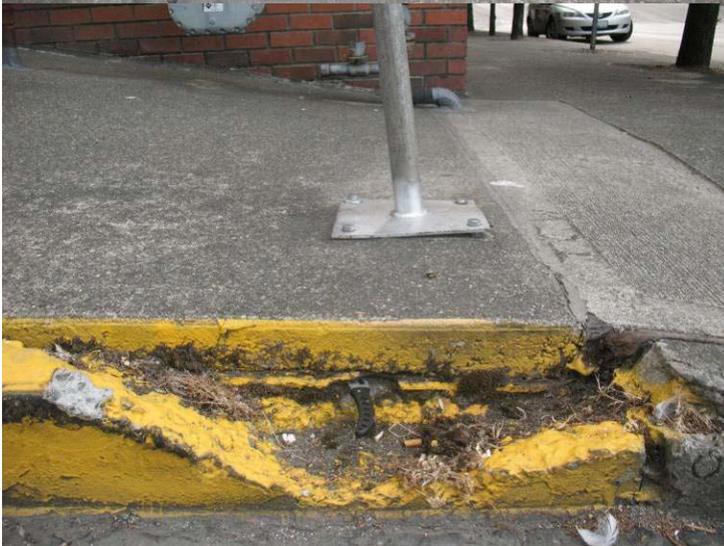
Photograph # 5.

Close-up of damage to the concrete curb at the Court C sidewalk adjacent to the southwest corner of the building. A knife was inserted at what appeared to be the exposed termination of the waterproofing below the concrete sidewalk. This area is located approximately over the southwest corner of the Mezzanine Level of the building.

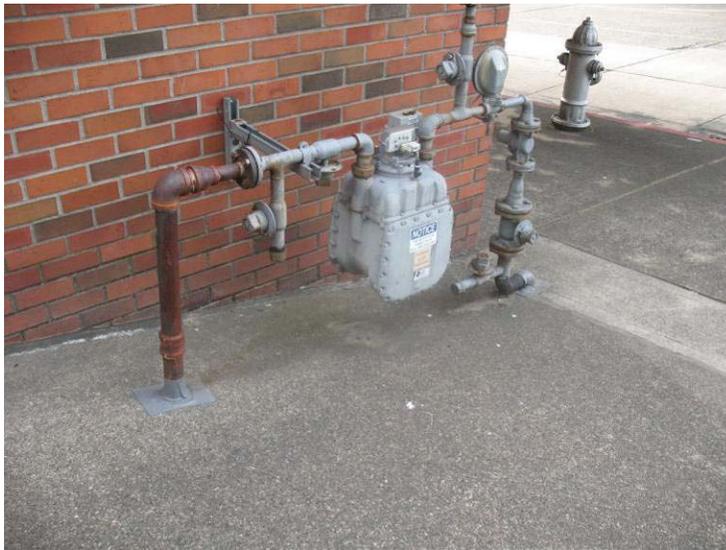
Photograph # 6.

Several gas lines penetrate the sidewalk over the Mezzanine Level of the building near the southwest corner.

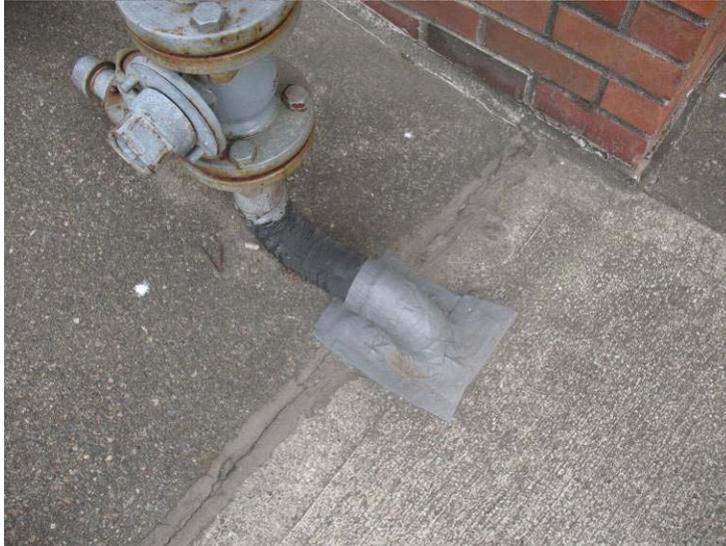
Photograph # 7.

An unknown flashing membrane was installed over the gas line penetration in the sidewalk. The membrane is not adhered to the concrete. It is assumed that this was done in an attempt to seal the pipe penetration at the surface of the concrete. However, the condition of the seal at the waterproofing membrane is not visible.

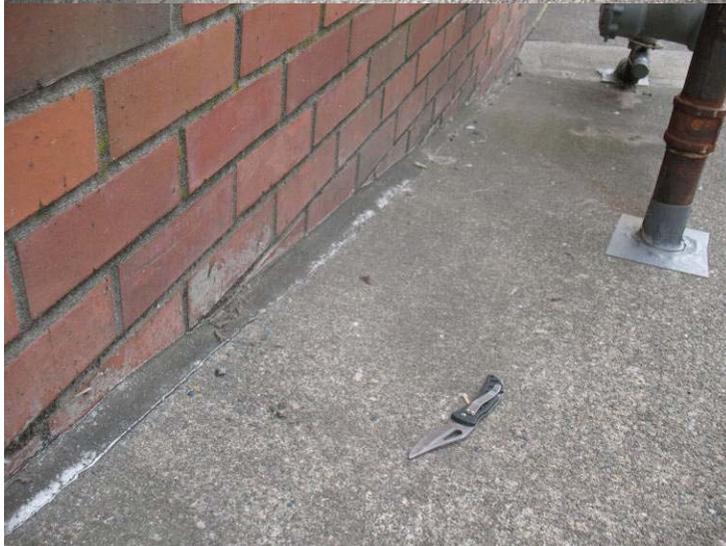
Photograph # 8.

A fillet bead of sealant has been applied between concrete sidewalk and brick veneer.

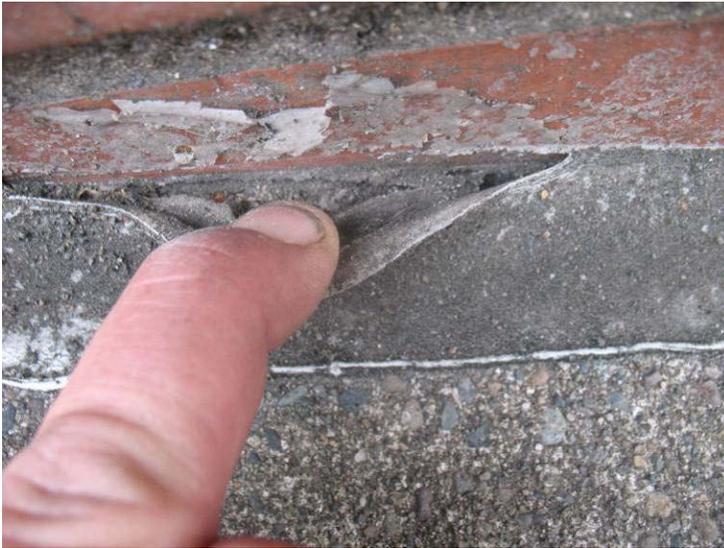
Photograph # 9.

Adhesive failure of the sealant was observed in most locations. At least three (3) subsequent layers of sealant have been applied. None are well adhered at this time.

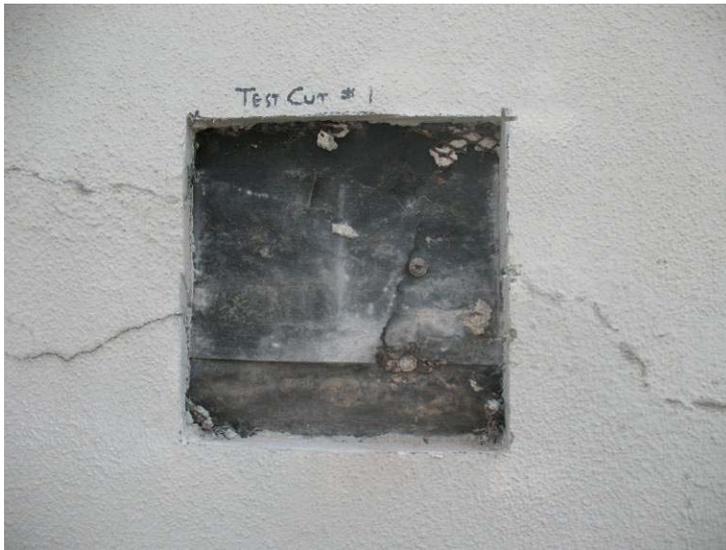
Photograph # 11.

Close-up of Test Cut #1 located at cracks in the stucco.

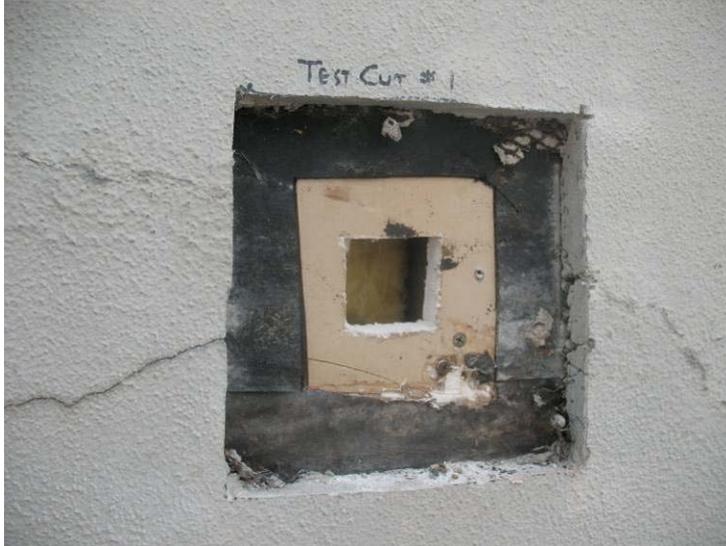
Photograph # 12.

Wall assembly at Test Cut #1 included steel stud framed wall with batt insulation, 5/8-inch gypsum sheathing, asphalt saturated building paper, followed by the stucco cladding.

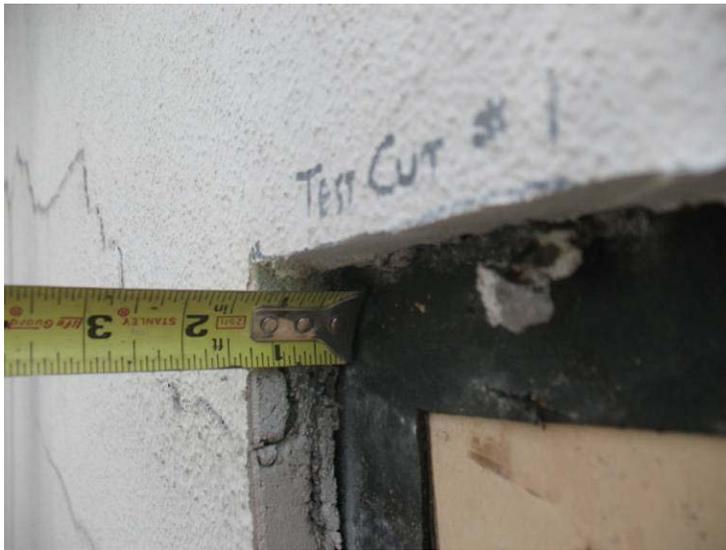
Photograph # 14.

Thickness of the stucco cladding at Test Cut #1 was measured as approximately 1 1/4-inches.

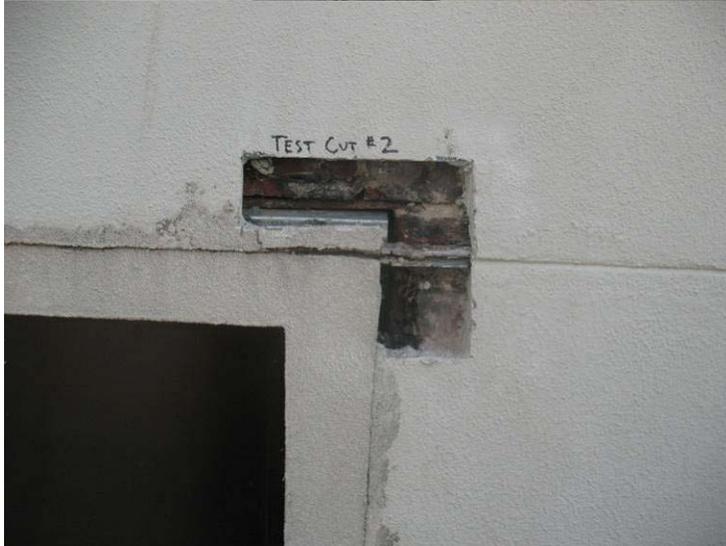
Photograph # 15.

Test Cut #2 was located at the juncture of the window jamb/head juncture. Original structural brick and more recently installed framing in the rough opening were observed. Plans for the 2001 remodel indicate this window was framed and installed at that time. The joint between existing and 2001 stucco does not appear to be well sealed.

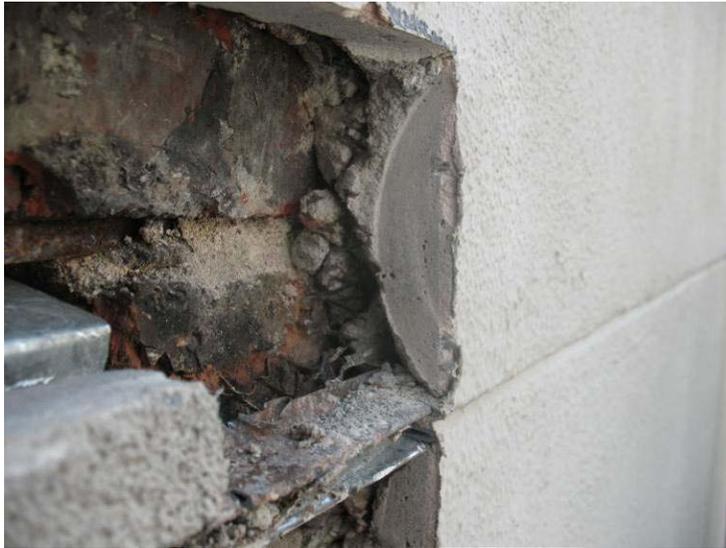
Photograph # 17.

No weather resistive barrier or window wrap membrane was noted at the location of Test Cut #2.

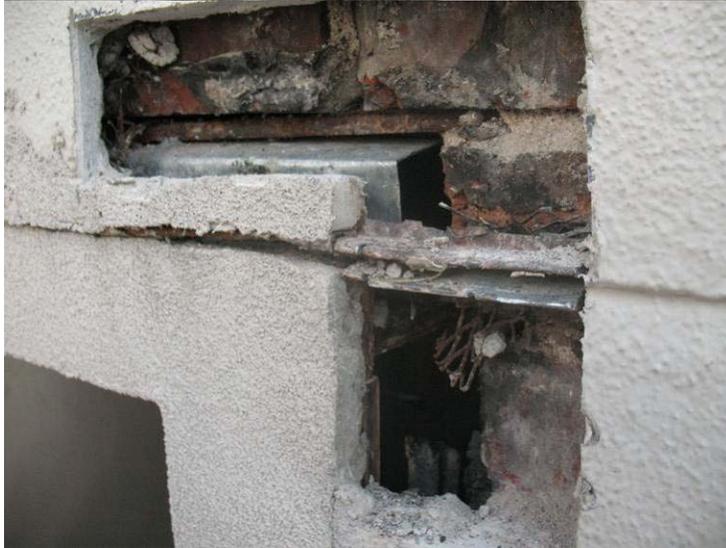
Photograph # 18.

Adjacent to Test Cut #2, the metal control joint located between newer and older stucco at the head of the window was open and a sealant probe was easily inserted through the stucco cladding.

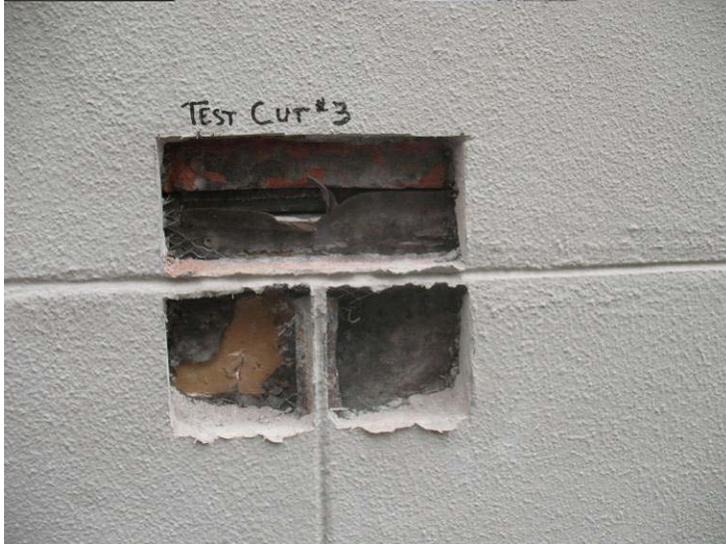
Photograph # 19.

Test cut #3 was located at a control joint T-intersection at approximately Level 3. This was discovered to be the location of a window head that had been framed in prior to the original stucco installation. The structural brick, steel head ledger, and framed wall assembly was visible at this location.

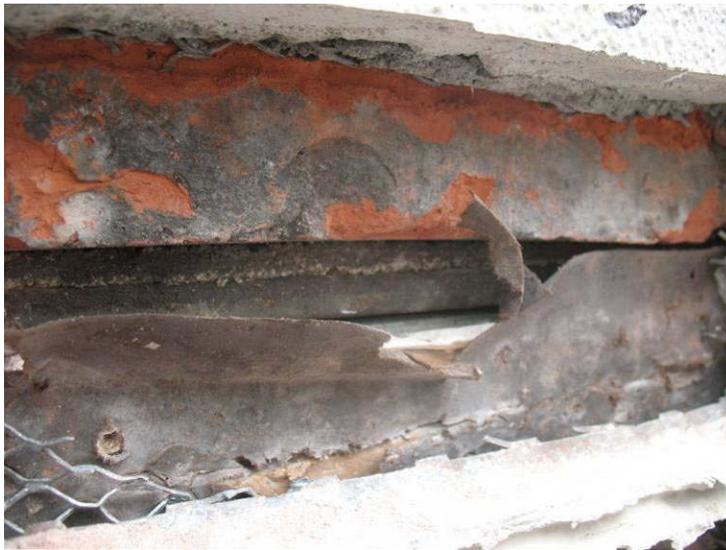
Photograph # 20.

Close-up of Test Cut #3 showing structural brick and steel ledger. Also, asphalt saturated building paper over gypsum sheathing is visible below.

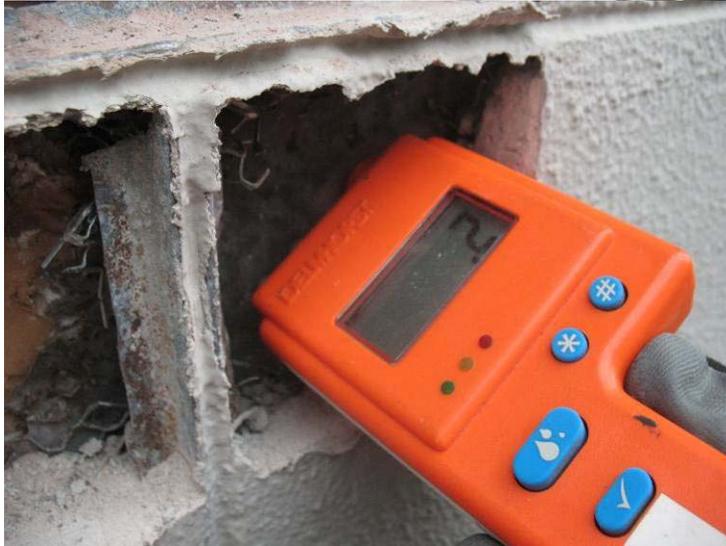
Photograph # 21.

A Delmhorst meter was used to measure moisture content of the gypsum sheathing on the gypsum scale at Test Cut #3. Dry conditions were confirmed.

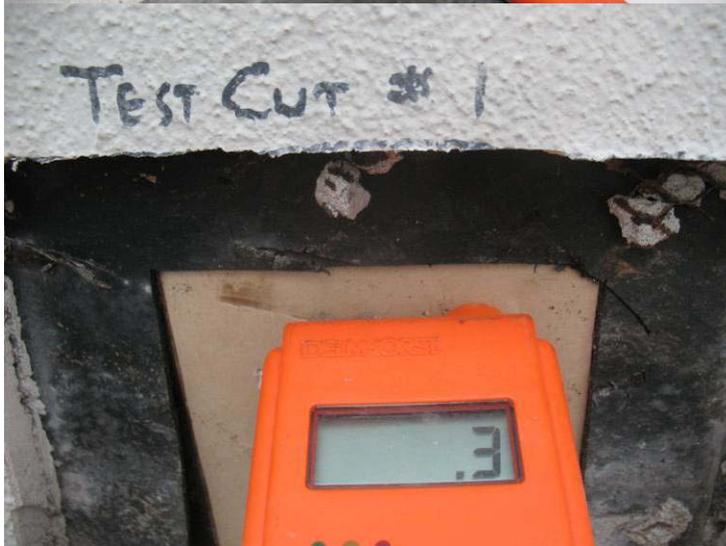
Photograph # 22.

A Delmhorst meter was used to measure moisture content of the gypsum sheathing on the gypsum scale at Test Cut #1. Dry conditions were confirmed.

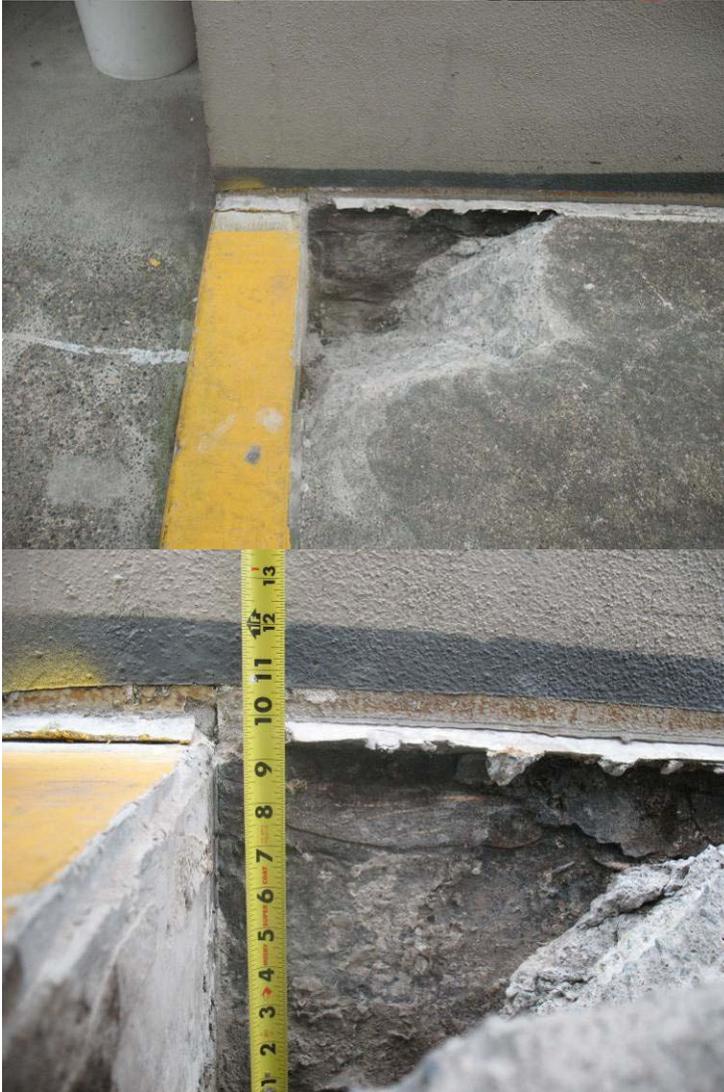
Photograph # 24.

Close-up of sidewalk test cut after careful removal of concrete. Only an approximately 6 x 8-inch area of the waterproofing was exposed in order to mitigate chance of damage to the waterproofing. Steel reinforcing mesh screen was observed on or just above the waterproofing layer.

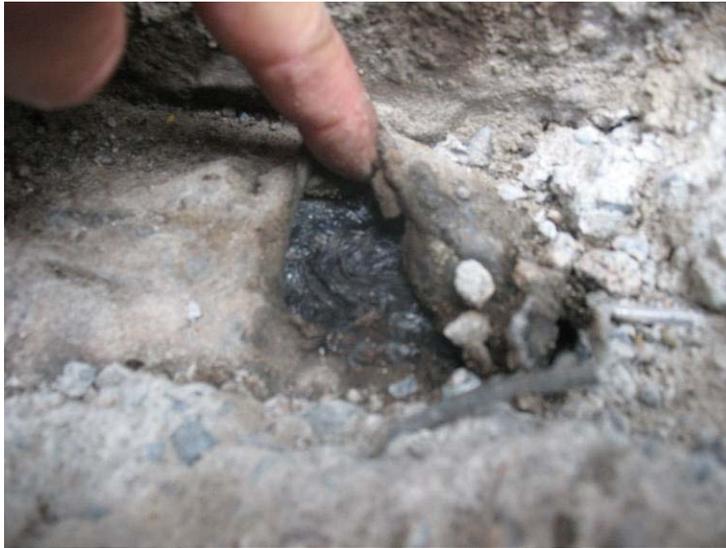
Photograph # 26.

It appears that an asphalt based waterproofing membrane was installed under the concrete sidewalk topping slab. A flashing membrane appears to have been installed over the waterproofing at the rising wall juncture.

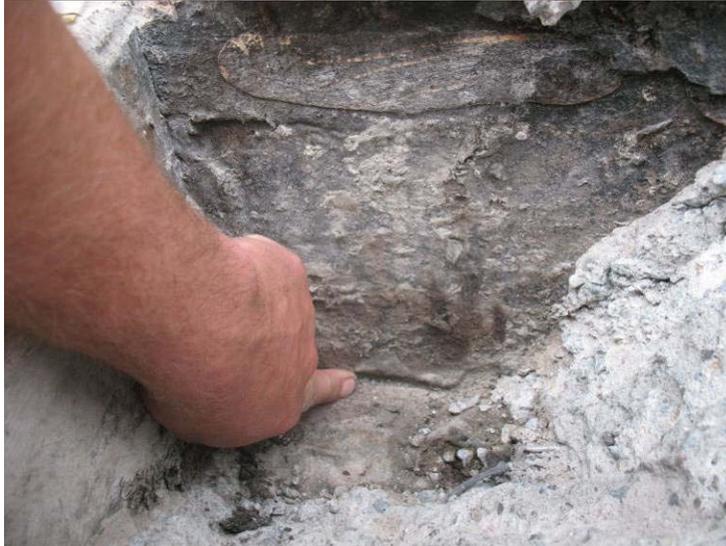
Photograph # 27.

Since the waterproofing was applied to the outside of the stucco cladding, water migrating within or behind the stucco cladding is forced to the interior of the building just above the location of the noted leaks. It was also confirmed that water penetrates the tie-in between the waterproofing and stucco cladding at the location of the sidewalk test cut. Water penetrating the joint between sidewalk and wall and penetrating joints in the concrete sidewalk, is likely to contribute to leakage.

The stucco cladding extends behind the sidewalk to within approximately 1/2-inch of the structural concrete. The waterproofing was applied over the outside of the stucco and up approximately 4-inches.

- 3) New waterproofing should be installed at the sidewalk that is properly integrated with the adjacent WRB and wall cladding assemblies. The following should be considered during design/installation of the new assembly:

- a) Installation of a protection course and drainage layer is recommended.
 - b) The downslope termination of the waterproofing and integration with the below-grade waterproofing will need to be determined once existing conditions are confirmed.

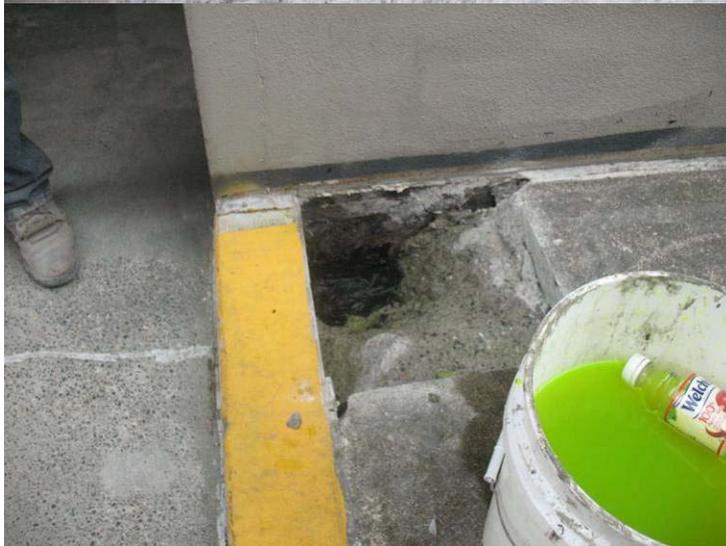
Photograph # 28.

Water testing was done with fluorescein dyed water in the test cut. Leakage to the Mezzanine Level below was confirmed within 1/2-hour duration (see following photo).

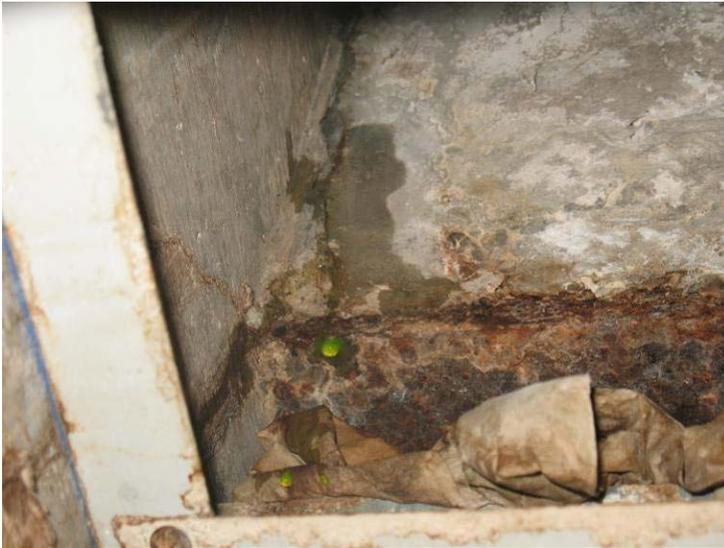
Photograph # 29.

Close-up of leakage from water test at sidewalk test cut. A ceiling tile was temporarily removed at a location approximately below the test cut and leakage of dyed water was confirmed.

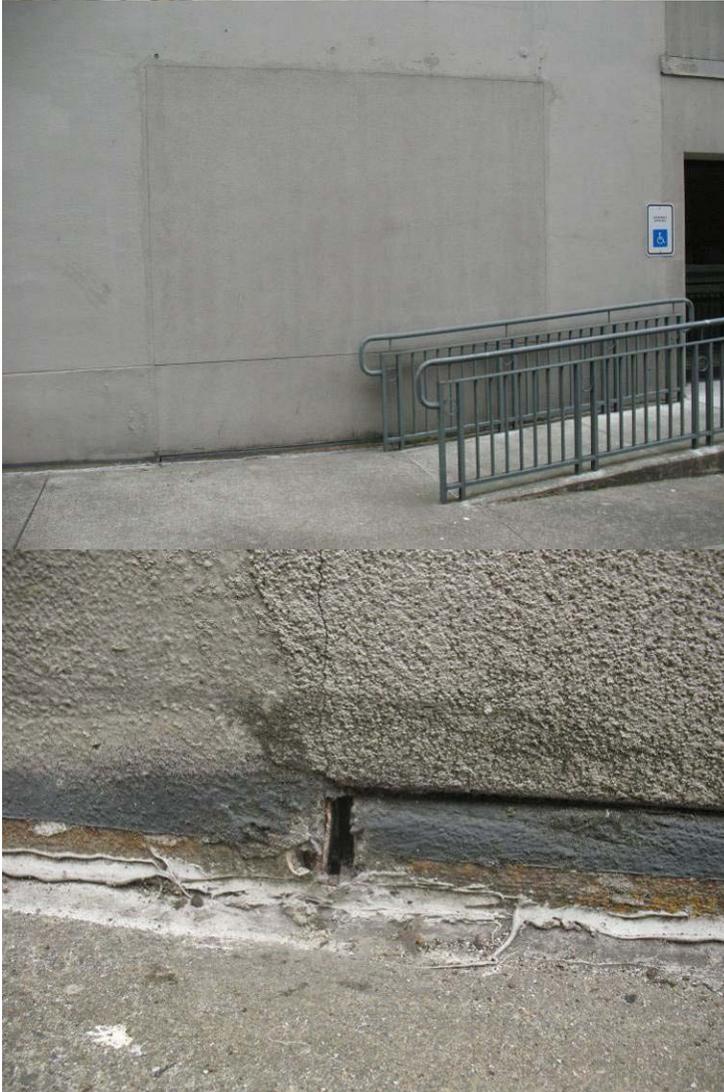
Photograph # 30.

At the area of west elevation wall to the north of the current L & I entrance, the 1999 architectural plans indicate that an old entrance to the building was framed in and eliminated. A concrete curb is located at the bottom of the old entrance. The stucco cladding terminates at the top of the curb at this location.

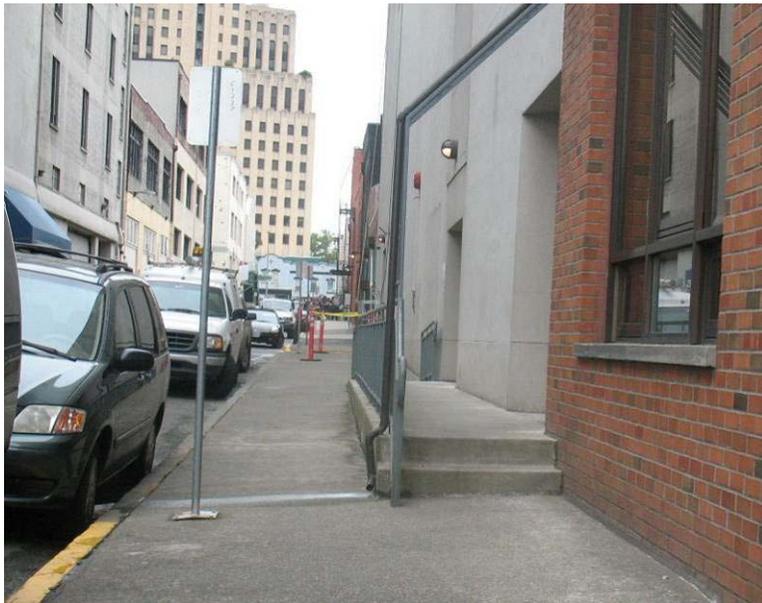
Photograph # 33.

It appears that the ADA concrete ramp was placed against the existing stucco cladding without modifying the condition at the bottom of wall.

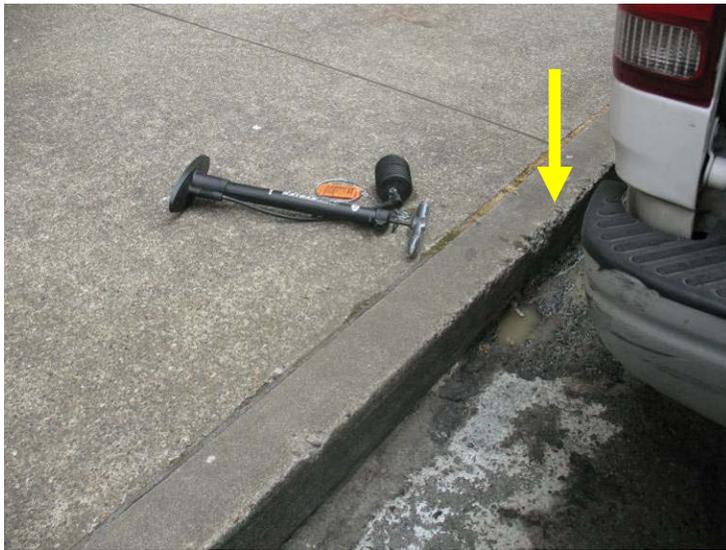
Photograph # 34.

Context view of the primary roof drain outlet at the street level of Court C. This pipe reportedly leaked into the Mezzanine Level below the west elevation wall and was subsequently repaired.

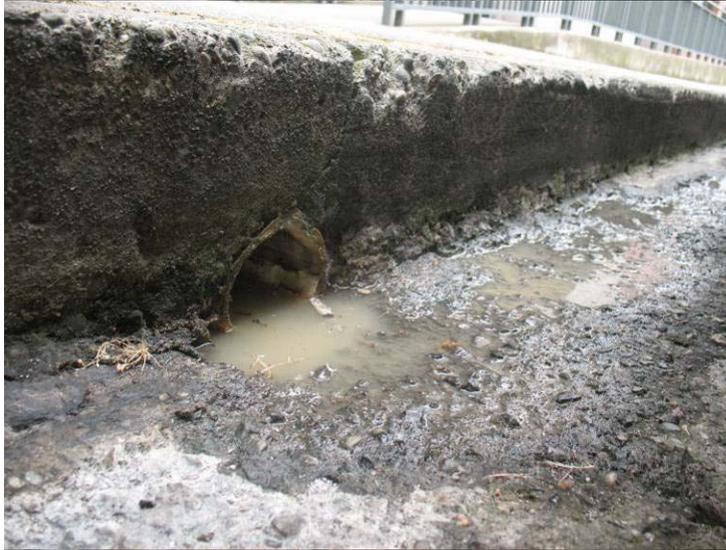
Photograph # 35.

Close-up of the previous photo. Fiberglass repair sleeve is visible at the end of the pipe. The pipe was plugged and filled with water in order to flood test the repair patch. No leakage was noted during the test.

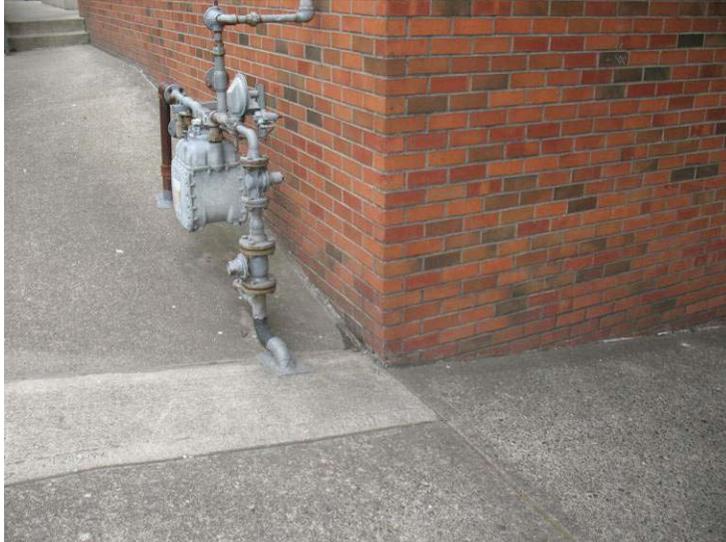
Photograph # 36.

It was noted that at the southwest corner of the building, the Court C sidewalk slopes toward the building over the top of the Mezzanine Level.

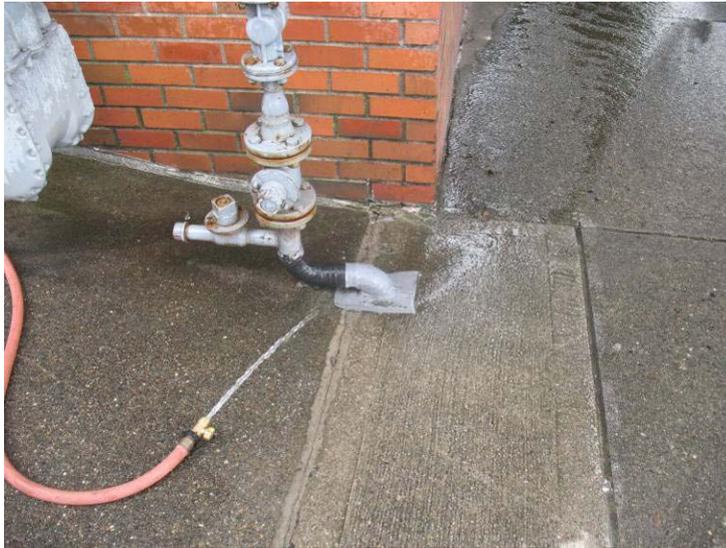
Photograph # 37.

Water testing was also done at the southwest corner of the building. A hose was used to flood the sidewalk-to-wall juncture for approximately 30-minutes. After this duration, no leakage was noted at the Mezzanine Level below this point.

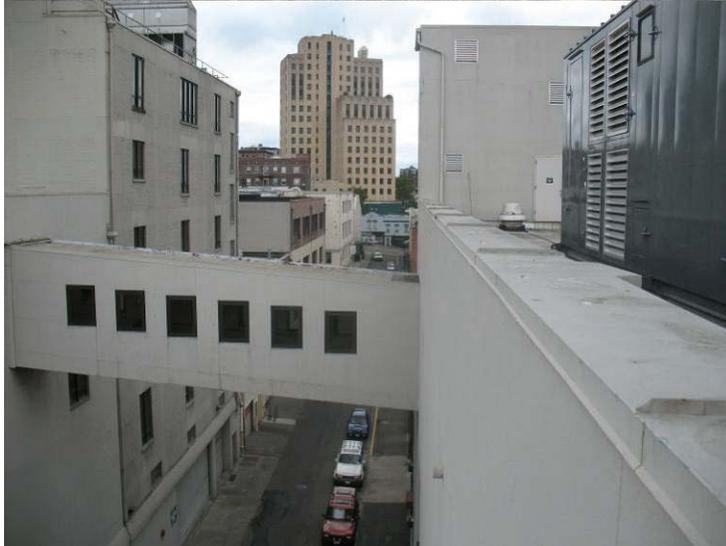
Photograph # 38.

The sky bridge roof slopes toward the Broadway Building west elevation wall.

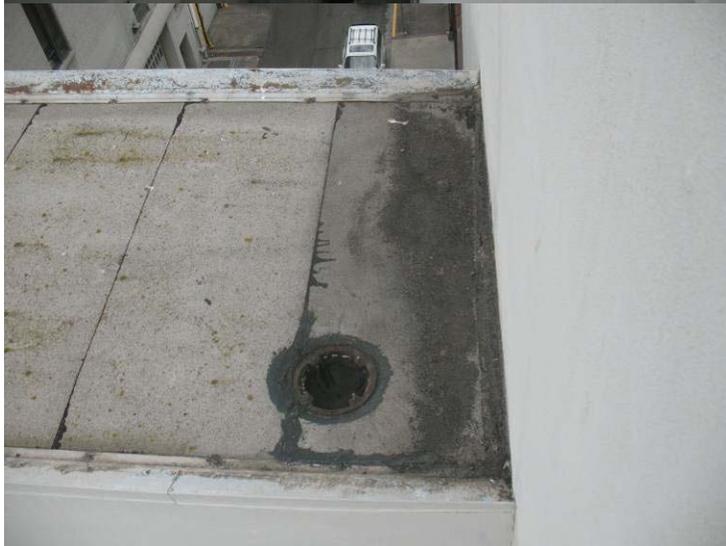
Photograph # 39.

The roof drain is located approximately 18-inches away from the roof-to-wall juncture. No opposing slope was installed to provide positive drainage to the drain and evidence of standing water against the stucco cladding was noted. Reported leakage into the building is likely a result of the standing water and improper integration of the roof-to-wall cladding assemblies.

- a) The roof drainage should be modified to provide positive slope to the drain and prevent standing water against the wall.
 - b) At the roof-to-wall juncture, the wall cladding and roof flashing should be modified to allow for additional flashing height and weather-lapped integration of the two assemblies.

- c) Transition flashing should be installed that integrates the sheet metal roof perimeter flashing into the adjacent wall assembly in weather-tight fashion.

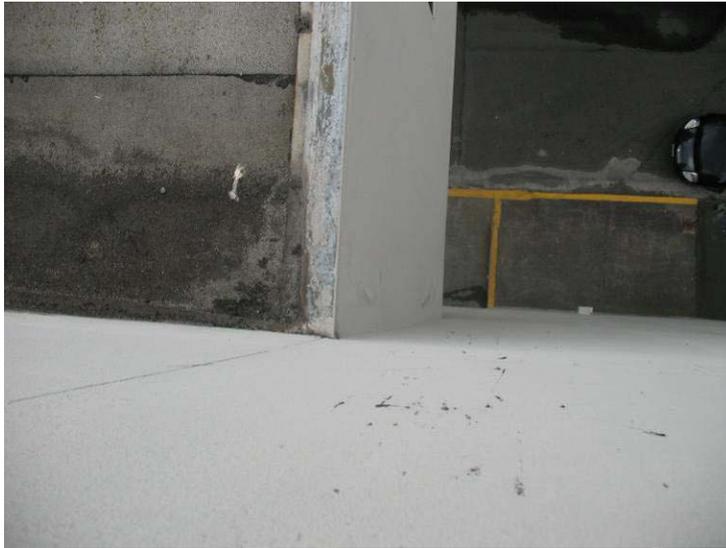
Photograph # 40.

View looking down at the side of the sky bridge where the roof perimeter-to-wall juncture is visible. Water staining below the roof perimeter-to-wall juncture suggests that leakage occurs at this location.
