**STRUCTURAL EVALUATION
FOR**

**RHODES CENTER
BROADWAY BUILDING
MARKET BUILDING
TACOMA, WASHINGTON**

**PREPARED BY
PCS STRUCTURAL SOLUTIONS**

**JUNE 22, 2017
17-513**

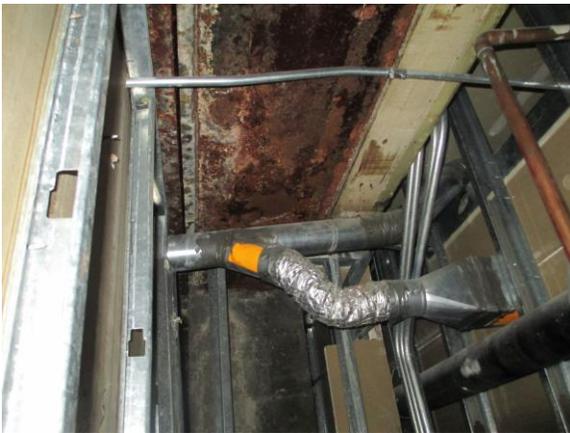
- Along the west wall at the alley level (level (3)), water has been infiltrating into the building. Some delamination was noted in the steel support beam supporting the masonry wall above. Moisture was also evident in the finishes of the adjacent nonstructural partitions. Water infiltration should be mitigated and further evaluation of the deterioration should be performed.
- Minor cracking in the west exterior wall stucco finish.
- Other than noted above, we observed no signs of structural distress, differential settlement, or deterioration.

- Deterioration of steel support beam along west wall at the alley level.

Delaminating Steel Beam at Third Level at West Wall.

Mitigation of the water infiltration along the wall is recommended along with further evaluation to determine the extent of deterioration.

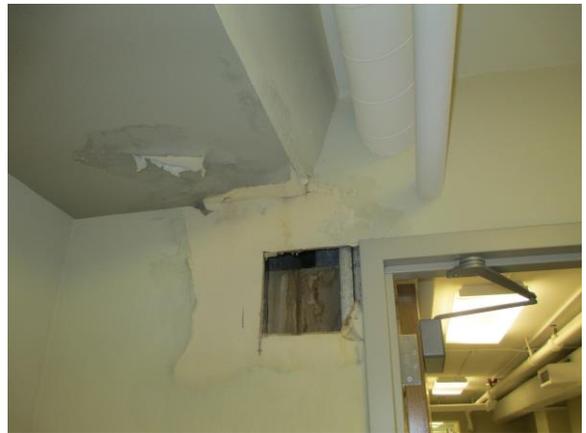
Water Damage in Finishes Second Level Below West Wall

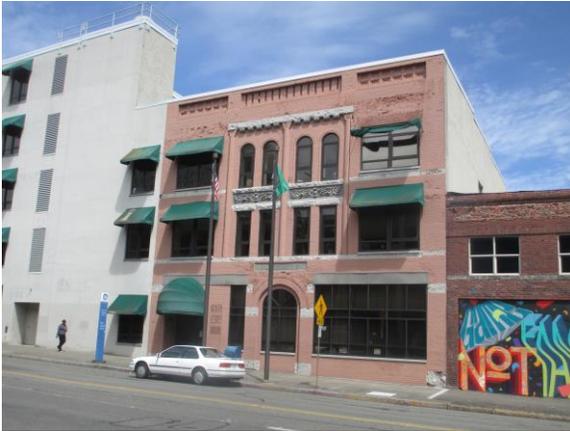
West Exterior Wall. Note Deterioration of Brick at Fifth Level.

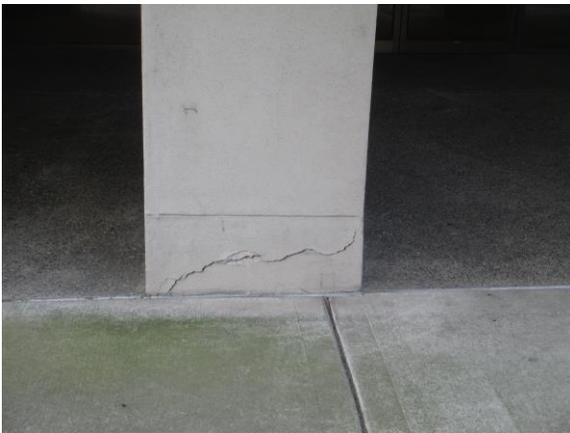
- Cracks were observed in the finishes of the two masonry columns at the east entry at ground floor. It is not clear if these cracks are just in the finish and what caused the cracks. There is the potential for impact damage or freeze thaw action. They do not appear to be from earthquake movement or other easily identifiable structural concern.
- Minor cracking in the east exterior wall stucco finish.
- Minor deterioration in the brick at the upper level of the west exterior wall.
- Water infiltration at the south wall of the CMU masonry stair wall near the top of the wall.
- Other than noted above, we observed no signs of structural distress, differential settlement, or deterioration.

- Damage to the finish at the base of the masonry columns at the east entry. Further investigation may determine this is cosmetic only.

Crack in East Column Base

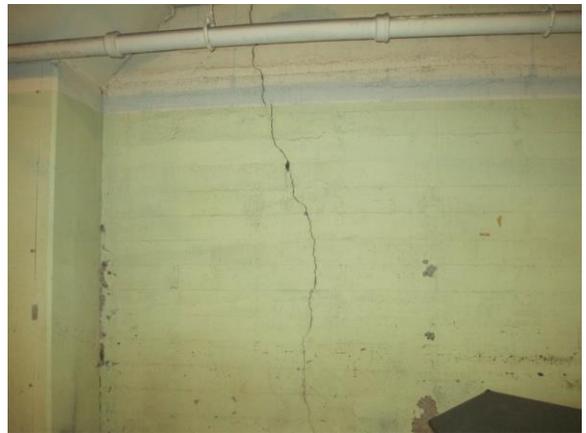
Crack in Concrete Cross Wall adjacent to Market Concrete Building

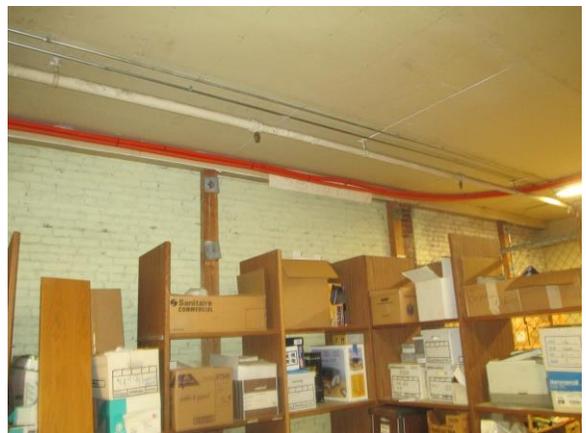
Redundant Support at South Cross Wall First Level.
