DEPARTMENT OF ENTERPRISE SERVICES

General Administration Building Predesign Update

November 28, 2012

Project No. 2012-218

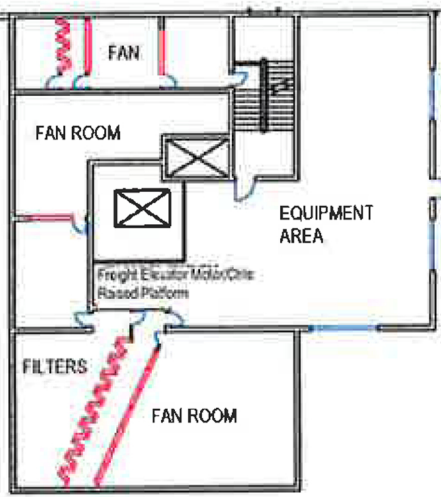
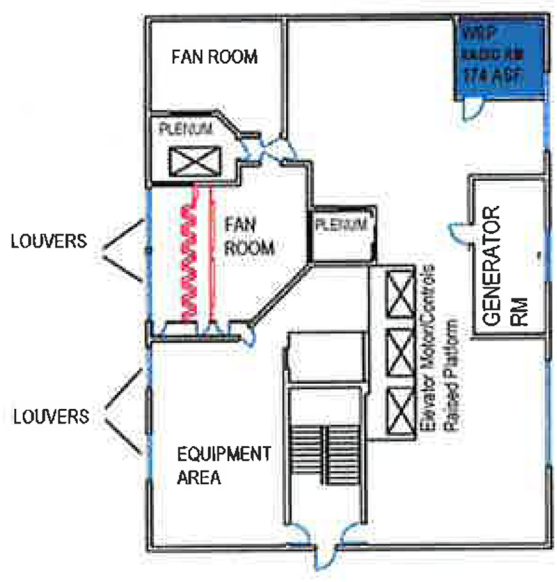
GENERAL ADMINISTRATION BUILDING ROOF/PENTHOUSE PLAN

TOTAL ASSIGNABLE FLOOR AREA = 174 ASF
TOTAL COMMON FLOOR AREA = 0
TOTAL USABLE FLOOR AREA = 174 ASF

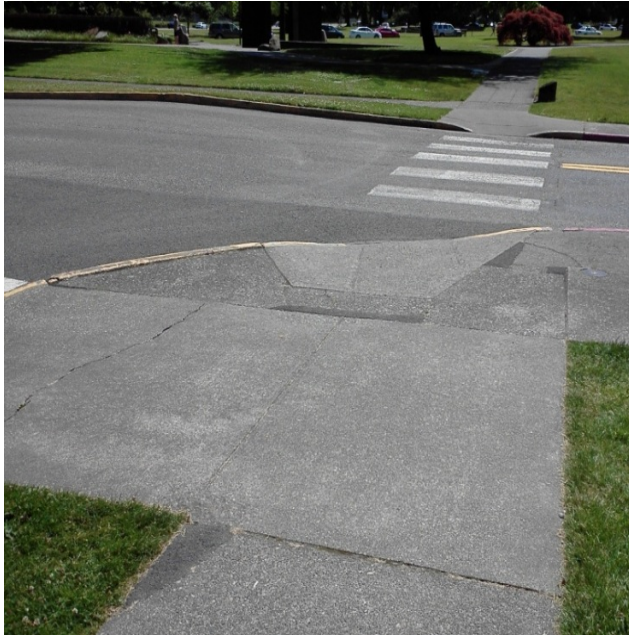
Photo 1. Cracked Sidewalk

The concrete sidewalks on the north and east sides of the building are aged and cracked (**Photo 1**). Many of the cracks are greater than 0.25-inch wide and show signs of spalling. While not mandatory, the sidewalks have surpassed their design life and should be replaced. Construct 380 SY concrete sidewalk.

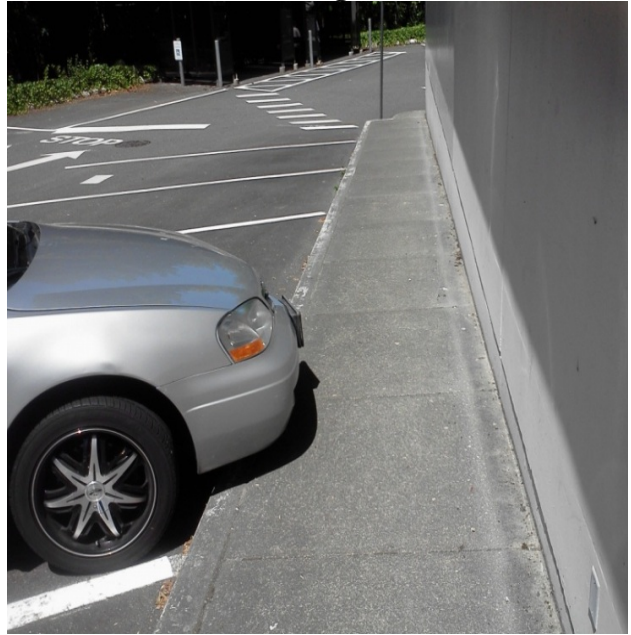
Photo 2. Vehicle Overhang

The sidewalk adjacent to the west wall of the building is being encroached by vehicle bumper overhang due to a lack of wheel stops in the angled parking stalls adjacent to the building (**Photo 2**). Twenty-one (21) concrete or recycled rubber wheel stops should be installed in the west parking lot adjacent to the building. Construct 21 EA wheel stops.

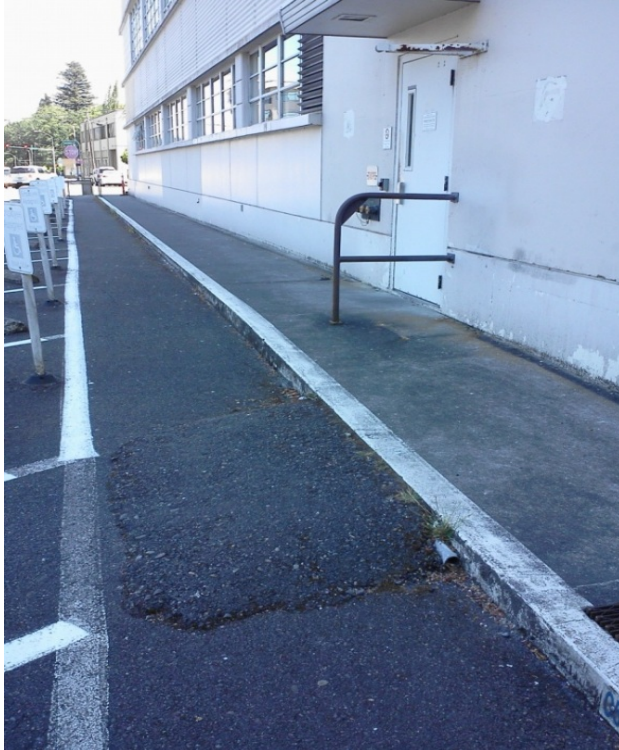
Photos 3. Railing Encroachment

The sidewalk adjacent to the north side of the building gradually slopes downward from east to west until reaching a ramp at the receiving area in the northwest corner of the building. The access door in the north face of the building has a railing extending two-thirds of the way across the sidewalk, restricting the usable width of the walk and rendering the sidewalk non-ADA compliant (**Photo 3**). Demolish 3 LF railing.

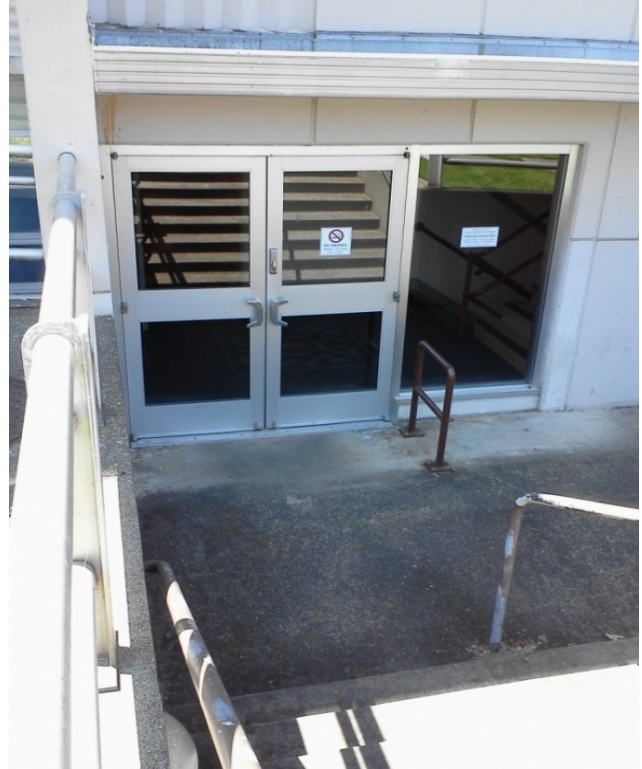
Photo 4. Railing Encroachment

The east entrance of the building is an ADA accessible entrance; however, a railing is protruding perpendicular to the double-doors into the required clear space (**Photo 4**). Demolish 3 LF railing.

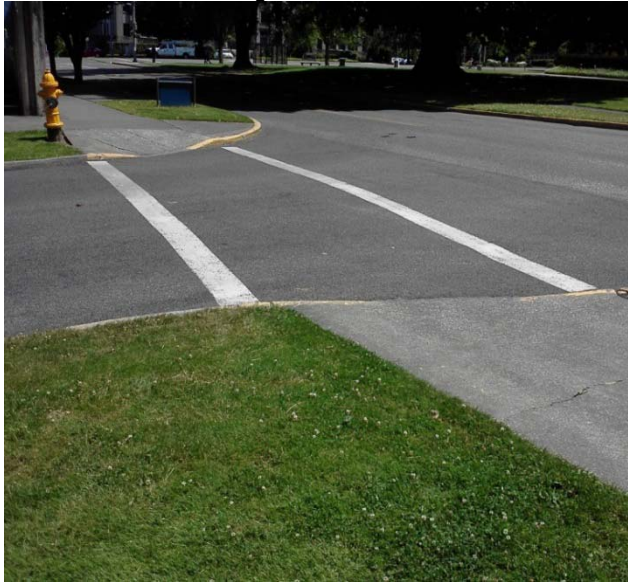
Photo 5. Curb Ramp

The three existing curb ramps (two on 11th Avenue and one on Columbia Street at 11th Avenue) are no longer meeting current ADA standards and should be replaced with the project (**Photos 5 through 7**). There are no curb ramps on the northeast corner of the building at Columbia Street and Union Avenue; however, marked crosswalks are present across Columbia Street and across the parking lot entrance. The sidewalk adjacent to the west side of the building ends on the northwest corner of the building without a curb ramp; however, a marked crosswalk to the bus shelters is painted there (**Photo 8**). There is an asphalt wedge used as a curb ramp from the north parking lot to the north sidewalk west of the building entrance (**Photo 9**). The grades and construction of this ramp are not in conformance with ADA standards. Construct 7 EA curb ramps.

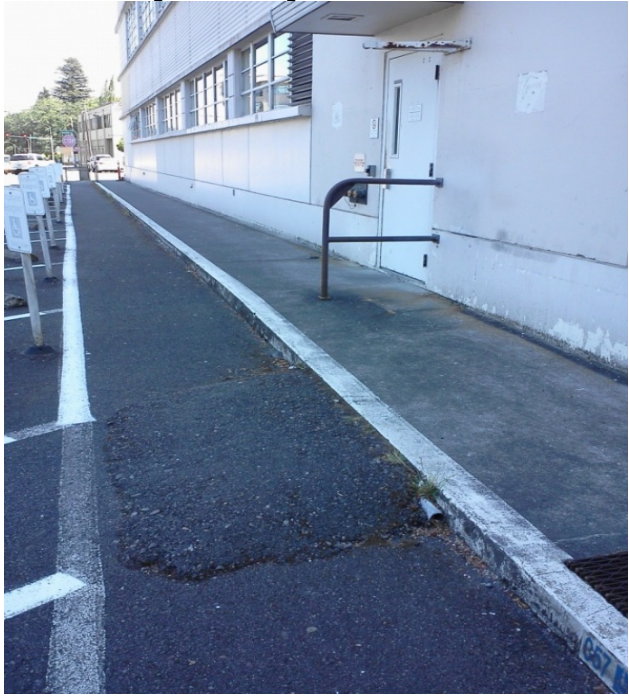
Photo 10. Concrete Ramp (Top)

There are two ADA parking stalls in the west parking lot at the southwest corner of the building. A concrete ramp extends from that general vicinity easterly to the main entrance (**Photos 10 and 11**). The ramp is no longer compliant with current ADA standards, as it is longer than 30 feet horizontally and steeper than 2 percent grade without providing a level landing. A multi-stage accessible path with ramps no steeper than 1V:12H and landings every 30 inches of vertical rise is required to meet ADA standards. Due to the grade difference from the entrance plaza to the sidewalk on the southwest corner of the building (approx. 5.7 feet), complete removal and replacement of the existing ramp will be required. Construct 27 SY concrete ramp minimum.

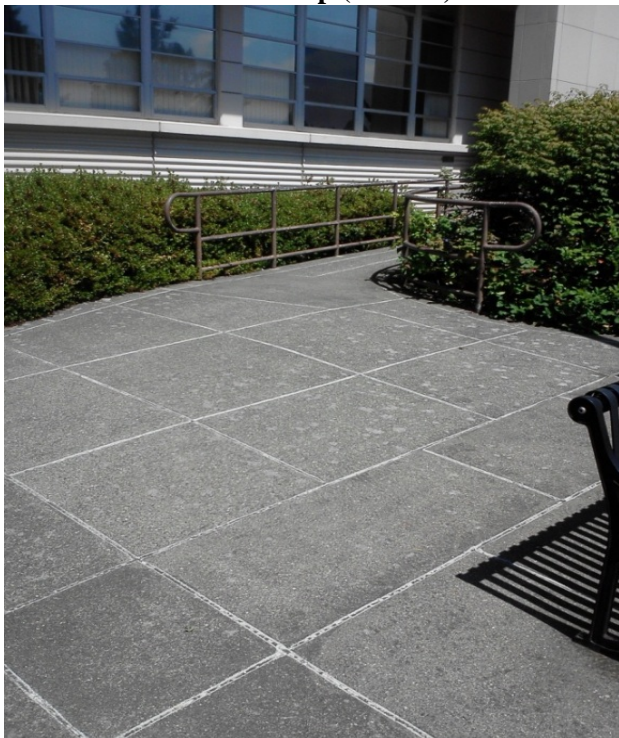
Photo 12. Concrete Ramp

There is another concrete ramp/walk on the east side of the building beginning at the northeast corner and climbing to the entrance at the middle of the building on the east face (**Photo 12**). This ramp is marked with an accessibility sign; however, the ramp is not compliant with current ADA standards, as it lacks the requisite landings. The ramp will require reconstruction. Construct 50 SY concrete ramp minimum.

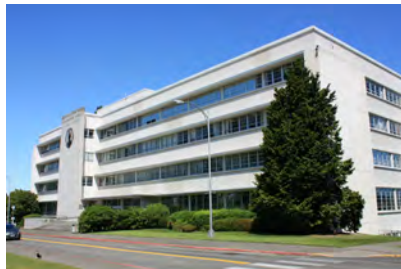
The GA building's International Modern design is primarily characterized by exterior design elements. The overall form and massing of the 4+ story building is defined by its horizontal emphasis, created by bands of multi-pane aluminum hopper windows, etched concrete panels, and inset boxed ledge canopies. Large, slightly projecting vertical elements interrupt the horizontal bands on each facade, although the most prominent and ornamental is the sandstone pylon with the Washington State seal on the south elevation. The rear stairwell and penthouse exterior comprise this vertical design element on the north elevation. Although each facade is slightly different, the materials and overall design concepts remain consistent on all elevations of the building. These key character-defining features are to remain unaltered in a building renovation.

South elevation

Preservation standards would not necessarily inhibit alterations to specific materials, but instead would require that the overall design concepts are retained. Window replacement, for example, would require retaining the original window openings and horizontal bands of lights, but the window materials could be replaced with a more energy efficient multi-pane aluminum or other metal window.

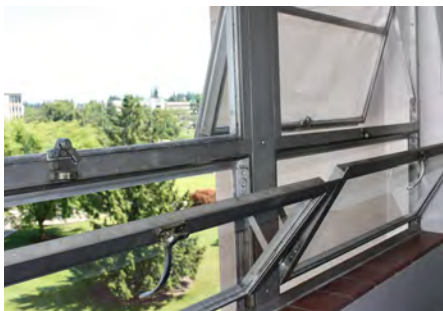
Window detail

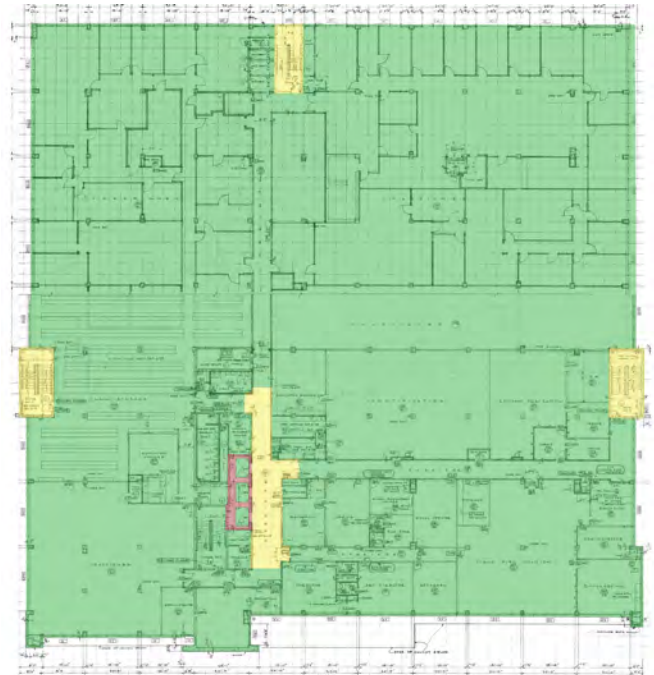
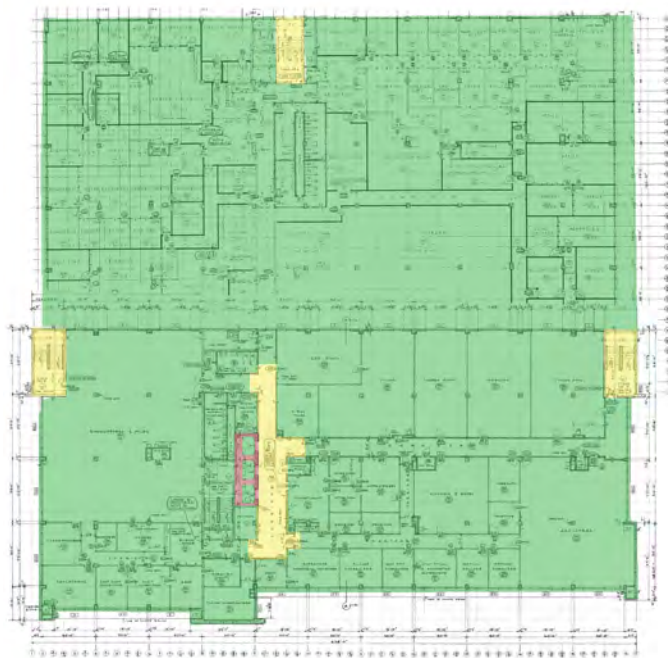
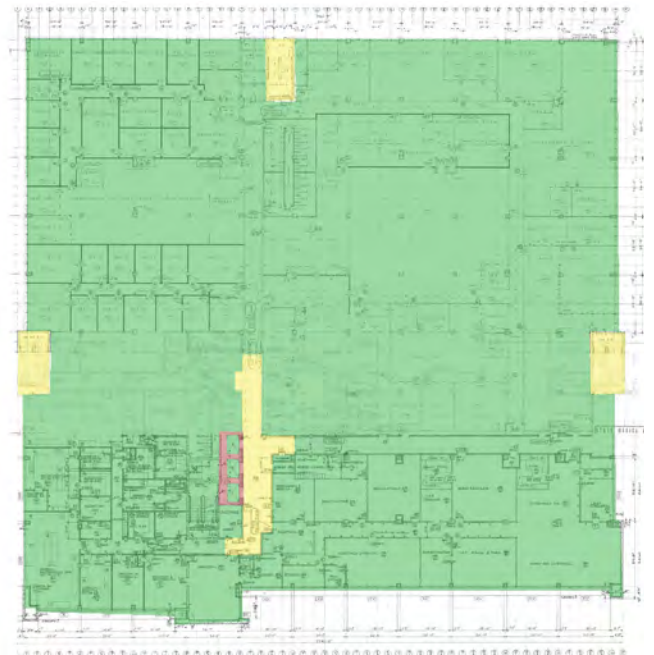
Floors 2-4 share identical preservation priority zones, with high priority given to the elevator shafts, medium priority given to the elevator lobbies and immediate corridor, medium priority to the stairwell shafts at the exterior walls as part of primary circulation patterns. Alterations vary with finishes and the retention of historic fixtures and elements. The 2nd floor retains more of the movable walls than other floors. Historic door hardware predominately remains on all floors.

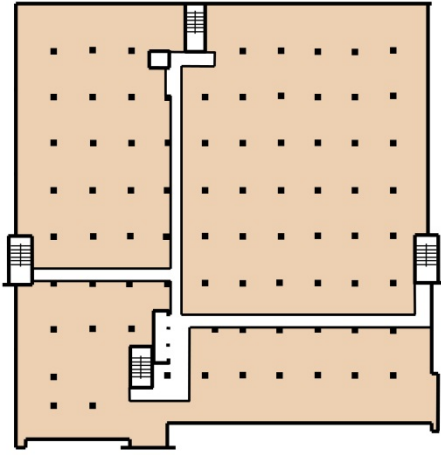
<ul style="list-style-type: none"> • Typical plan of floors 2,3,4 • ~ 209,000 useable SQFT

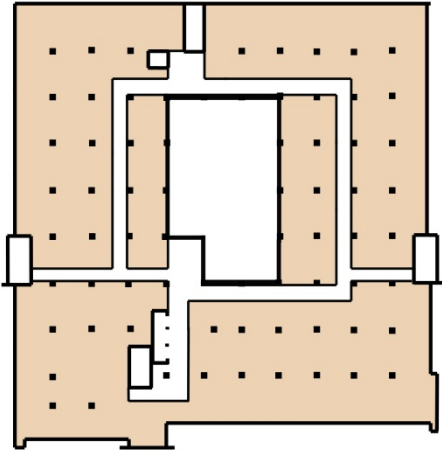
<ul style="list-style-type: none"> • Typical plan of floors 2,3,4 • ~ 176,200 useable SQFT
Daylighting

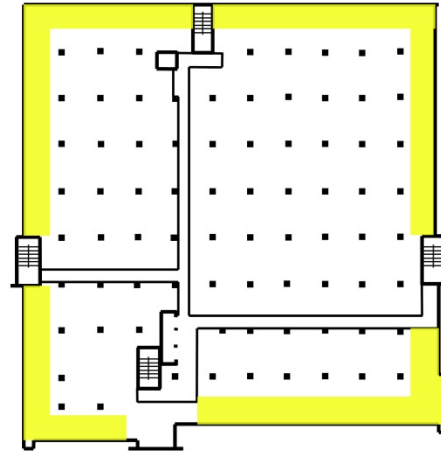
<ul style="list-style-type: none"> • 46% of floors 2,3,4 with access to daylight within 30' of window walls

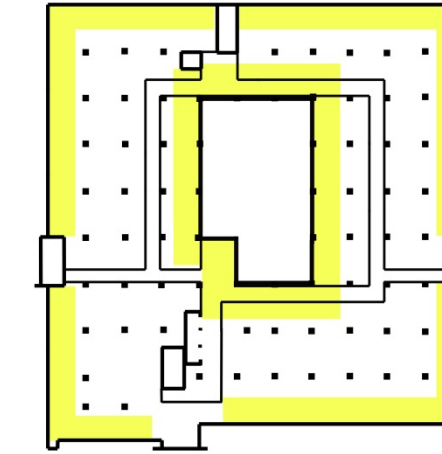
<ul style="list-style-type: none"> • 80% of building with access to daylight within 30' of window walls • Decreased annual lighting operating costs of about 16%.^{viii}

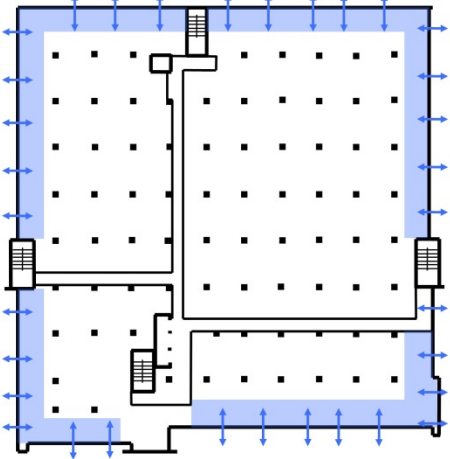
<ul style="list-style-type: none"> • Natural ventilation limited to spaces within 15' of exterior windows, ~ 23% • ~ 6% of year that natural ventilation in Olympia is feasible option.^{ix}

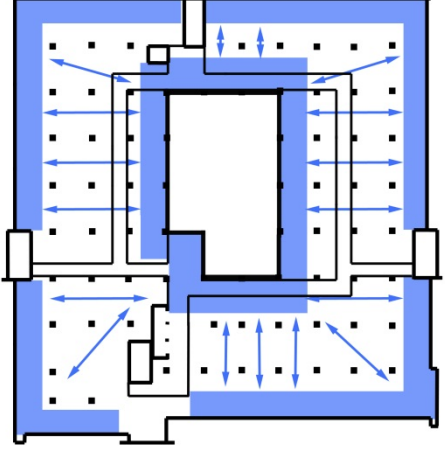
<ul style="list-style-type: none"> • Natural ventilation available for ~ 90% of floor area • ~25-30% of year that natural ventilation in Olympia is feasible option^x
<p>HVAC Load</p>	<ul style="list-style-type: none"> • Total system replacement required 	<ul style="list-style-type: none"> • Total system replacement required • Lower upfront cost due to smaller size of system needed • Decreased annual operating energy cost
<p>Historic Elements</p>	<ul style="list-style-type: none"> • Remain untouched 	<ul style="list-style-type: none"> • Remain untouched
<p>Green Spaces</p>	<ul style="list-style-type: none"> • Potential green roof space 	<ul style="list-style-type: none"> • Potential green roof space • Potential center core courtyard green space
