DES OLD CAPITOL ROOF REPLACEMENT STUDY

Pre-Design
June 2017

EXECUTIVE SUMMARY

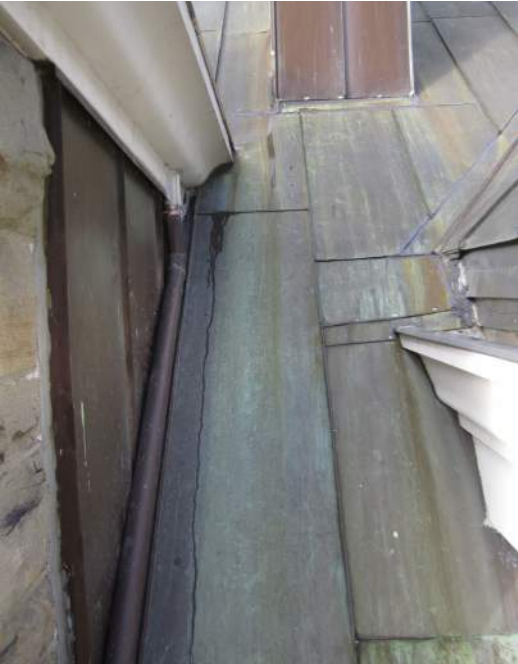
Roof slope at standing seam locations is approximately 12:12. The standing seam pan width is approximately 16 inches, with approximately 10 foot field lengths. At transverse joints, roofing pans transition with single hem seams, a potential area for water infiltration. Both following water testing, and even days after a rain event, water was observed to be actively leaking from these joints.

Figure 2. Water leaking at pan hem

The building’s preservation and maintenance needs can be attributed to natural building material life cycles, and unconventional installation of flashings and roofing. To address these issues in a systematic way, it is advisable to do a comprehensive roof replacement of the copper standing seam roofing to respond to all problem areas and sources of water infiltration.

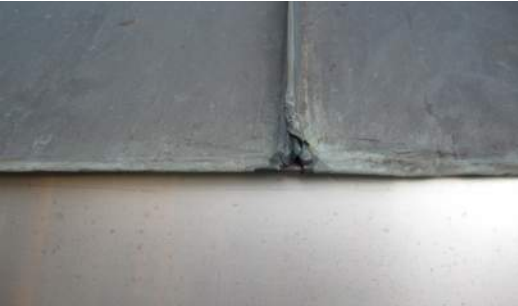
The standing seams are single hem seams, folded over at eave edges and ridge caps to provide closure. Single hem standing seams are vulnerable to wind driven water infiltration, especially when facing the prevailing wind direction. In many locations the folds at the eave and ridge have caused tearing at the edges of roof pans, creating a pinhole condition susceptible to water infiltration.

Figure 3. Torn pan at roof eave

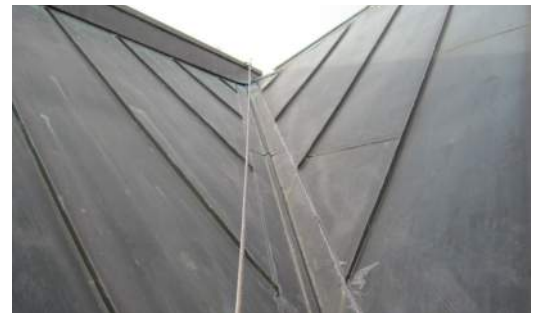
Valley flashing legs are approximately 4" wide and are interlocked with roofing pans with a single hem and without adequate overlap. Single hem seams at the valley are a potential area of water infiltration.

Figure 4. Valley flashing

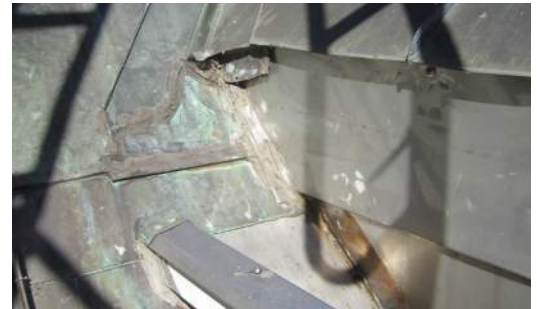
At dormers the valley, eave edge, and gutter flashings intersect with the main roof. Where the gutter intersects the main roof, sealant is used to provide closure. The sealant is hard and brittle and appears to be failing in many locations.

Figure 5. Gutter transition to main roof

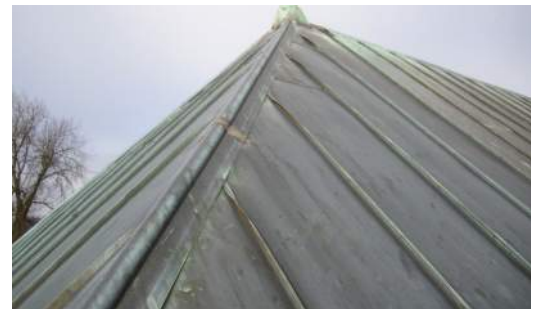
The ridge cap laps folded standing seam pans and is fastened with uncapped, exposed rivet fasteners. In some areas the ridge cap has torn or the fasteners have failed, leaving the ridge vulnerable to high wind exposure and potential water infiltration. Transverse ridge cap transitions are made with sealant and appear to be failing in numerous locations. It is unclear if sealant is original or was installed as part of ongoing maintenance efforts.

Figure 6. Ridge cap transition with sealant

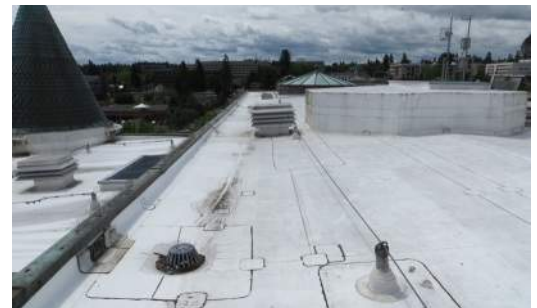
Single ply roofing membrane was installed on the east annex in 2006. At that time, rigid insulation was installed above deck with tapered insulation over top. The membrane appears to be in overall good condition. In some areas the membrane appears to have separated from the substrate and voids have formed underneath. No punctures in the membrane were observed and there does not appear to be any active water lakes attributed to the low slope roofing. The typical lifespan of single ply roof membrane is approximately 20 years.

Figure 7. PVC roofing at East Annex

The low slope roofing areas are in an overall good condition. However, they are more than halfway through their life cycle and will require replacement within the next 5 to 10 years. Furthermore, replacement of the copper roofing will cause additional wear and tear on the low slope membrane. With this lifespan in mind, it is recommended to replace the single ply membrane simultaneously with the standing seam roofing to allow for seamless detailing and

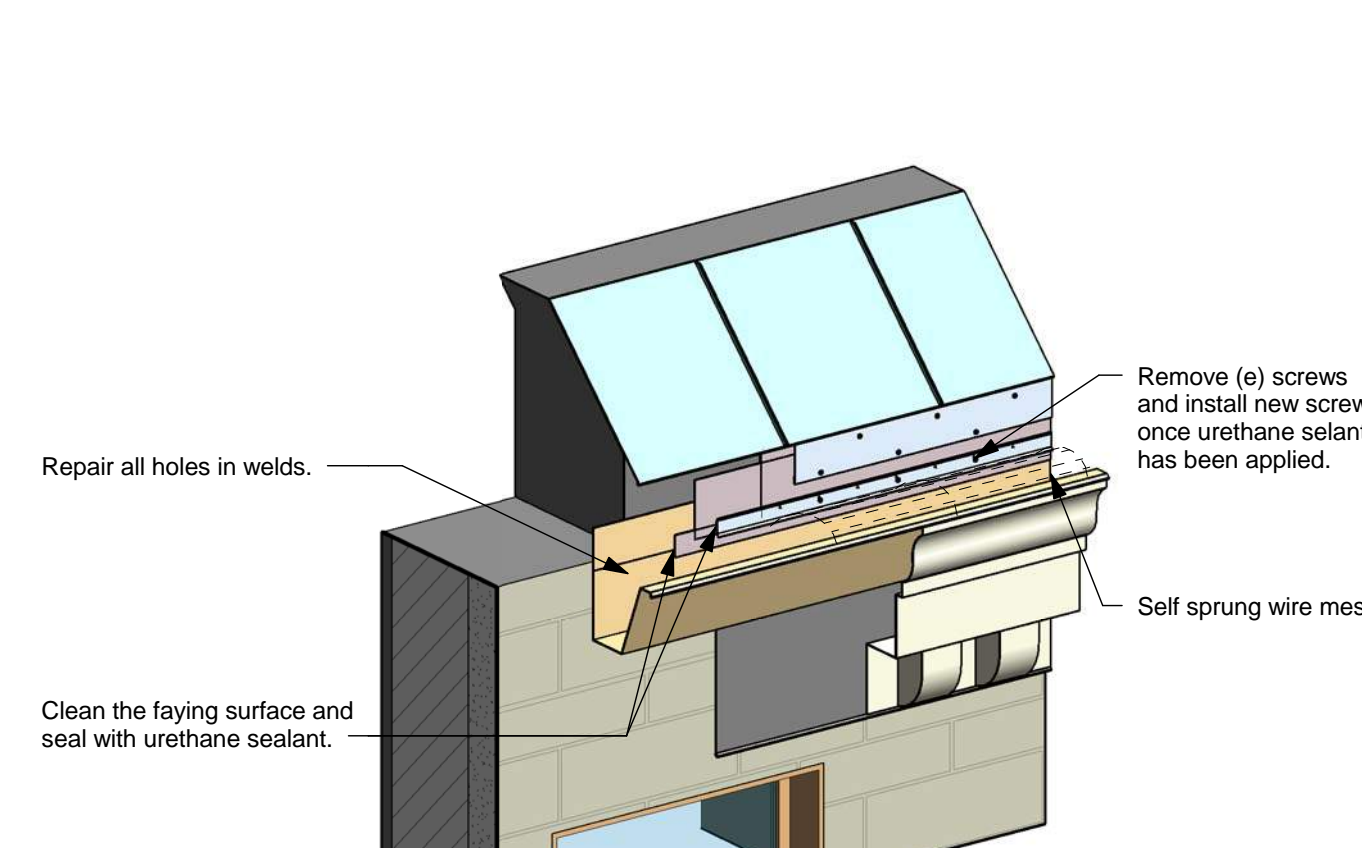
6 Type B Gutter
Diagrammatic Axonometric

Incomplete flashing system, provide (n) stainless flashing where needed and repair to match Type B Gutter

2 Gutter Type B Repair
Section
0 3' 6' 1'

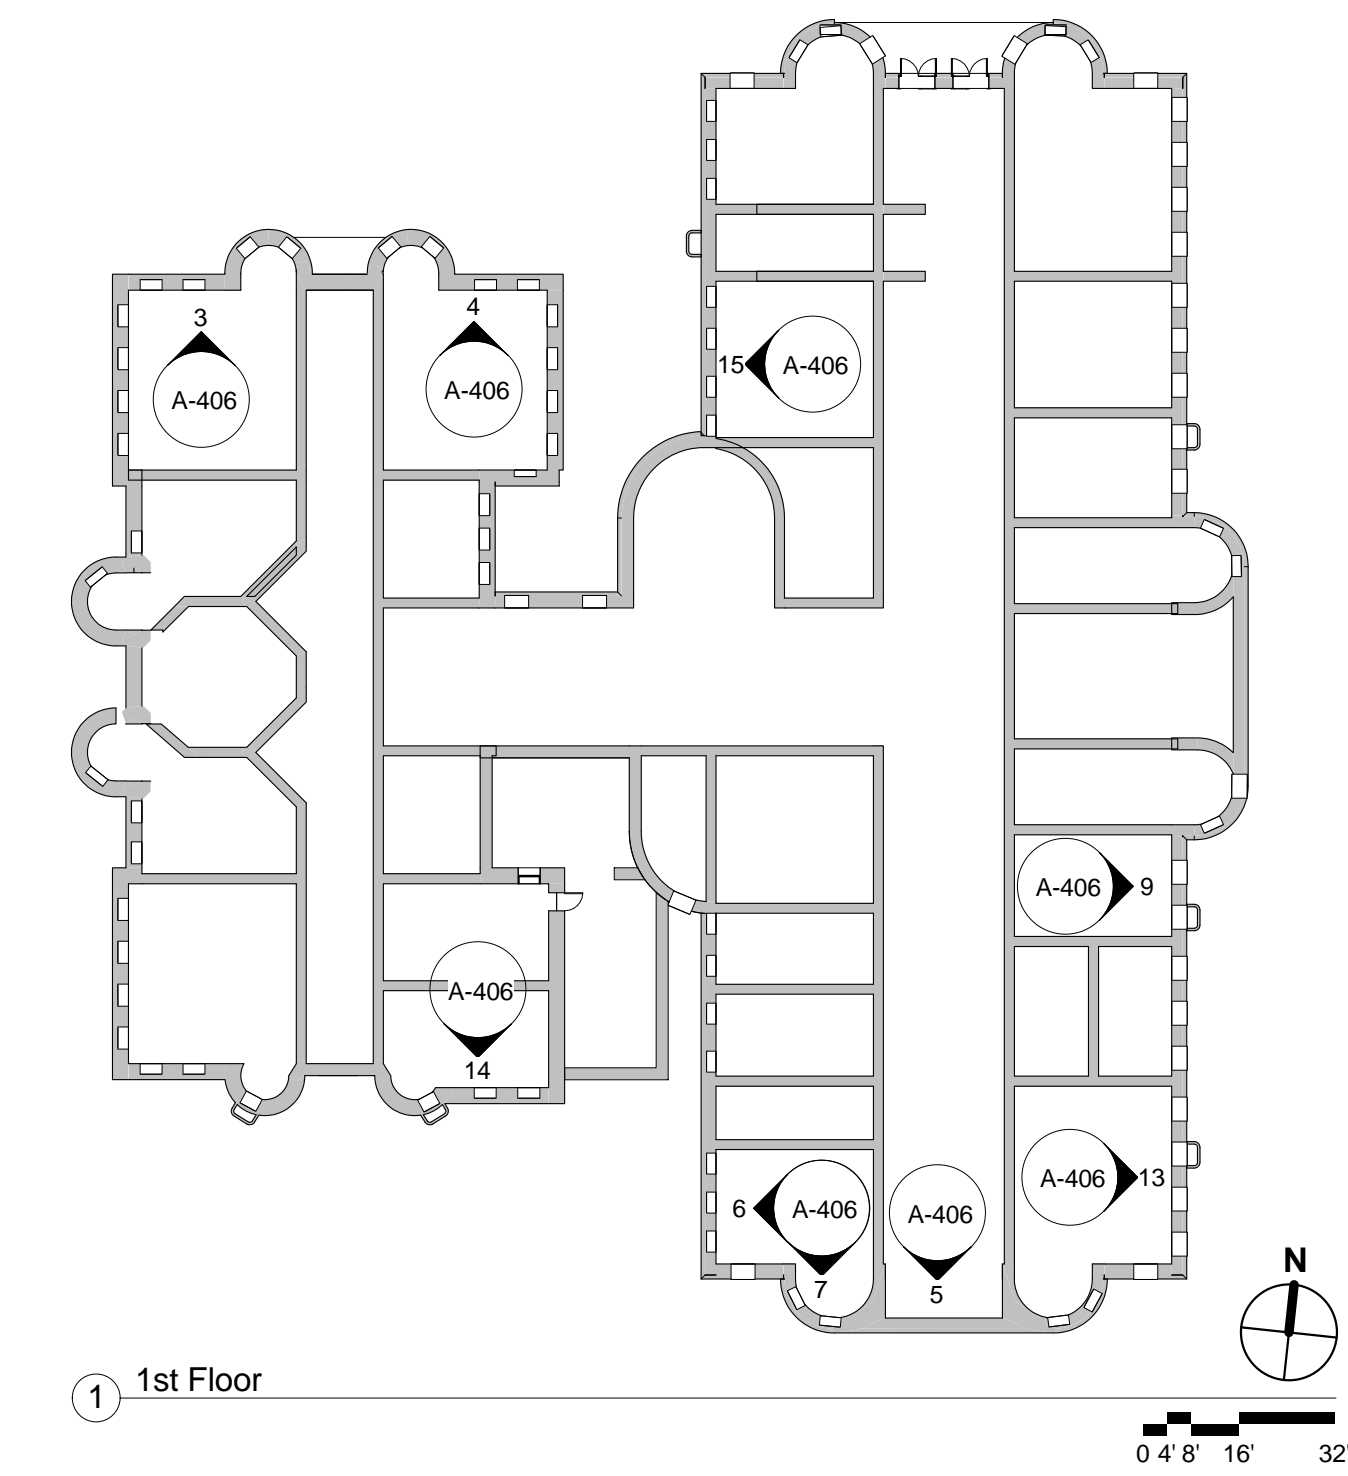
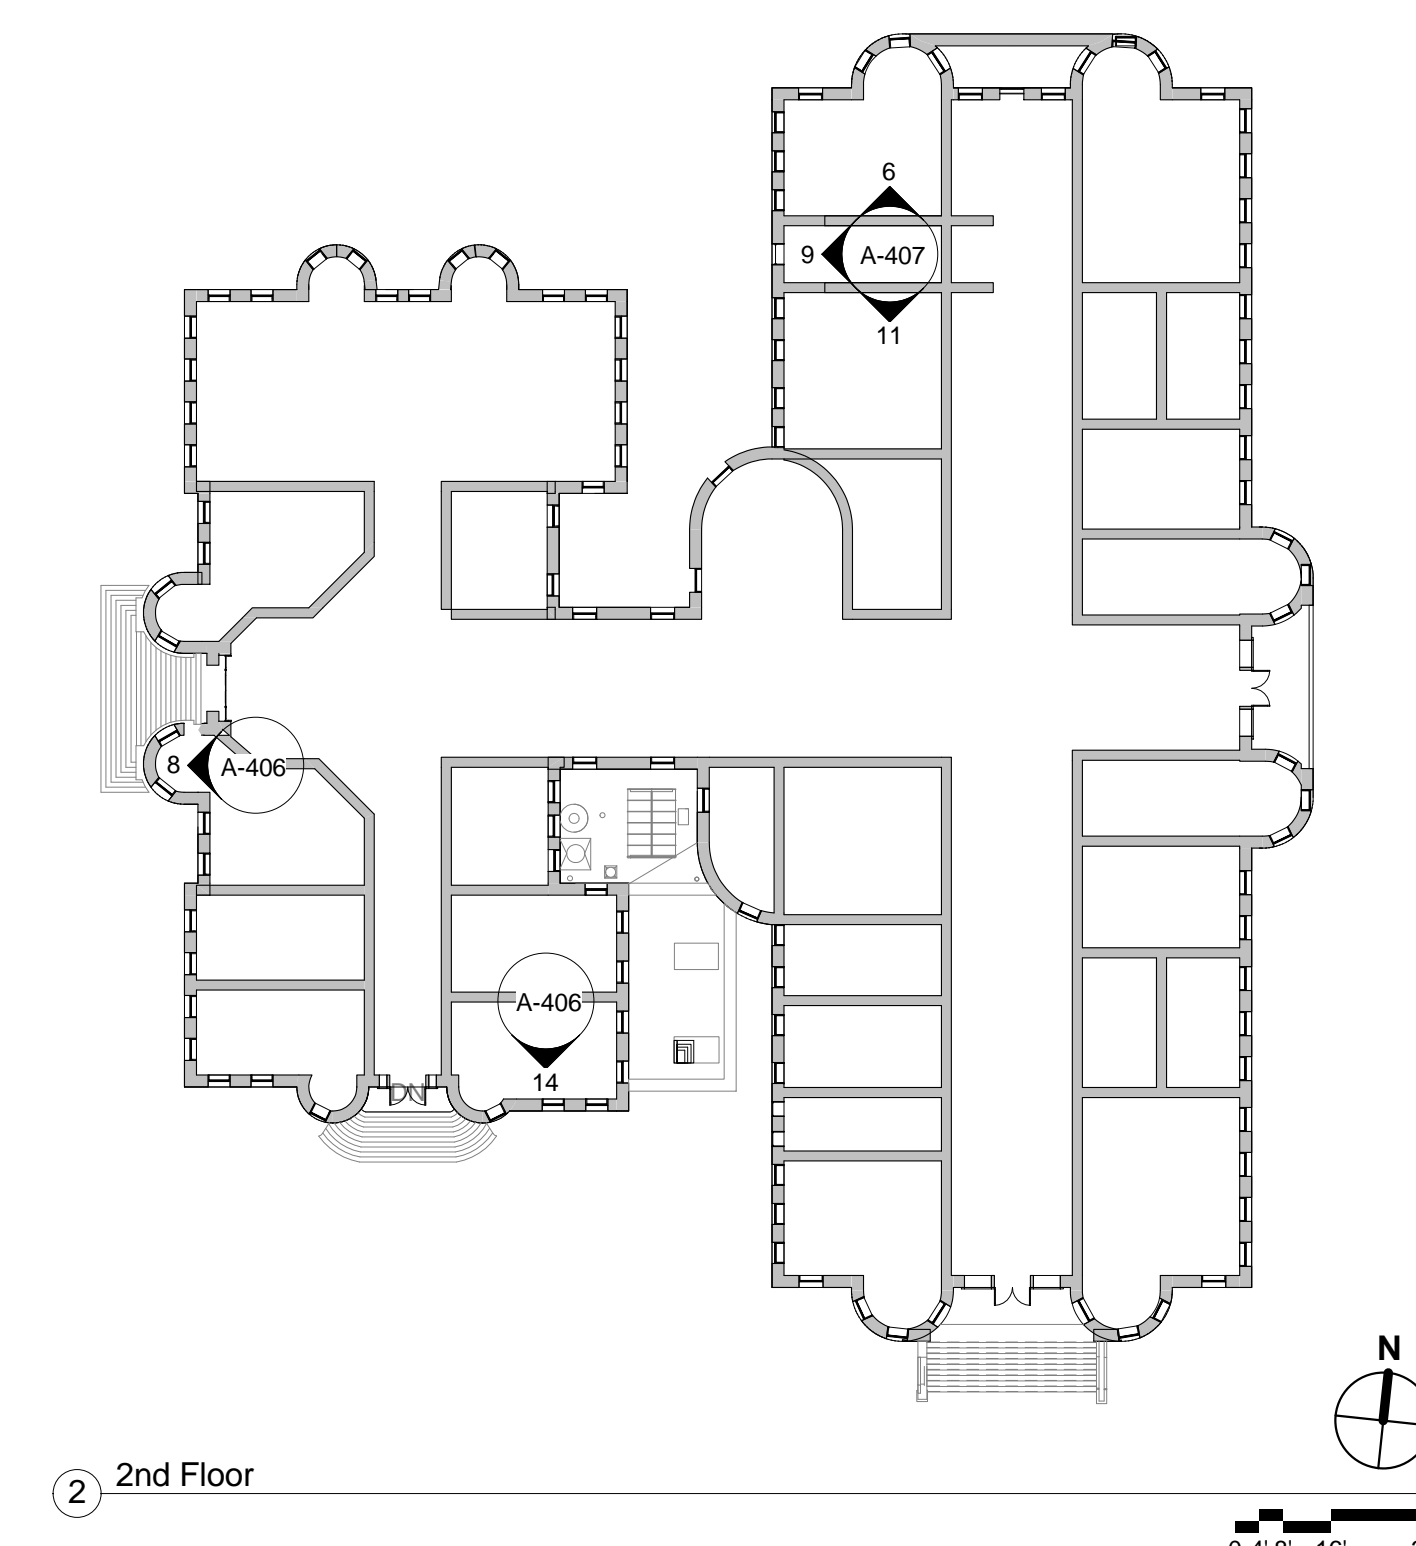
15 (e) Condition - Damaged Plaster

- 10 Install (n) overflow at (e) gutters to direct water away from face of building. (Alternate No.2)
- 11 Remove damaged (e) plaster and (e) metal lath, replace with new plaster and lath, paint to match (e) interior color.
