Legislative Chambers Skylight Restoration Feasibility Study

Washington State Legislative Building

Washington State Department of Enterprise Services

April 4, 2017

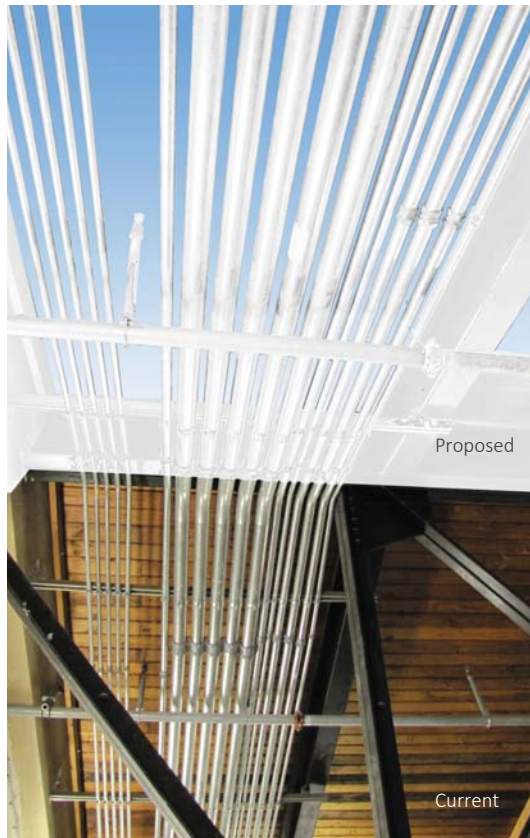
Figure ES06: Photo showing proposed reflective white paint on all surfaces of the skylight attic with glazing above

It is recommended to paint everything (conduit, pipes, structure, walls, railings, etc.) with a highly reflective white paint to create a light box in the skylight attic space. This will allow light from the skylights to bounce from surface to surface minimizing any shadowing from the various objects in the space. To complete the lightbox, doors or sliding panels will need to be added at the existing entry points to other areas of the attic.

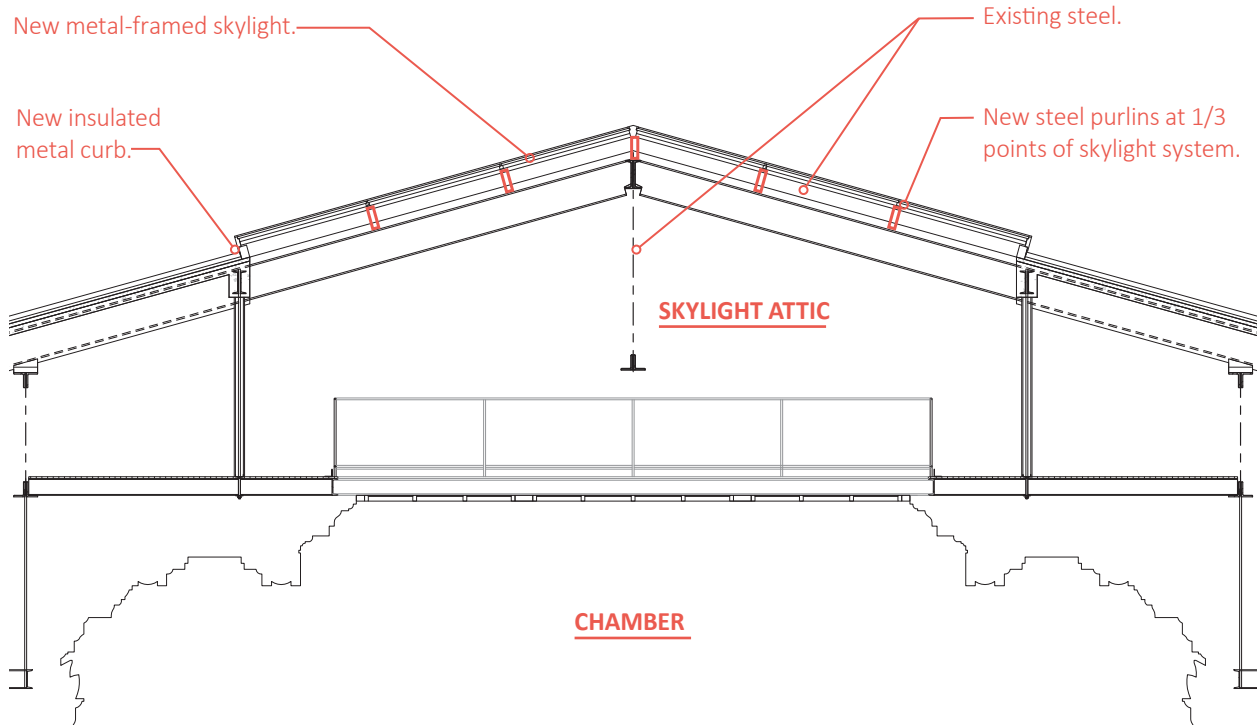
Figure ES09: Proposed skylight section

New steel purlins at 1/3 points of the spans may be necessary to minimize the depth of the skylight framing as shown in the section above. This will also result in a less expensive and lighter skylight system.

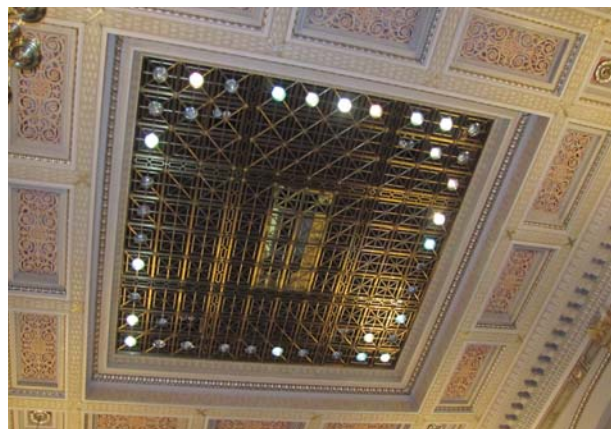
Figure 20: Senate ceiling laylight, showing downlight configuration

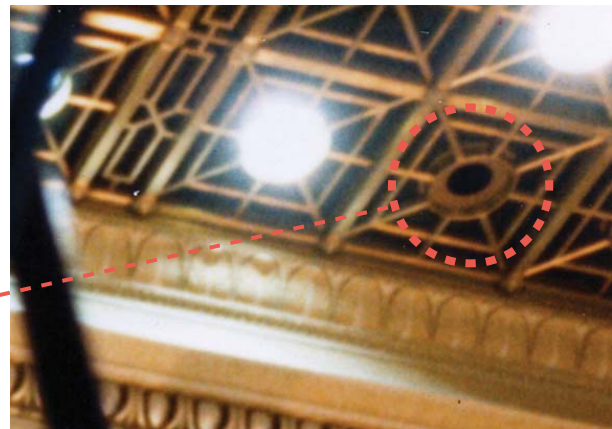
High bay lights added in 1967 show a smaller diameter light with a flat bronze housing.

Figure 34: 1967 Lights

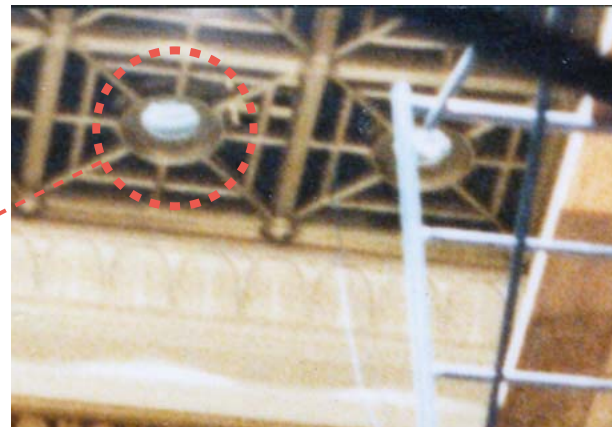
Early incandescent lights show a smaller diameter with a concave bronze reflector.

Figure 35: Early Lights added between 1923 and 1967
