CAPITOL LAKE DAM CONDITION ASSESSMENT AND LIFE EXPECTANCY

October 31, 2008

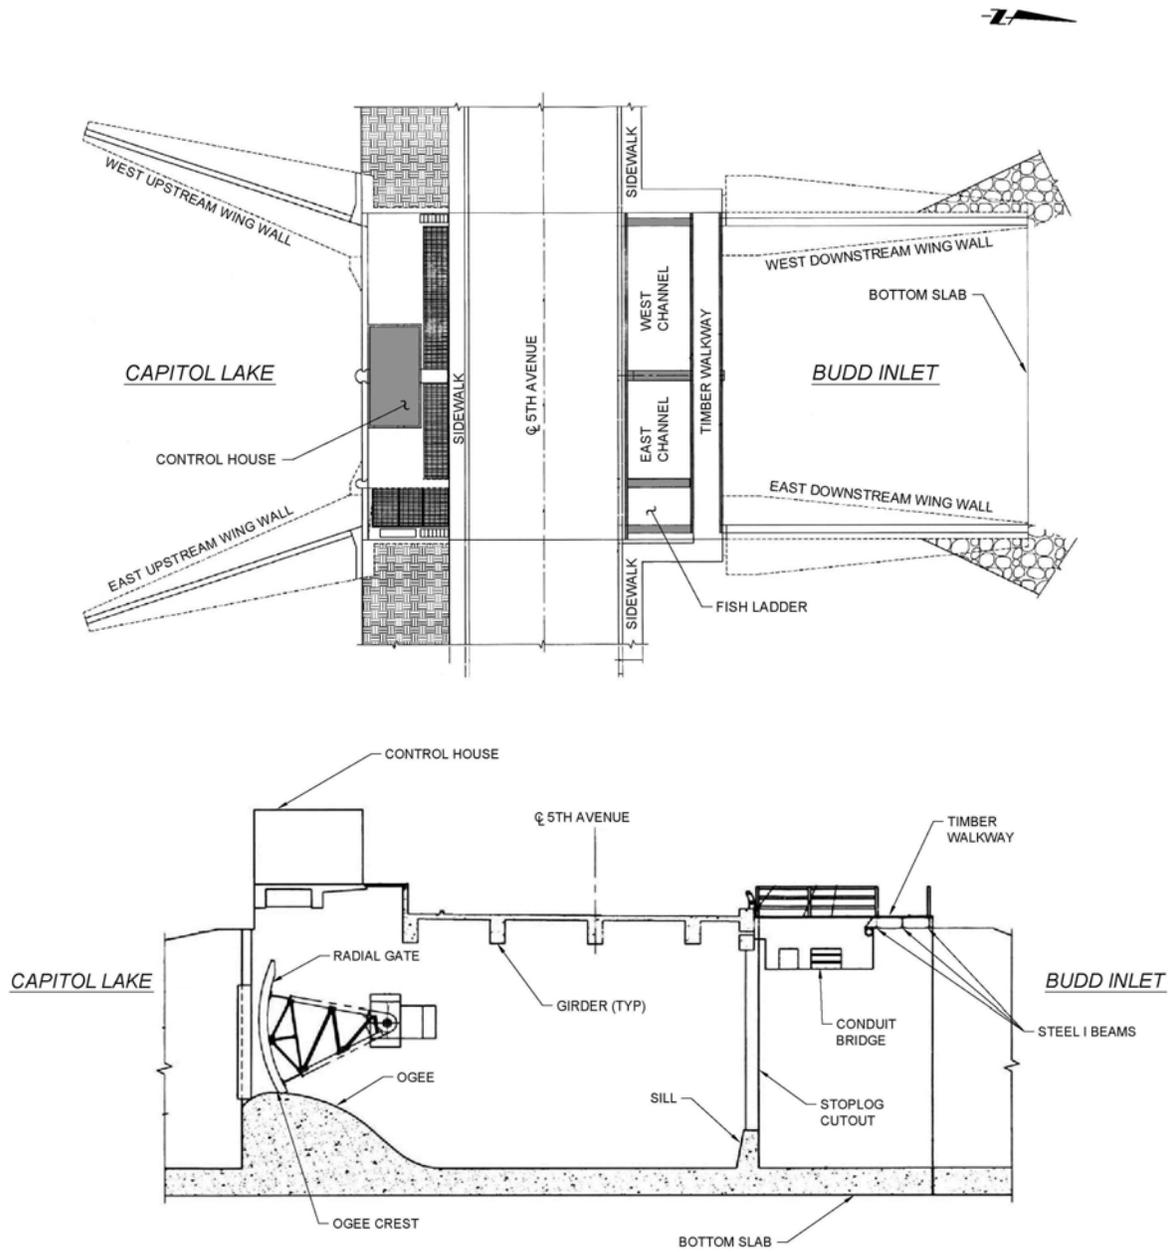
Figure 2. Capitol Lake Dam Plan & West Section

The underside of the timber walkway is composed of steel and timber members (see Figure 2). The timber exhibited no significant damage. The steel I-beams supporting the walkway have peeled and show moderate corrosion throughout, although section loss is minor and infrequent.

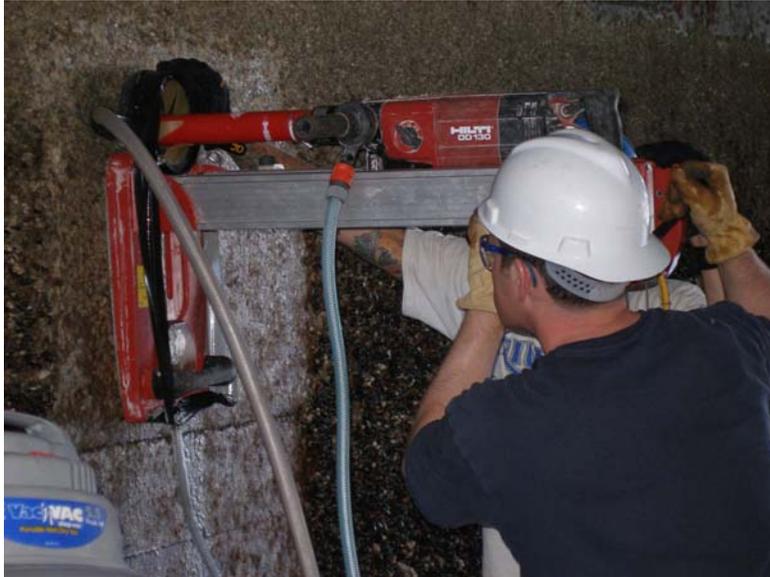
Figure 3. Over-Water Core Drilling

Fourteen concrete core samples were extracted from the dam's wing walls and pier walls. The core drilling machine was used from a boat to extract the samples (see Figure 3).

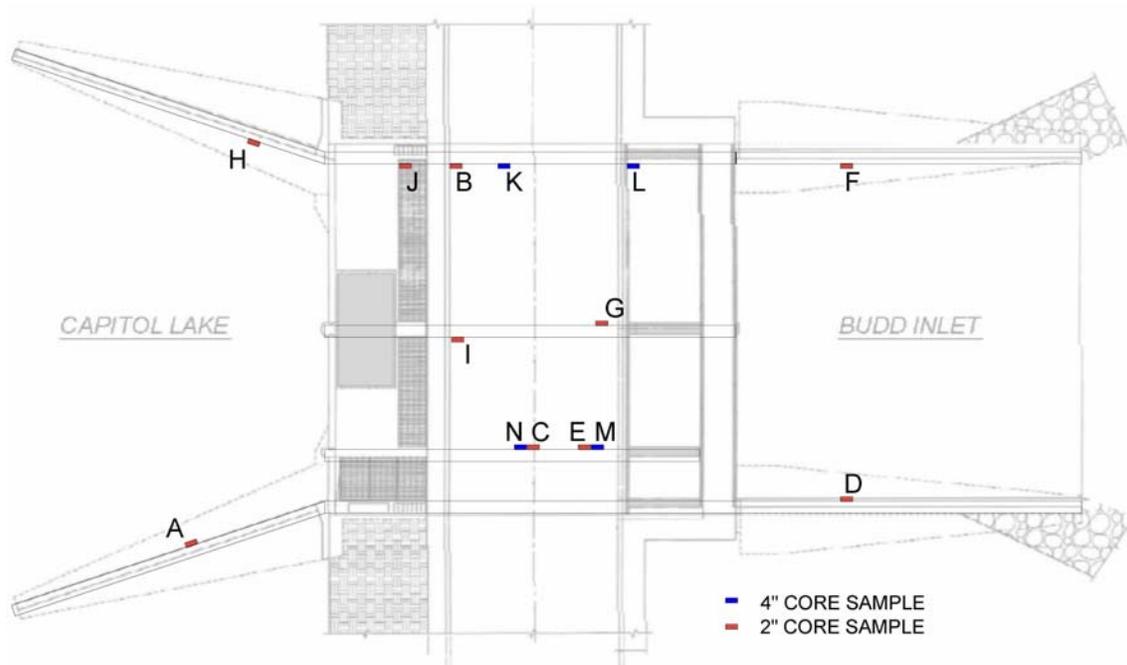
Figure 4. Core Plan

Chloride percentages obtained from laboratory testing are given in Table 2, with sample ID corresponding to Figure 4. The table summarizes the chloride ion sampling analysis provided in Appendix B.

Table 3 summarizes the pertinent petrographic parameters obtained in the analysis and compares them to normal, non air-entrained concrete. The data in Table 3 is taken from the report attached as Appendix B. Cores L and M correspond to the locations shown in Figure 4. Refer to Appendix B for a full report of the petrographic analysis.

Table 4 displays the results obtained from the transport properties testing, including absorption, Porosity, and Ionic Diffusion Coefficients. The data is compiled from Appendix C. Cores K and N respond to the locations shown in the Core Plan (Figure 4).
