Roof SURVEY REPORT

Limited Roof Survey and Leak Investigation

Rainier School Building 2010

Buckley, Washington

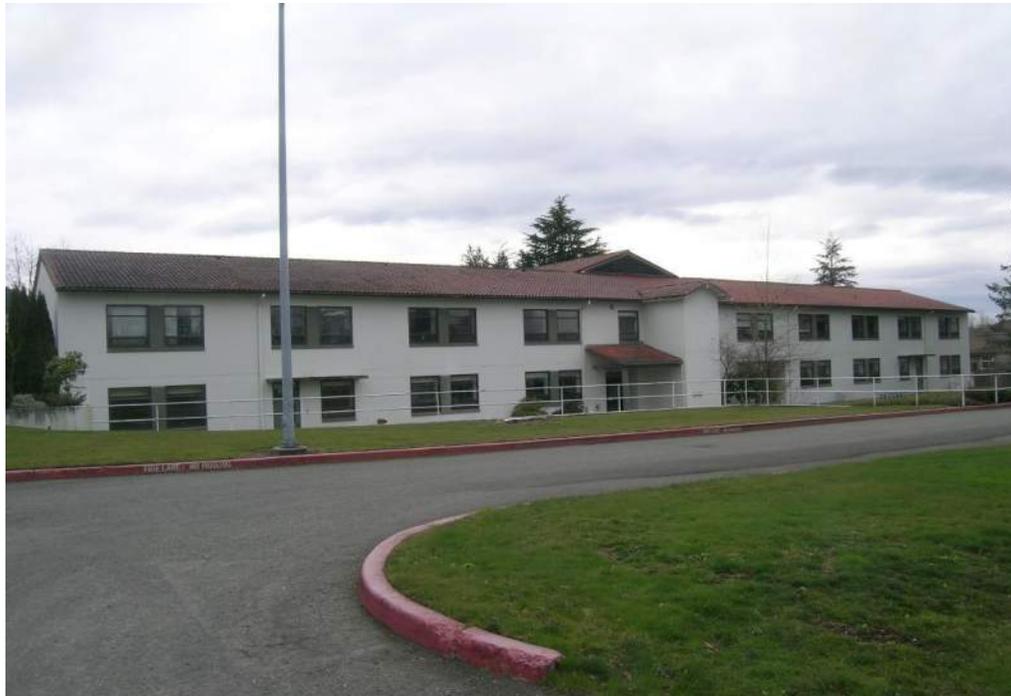
Photo No. 8 - View of the north-facing gable roof area at the 2010 Building that was the primary focus of our roofing survey.

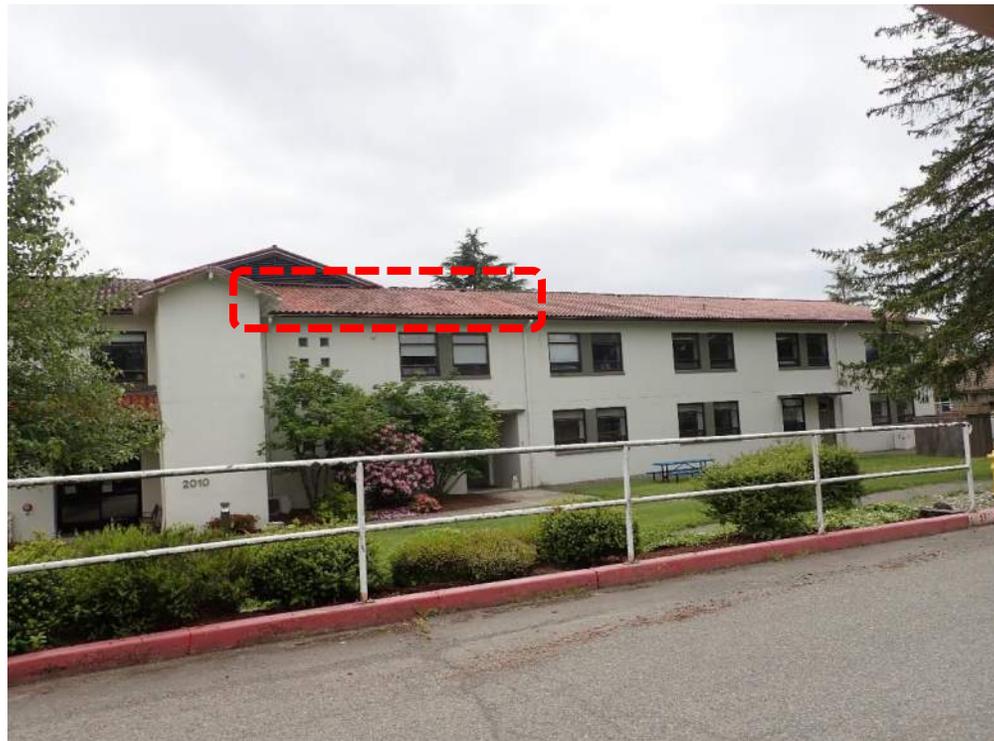
Photo No. 9 - View of the north-facing gable end roof area at the 2010 Building showing the west end of the roof area. It was reported that a portion of the roof area, shown by the red hatched line identified area, was previously repaired to address water-intrusions and water-damaged T&G roof decking.

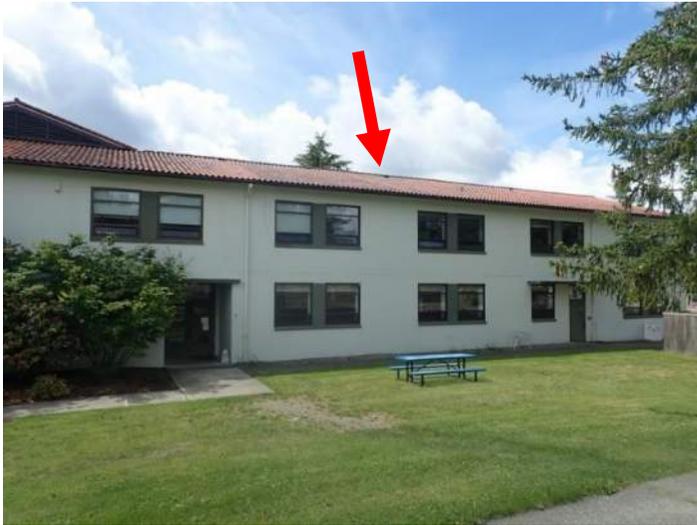
Photo No. 16 - Building 2010 North End Roof Area

As part of our roof survey, we removed select areas of interior insulation under the roof deck to observe conditions at the wood decking. The arrow depicts the general location of the testing and survey area at the west side area of the attic. The arrow points to a ridge vent that is shown in photos below.

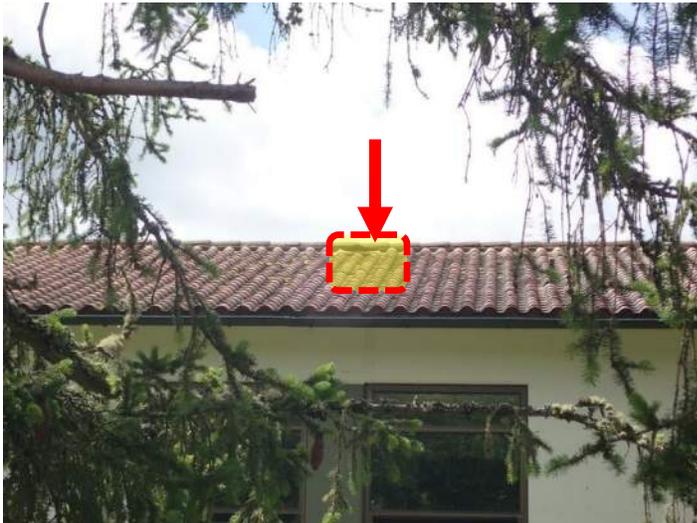
Photo No. 17 - North End Roof Area and Ridge Vent at Test Area

Closer photo of ridge vent location and general area where observations of the wood decking were documented from within the attic space.

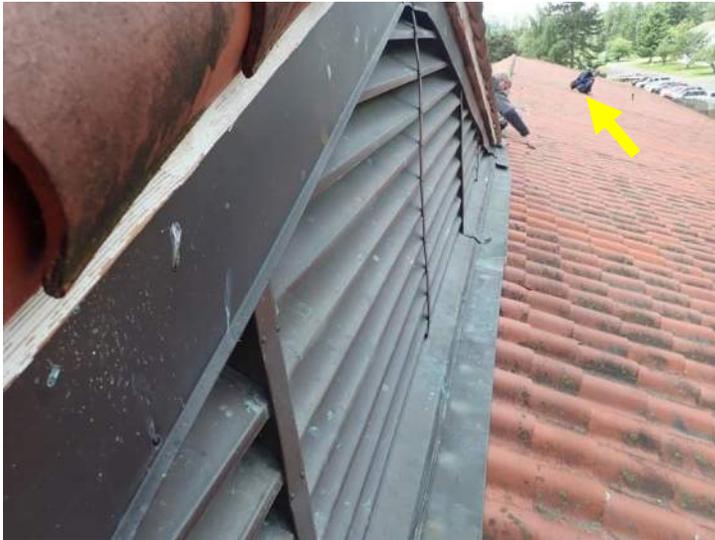
Photo No. 25 - North-facing gable end roof looking west

View of the north-facing side of the gable roof looking west. The arrow shows the approx. location of the test area shown in previous photos.

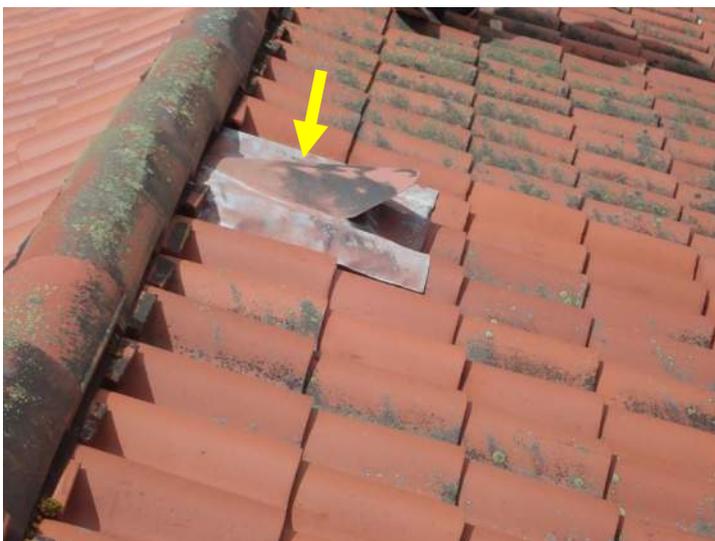
Photo No. 27 - Example gable vent at north end roof area

At the ridge vent, the openings were protected with a sheet metal flashing hood. As a general note, the small ridge vents do not appear to be effective for providing adequate roof ventilation, particularly as the rigid insulation fully blocks the vent opening. It also appeared that no downslope eave intake vents were provided.

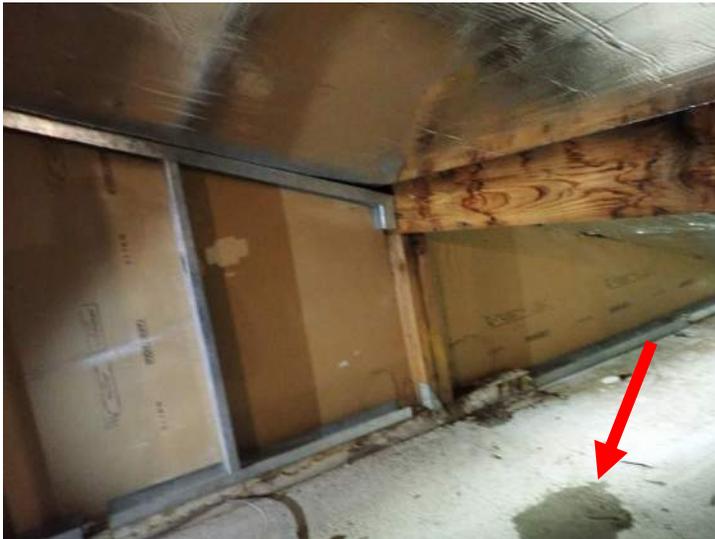
**Photo No. 38 - Rain-water leaks
Following Brief Storm During Survey**

Following a brief, but heavy rainfall during our survey, rain water was observed dripping from the roof at a minimum of three locations observed during a cursory walk through. This is example is located in the central roof area towards the west of the stairs.

Closer view of rain water collecting on the concrete attic floor following the rain storm.

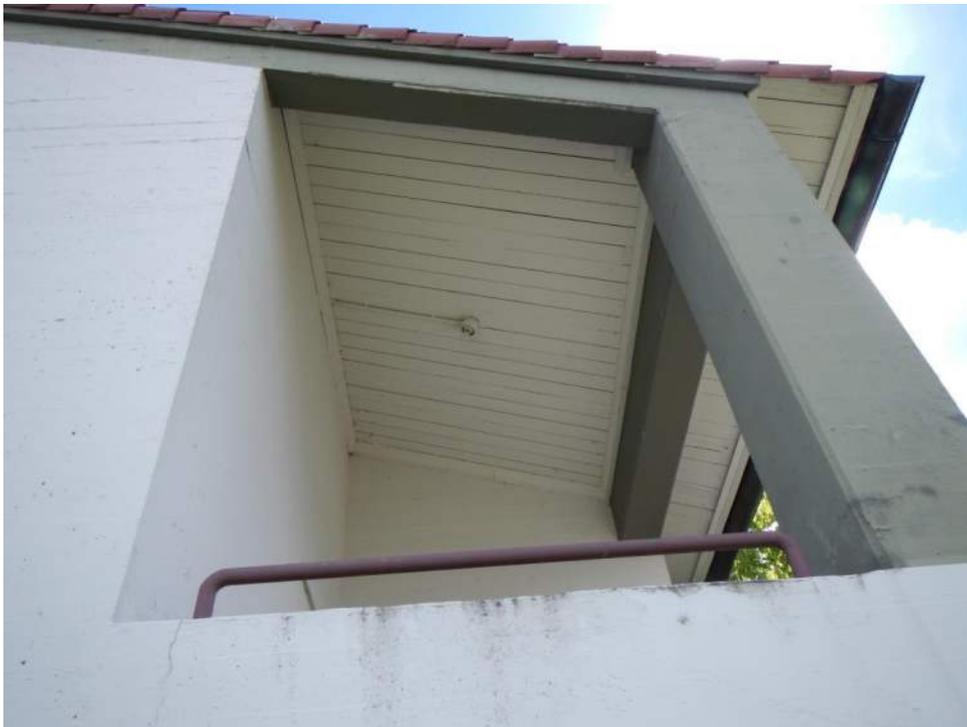
3. View of the north-west corner of the building. *See photograph # 3.*
4. Roof decking exposed at corner porch recesses. *See photograph # 4.*
5. View of the west half of the northern section of roof just in front of the gable end vent. *See photograph # 5.*

Photograph # 4: Exposed roof decking at corner porch recesses.

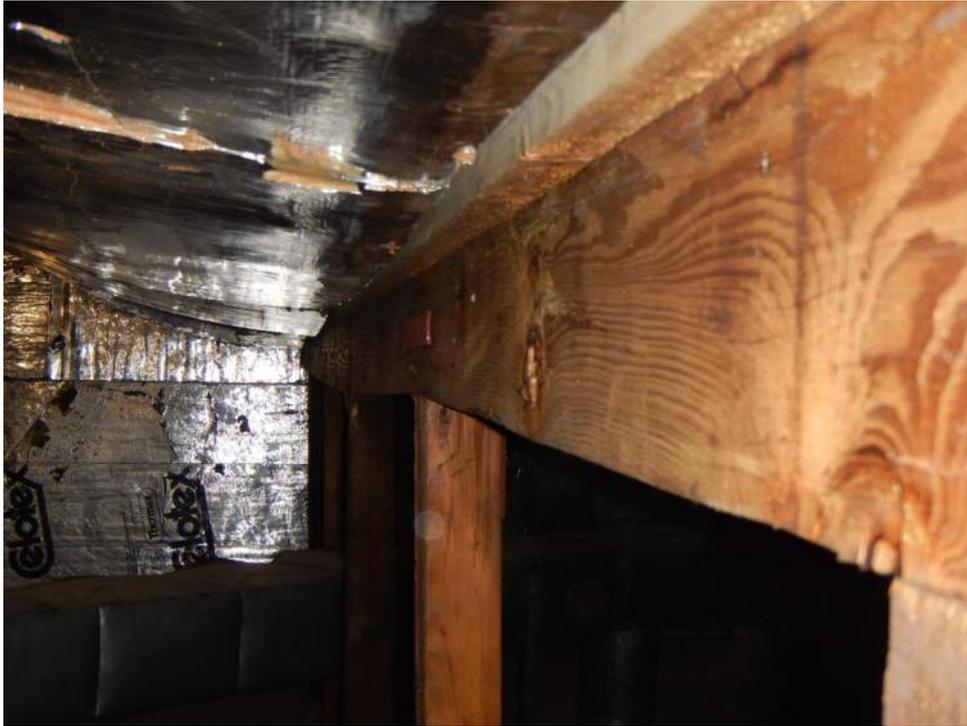
8. Example of water seepage staining noted on the beam and post supporting the roof. *See photograph # 8.*
9. Typical rigid insulation installed below the roof decking with beam and post. *See photograph # 9.*

Photograph # 9: Rigid insulation at decking soffit abutting beams and posts.

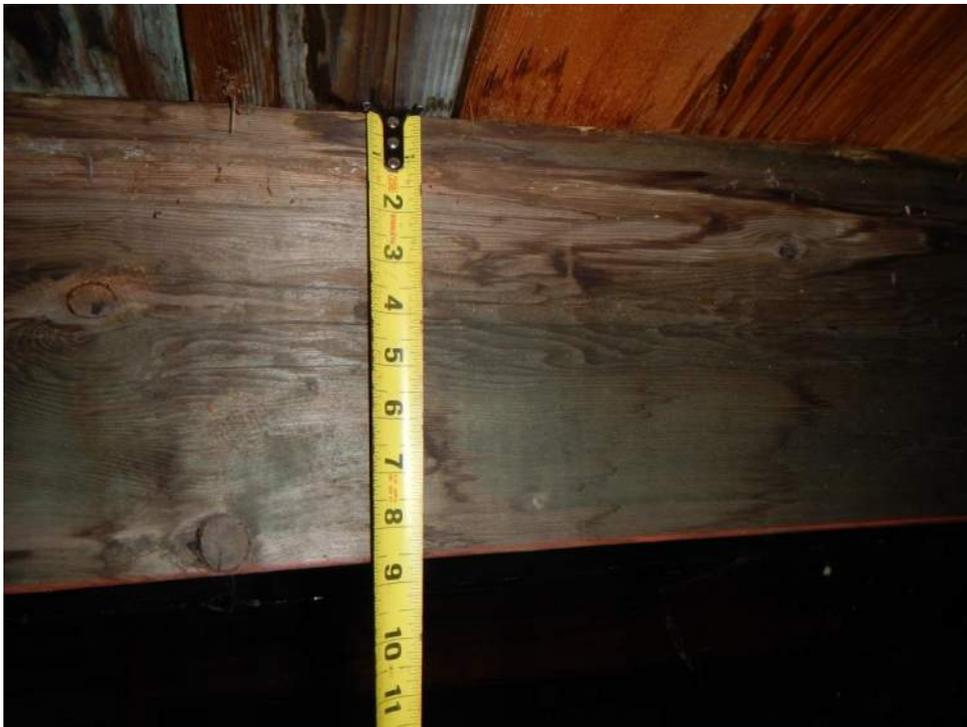
15. Decayed and deteriorated sill plate below the western valley of the central roof chamber.
See photograph # 15.
16. Example of plumb installation of 4X10 beams shaped at the top to receive roof decking.
See photograph # 16.

Photograph # 16: Example of plumb shaped 4X roof support beam.

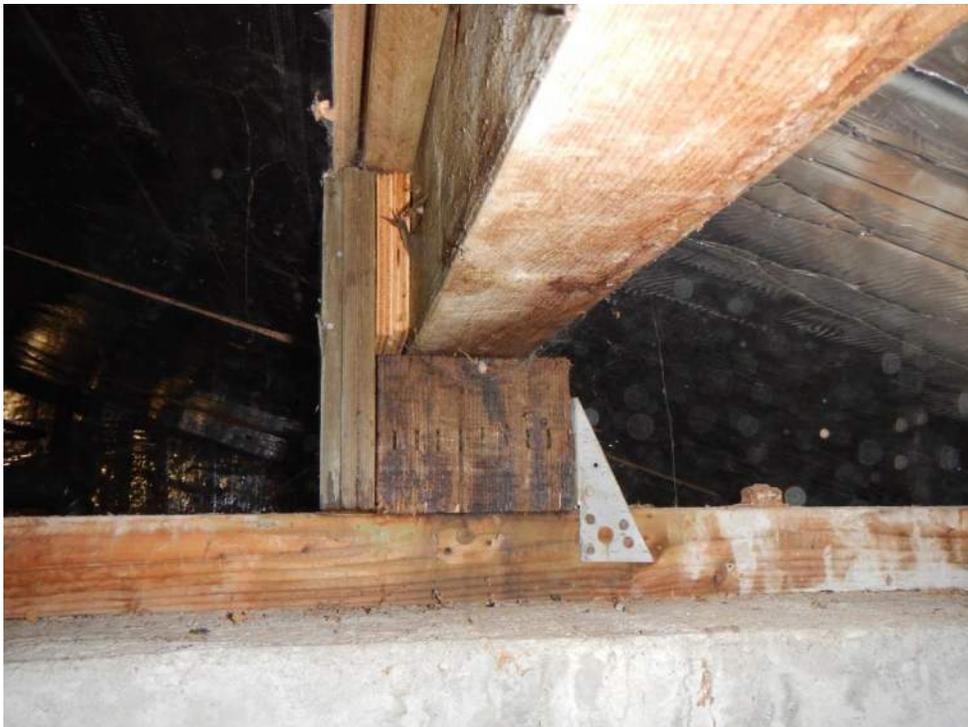
17. Example of roof seepage staining noted at the western attic chamber. *See photograph # 17.*
18. Example of short post repair at upturned concrete beam in the western attic chamber.
See photograph # 18.

Photograph # 18: Repair of short timber post on upturned concrete beam.

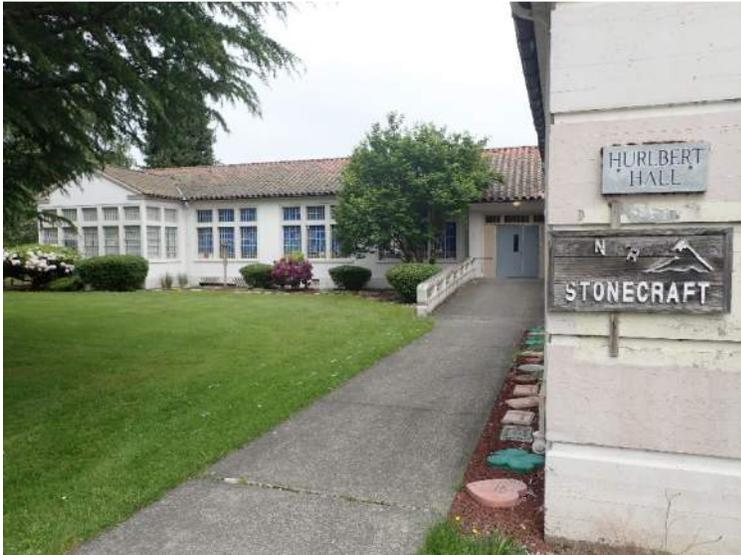
Photo No. 1 - Hurlbert Hall

View of the main south-facing entry and elevation of Hurlbert Hall.

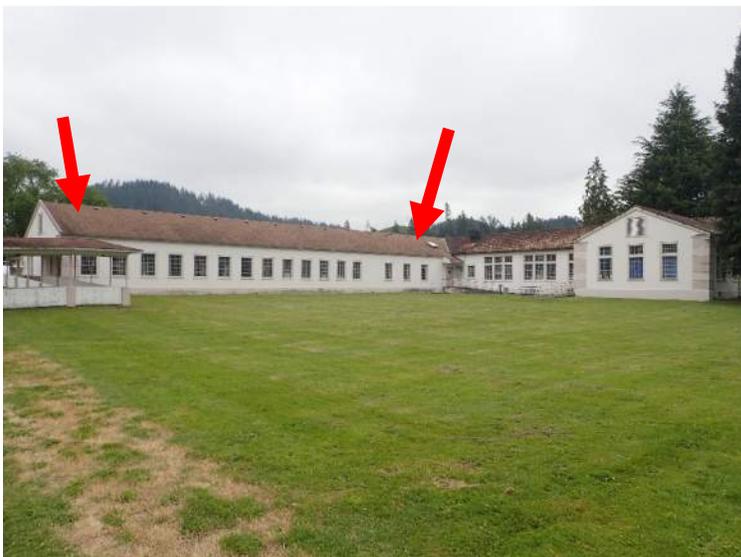
Photo No. 2 - Hurlbert Hall

Hurlbert Hall is one of the original core campus building at Rainier School. It has been reported that water-intrusion and leaking has been a long-term problem for this building. During previous retrofit attempts, the section of roofing on the north wing of the building had the original pan-and-cover clay roofing tiles removed and replaced with an asphalt shingle roof system. Water intrusion has continued, and it is our opinion that extensive roof repairs and replacement is critically needed to prolong the service life of this significant campus building.

Photo of Hurlbert Hall looking southeast from the backside of the building. The arrows identify the north gable end wing of the building that has been reroofed with asphalt shingles during previous repair projects. Reroofing is recommended to preserve this architecturally significant building for the Rainier School campus.

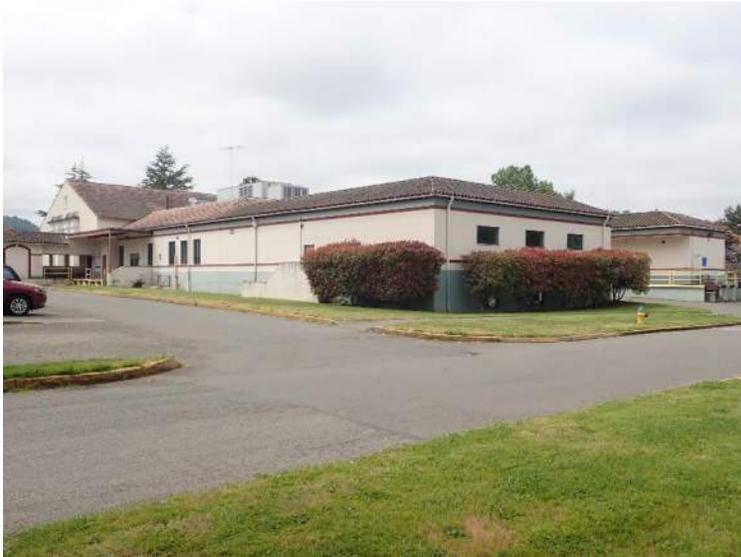
Photo No. 3 - Main Kitchen Building

Overview from the north showing the perimeter steep-slope mansard style roof areas with pan-and-cover clay tiles with the low-slope roof areas located near the center of the building.

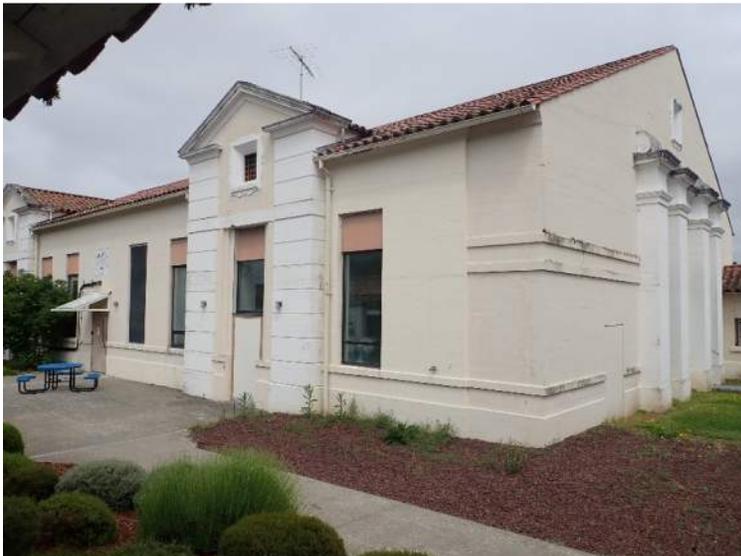
Photo No. 4 - Main Kitchen Building

Photo of the south side of the building where the café is located. The ornate concrete exterior walls are roofed with a steep-slope pan-and-cover clay roofing tile system, similar to other buildings.

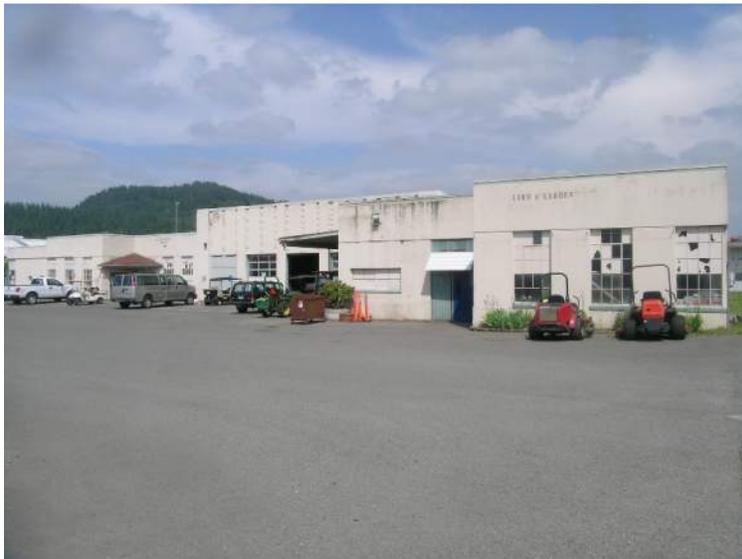
Photo No. 5 - Maintenance Building

Similar to the older, original campus buildings, the Maintenance Building is a largely composed of concrete. The existing low-slope roof membrane is reportedly an aged single-ply Hypalon roofing membrane. Rain water leaks have been reported at numerous areas and it is our opinion that due to the age, existing membrane condition, and reports of water intrusion, it is prudent to consider roof replacement with a new multiple-ply roofing membrane system. This Project Team has successfully designed, specified, and administered the construction phase and installation, in conjunction with qualified roofing contractors, with a new low-slope multiple-ply SBS-modified asphalt roofing membrane system. Replacement of the aged single-ply Hypalon roof membranes should be prioritized as high importance.

Overview looking east towards the Maintenance Building.

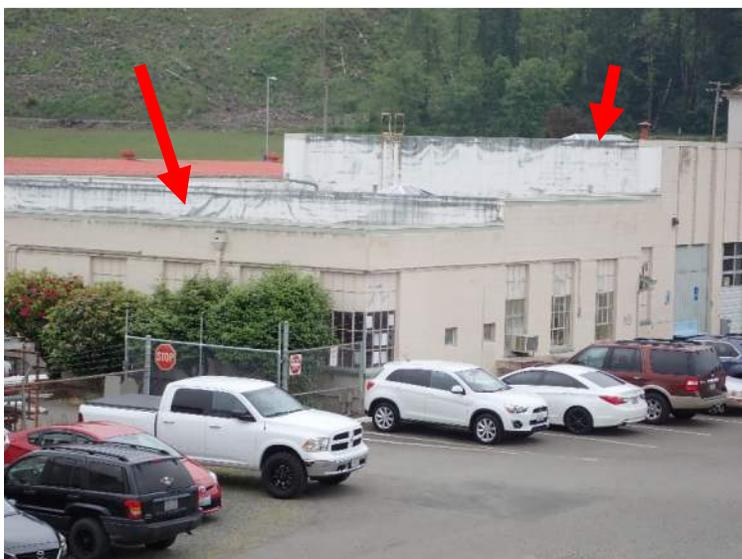
Photo No. 6 - Maintenance Building

Photo depicting the series of low-slope roof areas needing replacement prior to failure of the existing roof membrane system. The building currently experiences rain water intrusion leaks at several locations.

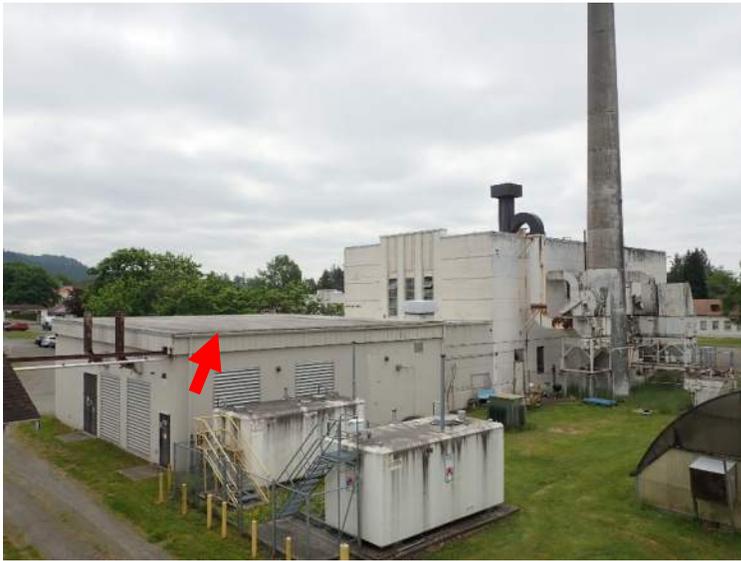
Photo No. 7 - Power House Building

The Power House also consists of a single-ply Hypalon roofing membrane at the various roof levels of the building. Although we have not closely surveyed the roof areas, it is evident from a distance that the existing roof membrane has deteriorated and is in need of replacement. Providing power to the campus, this building serves a critical function for the entire facility.

Overview from the P-43 Building looking southwest towards the Power House. The low-slope single-ply Hypalon membrane was extended and rolled over the perimeter edge of the identified roof area. Visual evidence, even from this distance, showed that the existing membrane is aged, has deteriorated, and is recommended for replacement, as the membrane has reached the end of its useful service life.

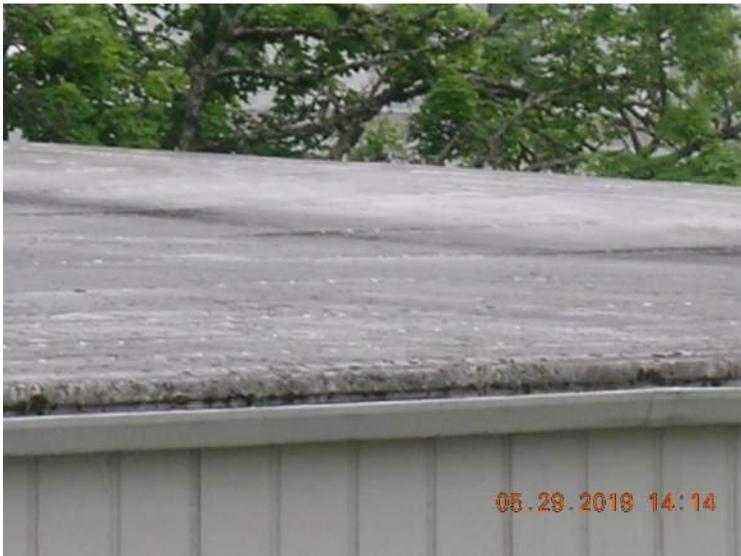
Photo No. 8 - Power House Building Low-Slope Roof

Close-up view of the existing single-ply Hypalon membrane at the east end roof area, identified above. Areas of ponding are evident and the edge of the membrane shows signs of deterioration and is recommended for replacement.

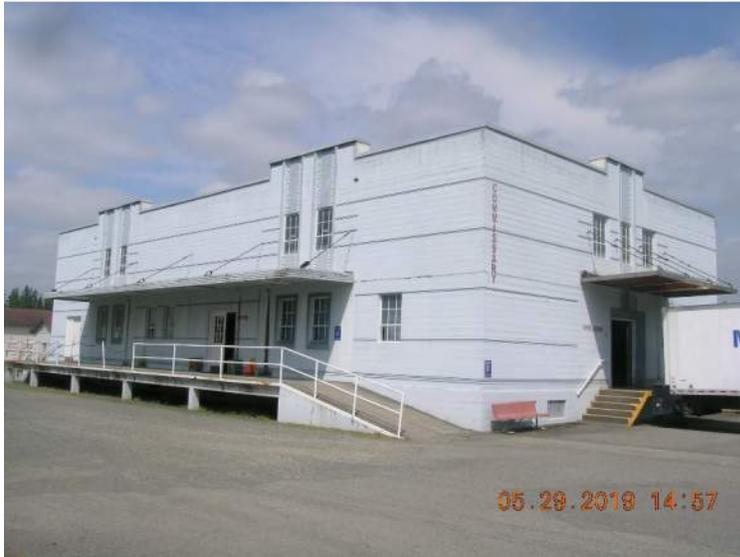
Photo No. 9 - Commissary Building

Overview showing the south and west elevations of the Commissary Building. The concrete-farmed exterior of the building is part of the original campus buildings.

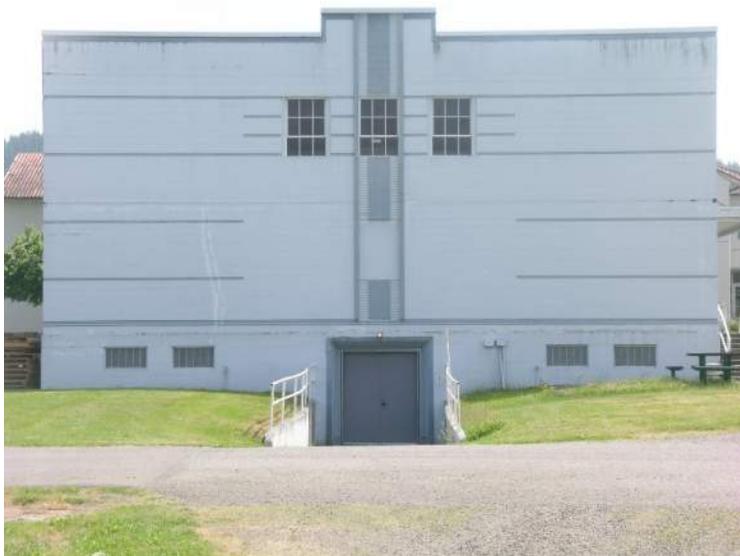
Photo No. 10 - Commissary Building

Photo depicting the north elevation of the Commissary Building.

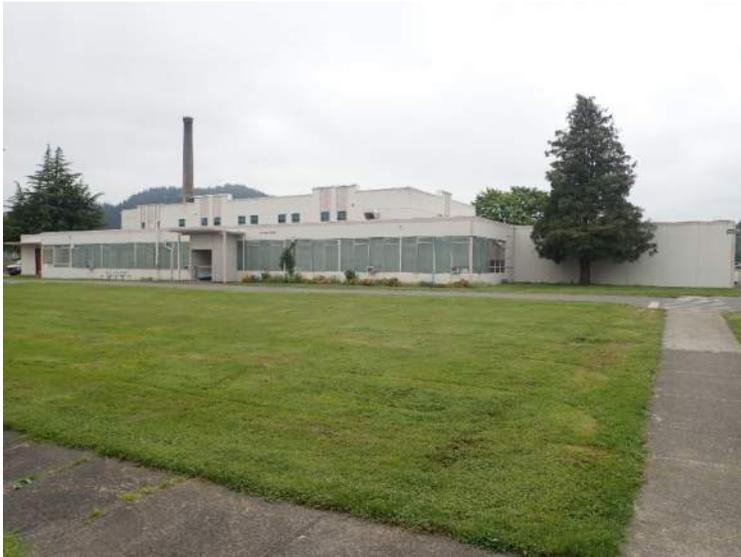
Photo No. 11 - Laundry Building

Overview showing the original two-story Laundry Building near the center and later one-story addition that surrounds the original building.

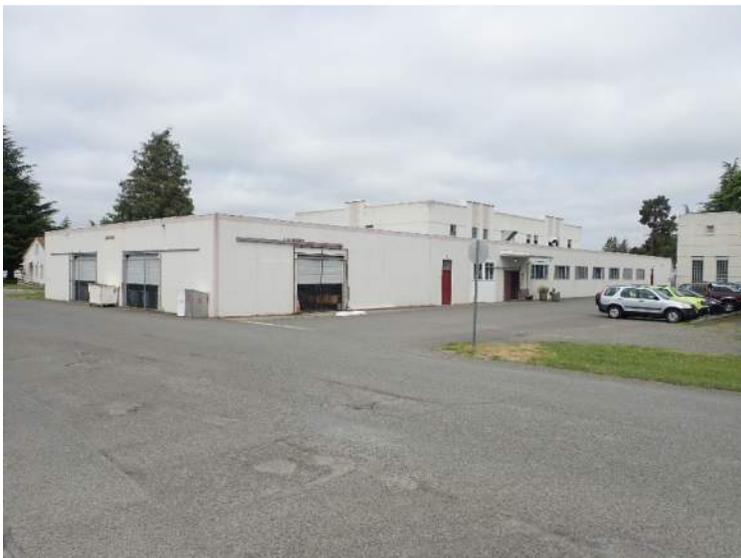
Photo No. 12 - Laundry Building

Photo looking northwest towards the Laundry Building. The later single-story addition that surrounds the original building appears to have been constructed of tilt-up concrete wall panels and low-slope roof areas.

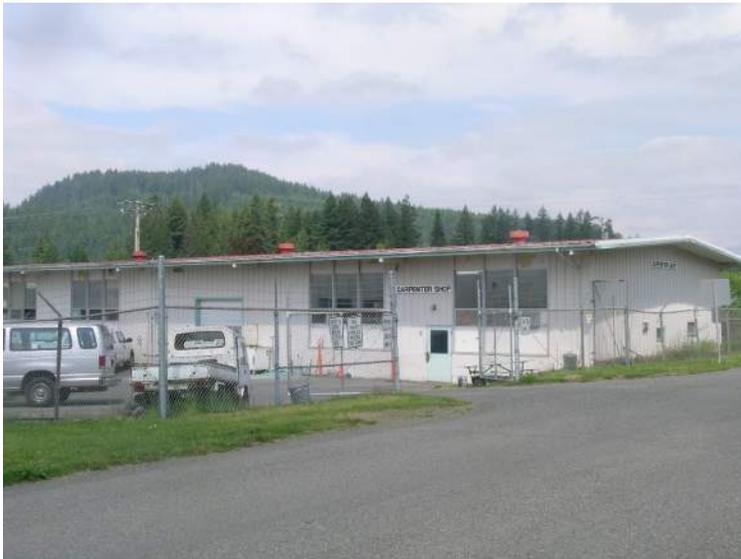
Photo No. 13 - Carpentry Shop

The Carpentry Shop is currently roofed with a low-slope sheet metal panel standing seam roof system. Numerous interior leaks have been reported and are recommended to be addressed. Additional survey is needed to better understand the source or water intrusion to assist with proper design and specification of roofing related repairs.

Overview depicting the existing Carpentry Shop at Rainier School showing the low-slope roof profile at the gable end.

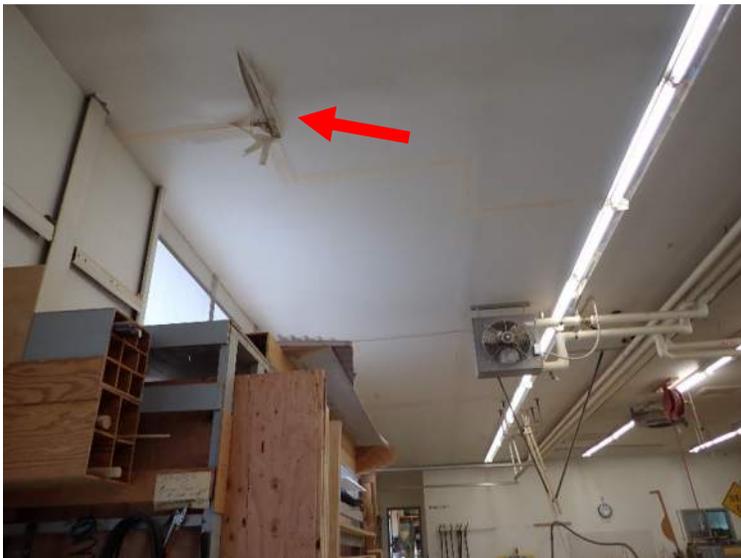
Photo No. 14 - Carpentry Shop Interior

Several interior leak locations were reported. This photo shows interior ceiling damage due to ongoing water intrusion.

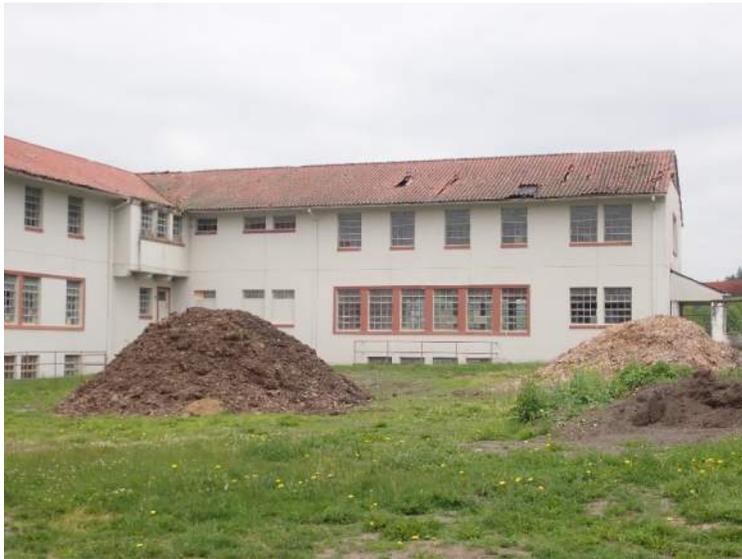
Photo No. 15 - Adler Hall and other Residence Buildings

Photo depicting extensive roof damage at Adler Hall. Reroofing and replacement of damaged roof structure members is recommended for this building and the other buildings that create a four-building quad. While roof replacement work may be extensive, the high-quality construction of the main building structure is worth protecting on our opinion.

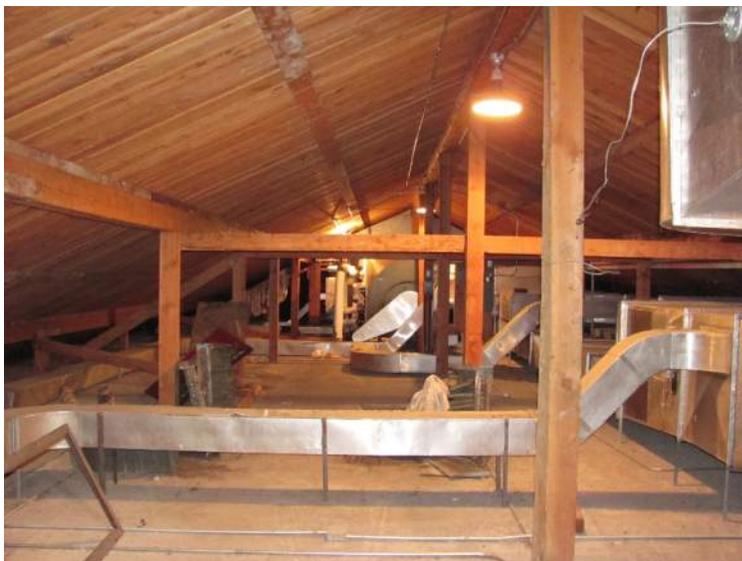
Photo No. 16 - Adler Hall and other Residence Buildings

Photo provided by the State of Washington from the attic spaces within these residential buildings. Note that the tongue-and-groove roof decking runs parallel with the slope of the roof. It is likely that much of the damage and decay is isolated to the roof decking and the primary, large-dimension wood framed structural support members remain largely intact and serviceable for reroofing.

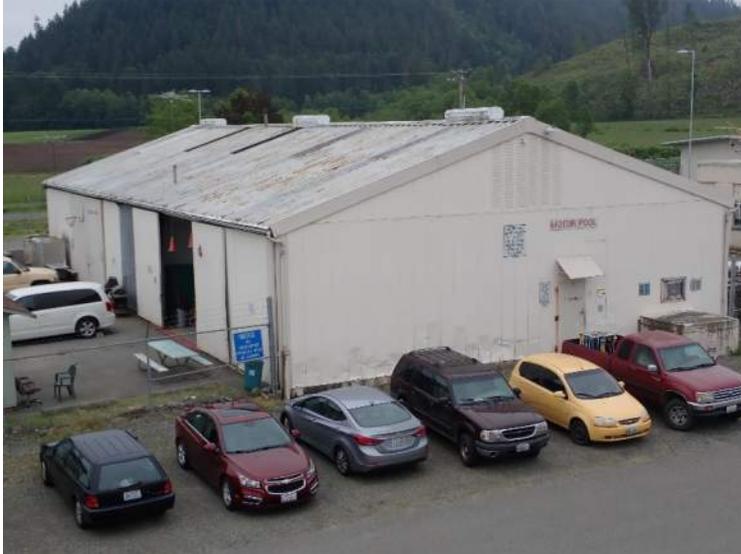
Photo No. 17 - Motor Pool Building

The Motor Pool, similar to the original roof system of the recently reroofed P-43 Maintenance Building, consists of sheet metal panel roofing system. Water intrusion leaks have been reported and should be addressed as budget allows for the campus.

Photo from the P-43 Building looking east towards the Motor Pool Building.

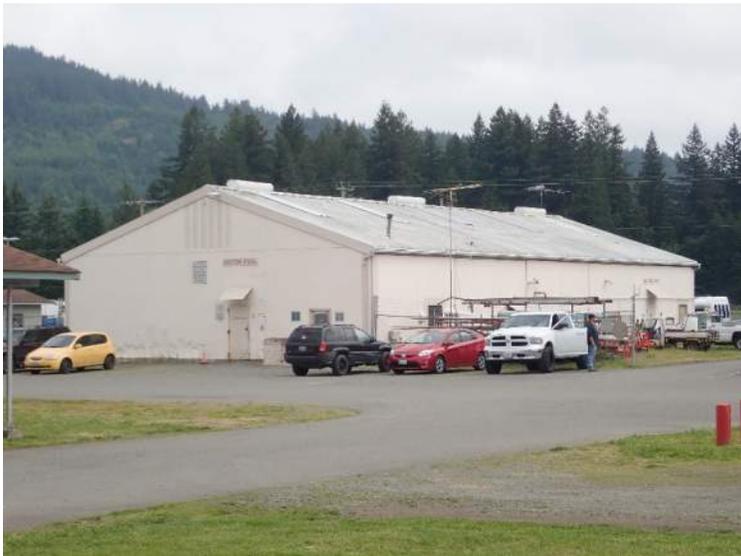
Photo No. 18 - Motor Pool Building

View showing the west and south elevations to the Motor Pool Building.
