LEAK INVESTIGATION REPORT

**Tacoma Rhodes Center
Broadway Building – West Elevation Wall
Tacoma, Washington**

*Job No. 0807-10B
June 24, 2009*

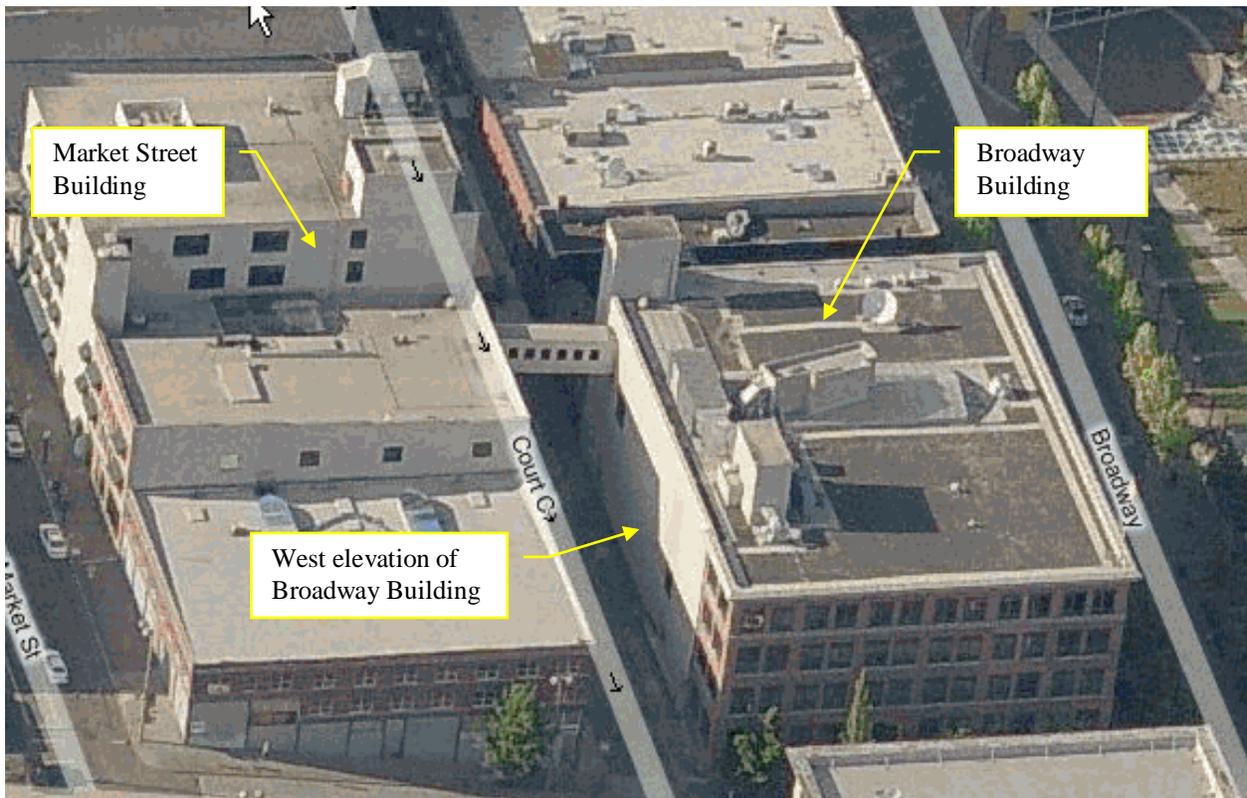
Photograph # 1. Overview of the Tacoma Rhodes Center from the south.

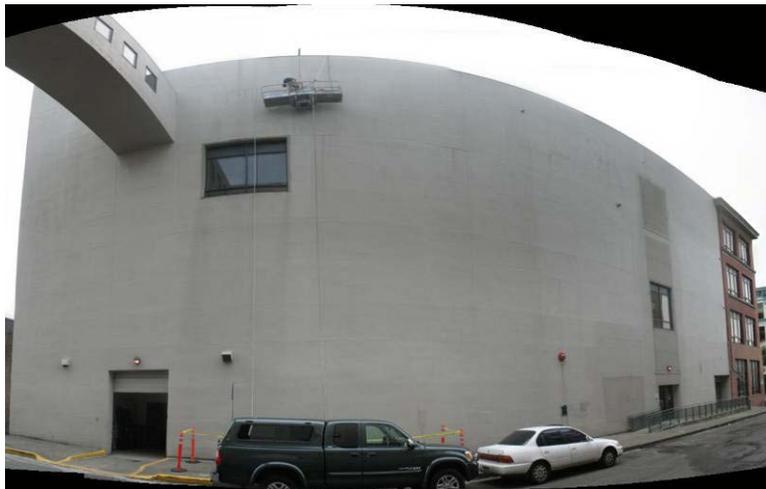
Photograph # 2.

Panorama overview of the Broadway Building west elevation from across the Court C alley.

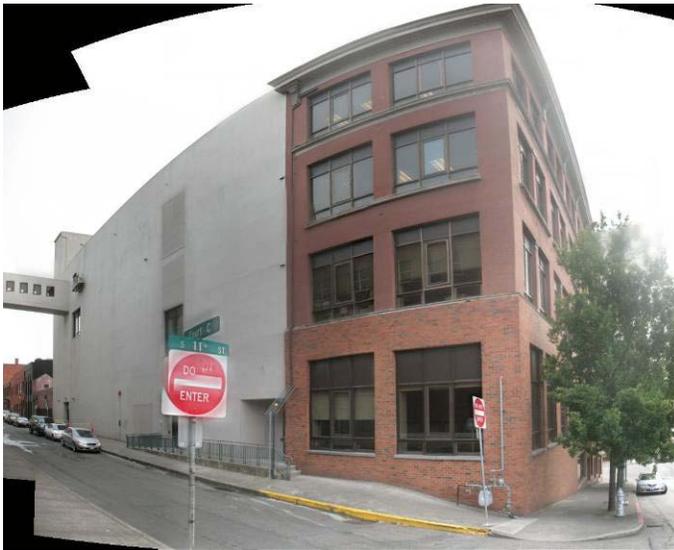
Photograph # 3.

Panorama overview of the Broadway Building west elevation from across the intersection of Court C and South 11th Street. The southwest corner of the building is visible.

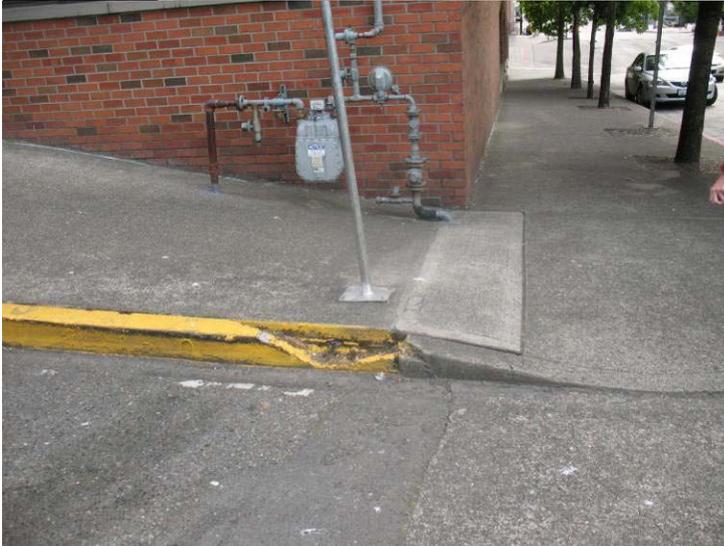
Photograph # 4.

Context view of the Court C sidewalk adjacent to the southwest corner of the building.

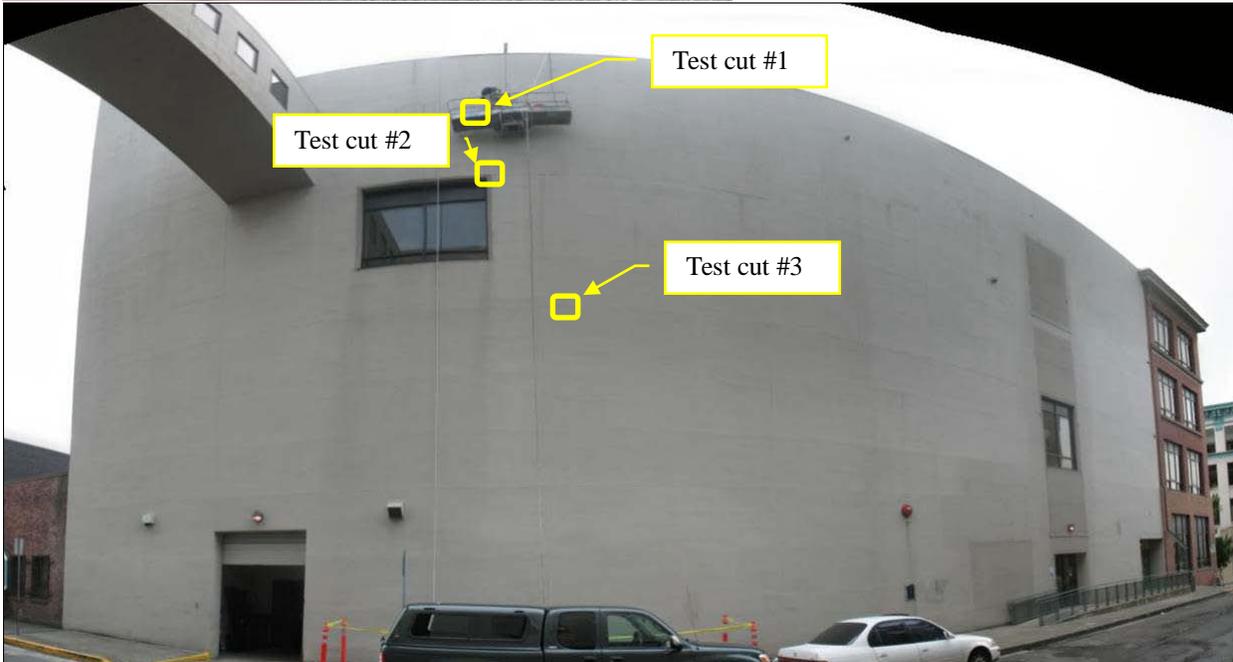
Cracks, holes, damage, and unsealed joints in the stucco cladding were observed sporadically across the entire west elevation area. It appears that items that were previously mounted to the wall with penetrating fasteners were removed and the holes were not repaired. Cracks and other conditions associated with long-term weathering were observed that are allowing water penetration behind the stucco.

Photograph # 10. Overview of test cut locations in the stucco cladding.

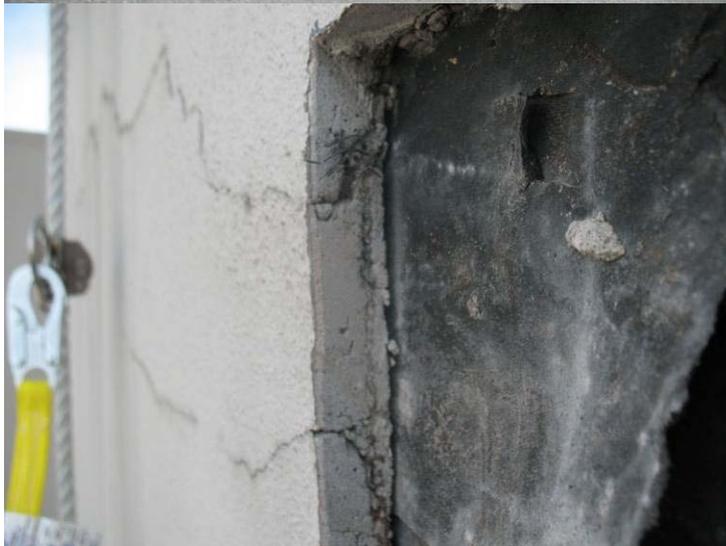
Photograph # 13.

Close-up of cross sectional view of the stucco cladding adjacent to Test Cut #1.

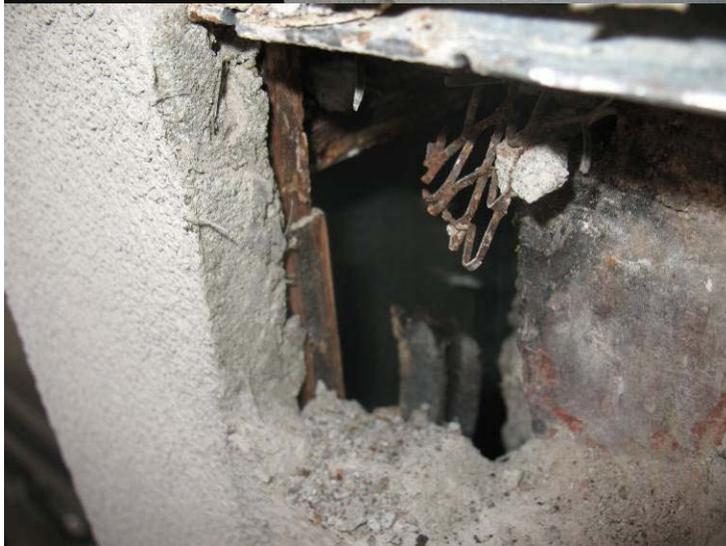
Photograph # 16.

Test Cut #2 was located at the juncture of the window jamb/head juncture. Original structural brick and more recently installed framing in the rough opening were observed. Plans for the 2001 remodel indicate this window was framed and installed at that time. The joint between existing and 2001 stucco does not appear to be well sealed.

Close-up looking into open framing at window jamb behind Test Cut #2.

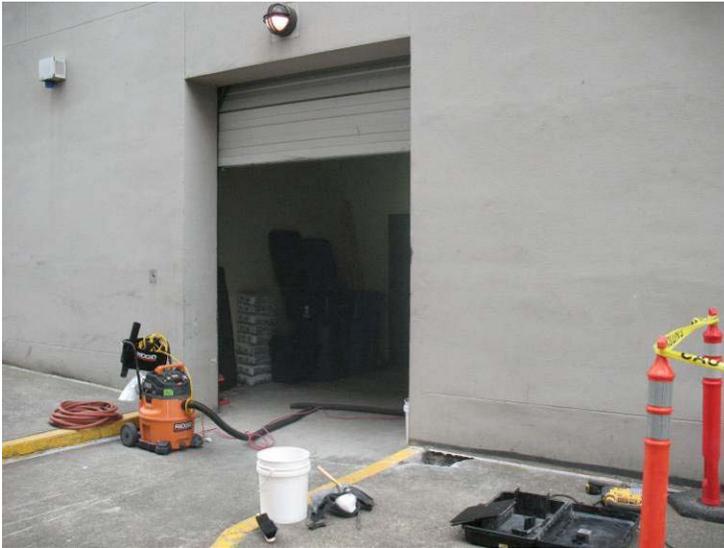
Photograph # 23.

It appears that no protection course was installed over the waterproofing. Steel mesh visible in the test cut appears to have been laid on the waterproofing prior to placement of concrete and damage to the waterproofing at the juncture with the stucco cladding appears probable.

A water test was done at the location of the sidewalk test cut. Water colored with flourescein dye was poured into the test cut. Leakage to the interior was confirmed at a location roughly below this point within ~½-hour.

Since the waterproofing was applied to the outside of the stucco cladding, water migrating within or behind the stucco cladding is forced to the interior of the building just above the location of the noted leaks. It was also confirmed that water penetrates the tie-in between the waterproofing and stucco cladding at the location of the sidewalk test cut. Water penetrating the joint between sidewalk and wall and penetrating joints in the concrete sidewalk, is likely to contribute to leakage.

Context view of the Loading Dock and location of the test cut in the concrete sidewalk.

Proper integration of waterproofing and wall cladding would normally include the following: A direct tie-in between the waterproofing and the WRB behind the wall cladding should be created. The wall cladding should terminate above the concrete topping slab. A provision for drainage of migrating water behind the cladding should be created. A protection layer between the waterproofing and the concrete topping slab is strongly recommended in order to prevent damage to the waterproofing and provide a slippage plane.

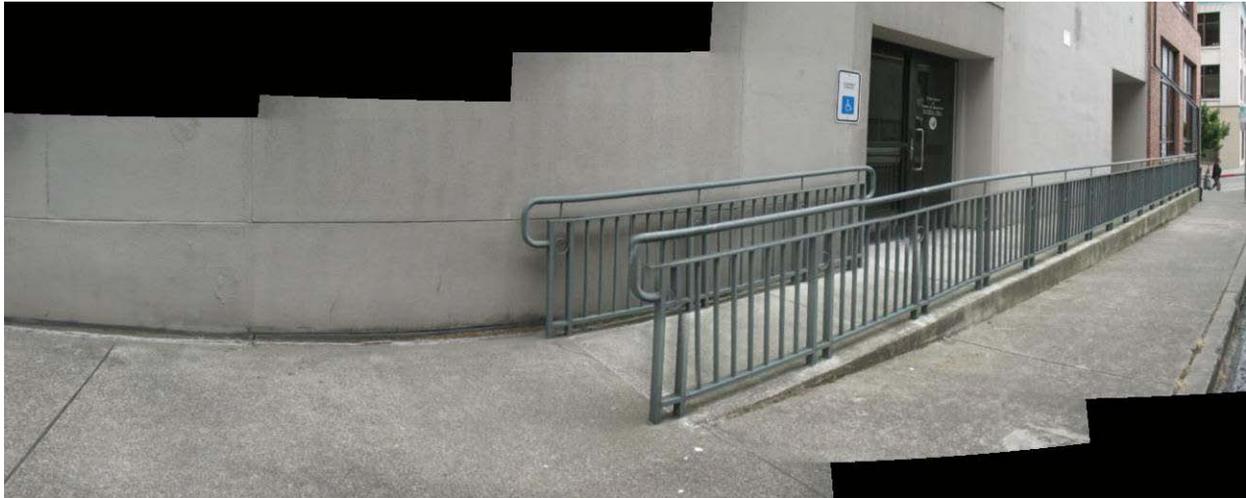
Photograph # 32. During the 2001 renovation, a new ADA accessible concrete ramp was constructed over the concrete sidewalk.

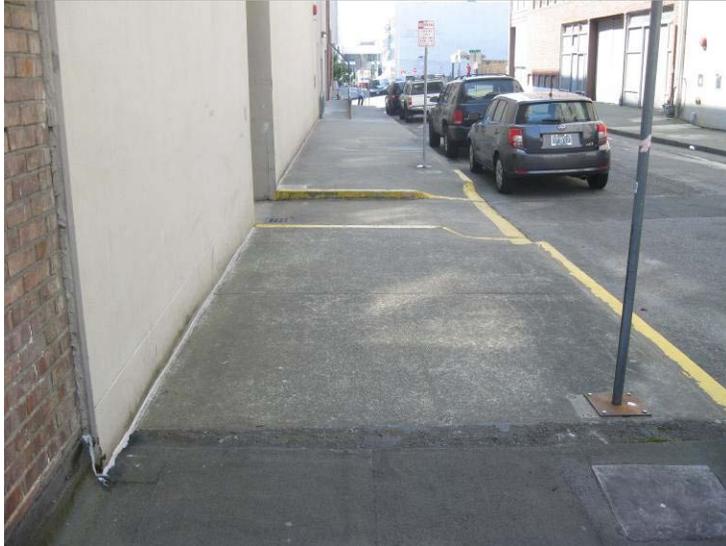
Photograph # 41.

Looking south along sidewalk and west wall.
