West Capitol Campus

Historic Landscape Preservation Master Plan

June 2009 | GA project # 08-099

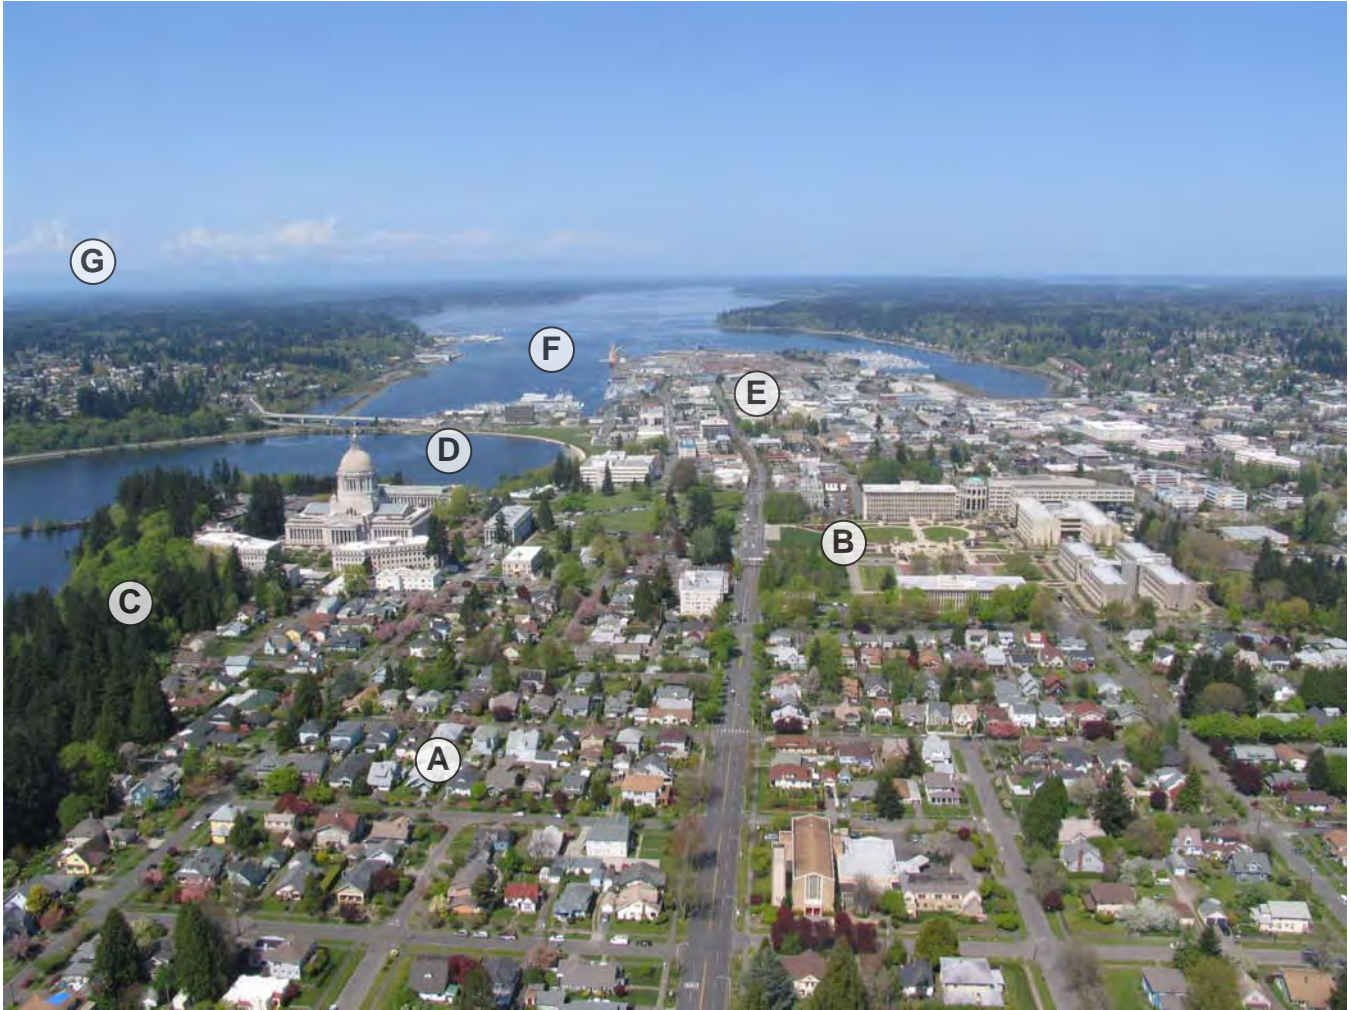
Fig. 3.6 Aerial View looking north showing the Capitol and many of the essential components of the surrounding context: A) The South Capitol Neighborhood (National Register Historic District), B) the East Campus, C) the Native Forest edge, D) Capitol Lake, E) Olympia, F) Budd Inlet, G) the Olympic Mountains (2006, Photo Source: Washington State Department of Transportation)

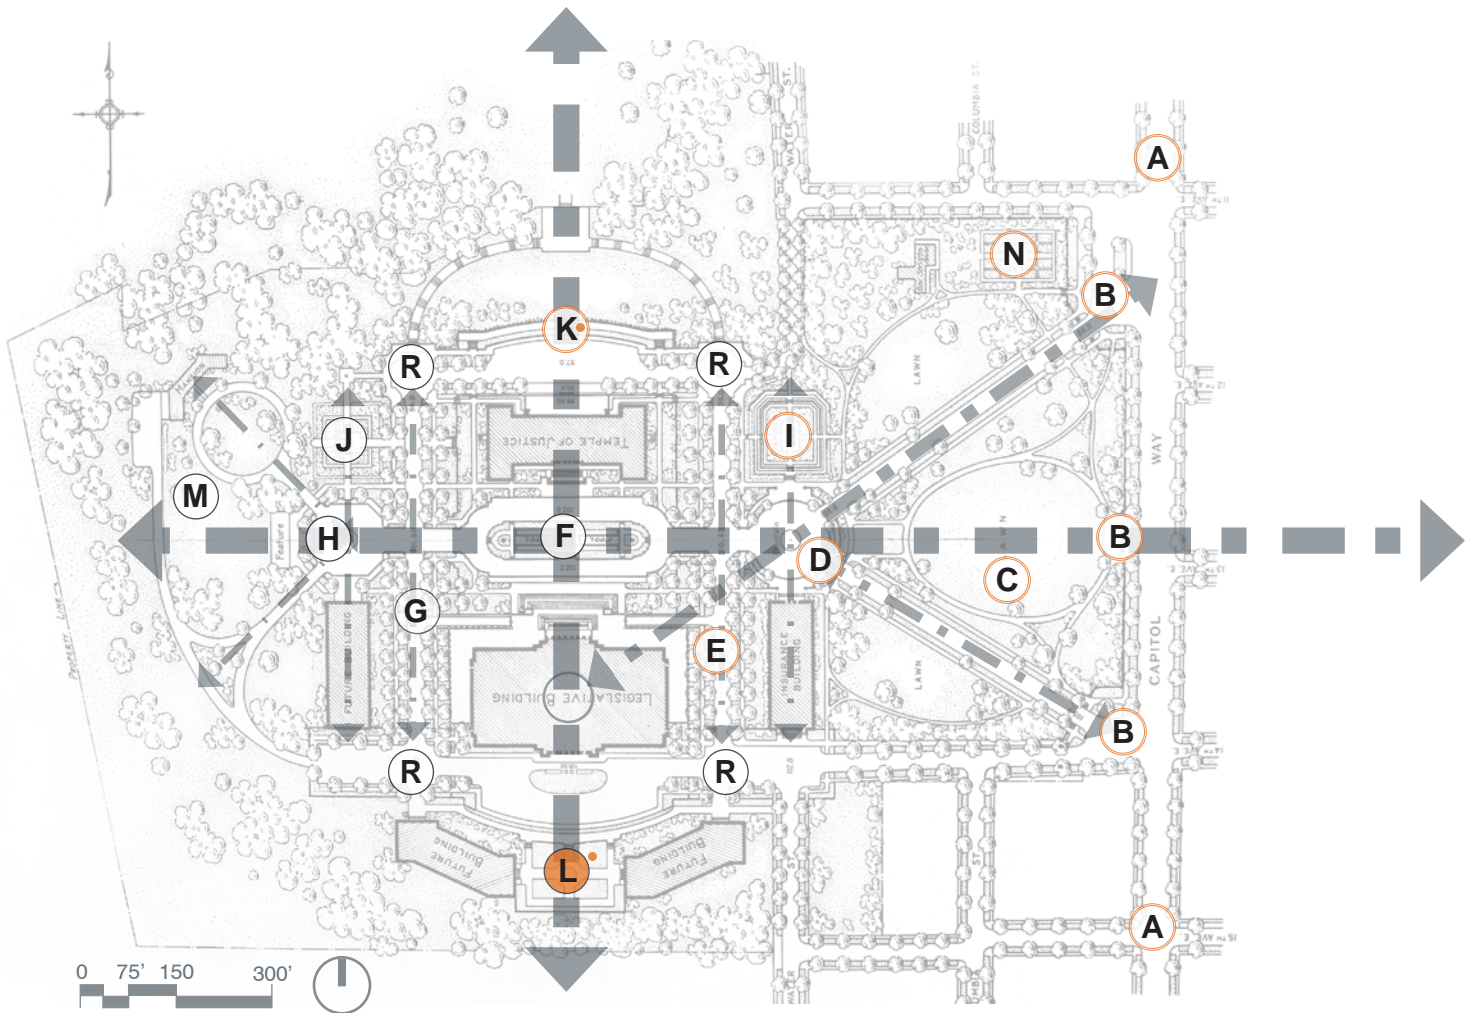
Fig. 5.6a Features depicted by the 1928 Olmsted Brothers General Plan

Key: letters correspond with the Health and Integrity Matrix on previous page foldouts

Note: Features preceded by a lettered indication correspond with the "Features" maps, past and present, Figs. 5.6a and 5.6b.

Notes: * Features preceded by a lettered indication correspond with the "Features" maps, past and present, Figs. 5.6a and 5.6b.
 * See KEY on previous foldout, Fig. 5.5a.

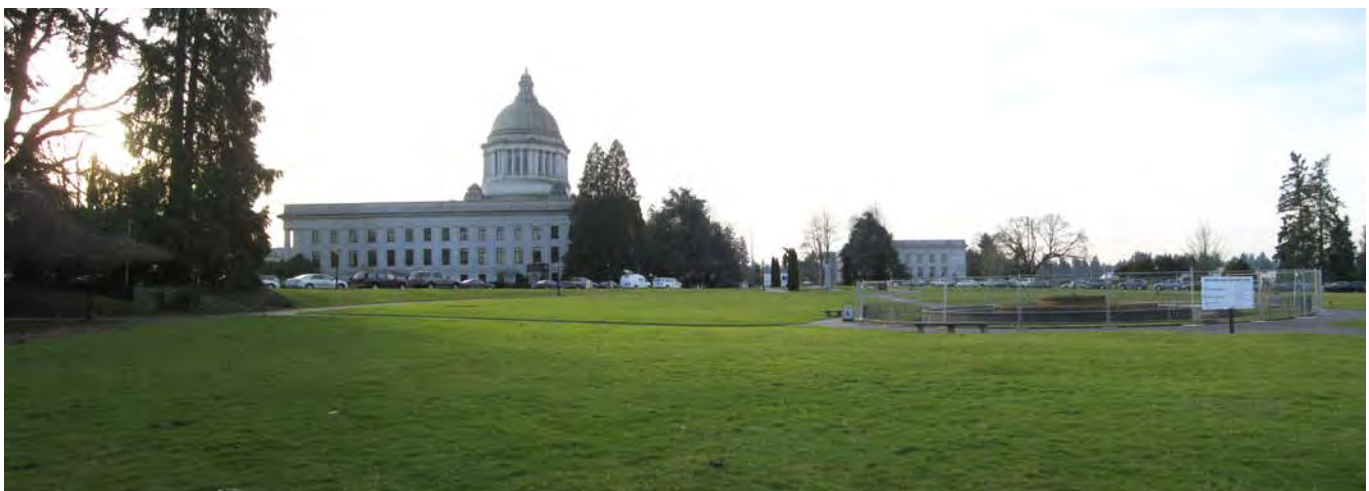
Fig. 5.8 View of existing greensward: Expansive lawn exists in lieu of the majority of the intended trees and shrubs that would serve to provide a foreground for the Capitol Group and a more human scale. (Feb. 2009, Source: Mithun)

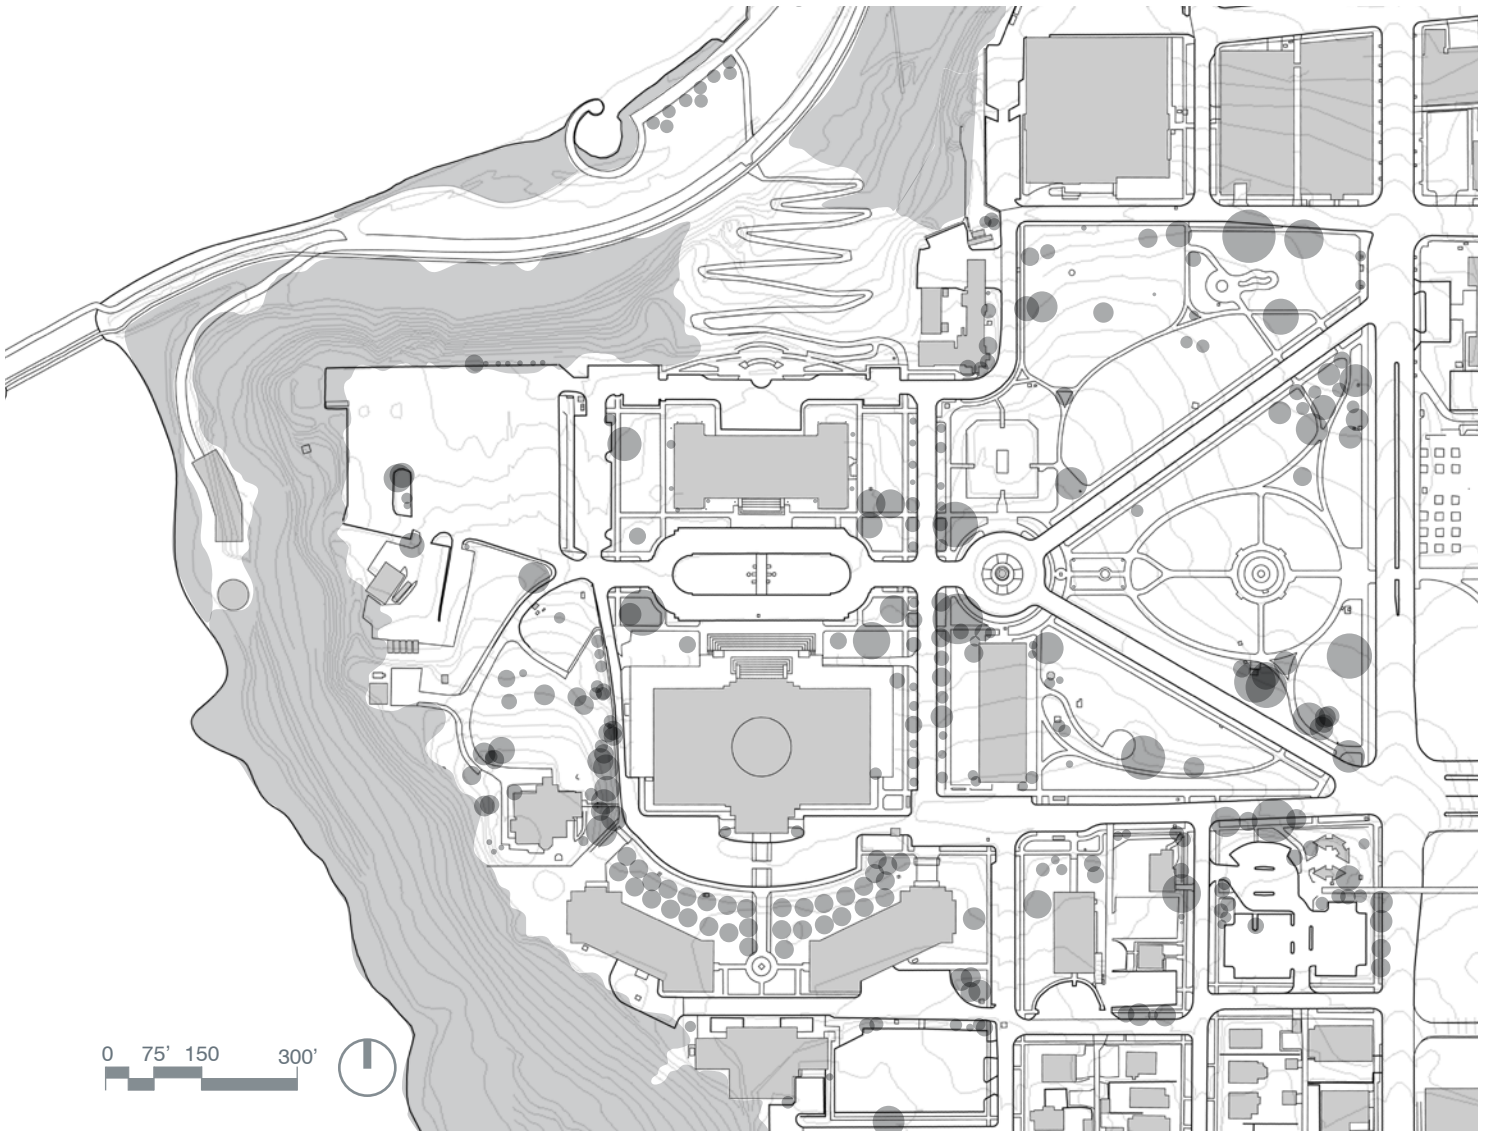
Fig. 5.9b Existing Campus Base Plan overlain with existing trees.

A comparison of the spatial composition depicted by the Olmsted Brothers' 1928-1929 plans for the State Capitol with the spatial composition shown on today's plan reveals key discrepancies (see Fig. 5.9a and 5.9b):

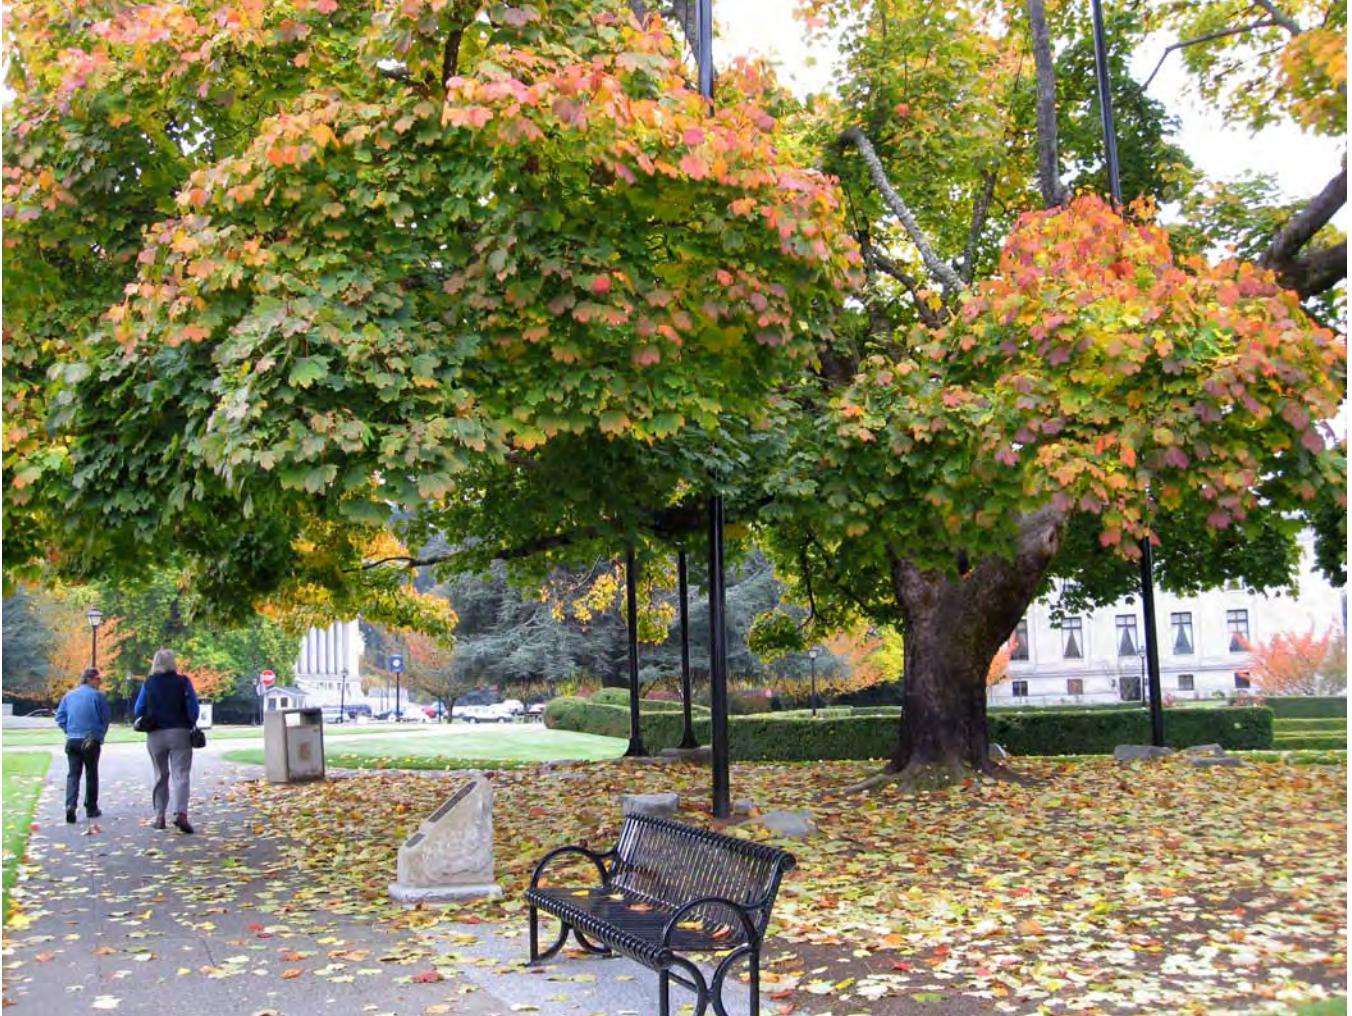
Fig. 5.10 Norway Maple near Winged Victory Circle. A significant percentage of the existing trees on Campus are post-mature and in decline. Declining trees require more care and maintenance to manage risk, as illustrated by this system of structural reinforcement. (Oct. 2008, Source: Mithun)

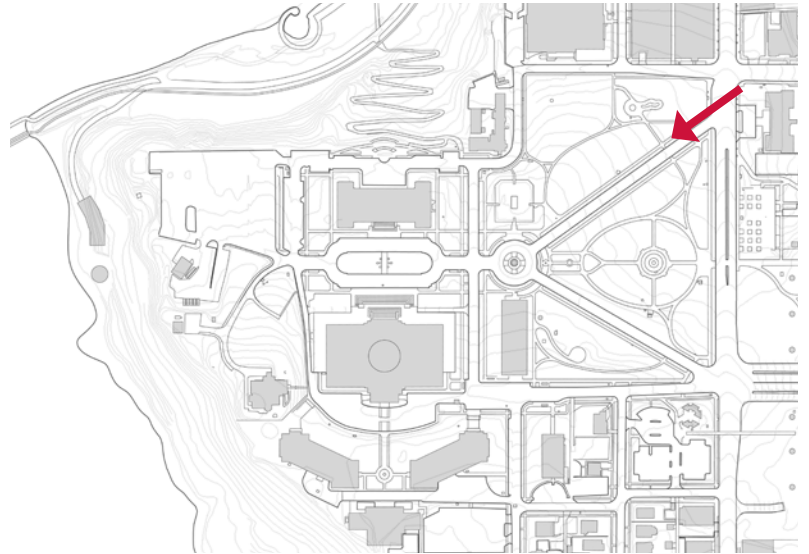
Fig. 5.11 Key map of view location along North Diagonal

This study compares the existing view along the North Diagonal near the entrance to the Campus with two different future scenarios: 1) absence of ongoing tree monitoring and tree care (inaction), or, alternatively, 2) implementation of preservation recommendations toward reinforcing the historic design of the Campus. In Scenario 1, the existing view was modified according to likely near-term tree loss based upon the 2008-09 tree condition survey (Fig. 10.____ and Table of Trees). In Scenario 2, the existing view was modified according to the Landscape Preservation Master Plan and VMP recommendations. It assumes that some degree of tree attrition is natural, but that regeneration planting occurs simultaneously with consistent preventive care.

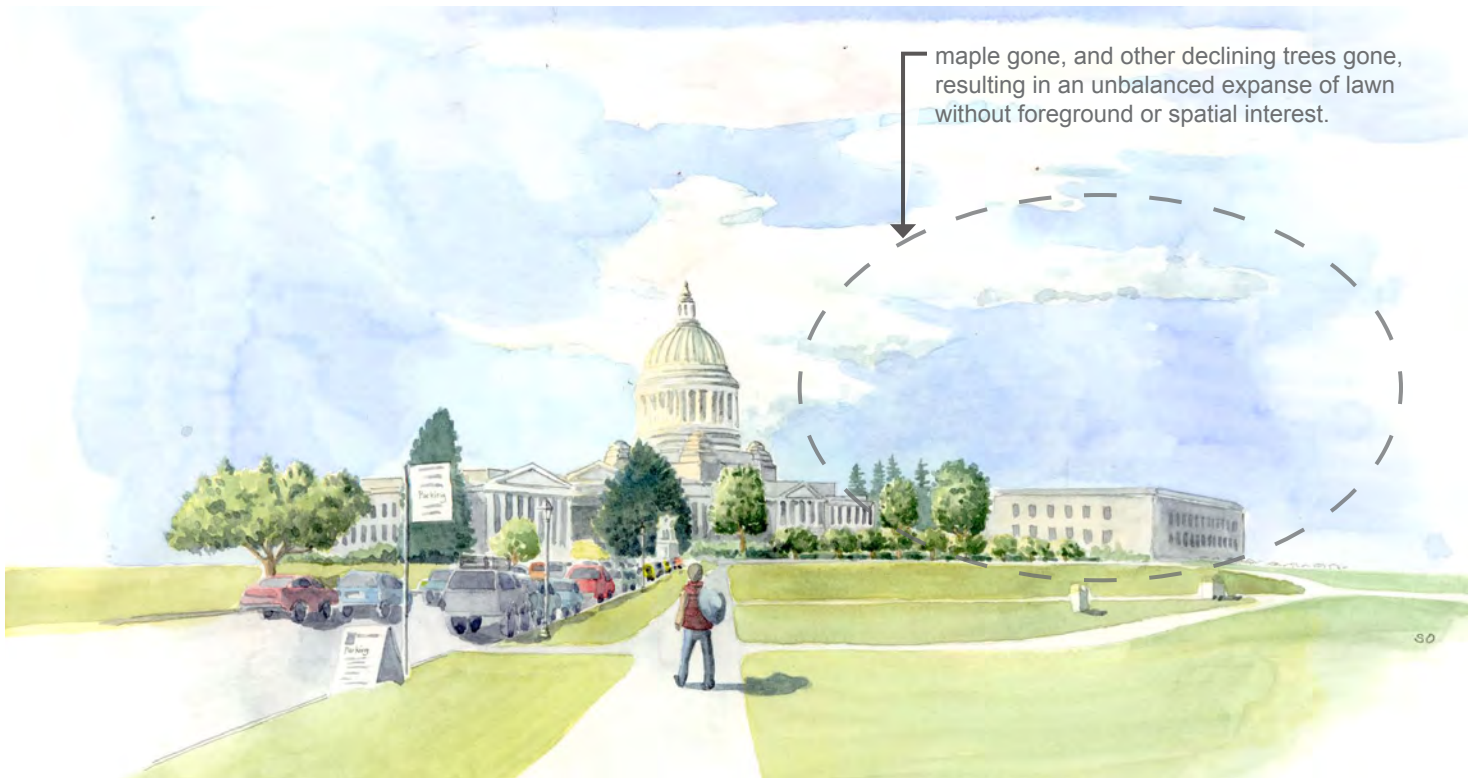
Fig. 5.12 Scenario 1: North Diagonal approach to the Capitol in the near future in the absence of ongoing tree monitoring and tree care. (Source: Susan Olmsted)

- Loss of heritage maple
- Greater visual emphasis on vehicular parking, parking signage, and garbage receptacles
- Overly-expansive lawn lacks a sense of scale in relationship to the Capitol Group
- View of Dome lacks foreground and framing

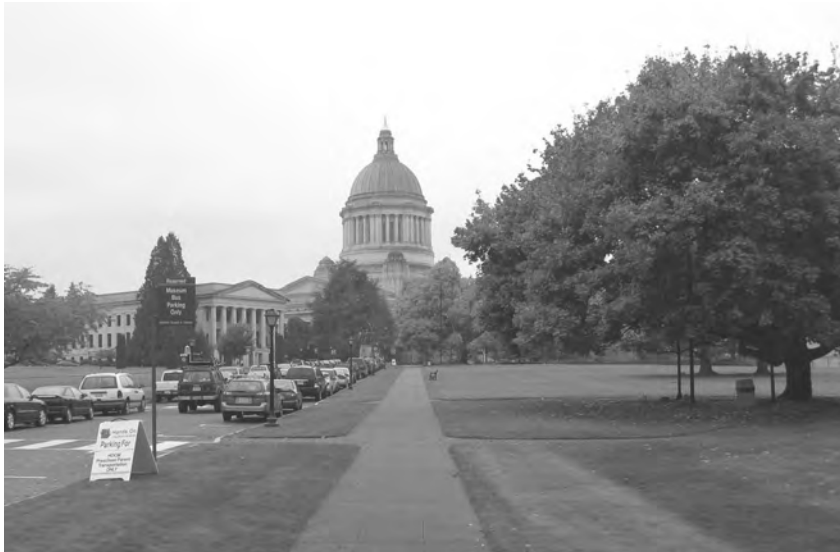
← existing Norway Maple, post-mature and in decline

Fig. 5.13 Existing view of North Diagonal approach to the Capitol (Oct. 2008, Source: Mithun)

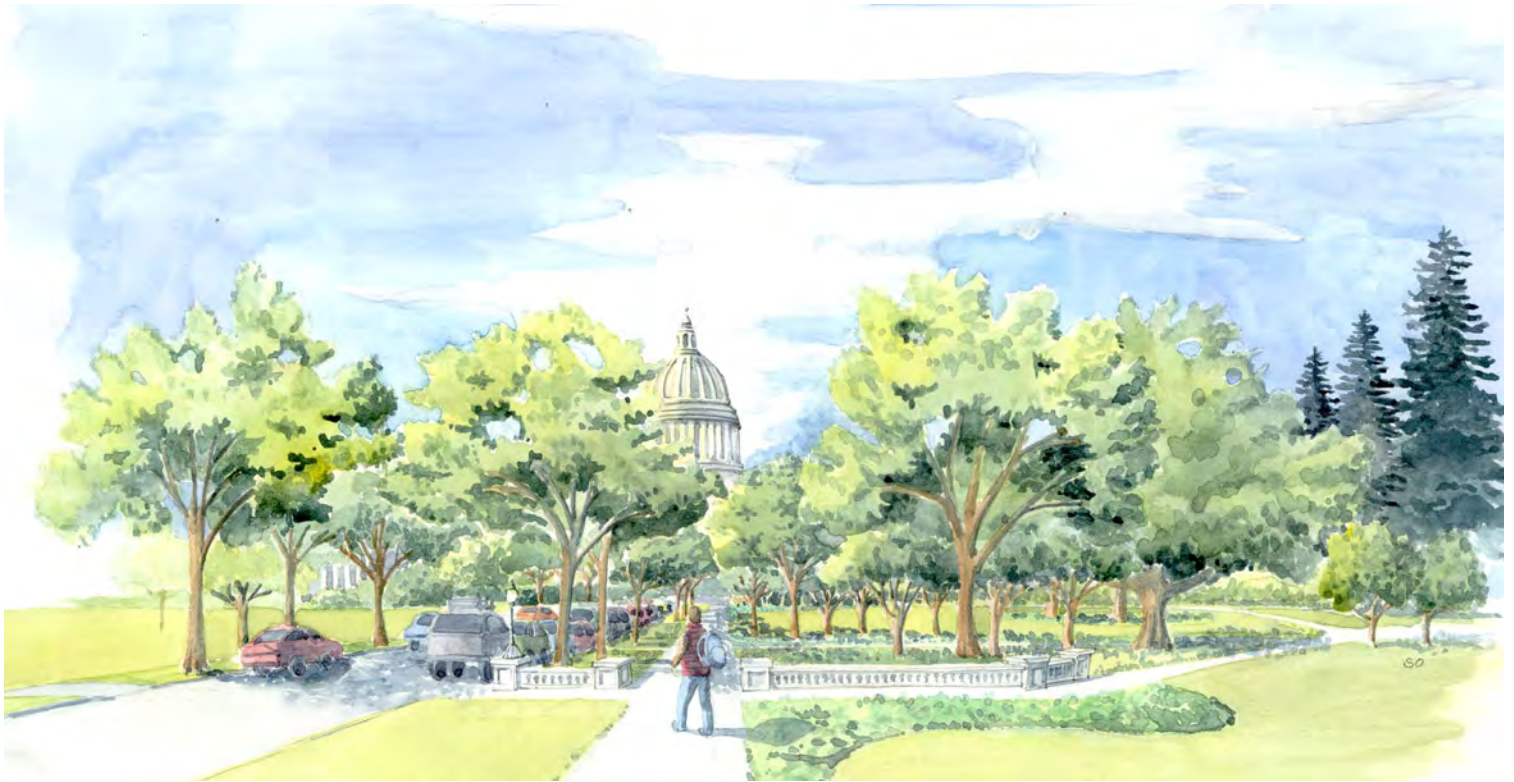
Fig. 5.14 Scenario 2: North Diagonal approach to the Capitol in the future with the implementation of preservation recommendations. (Source: Susan Olmsted)

- Heritage Maple is preserved, and replacement tree is planted
- Street trees lining the North Diagonal provide a sense of scale and foreground while framing views of the Dome.
- Groves of historically intended trees create 'rooms' within the landscape.
- Historically intended gateway with light post.

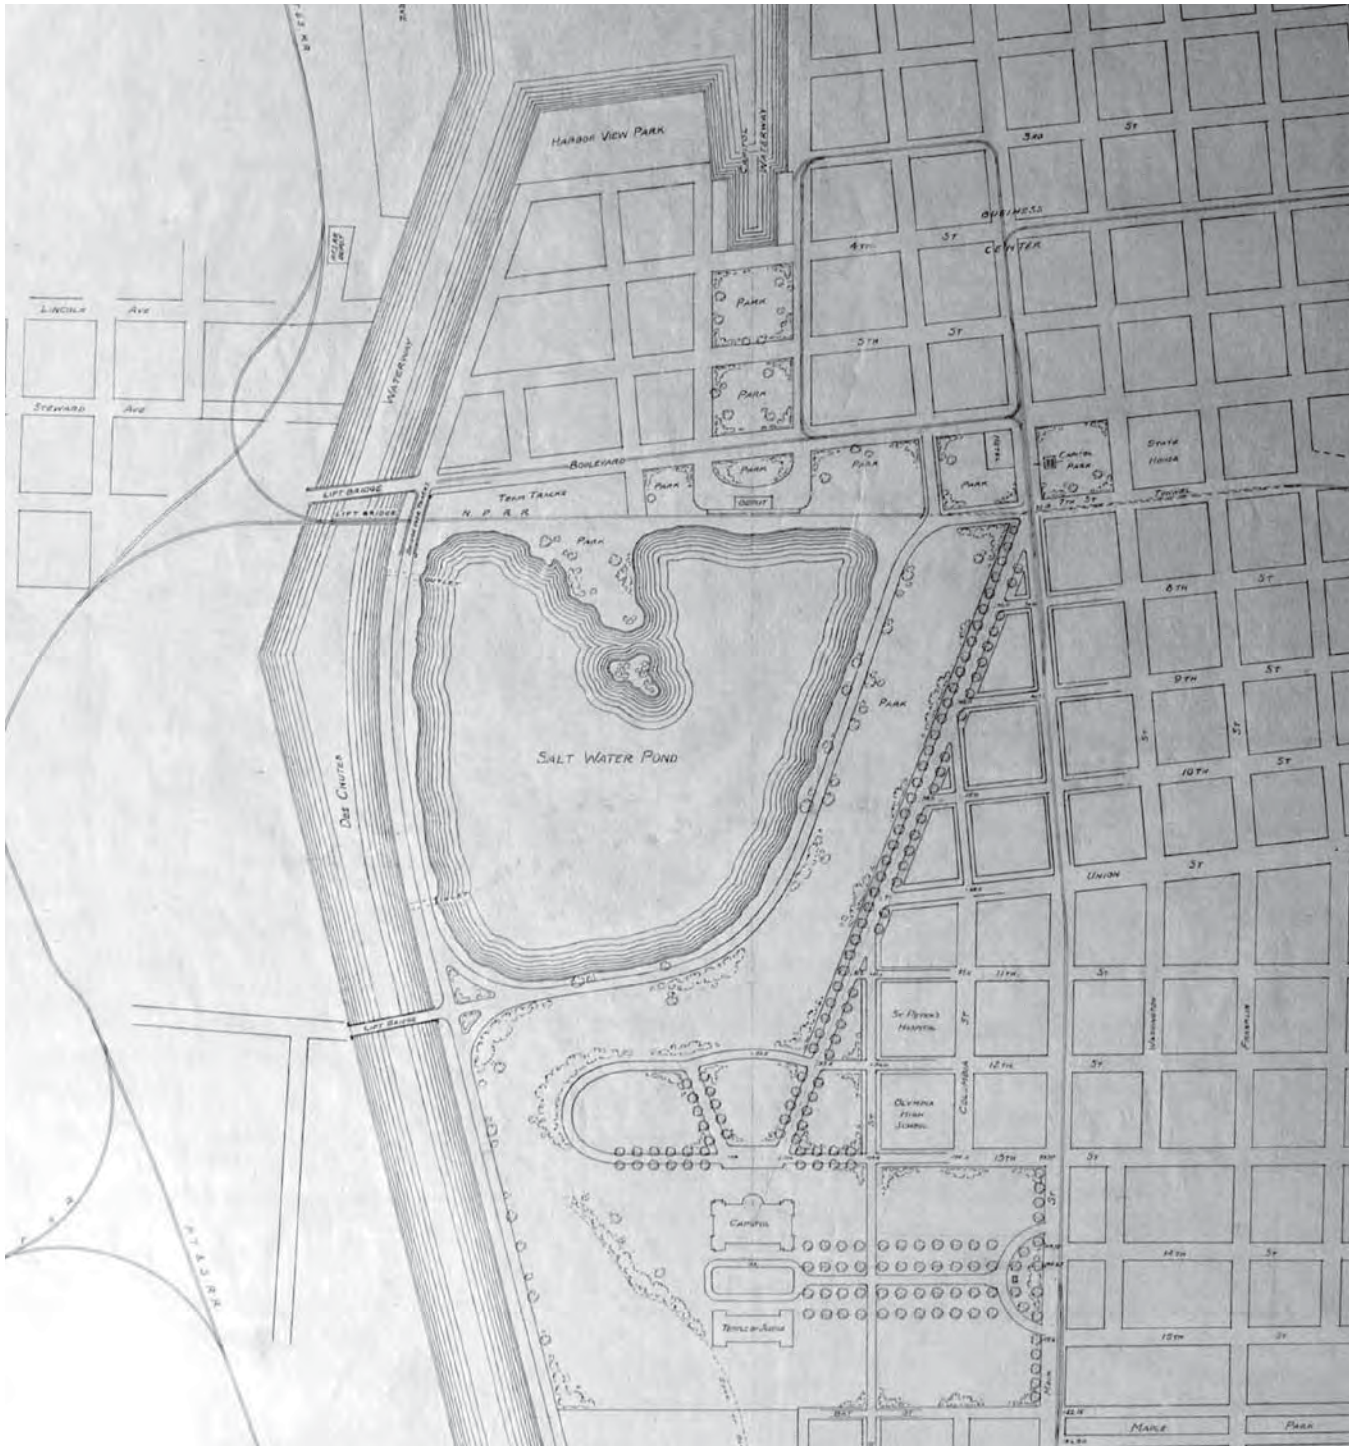
Fig. 5.15 5350-16 Plan for Land and Water Approaches to the Capitol, January 18, 1912, approved by John Charles Olmsted (Source: Frederick Law Olmsted National Historic Site)

The connection between the campus and the community was clearly an important concern, and while the proposed direct diagonal connection to Sylvester Park and downtown Olympia shown in the plan that accompanied their letter to the Governor (5350-16, Fig. 5.15) was disregarded by the Capitol Commission, their suggestion of "a direct, obvious, and attractive approach from Main Street" later became the essential east-west organizational axis through the campus.

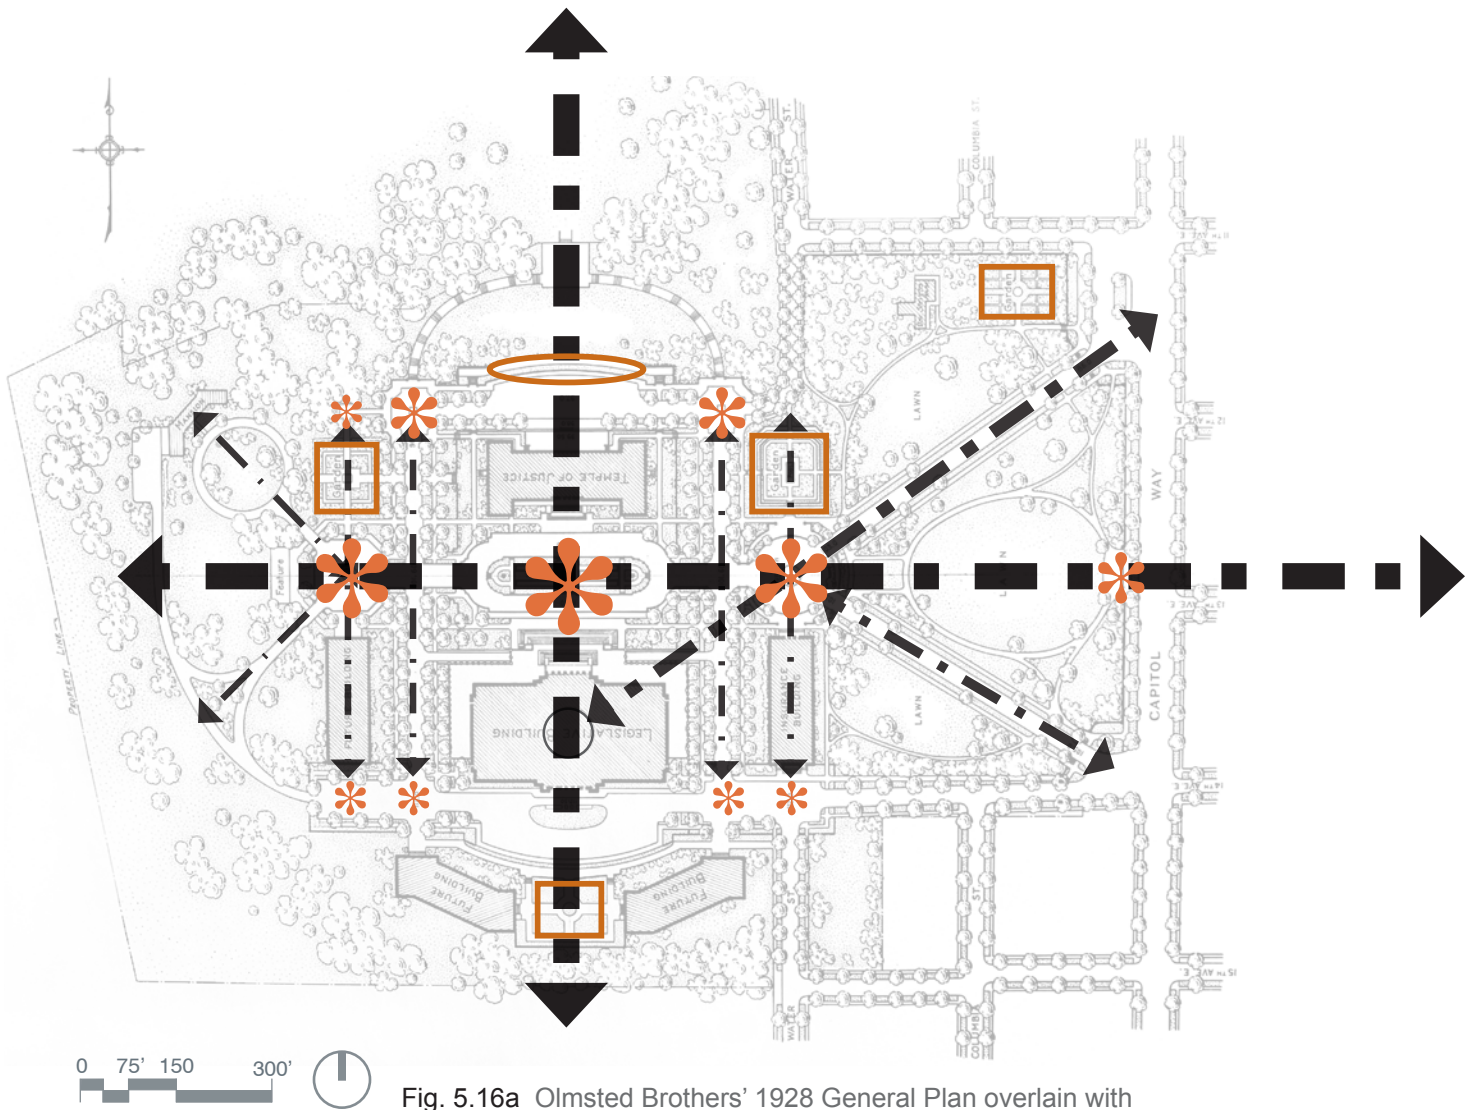
Fig. 5.16a Olmsted Brothers' 1928 General Plan overlain with historically intended axes, nodes, and features

A hierarchy of organizational axes is illustrated by the Olmsted Brothers 1928 General Plan (Fig. 5.16a). The Olmsted Brothers paid careful attention in laying out axes for the campus. In an October 2nd, 1929 letter to Mr. Alonzo Victor Lewis, in discussing the intent of axial relationships and nodes appropriate to accommodate monuments in response to Alonzo's inquiry to adjust the location of the Winged Victory Monument, the Olmsteds wrote:

The West Campus currently lacks the originally intended balance and symmetry shown within the historic plans. The majority of the intended organizational axes are legible within the landscape today, though due to vegetation attrition and budgetary limitations, many aspects of the campus that were intended to reinforce these axes are weak or missing. Consequently, the potential power of the axes in structuring the campus is diminished. A comparison between intended and existing axes, organization, and structure (Fig. 5.16a and 5.16b) reveals key discrepancies:

- The "Feature" indicated west of the central plaza that was intended to balance the Winged Victory Monument east of the central plaza is missing.
- The Campus organizational structure has been weakened over time by the *addition* of significant interventions, such as the Vietnam Veterans Memorial and the Tivoli Fountain, that have departed from the historic design. The WWII Monument occupies the location of what was depicted in the Olmsted Brothers' plans as a formal garden, and arguably reinforces the general Campus structure, though not association, feeling, or design. These monuments and memorials are now important and significant places in their own right, and as such, should be preserved.

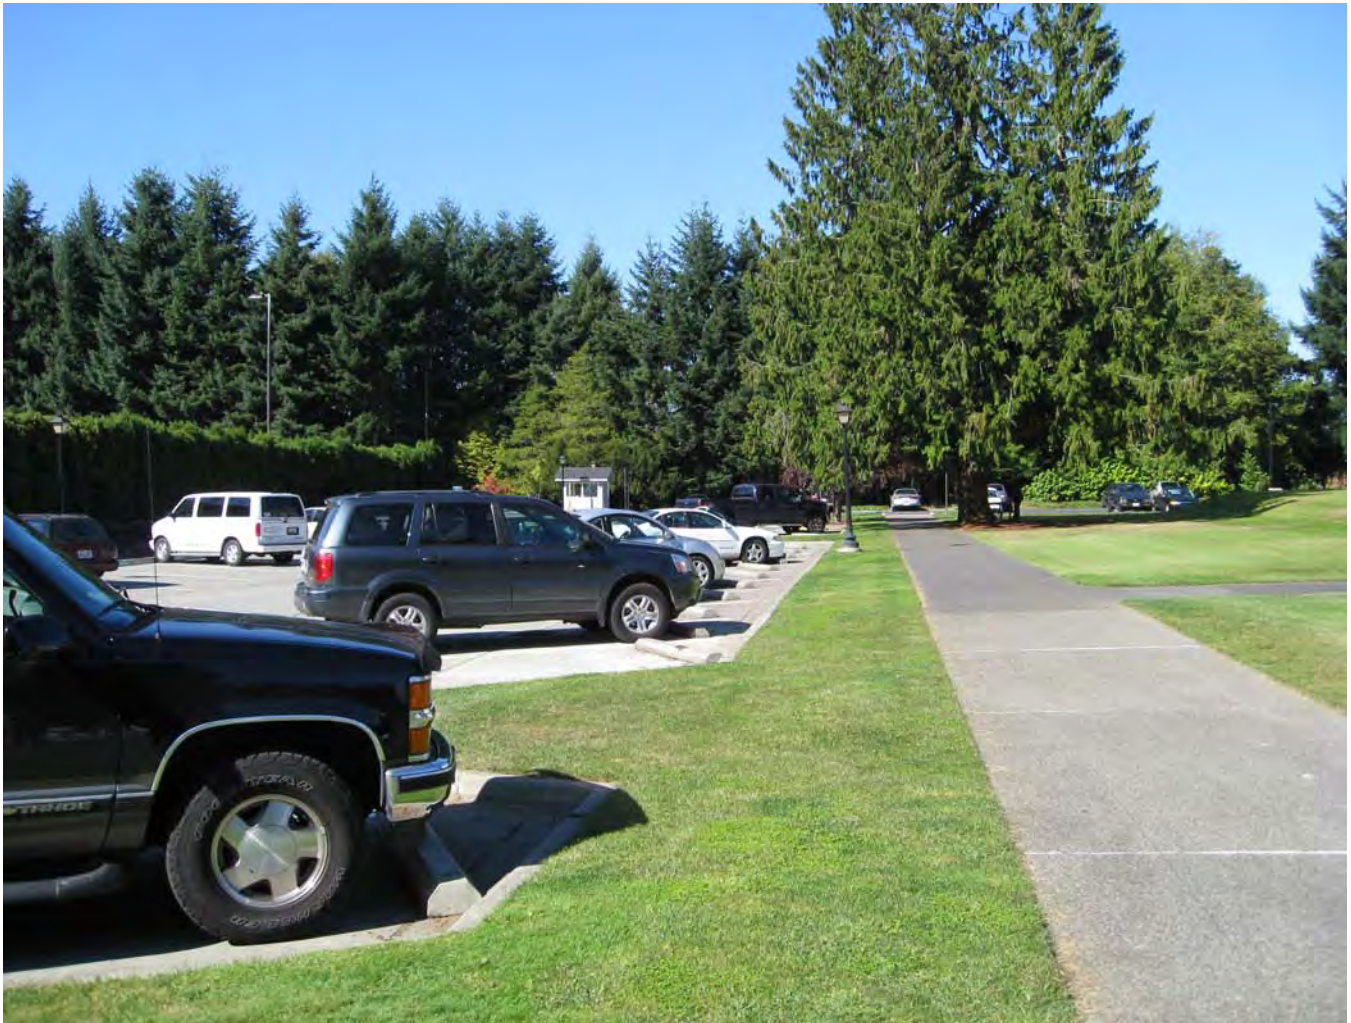
Fig. 5.17 Pleasant Lane view looking north toward terminus occupied by parking (Sept. 2008, Source: Mithun)

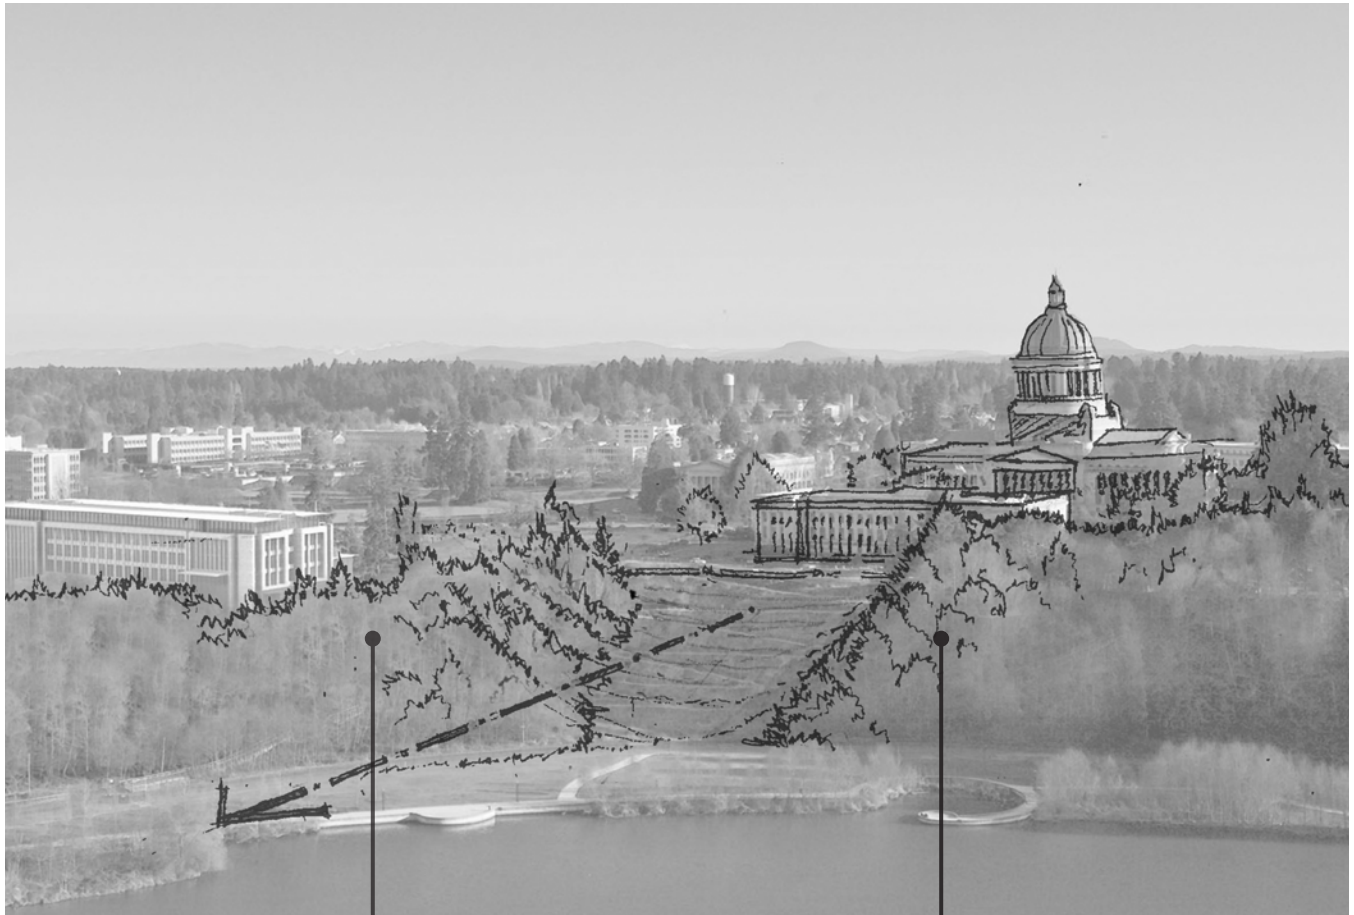
Fig. 5.20 Axis Study: Importance of native vegetation in reinforcing the major north/south axis and intended hierarchy of focus

Restored native vegetation helps to frame view of Legislative Building along the north/south axis and minimize the visual competition of the future HCEOB development.

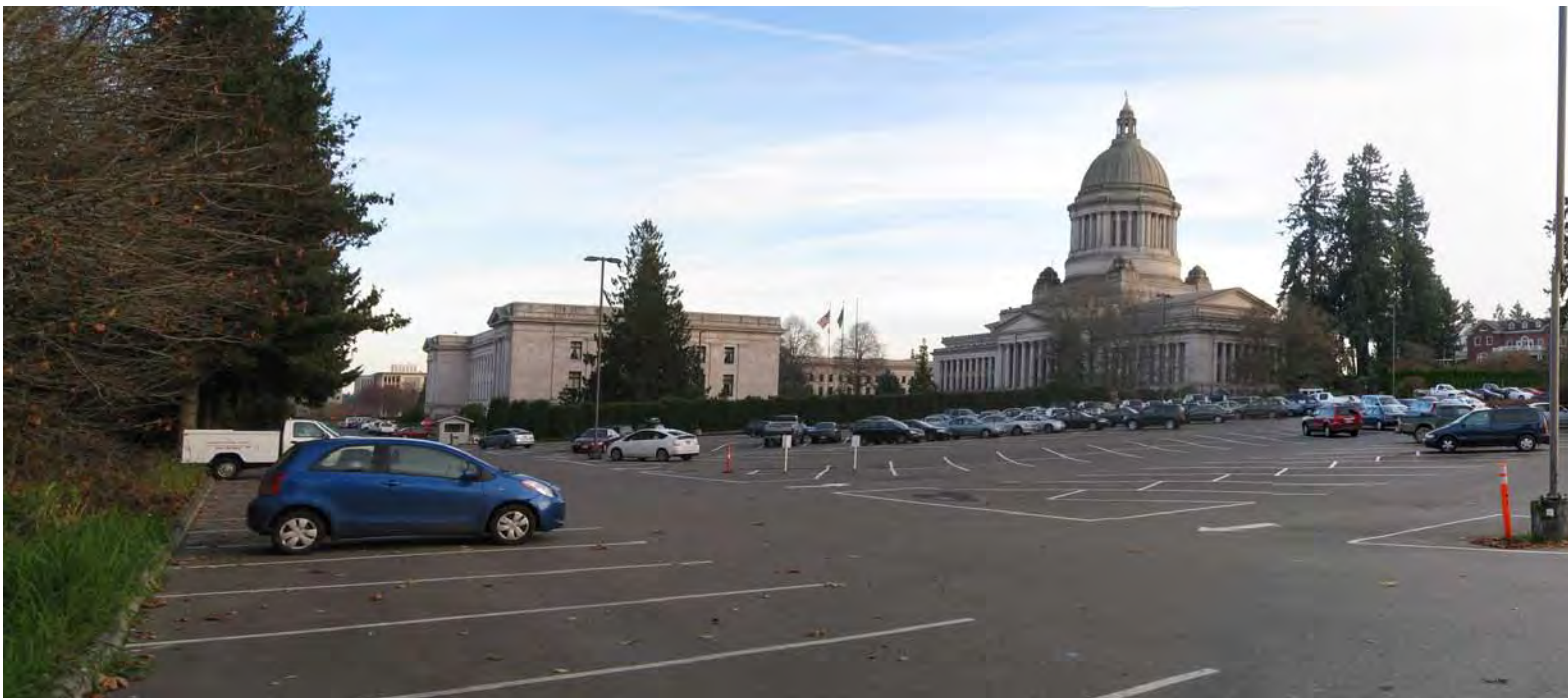
Fig. 5.21 View of parking area at west end, close to where garden was historically intended (Nov. 2008, Source: Mithun)

view of parking area where, historically, a garden was intended (Fig 5.21)

- Also within the Campus, the under-realized west end of the campus creates an imbalance of views between the east and west, looking to-and-from the central core of the Capitol Group.
- This imbalance is acutely noticeable in the disparity between what was supposed to be flanking gardens east and west of the Temple of Justice: the elegant view of the Capitol from the existing Sunken Garden northeast of the Capitol Group and the disparaging view of the Capitol from the existing parking lot northwest of the Capitol Group. (Figs. 5.21, 5.22, 5.23)

- The eventual transformation of this portion of the Campus could include a series of formal and informal gardens, monuments, memorials, pathways, open spaces, and viewpoints linked together by an organizational structure that reinforces the organization of the West Campus, as a whole. (See Fig. 6.15; see also Figs. 5.21, 5.22, 5.23.)

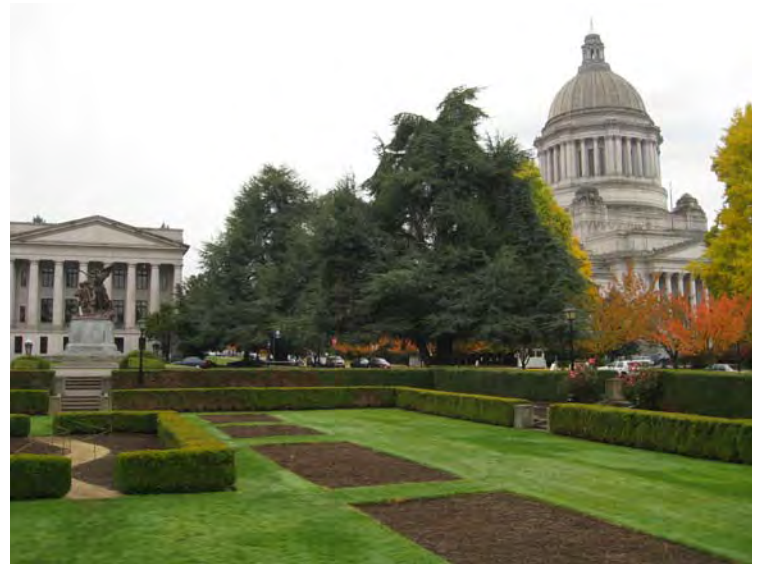
view of existing sunken garden (Fig 5.23)

Fig. 5.23 View of Existing Sunken Garden (Nov. 2008, Source: Mithun)

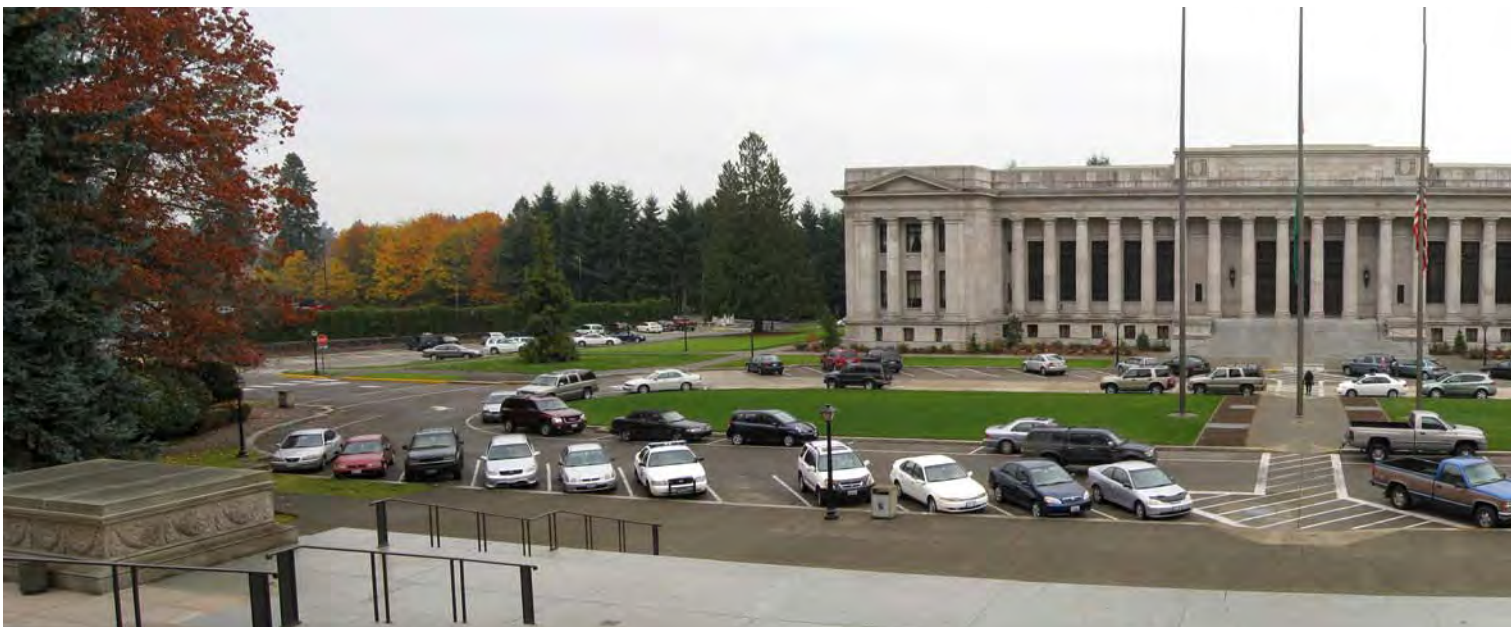
Fig. 5.24 View of Flag Circle, dominated by vehicles (Oct. 2008, Source: Mithun)

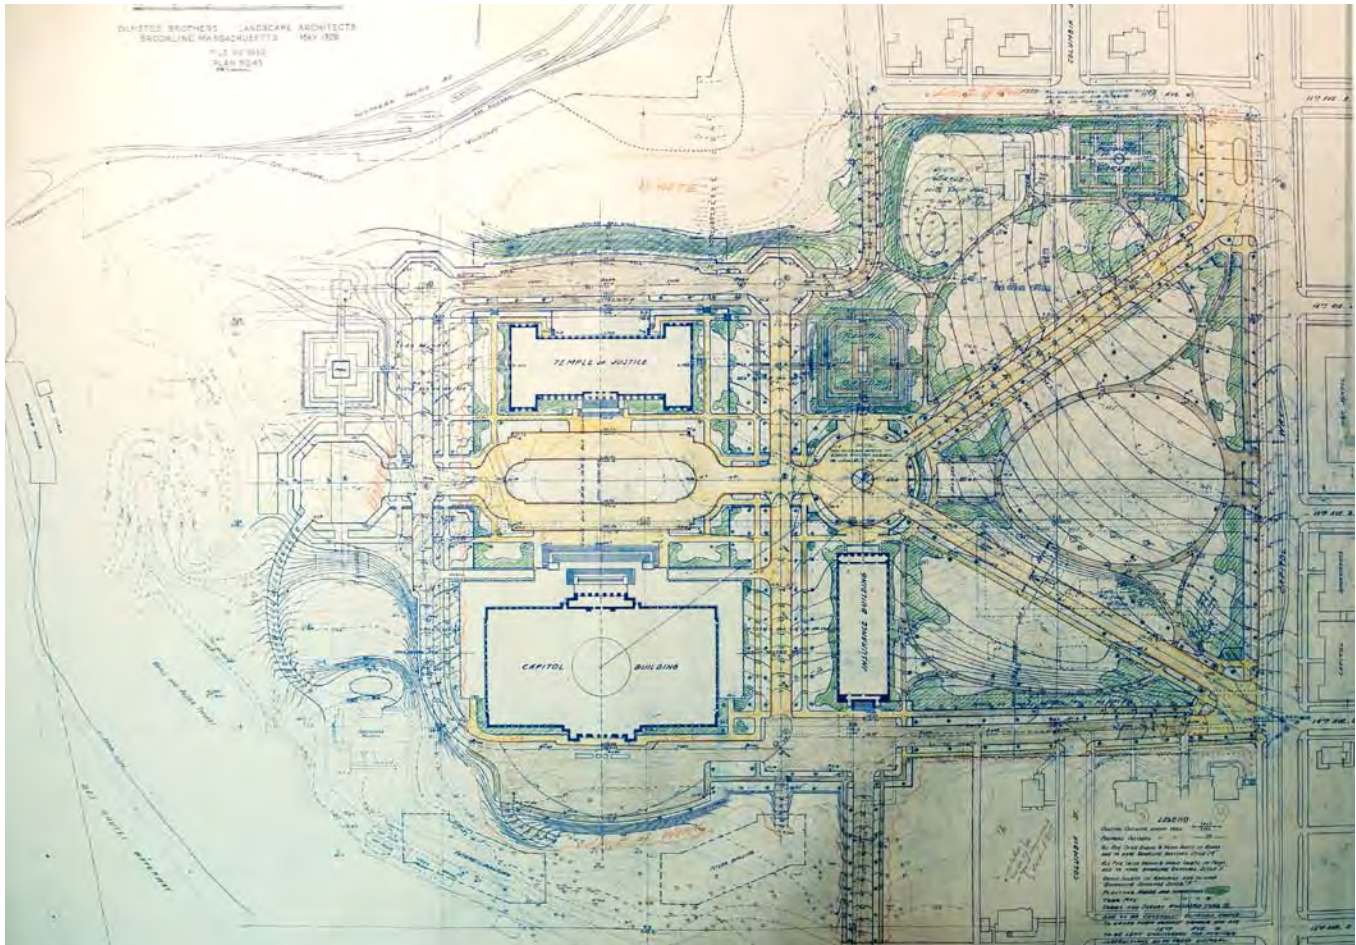
Fig. 5.25 5350_43_pt1 Grading Plan, Olmsted Brothers, 1928 (Source: Frederick Law Olmsted National Historic Site, National Park Service)

Though the Olmsteds envisioned greater topographic variety throughout the Campus during their initial grading design, the tumultuous construction phase resulted in greater topographic homogeneity.

The West Campus has historically been plagued by drainage problems resulting from a combination of clay soils, hydrologic flow, topography, and climate. The historic correspondence describes drainage problems in the past, and measures were taken to improve drainage around tree pits during the early installation phases.
