West Capitol Campus

Historic Landscape Preservation Master Plan

June 2009 | GA project # 08-099

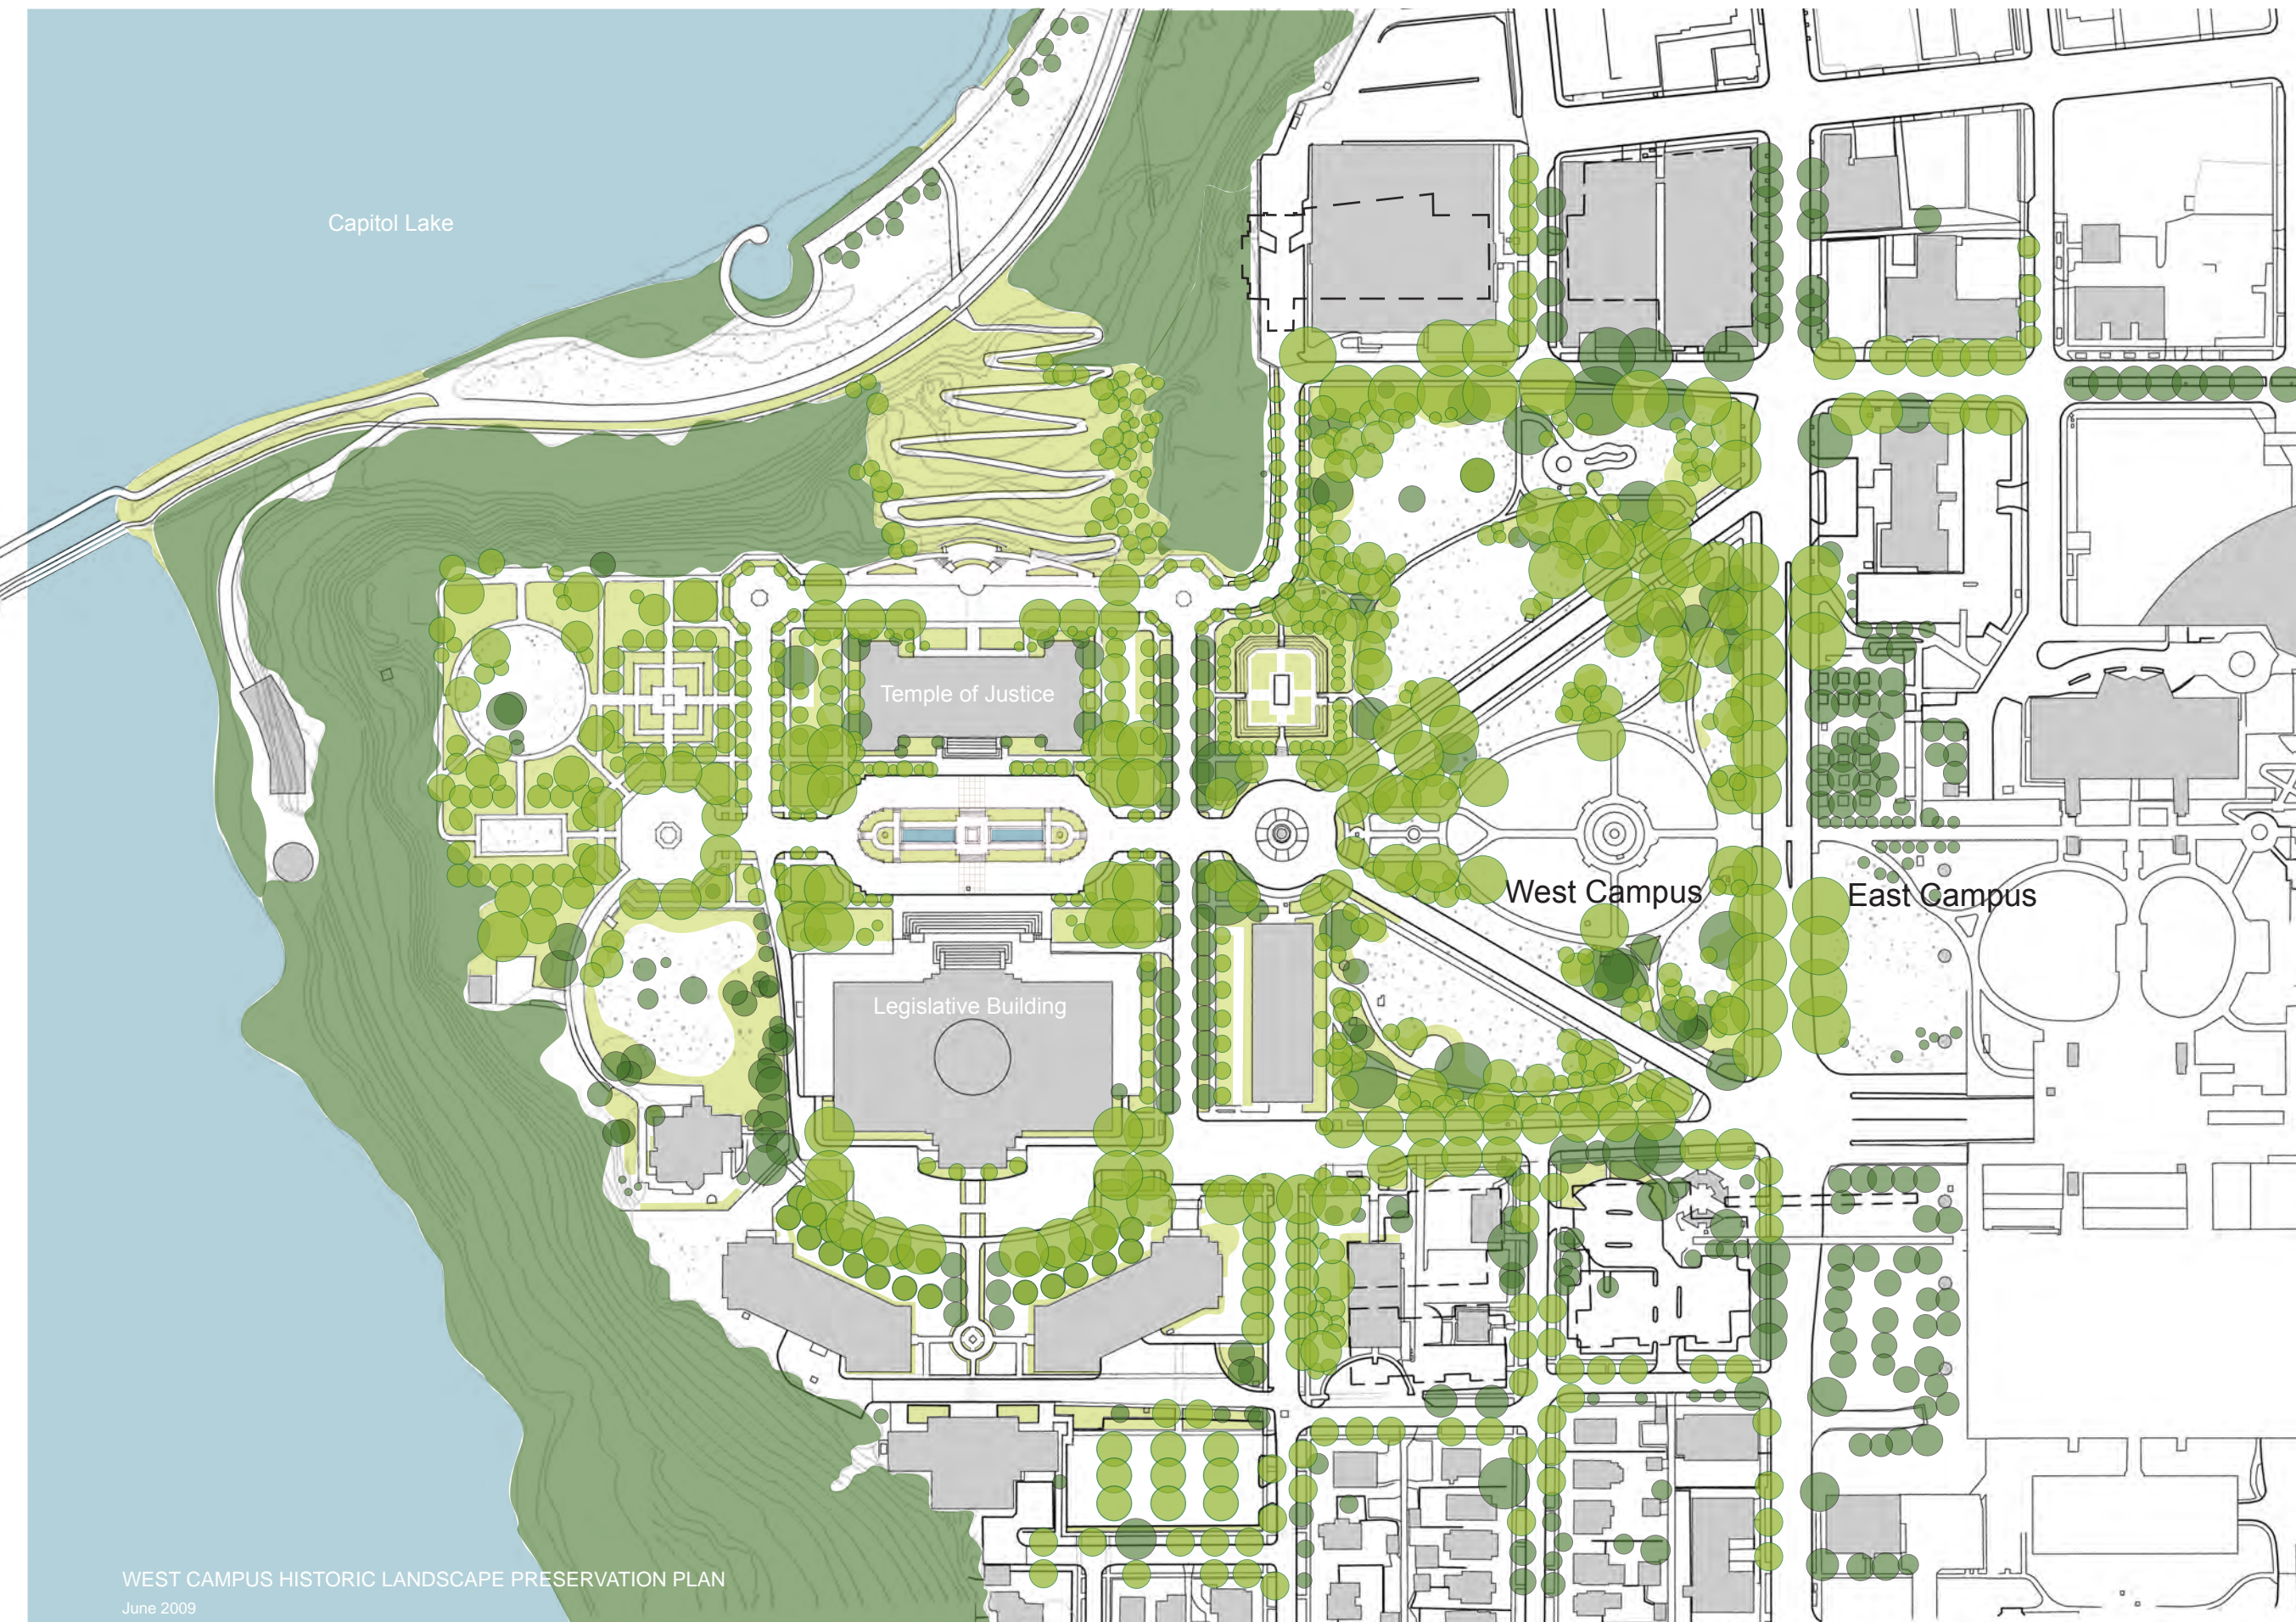
Fig. 6.1 West Capitol Campus Landscape Preservation Master Plan

The Landscape Master Plan illustrates the overall structure and character for Campus. For more detailed information regarding tree species and tree care, see Ch. 7: Large Tree Layer Plan and Ch. 10: Vegetation Management Plan.

- Key
-   existing tree
 -   proposed tree
 -   shrub layer
 -   eco-lawn
 -   future development

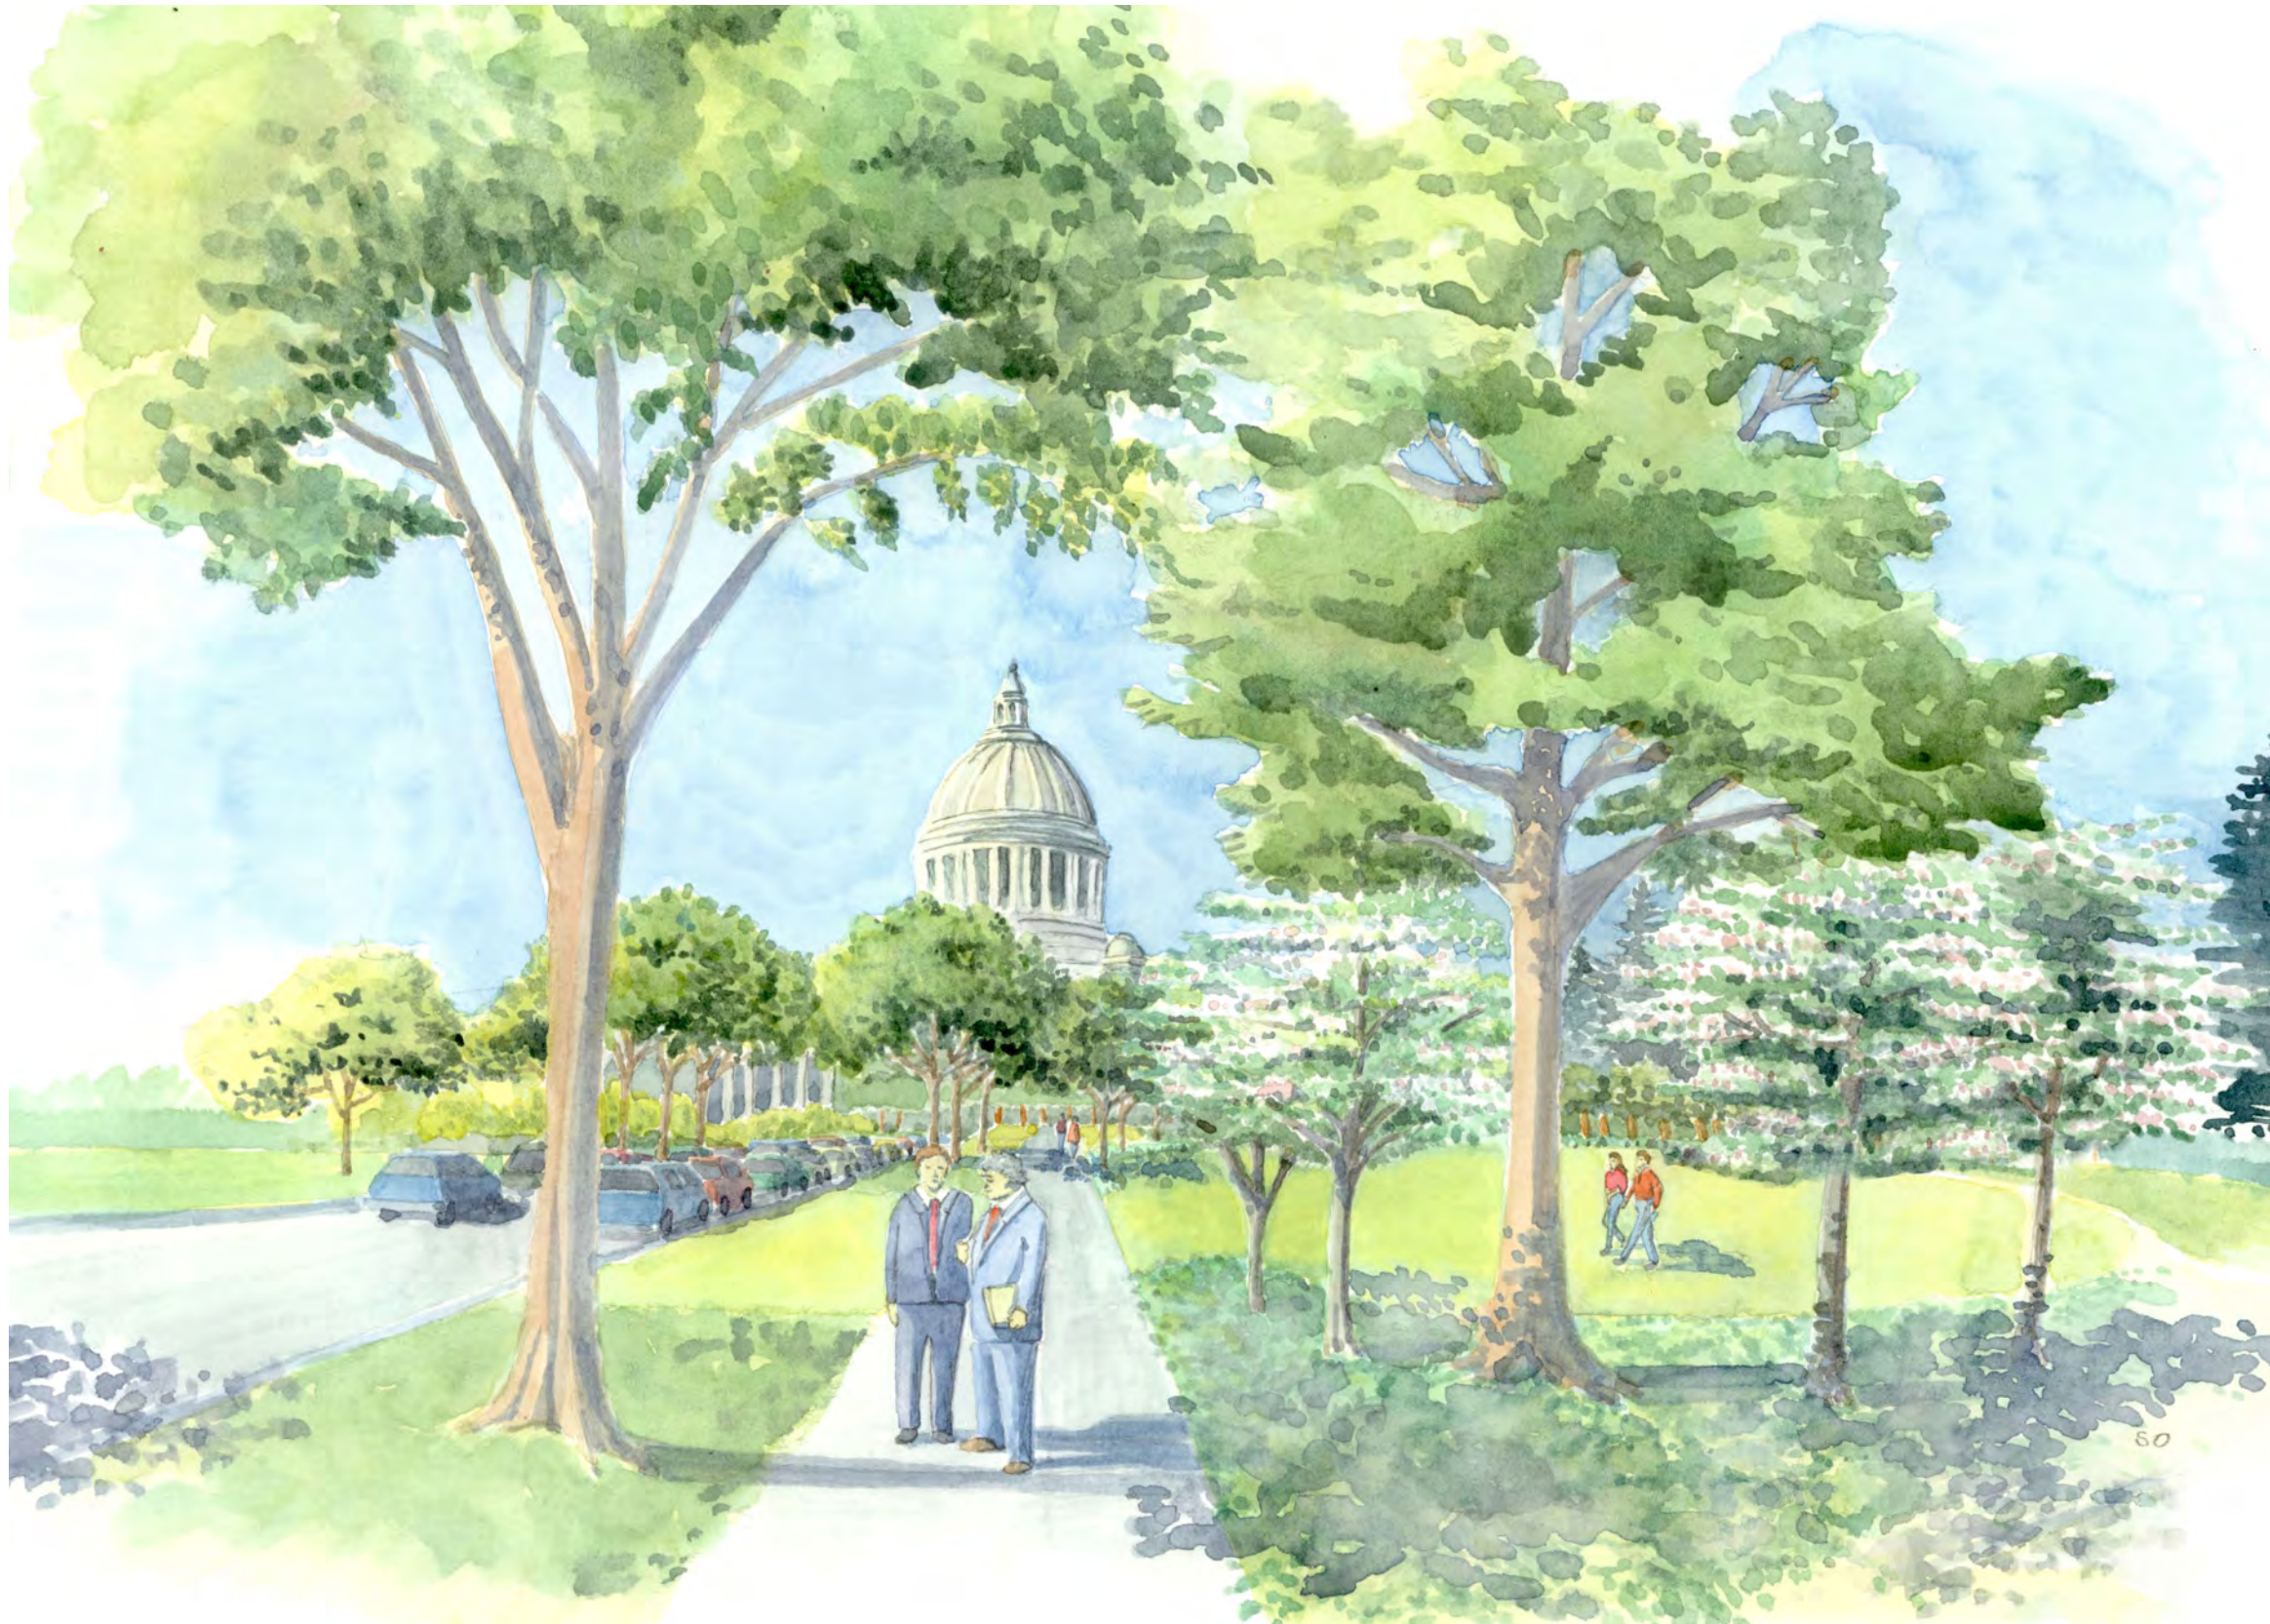
Fig. 6.4a Future View of North Diagonal Approach to Capitol (Source: Susan Olmsted, 2009)

This sketch shows the historic rhythm of trees which structured the North Diagonal approach, offering framed views of the Dome and creating a variable sequence of openness and enclosure. The additional canopy trees, understory trees, and shrubs would help delineate the edges of the landscape 'rooms' within the greensward.

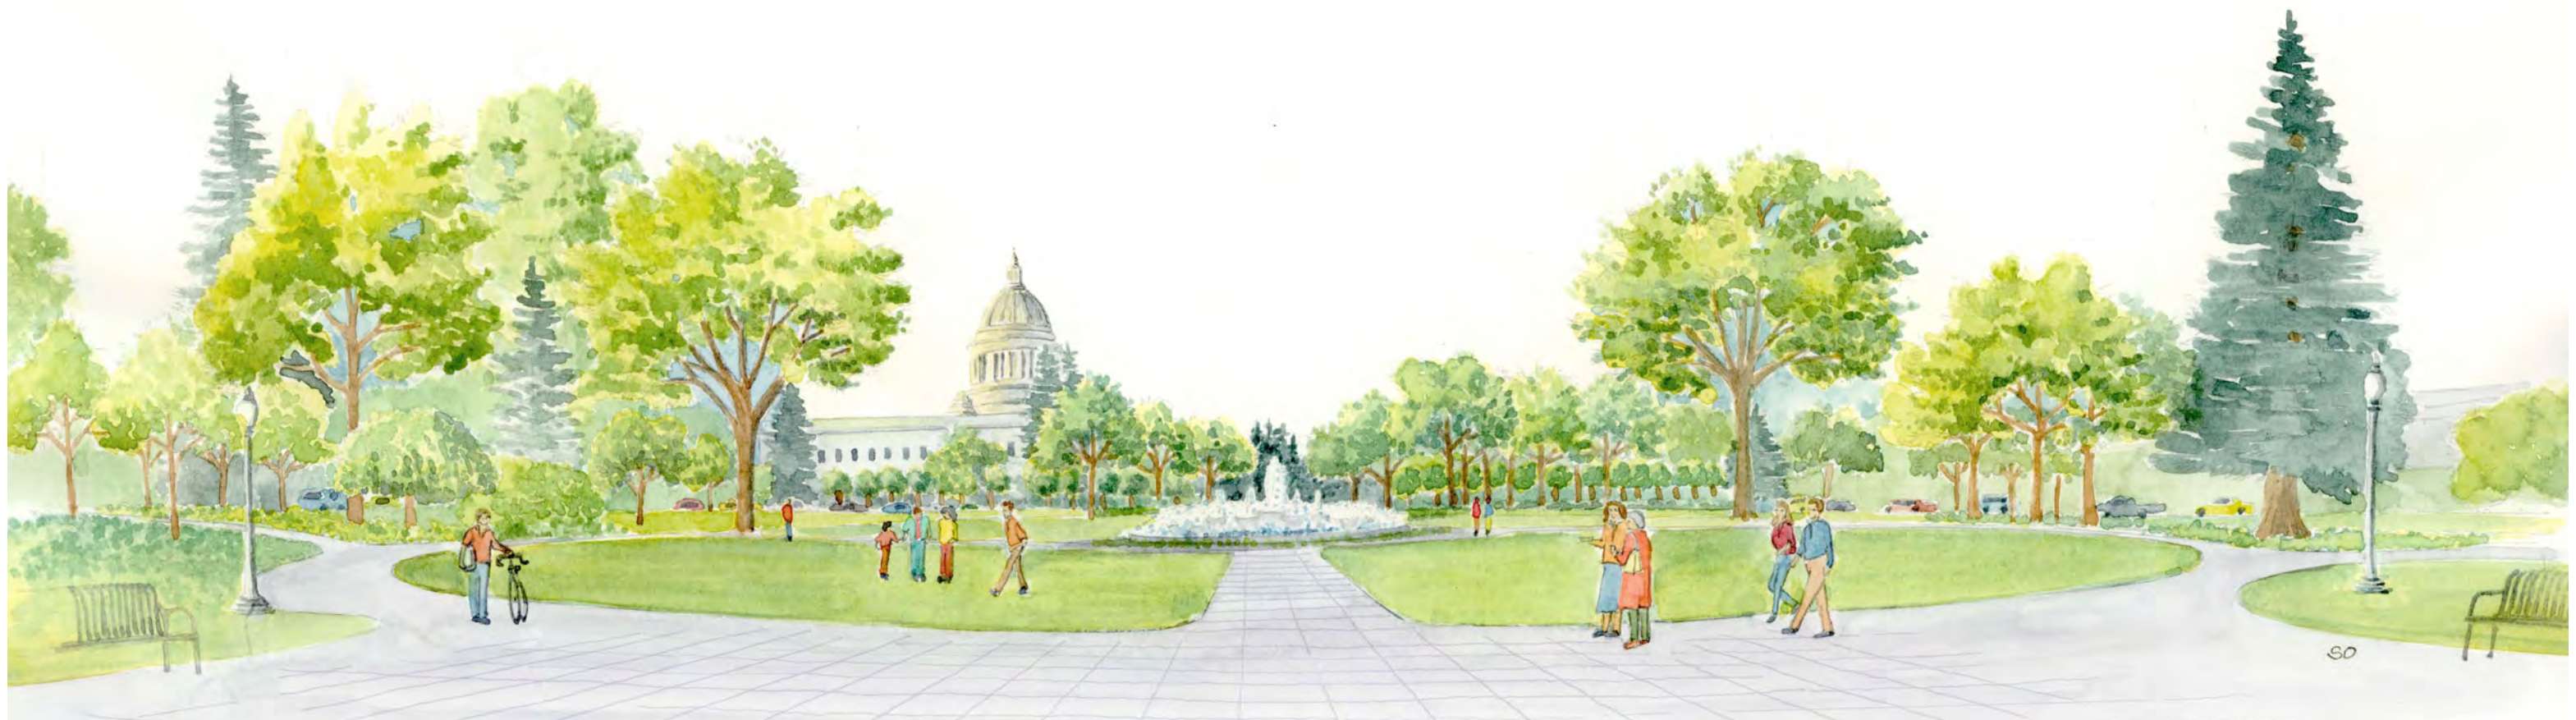
Fig. 6.5a Future View of Greensward [and Tivoli Fountain] (Source: Susan Olmsted, 2009)

This sketch shows the central oval in the greensward area with the historically-intended layers of vegetation. A balanced arrangement of Elm Trees lead the eye to the central core of the Capitol Group along the major east/west organizational axis (this directionality is reinforced by the 1953 replica of the Tivoli Fountain), though the circulation pattern invites the pedestrian to meander through the other landscape ‘rooms’ within the greensward. Layers of ground covers, low shrubs, understory trees, and canopy trees define the edges, without compromising the wide range of activities that occur within this important open space.

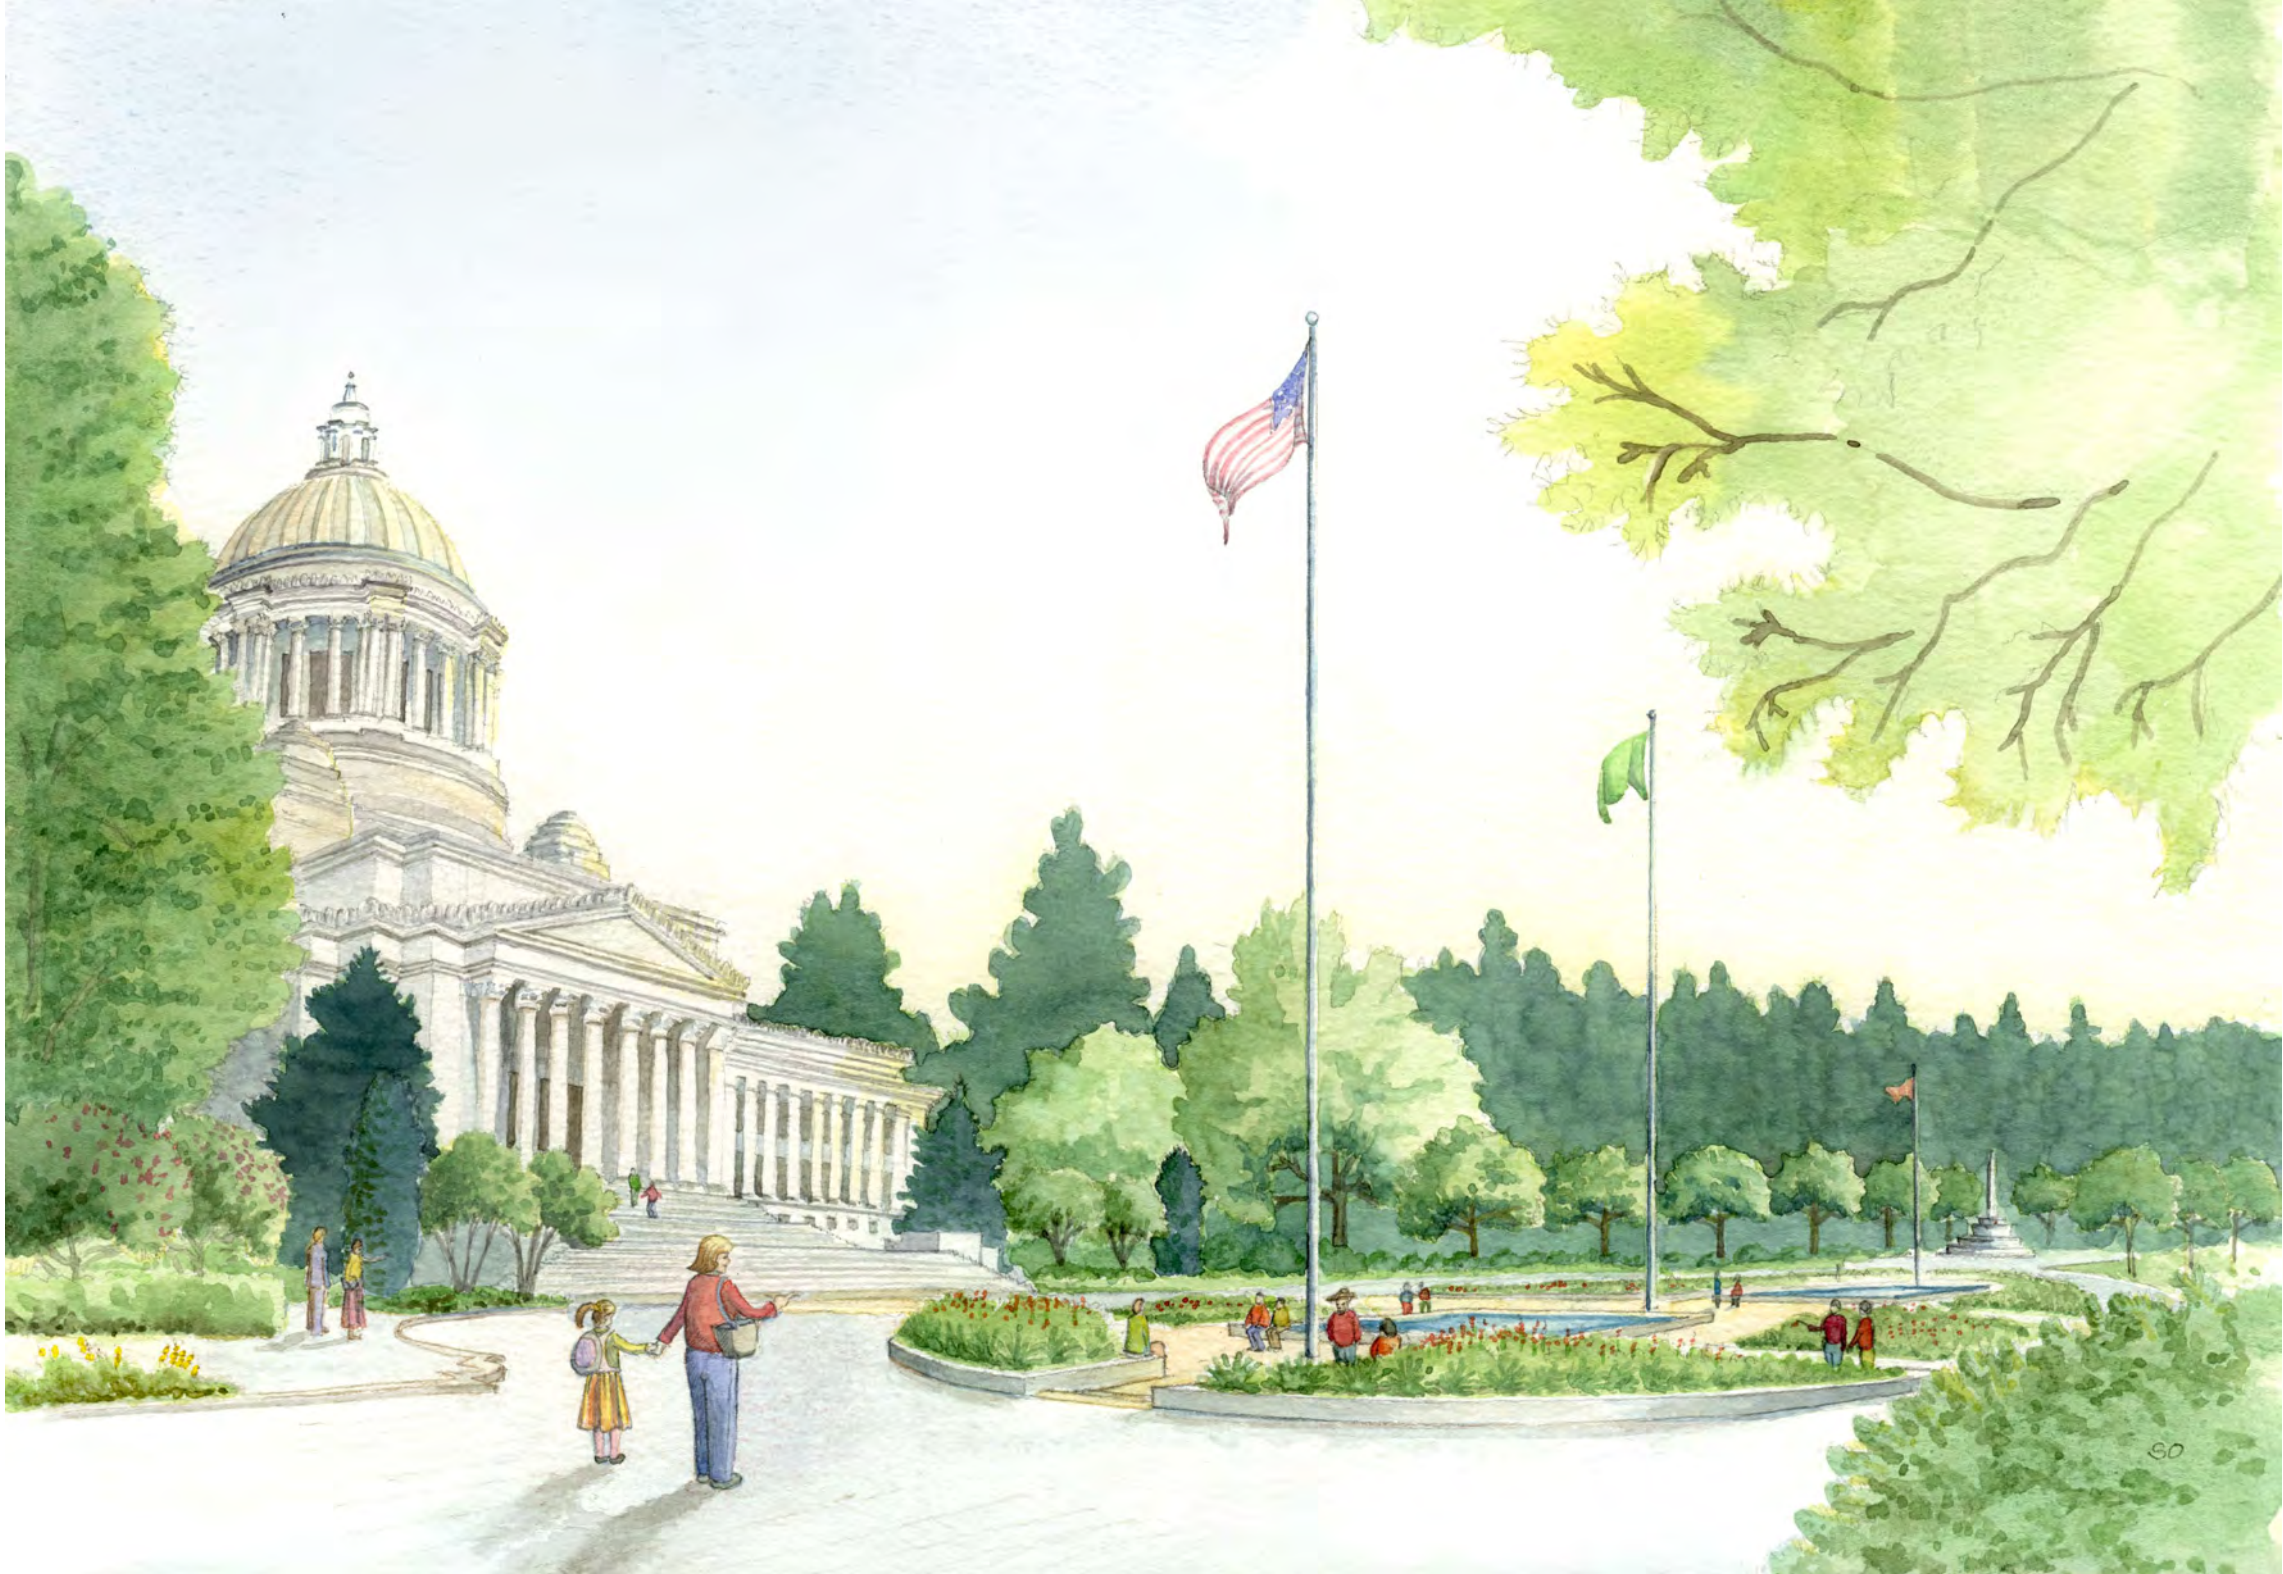
Fig. 6.10a Future View of Flag Circle / Civic Plaza with Sunken Garden and Water Feature (Source: Susan Olmsted, 2009)

This sketch shows some of the features and ideas described by the Olmsted Brothers for the civic plaza between the Legislative Building and the Temple of Justice: sunken gardens, flags, reflecting pools, and formal arrangements of trees, shrubs, and flowering perennials. The intended structure/enclosure of the garden (described by the Olmsteds as “low architectural balustrade”) would improve the connection between the architecture with the landscape. A counterpoint to the Winged Victory Monument to the east (behind) is shown at the west end of the space, with a backdrop of restored native forest. This space is currently dominated by individually-dedicated vehicular parking and a central ‘temporary’ lawn. As the landscape equivalent of the Legislative Building Dome, the culmination of the Campus arrival experience, and the central stage of democracy, this space holds tremendous potential for elevating the human spirit and celebrating the State of Washington.

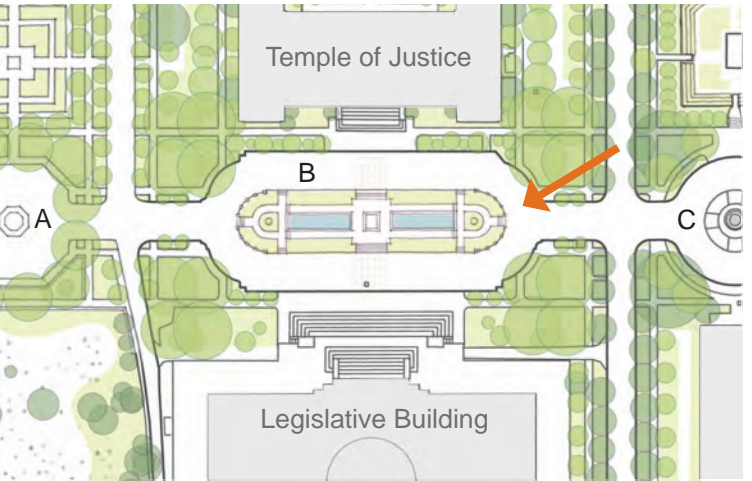
Fig. 6.10c Flag Circle plan with view indicated (not to scale)

- Key
- A. New monument opportunity
 - B. Flag Circle / Central Plaza
 - C. Winged Victory Monument

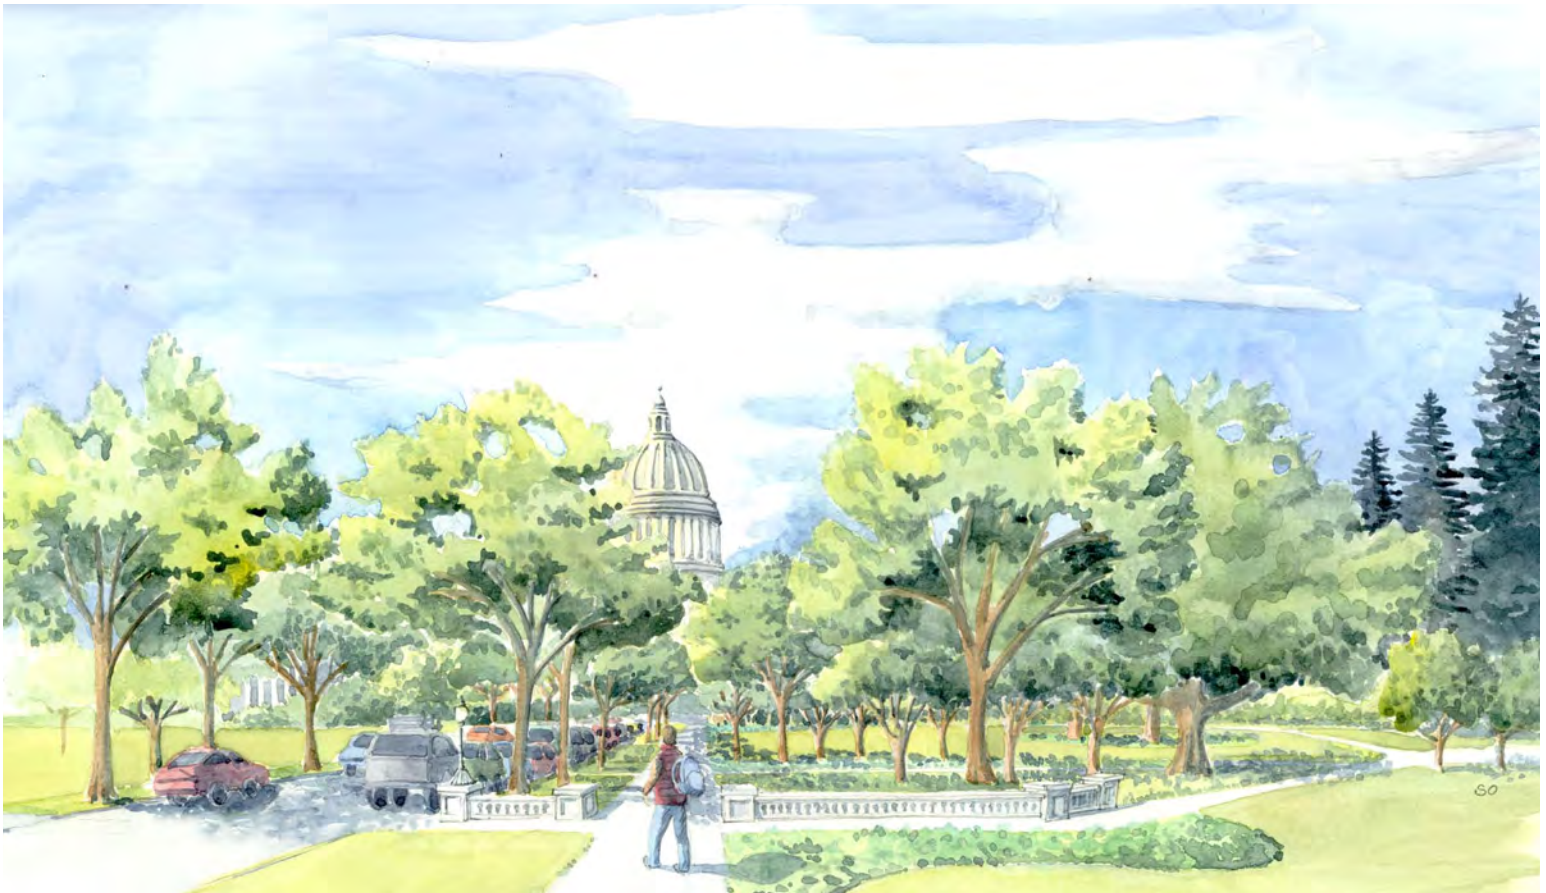
Fig. 6.12b Future North Diagonal approach to the Capitol with landscape rehabilitation: The low balustrade/gateway, the layering of trees and shrubs, and a series of outdoor 'rooms', compel visitors through the landscape. (Source: Susan Olmsted, 2009)

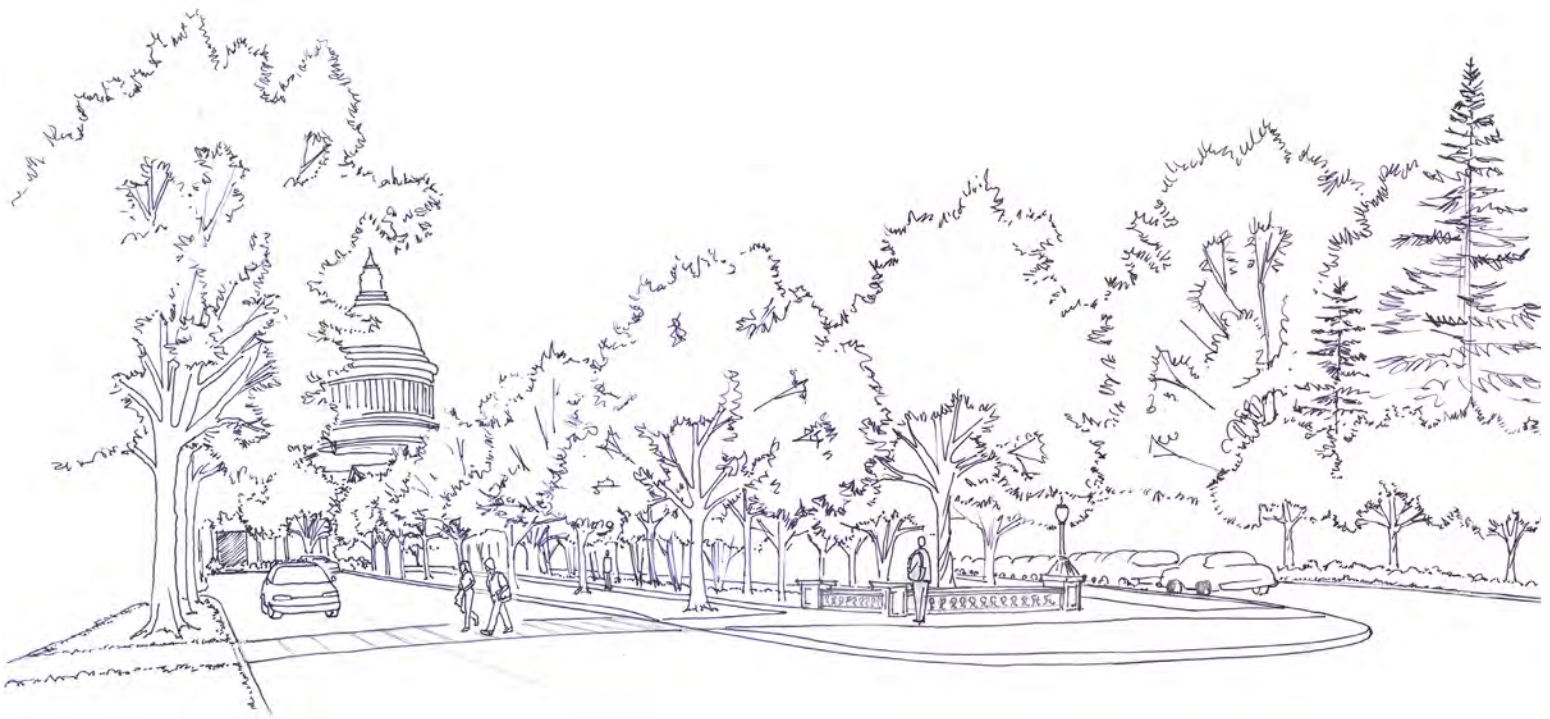
Fig. 6.12c Future approach to the Capitol along Sid Snyder Avenue with landscape rehabilitation: The framed view of the Dome, the layered vegetation, and the low balustrade entrance gateway help to extend/connect the Capitol with the landscape and the community. (Source: Susan Olmsted, 2009)

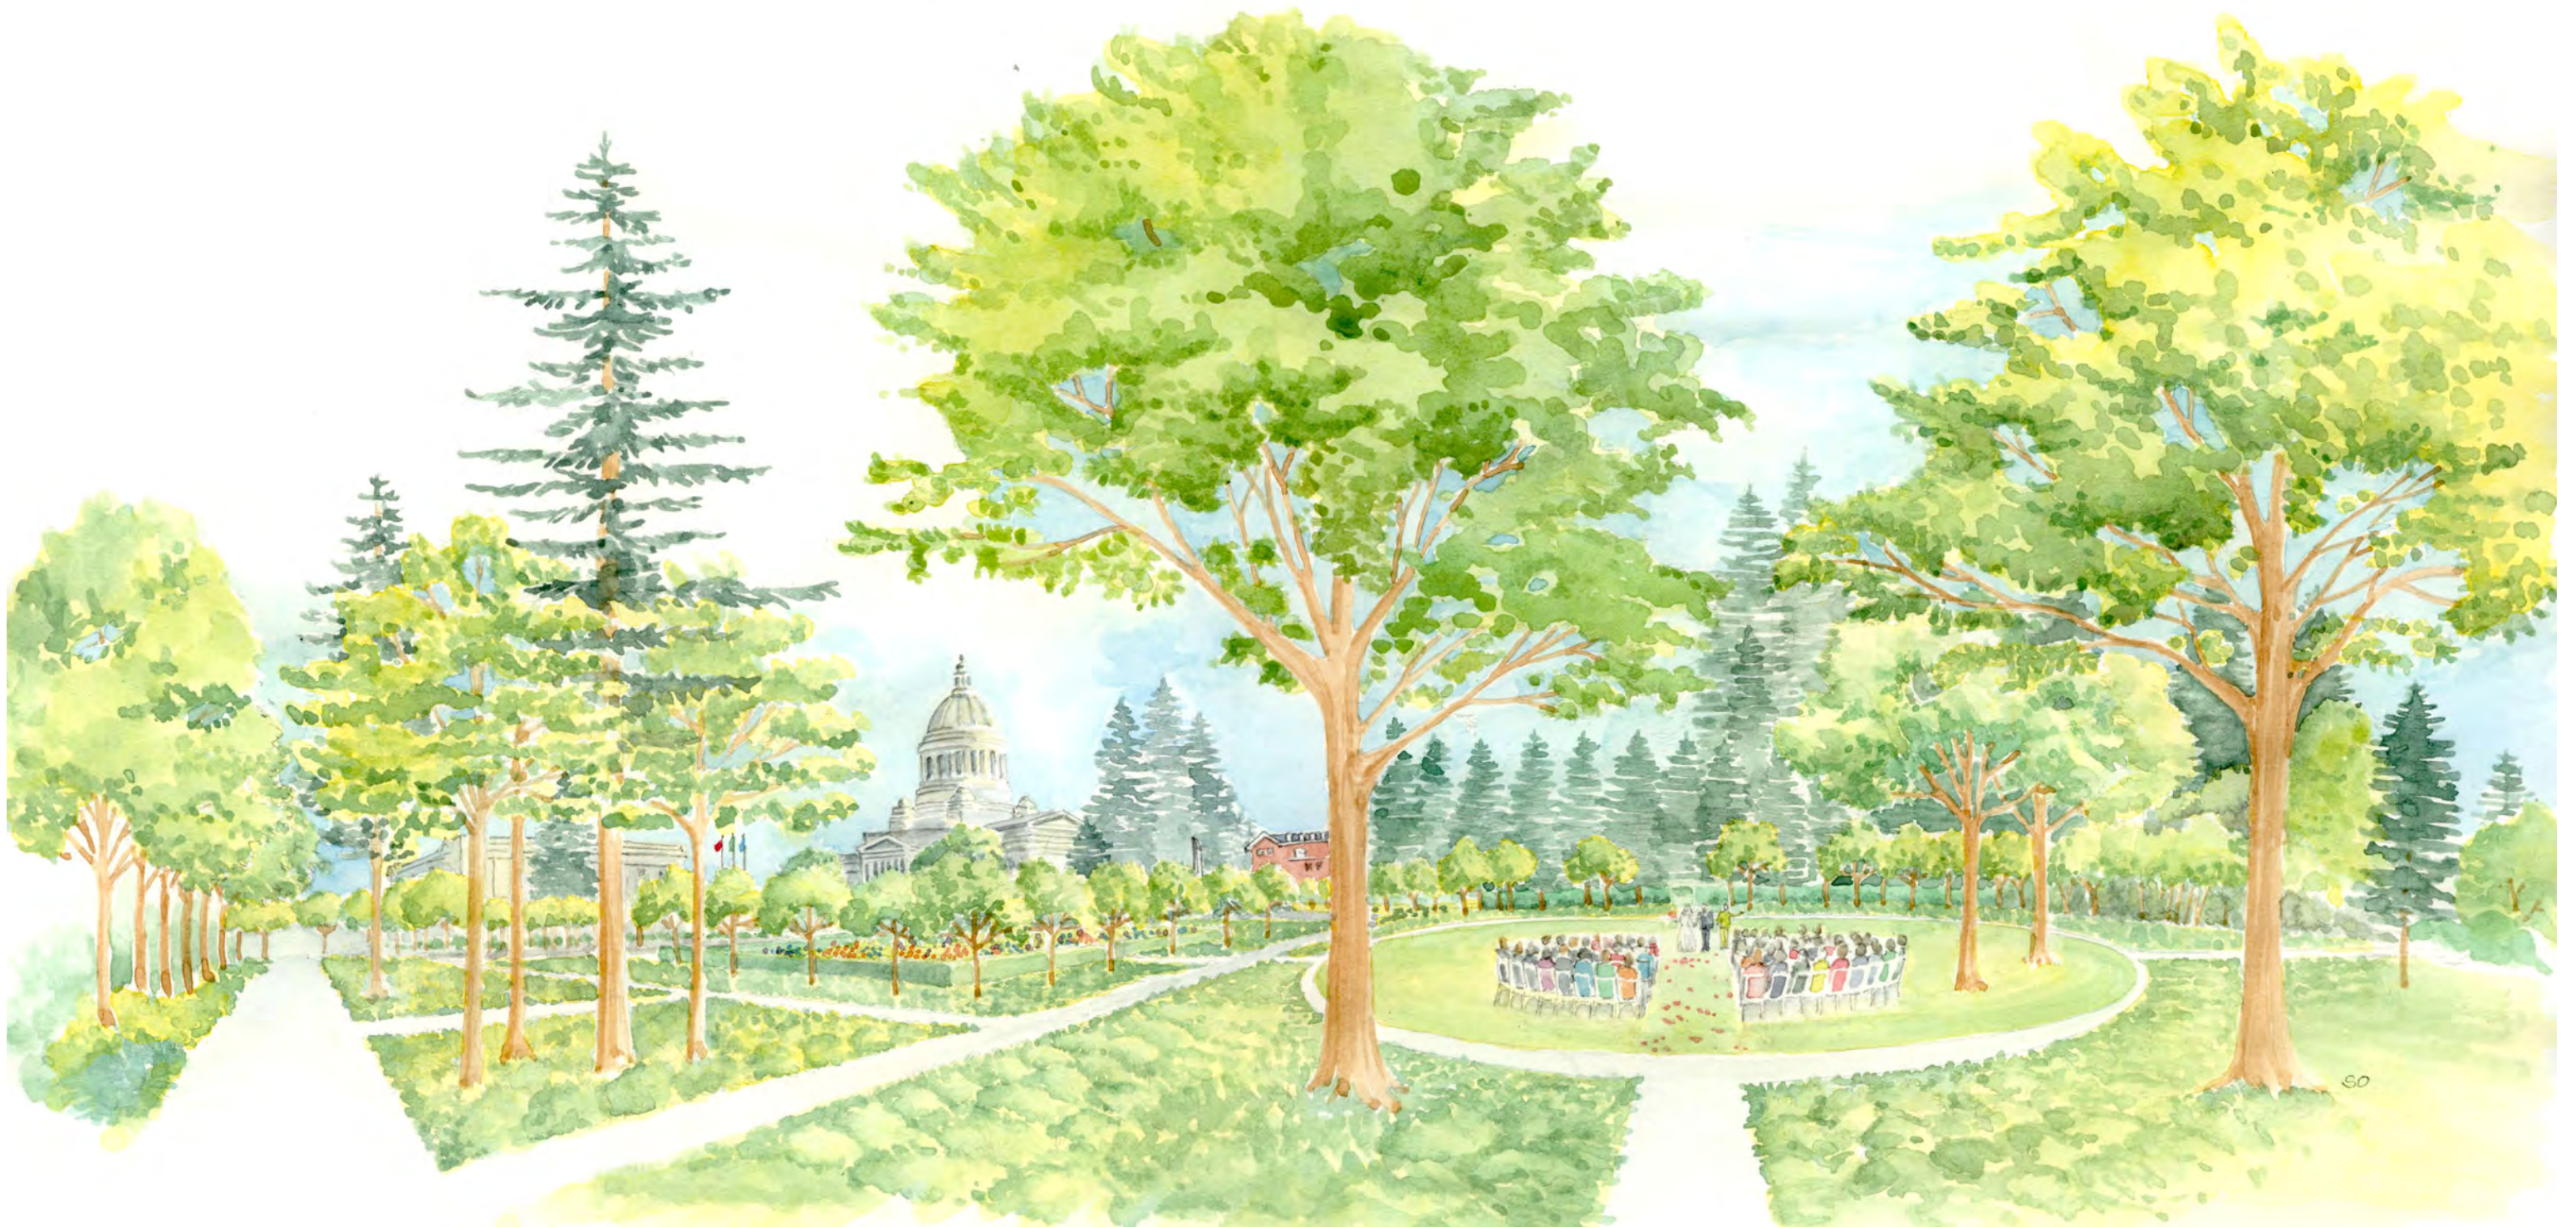
Fig. 6.15 Future View of West End of Campus (Source: Susan Olmsted, 2009)

This sketch depicts some of the features and ideas described by the Olmsted Brothers for the West End of the Campus: a circular greensward area with informal groupings of trees, a formal garden (to balance the Sunken Garden on the east side of Campus), 'structural' trees, and the native forest edge. This portion of campus could include new monuments and memorials (See Fig. 6.14), viewpoints overlooking Capitol Lake and the Olympic Mountains, sustainable demonstration/testing gardens, and a variety of gathering spaces, pathways, and experiences. This valuable location is currently used for surface parking, staging, material storage, and maintenance facilities.

- The eventual transformation of this portion of the Campus could include a series of formal and informal gardens, monuments, memorials, pathways, open spaces, and viewpoints linked together by an organizational structure that reinforces the organization of the West Campus, as a whole. (See Fig. 6.15; see also Figs. 5.21, 5.22, 5.23.)

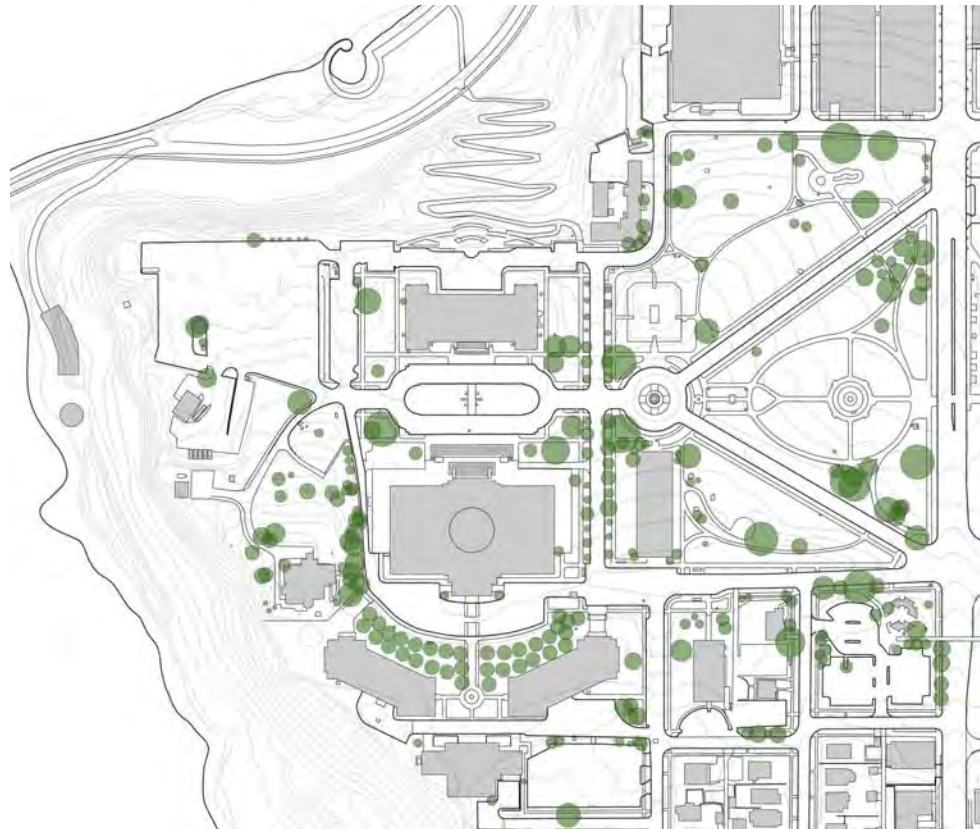
Fig. 7.2a Existing trees, 2008-09

The above diagrams illustrate the Campus tree canopy today and in the near future, in the absence of consistent, ongoing preventive care and replacement plantings, based upon the 2008-09 visual tree assessment conducted by Arbutus Design, LLC. The Tree Condition Survey (Fig. 10.4.4 and the Table of Trees (C. 10.9, p. 249) summarizes the results of the 2008-09 visual tree assessment. A comparison with the pre-existing 2001 tree data set revealed that the Campus tree population had declined almost 15 percent since 2001, and only two thirds of the lost trees had been replaced. Nearly *half* of the existing Campus trees (Fig. 7.2a) are in poor or fair condition, and in the near future, if actions are not undertaken to prevent further decline and attrition, and if replenishment efforts are not commenced soon, the canopy will resemble Fig. 7.2b. Well over a third of the existing trees exhibit current or potential risk. Fig. 7.2c shows the canopy composition that would result from the additional loss of trees with a current risk.

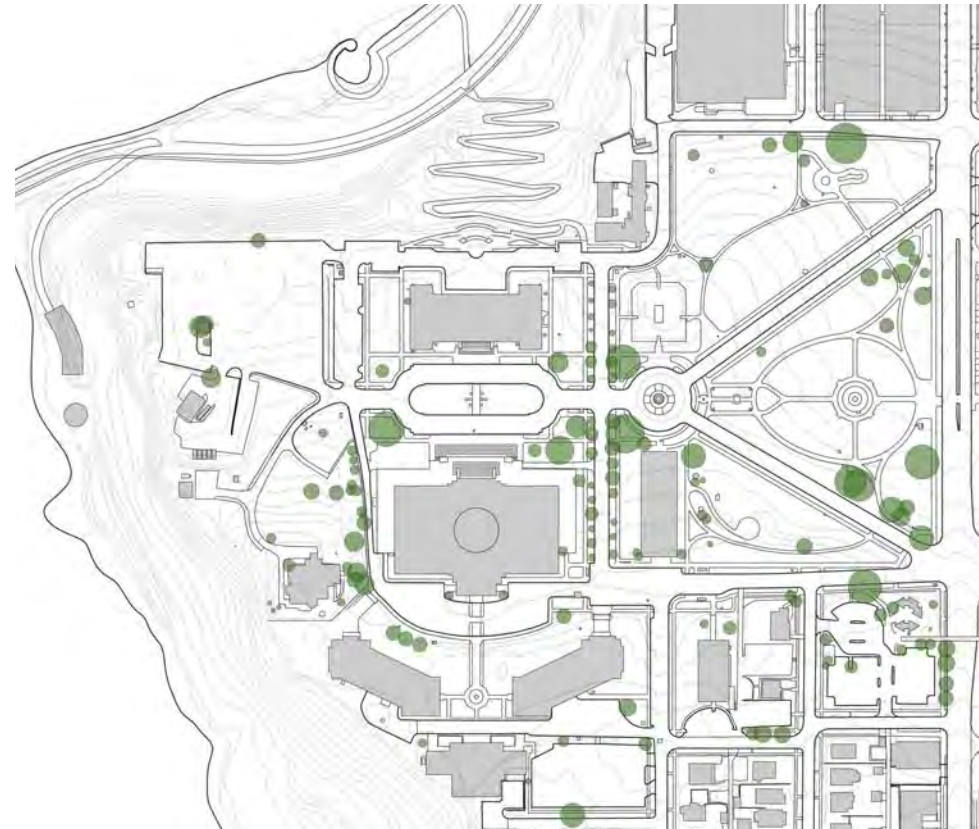
Fig. 7.2b Trees in good or excellent health, based upon Tree Condition Survey
