West Capitol Campus

Historic Landscape Preservation Master Plan

June 2009 | GA project # 08-099

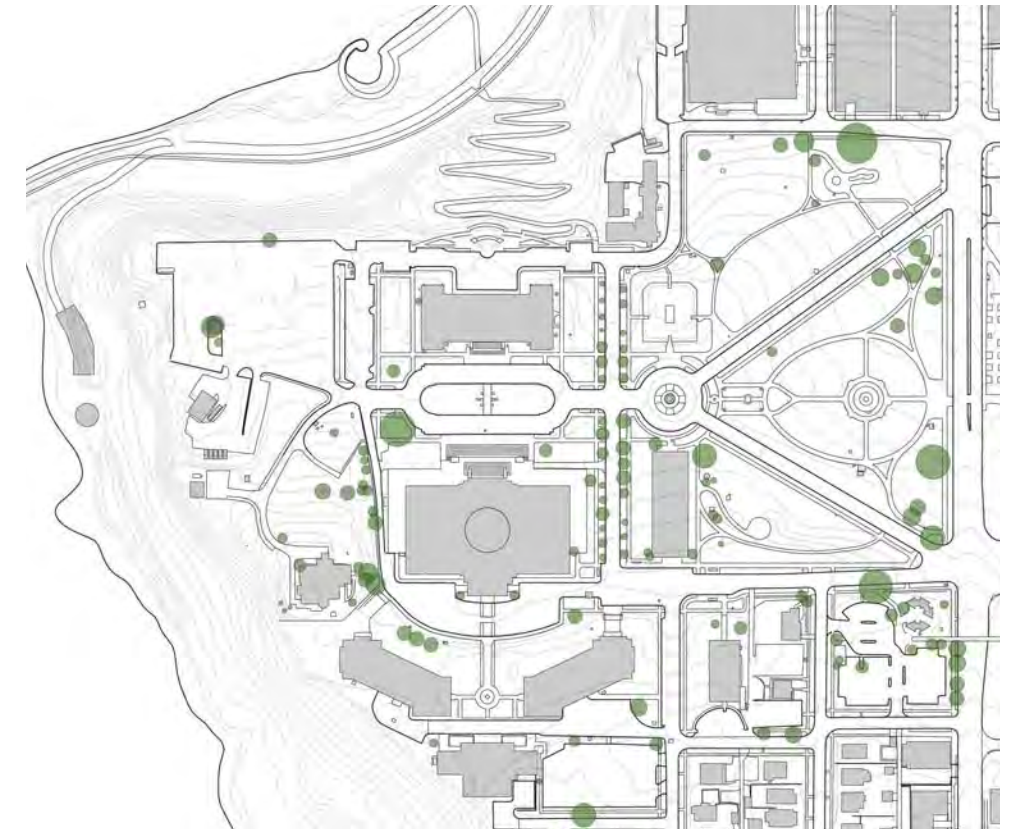
Fig. 7.2c Trees in good or excellent health, without a current risk, based upon Tree Condition Survey

The above diagrams illustrate the Campus tree canopy today and in the near future, in the absence of consistent, ongoing preventive care and replacement plantings, based upon the 2008-09 visual tree assessment conducted by Arbutus Design, LLC. The Tree Condition Survey (Fig. 10.4.4 and the Table of Trees (C. 10.9, p. 249) summarizes the results of the 2008-09 visual tree assessment. A comparison with the pre-existing 2001 tree data set revealed that the Campus tree population had declined almost 15 percent since 2001, and only two thirds of the lost trees had been replaced. Nearly *half* of the existing Campus trees (Fig. 7.2a) are in poor or fair condition, and in the near future, if actions are not undertaken to prevent further decline and attrition, and if replenishment efforts are not commenced soon, the canopy will resemble Fig. 7.2b. Well over a third of the existing trees exhibit current or potential risk. Fig. 7.2c shows the canopy composition that would result from the additional loss of trees with a current risk.

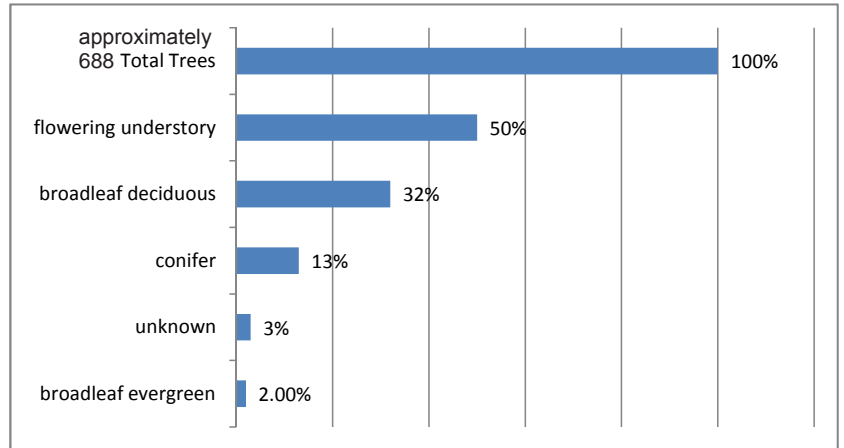
Fig. 7.6 Approximate percentage of tree types shown in the **1929 Olmsted Brothers Planting Plan**, excluding the native edge trees.

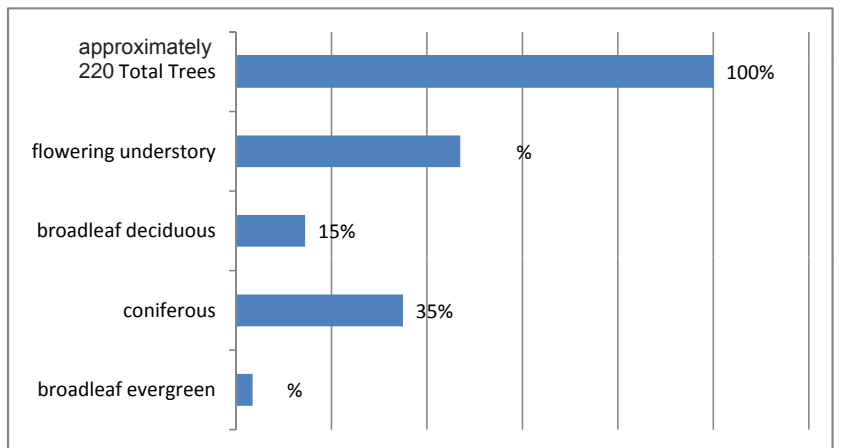
Fig. 7.7 Approximate percentage of tree types that **exist today**, within the same general area as 1929 plan (See Fig. 3.3).

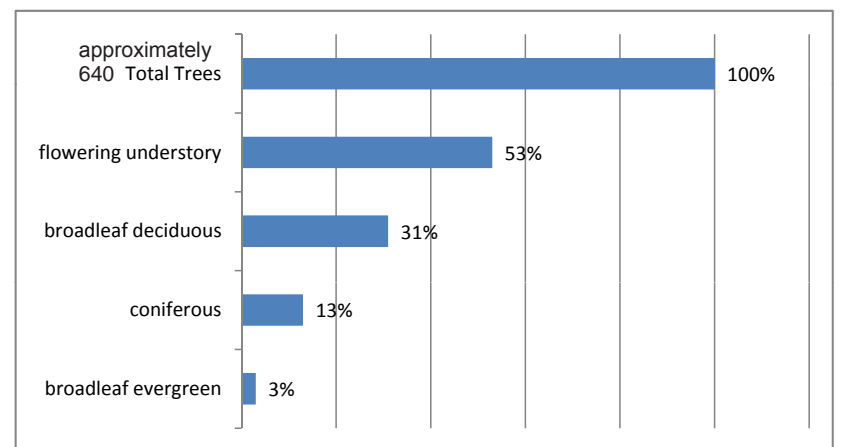
Fig. 7.8 Approximate **future** percentage of tree types based upon **LTL planting plan**, within the same general area as 1929 plan (See Fig. 3.3).

The percentage of tree types shown in the LTL shifts the balance of tree types closer to the historically intended proportions.

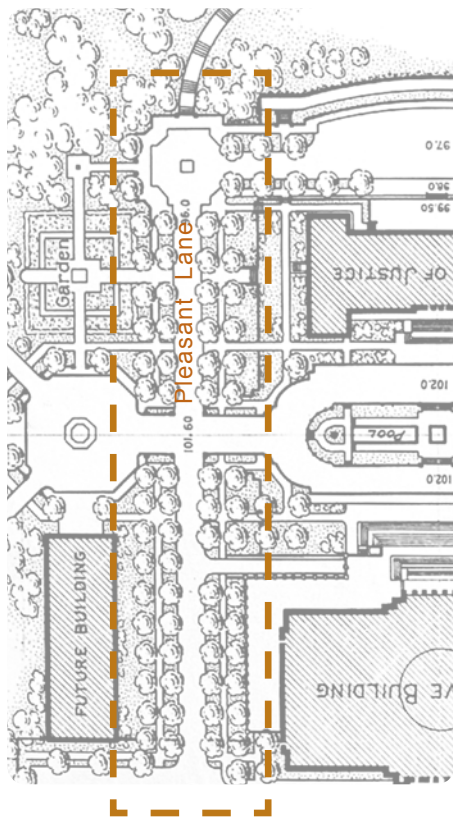
Fig. 8.2 PAST: 1928 Olmsted Brothers General Plan showing a double allee of trees along Pleasant Lane

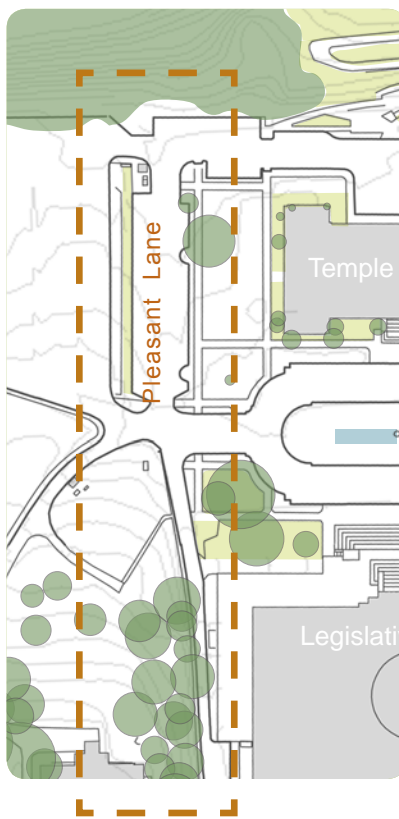
Fig. 8.3 PRESENT: Existing Plan at Pleasant Lane

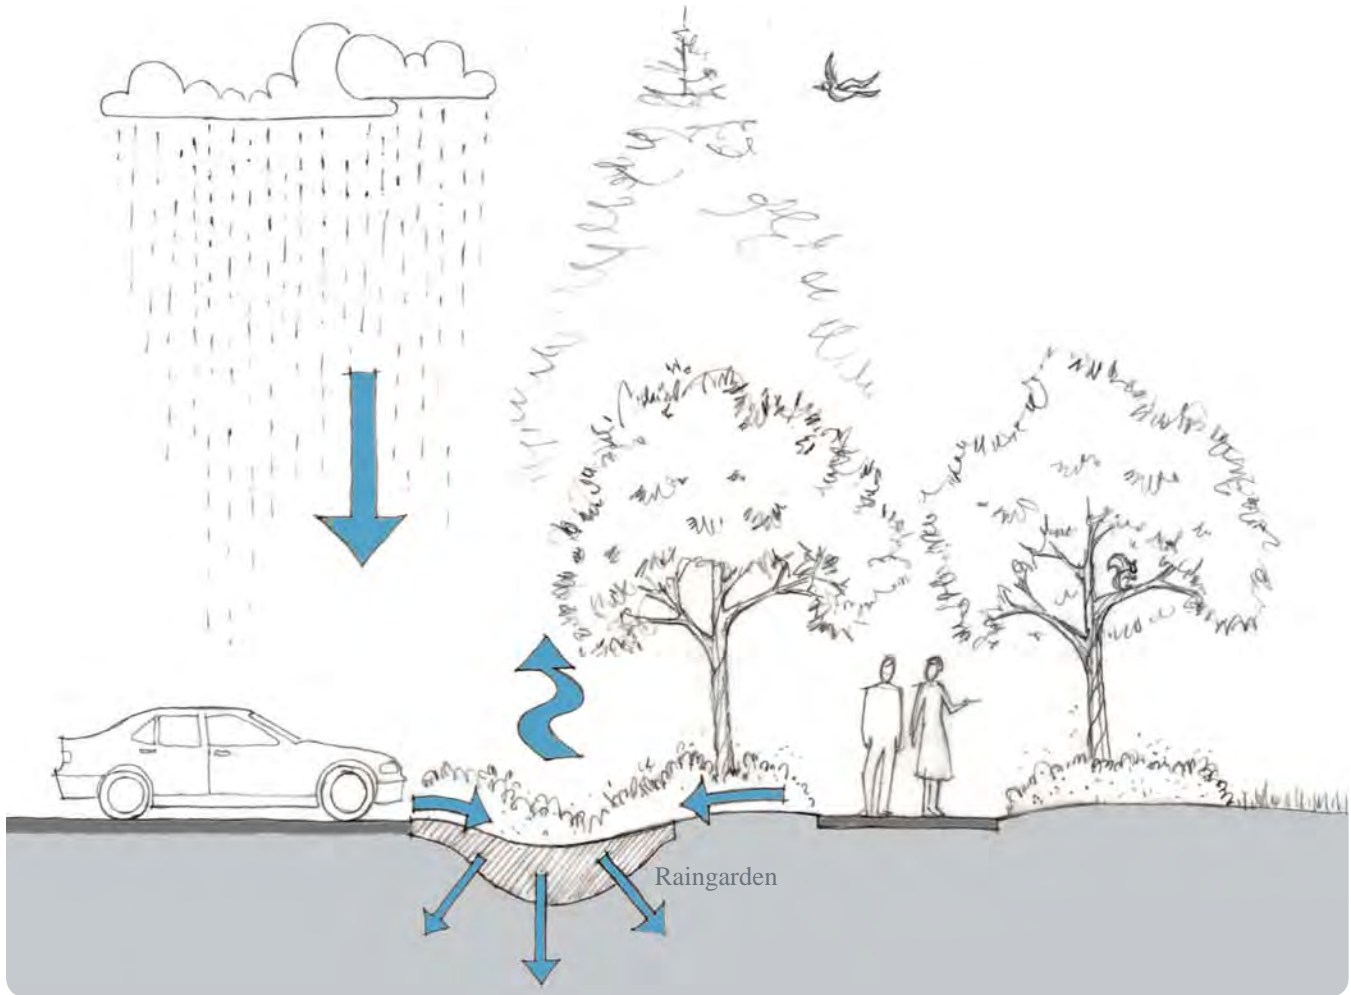
Fig. 8.5 Install raingardens to increase stormwater function at surface parking areas. Along Pleasant Way, raingardens could be integrated with the installation of the historically intended allees of flowering trees and layered understory.

- eco-lawn testing area, accompanied by interpretive signage
- raingarden demonstration or testing area, accompanied by interpretive signage (see Figs. 8.1 - 8.7)
- removal of invasive plant species, accompanied by interpretive signage
- relocation of a surface parking area, replaced by a demonstration garden or public amenity

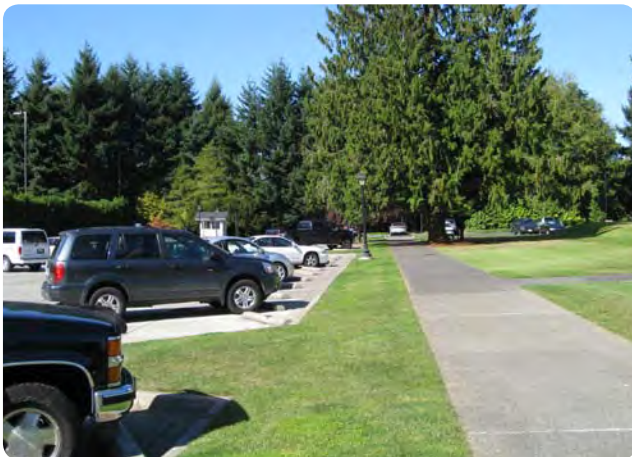
Fig. 8.6 Existing parking area along Pleasant Way (Sept. 2008, Source: Mithun)

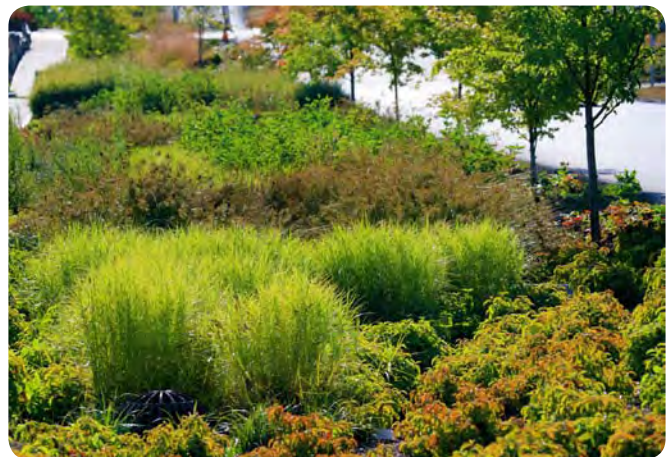
Fig. 8.7 Raingarden at High Point Neighborhood, Seattle (2008, Source: Mithun)

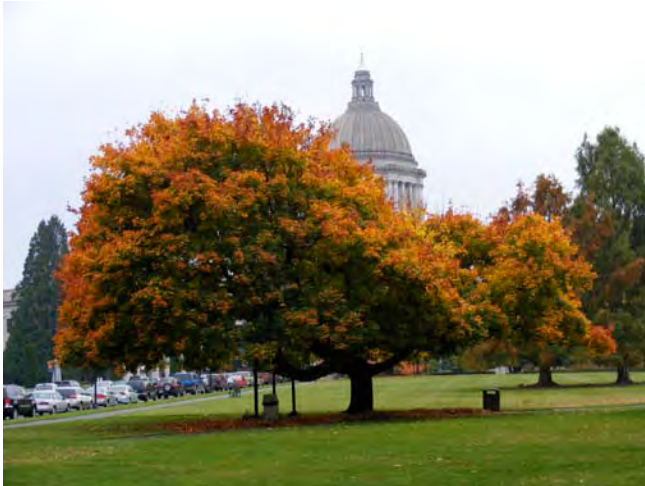
Fig. 10.1.4 Heritage Norway Maple has received special structural supports and health treatments (October 2009, Source: Arbutus Design)

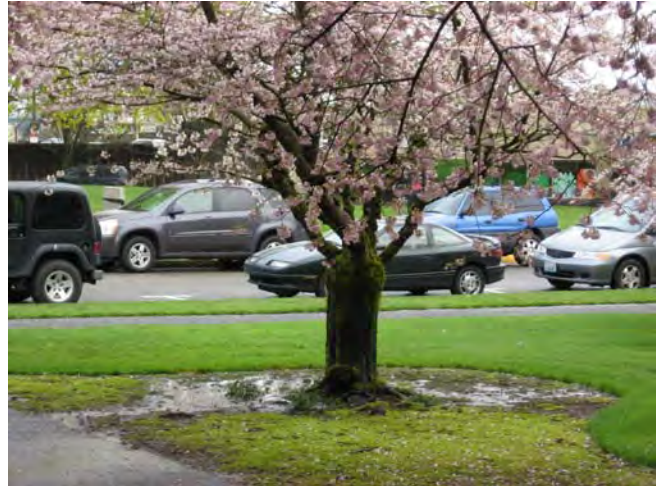
Fig. 10.1.5 Kwanzan cherries in 13 Colonies grove suffer decay from poor drainage (April 2009, Source: Arbutus Design)

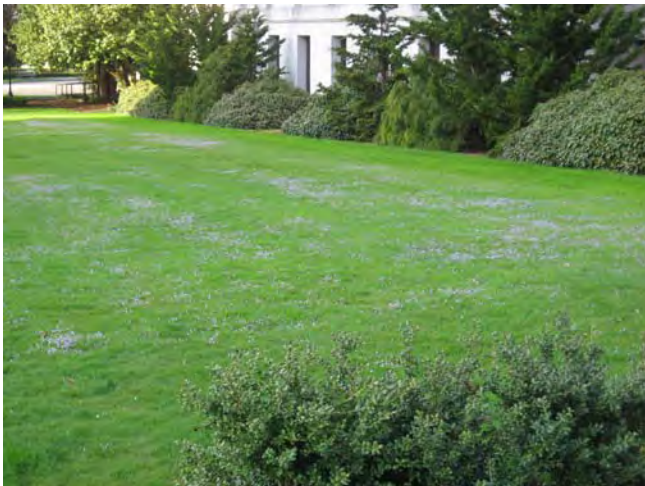
Fig. 10.1.6 Veronica in lawn indicates poor drainage. Shrubs beyond obscure windows and crowd building (April 2009, Source: Arbutus Design)

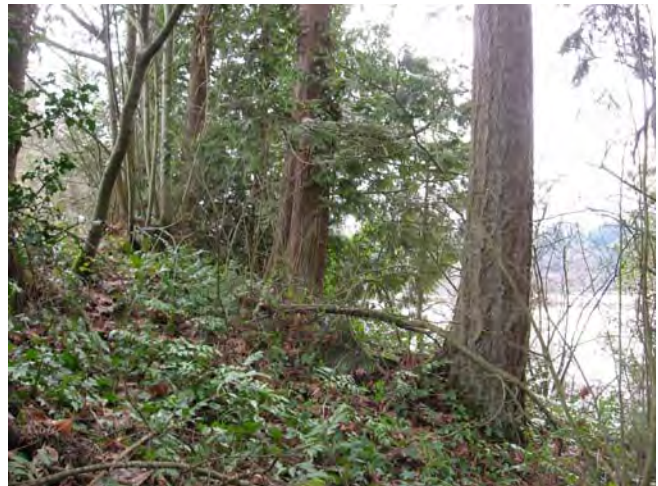
Fig. 10.1.7 Healthy native understory at NW corner of bluff contrasts with ivy-engulfed ground and trees nearby. (March 2009, Source: Arbutus Design)

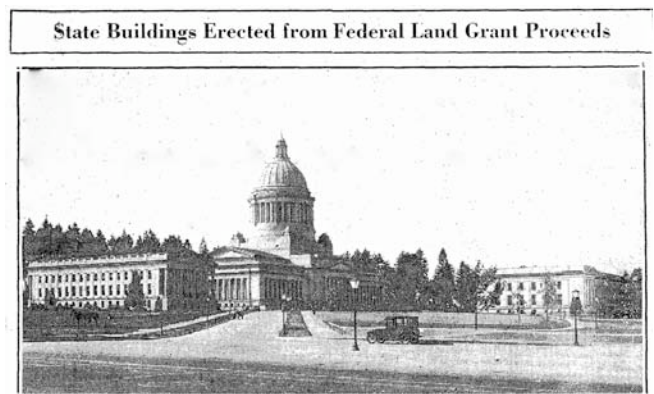
Fig. 10.2.3 North Diagonal before installation of Olmsted landscape shows native forest setting and absence of canopy and base plantings (Source: Library of Congress)

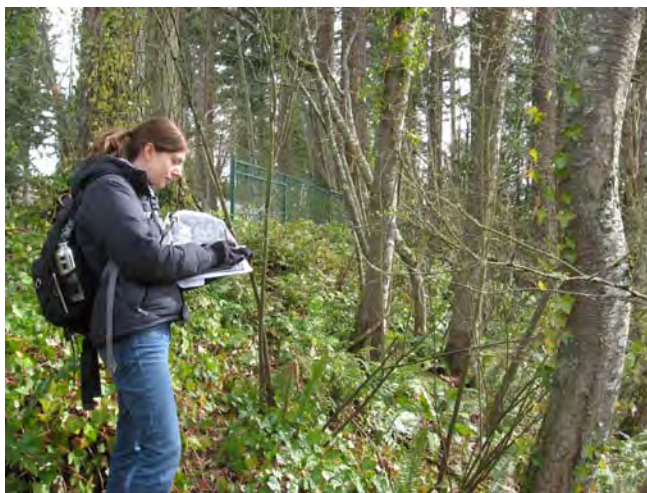
Fig. 10.3.1 2009 inventory of Native Edge added 175 new tree records, plus over 100 more in developed campus areas (March 2009, Source: Arbutus Design)

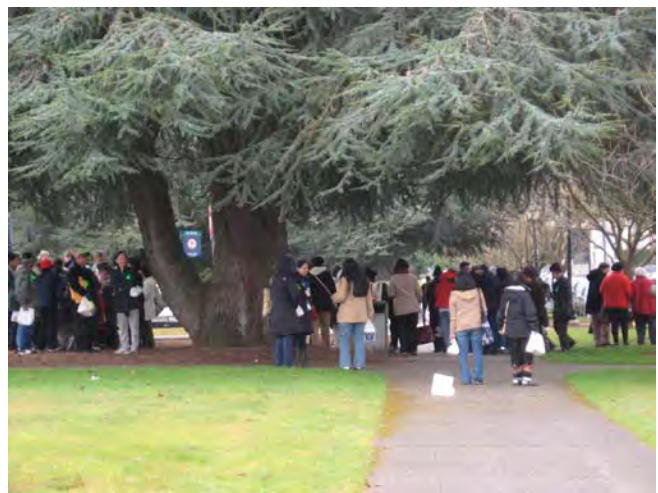
Fig. 10.3.2 Large Blue Atlas cedar exemplifies tree risk: it can shed heavy limbs and people often sit, stand, or walk under it (February 2009. Source: Arbutus Design)

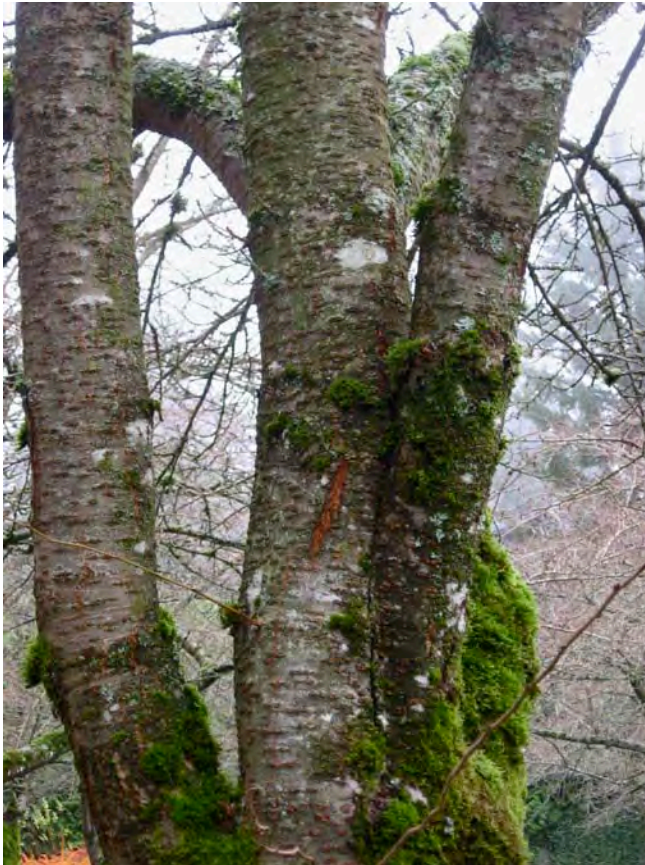
Fig. 10.3.5 Yoshino cherry with tight, co-dominant trunks that may split apart as they enlarge. Early pruning easily corrects such defects and prevents breakout. (December 2008, Source: Arbutus Design)

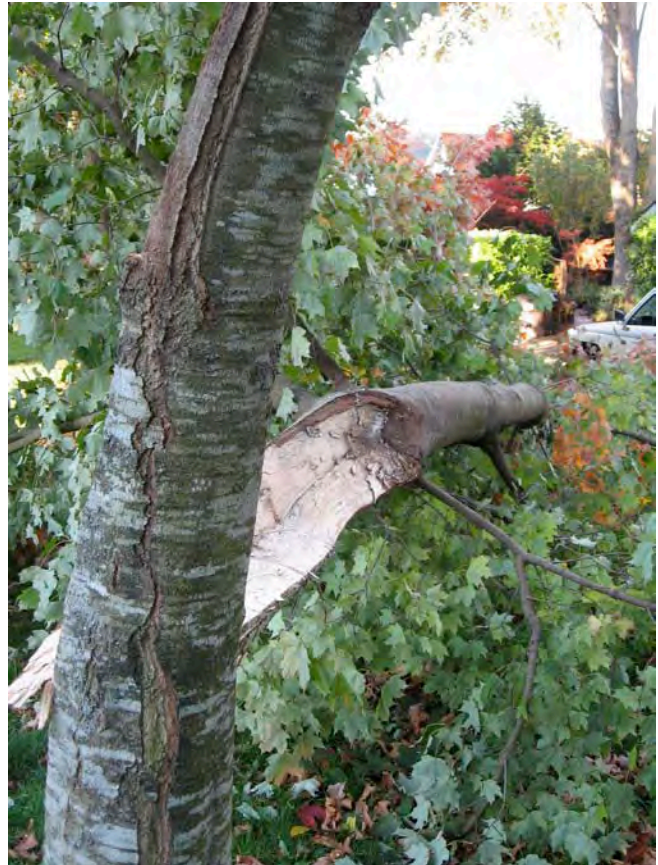
Fig. 10.3.6 Red maple with similar size trunks and defect ‘unzipped’ in busy Seattle park during summer wind squall. (September 2006. Source: Arbutus Design)

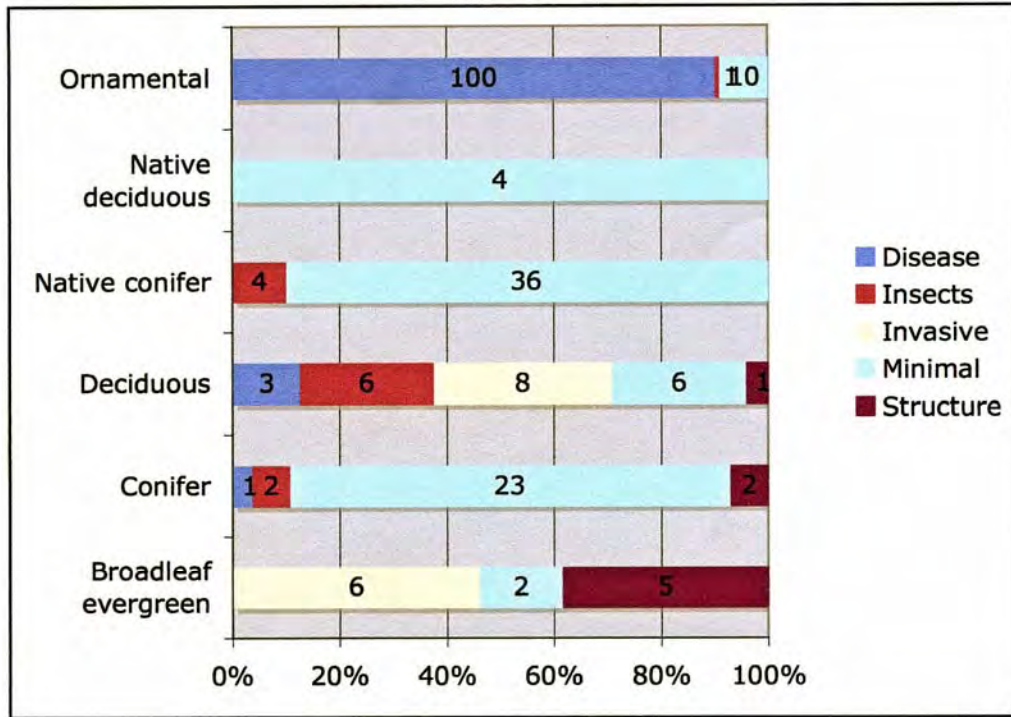
CULTURAL ISSUE by SPECIES
Count within Tree Types

(top) Fig. 10.3.7 Cultural Issue by Tree Species. (2009. Source: Arbutus Design)
(bottom) Fig. 10.3.8 Tree Maturity (2009. Source: Arbutus Design)

Patterns of disease, infestation, structural defects and invasiveness tell a great deal about tree condition and outstanding management needs. As illustrated below, issues vary considerably among types of trees. WCC “Ornamentals” are predominantly cherries, which almost universally suffer from diseases, whereas “Deciduous” trees manifest a variety of problems in limited numbers, partly reflecting species diversity and the resiliency that imparts to a tree population.

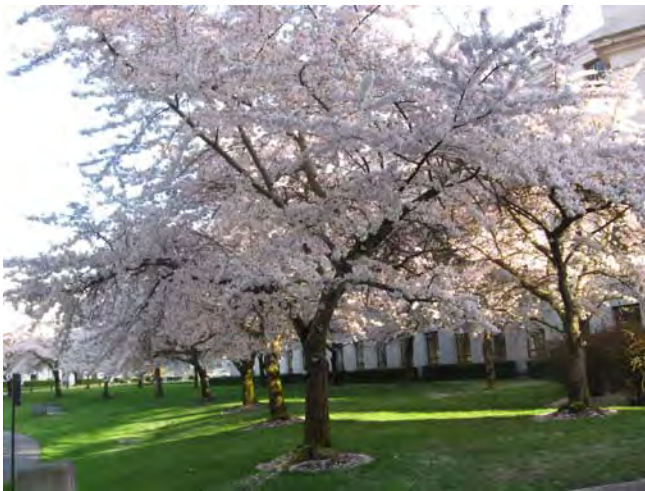
Fig. 10.3.9 35% of Campus trees are cherries, outnumbering the second most abundant species by almost 3:1 (April 2009, Source: Arbutus Design)

- Cherries overwhelmingly outnumber all other trees, over 35% of total. The next most abundant is Douglas fir, with little more than a third as many, at 13%. While beautiful and popular, cherries are plagued by serious horticultural problems on this site.

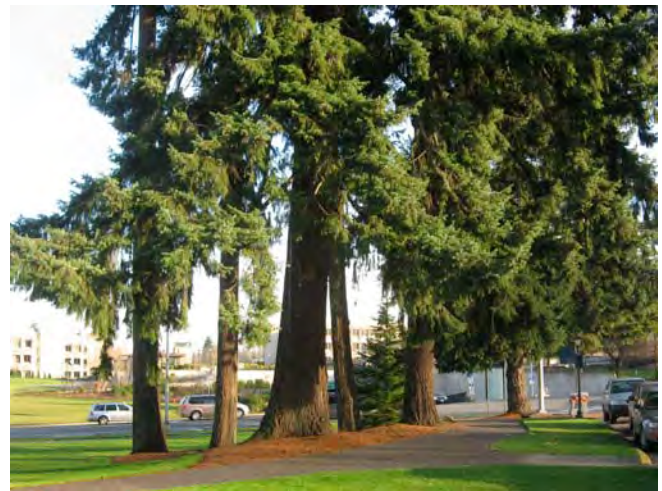
Fig. 10.3.10 Douglas firs are second most abundant in WCC developed landscape (13%) and Native Edge (28%) (November 2008. Source: Arbutus Design)

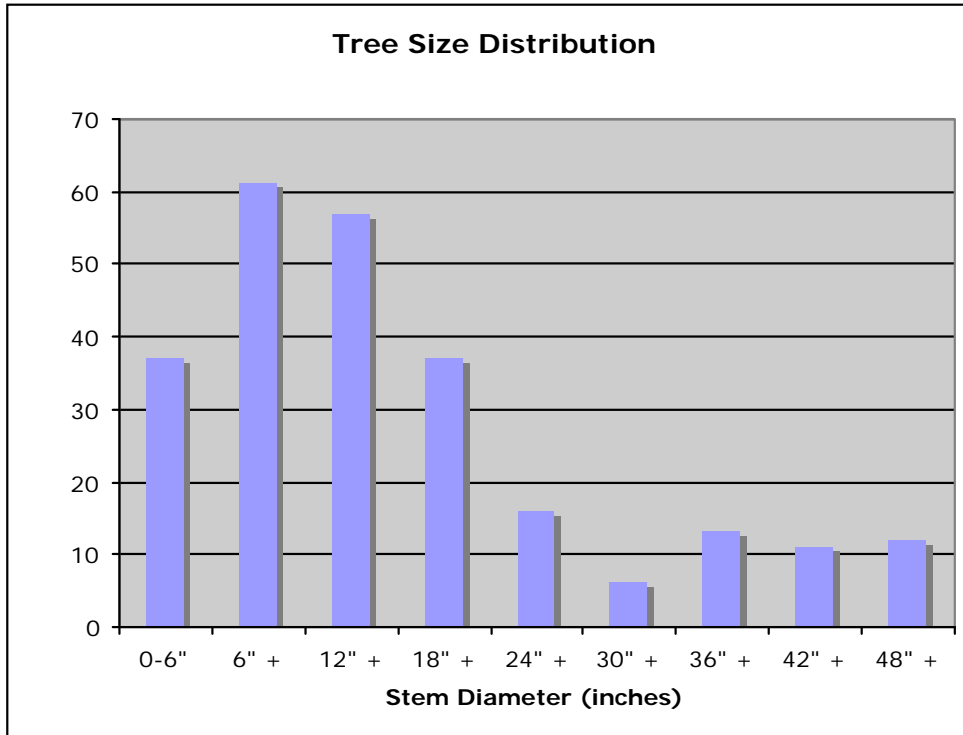
(top) Fig. 10.3.12 Tree Size Distribution. (2009, Source: Arbutus Design)

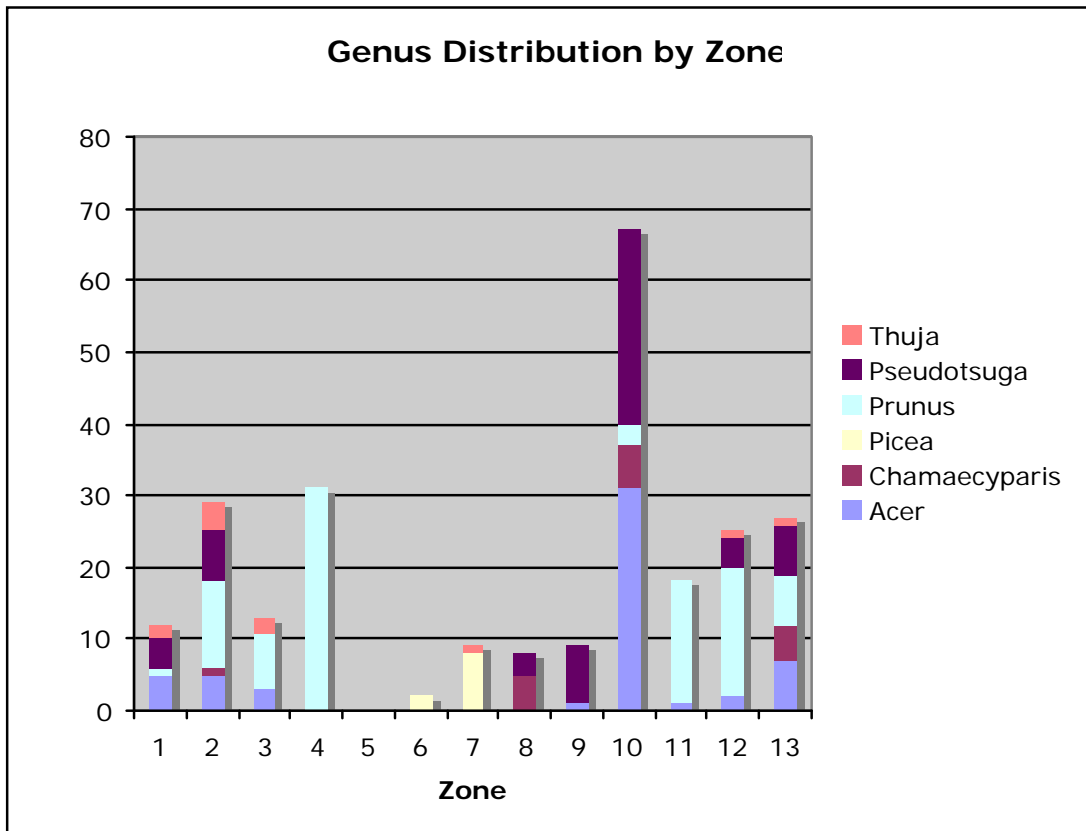
(bottom) Fig. 10.3.13 Genus Distribution by Zone. (2009, Source: Arbutus Design)

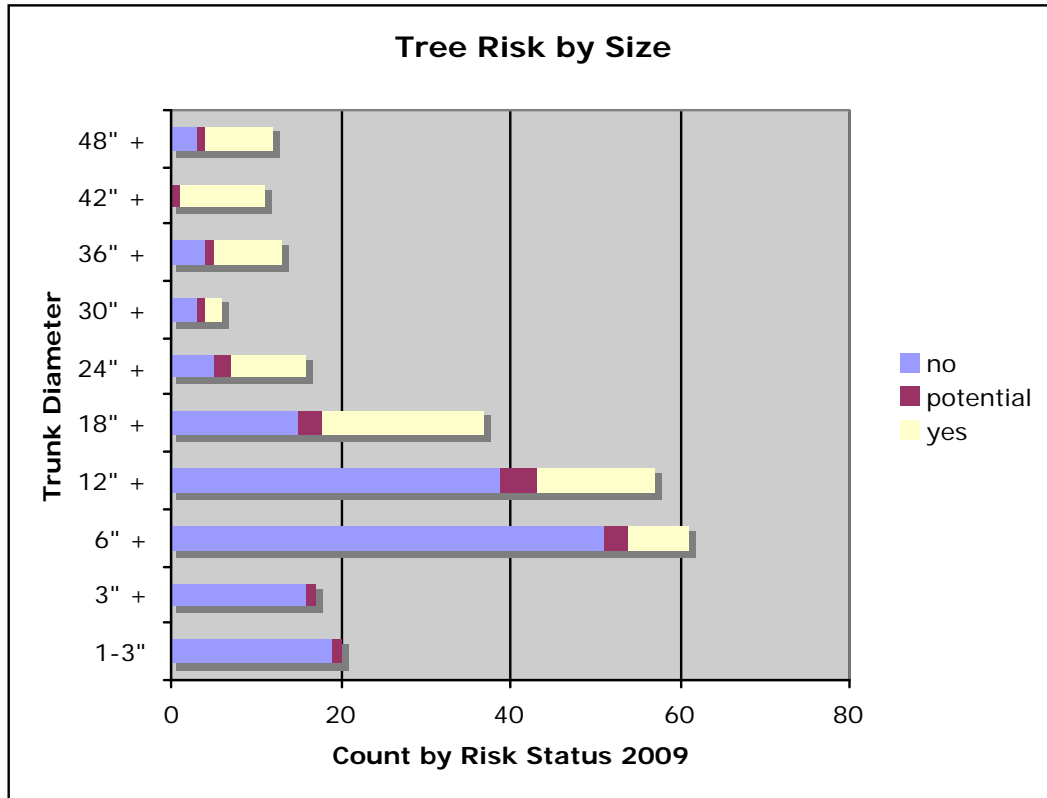
Fig. 10.3.15 Tree Risk by Size. (2009, Source: Arbutus Design)

Tree risk and tree condition often go hand-in-hand, but not always. A tree in poor condition can pose no risk if it is declining but has neither major defect nor target. Conversely, a healthy, vigorous tree may pose a risk if its structure is flawed and prone to breakage. Both condition and risk are parameters that predict tree longevity in the landscape (Fig. 10.4.4). Active management sometimes can improve condition or risk status, through pruning, health treatment, diverting foot traffic, etc.

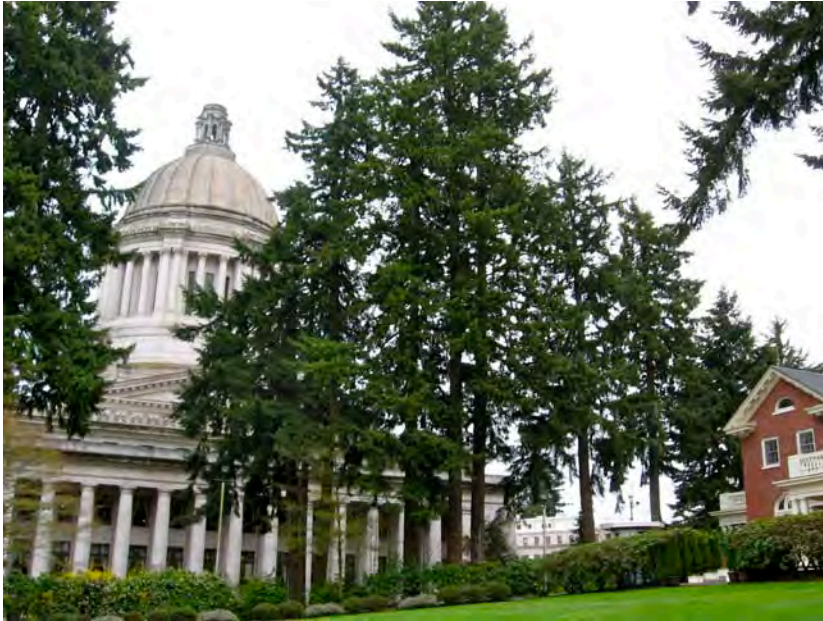
Fig. 10.3.16 Douglas firs dominate Mansion landscape, vestige trees from adjacent native forest. Specimens growing in lawn are especially affected by root decay. (April 2009, Source: Arbutus Design)

Tree condition follows a similar pattern on the Mansion property to that in the remaining developed WCC landscape, with 57% of trees rated good or excellent, 43% poor or fair. Trees exhibiting current or potential risk total 25% of the population, and represent just five of 21 taxa. The vast preponderance are large old Douglas firs. In fact, 70% of Douglas firs were identified as posing current or potential risk – an unfortunate finding given the character-defining importance of this species to the Mansion grounds.

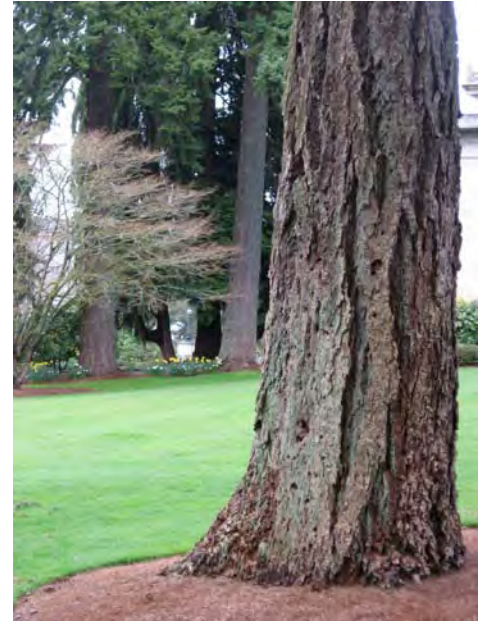
Fig. 10.3.17 70% of Douglas firs exhibit some risk; fewer than half are in good to excellent condition (April 2009. Source: Arbutus Design)

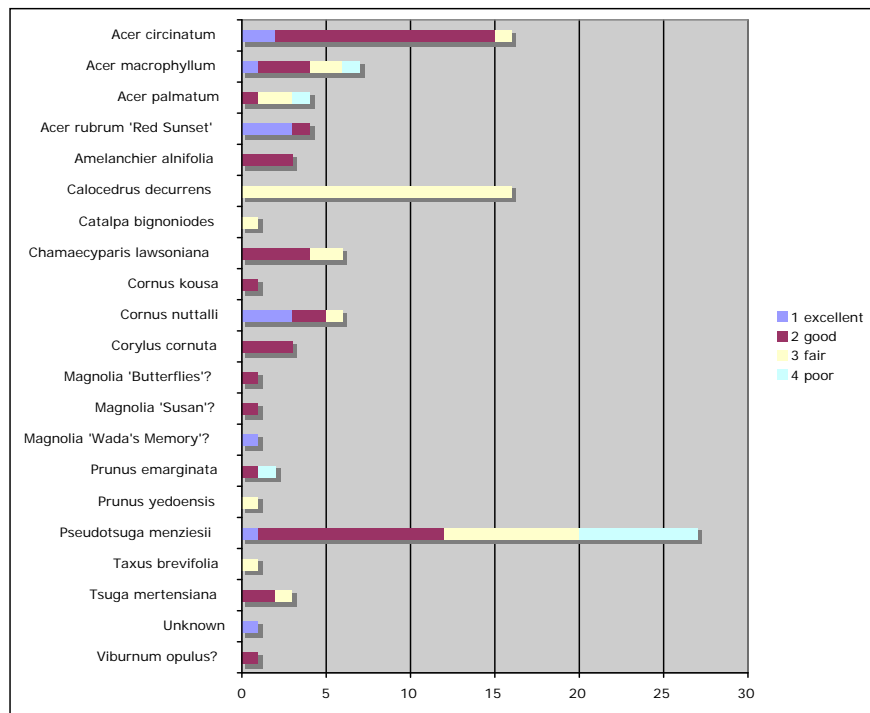
Fig. 10.3.18 Graph of Condition and Count of Tree Species (2009. Source: Arbutus Design)

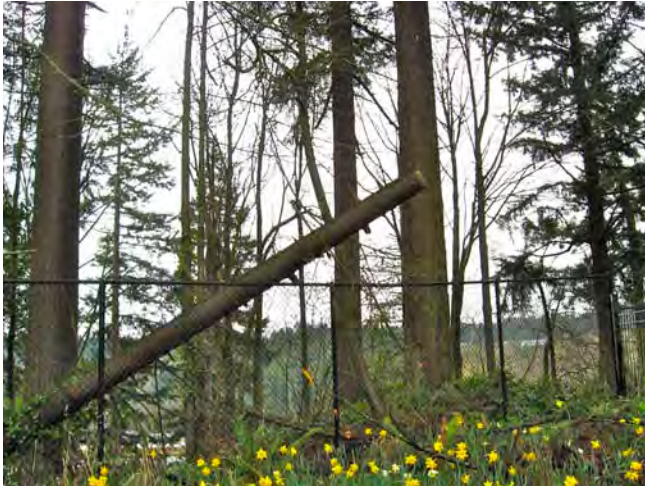
Fig. 10.3.21 Douglas fir dominates the west bluff's mixed deciduous-coniferous forest; some are well over a century old. (April 2009, Source: Arbutus Design)

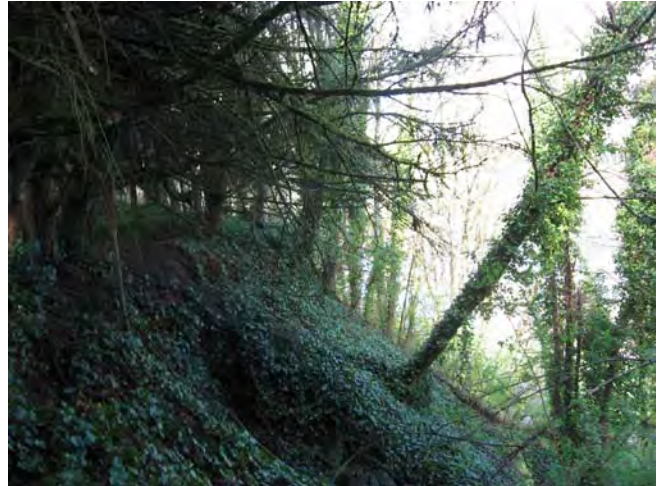
Fig. 10.3.22 Most 'green' on the slide prone north greenbelt slope is English Ivy growing in and under deciduous trees. (April 2009. Source: Arbutus Design)

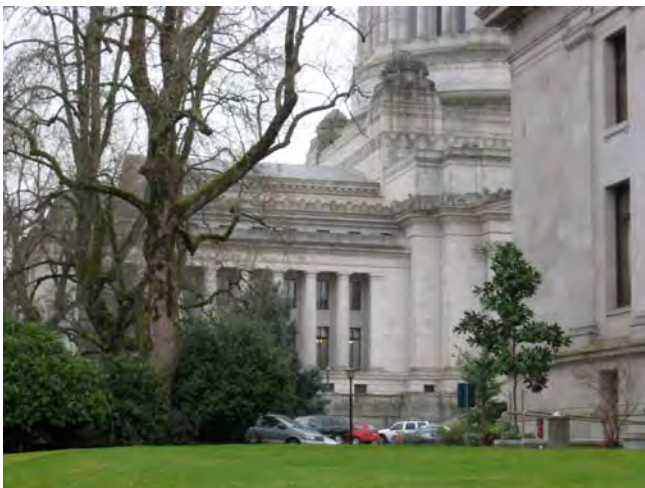
Fig. 10.3.25 Overgrown base plantings crowd trees and obscure view of Capitol; on right, new perimeter vegetation will restore intended scale. (January 2009, Source: Arbutus Design)

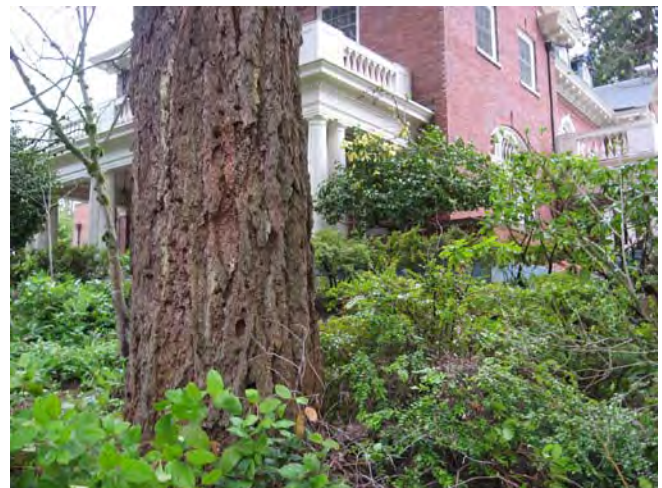
Fig. 10.3.26 Lush native vegetation partially surrounding the Governor’s Mansion extends habitat from forest into the developed campus landscape (April 2009. Source: Arbutus Design)

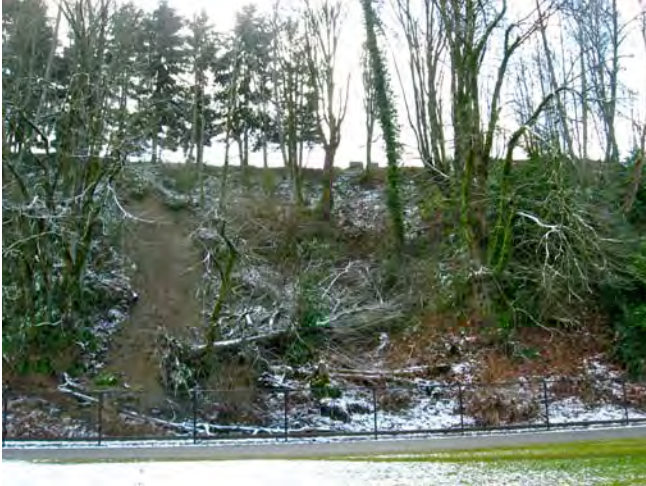
Fig. 10.3.28 Tree uprooted by recent north bluff landslide further opens canopy to invasives and soil to erosion. (March 2009, Source: Arbutus Design)

blackberry -dominate in several areas. Deep slides on the north bluff have been corrected through geotechnical improvements and surface vegetation installed to strengthen the upper soil layer. New slides are evident further west along the slope, and have uprooted multiple trees. Landscape management atop the bluff must help protect rather than damage these vulnerable edges.

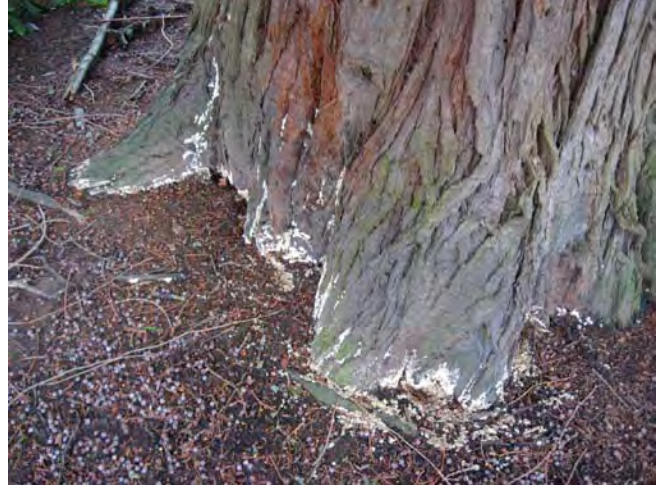
Fig. 10.3.29 Compaction and water-borne soil fungi contribute to butt and root decay in campus trees like this conifer. (November 2008. Source: Arbutus Design)

Poor drainage and soil-borne pathogens pose considerable challenges to plant health throughout the campus landscape. Multiple root rots affecting significant trees have been diagnosed and treated over the course of the past decade. Some trees have been lost. Decay takes a continuing, largely invisible toll on both trees and shrubs. Factors of species susceptibility, compaction, physical damage, poor drainage and old age combine to threaten valuable campus vegetation. Decay cannot be reversed, but can be slowed or even arrested through aggressive management. That said, decay is a natural part of plant senescence. As living systems, landscapes need periodic regeneration planting.

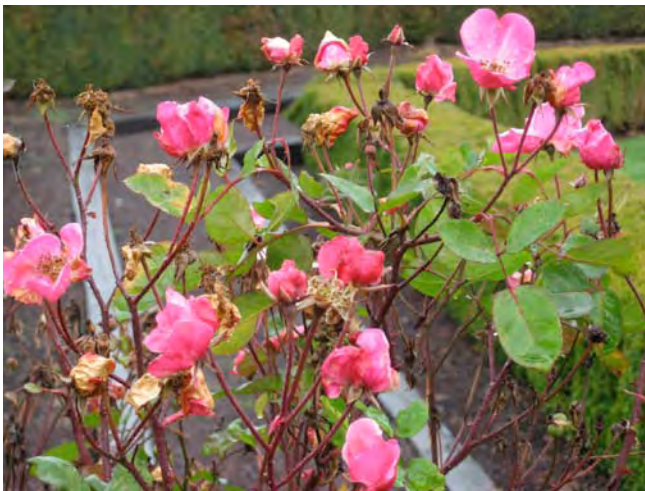
Fig. 10.3.30 Deer frequently browse rosebuds, but avoid thorny plant parts. (December 2008, Source: Arbutus Design)

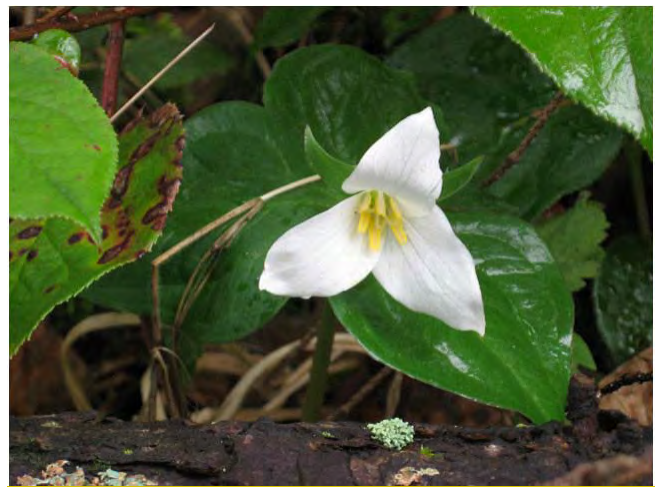
Fig. 10.3.31 Deer leave crocus and native trillium (above) alone, but feast on many other bulbs. (April 2009, Source: Arbutus Design)

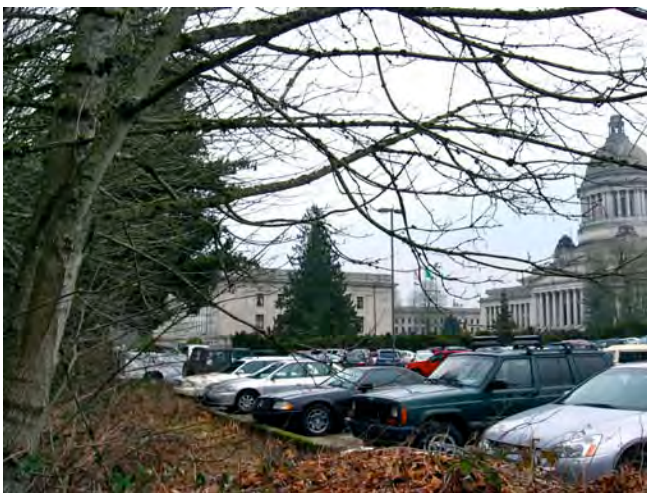
Fig. 10.3.32 West end of campus has potential for landscape development that fulfills 1928 Olmsted General Plan. (January 2009, Source: Arbutus Design)

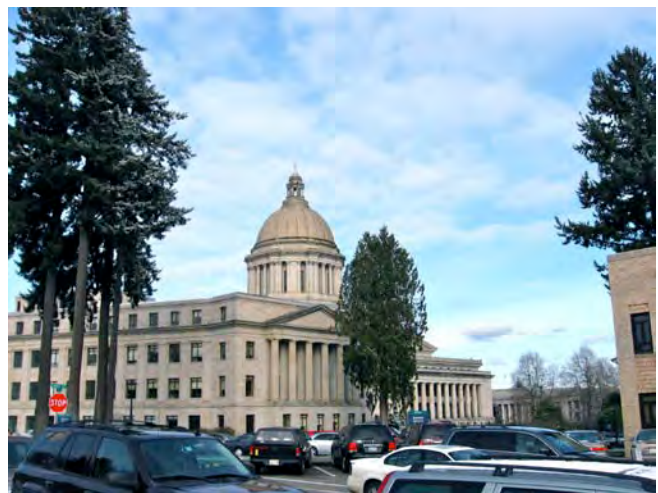
Fig. 10.3.33 Surface parking lots and structures along south campus edge are slated for new buildings and plantings. (March 2009, Source: Arbutus Design)

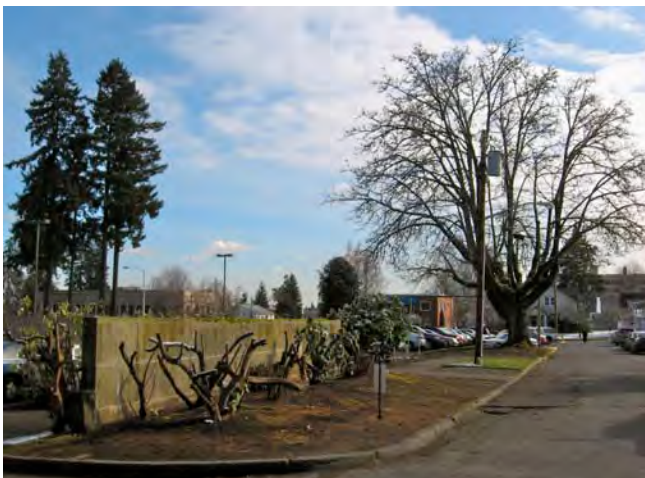
Fig. 10.3.35 Front: row of vine maples and rhododendrons damaged by misdirected hard pruning. Rear: specimen bigleaf maple well-pruned by professional arborist. (March 2009, Source: Arbutus Design)

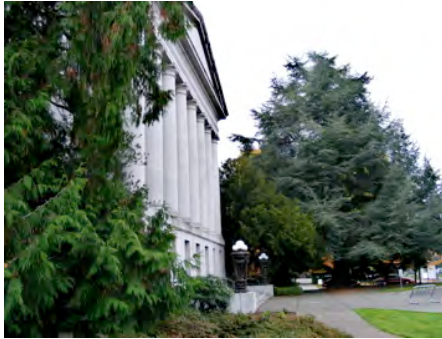
Trees & tall shrubs crowd walls. Beyond: heritage cedar suffers from compaction & drops limbs in storms.

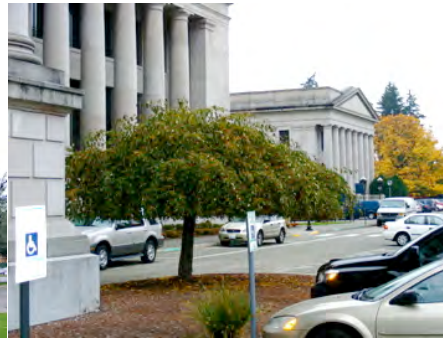
Weeping crabapple in unlikely site: dwarfed by the Capitol. pendulous branches block cars & pedestrians.

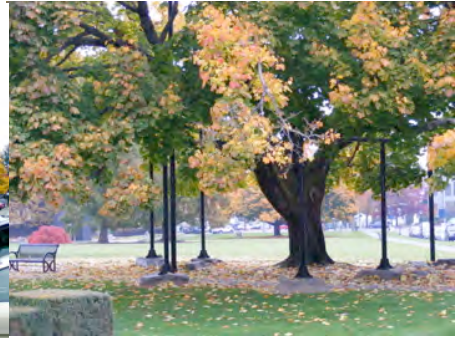
Historic maple in decline stands only with external supports; no nearby replacement has been planted yet.

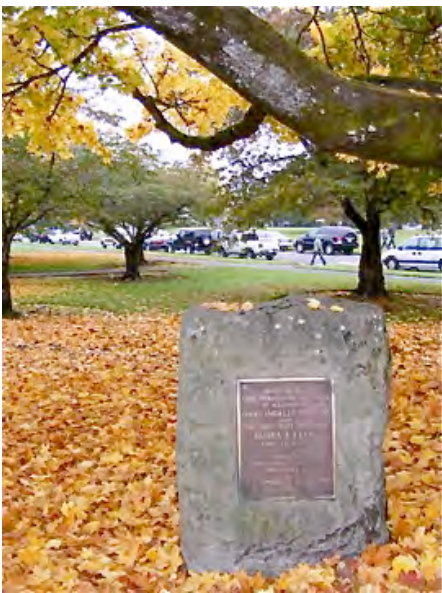
Commemorative trees deserve special care, but several are old, defective, sick or poorly sited.

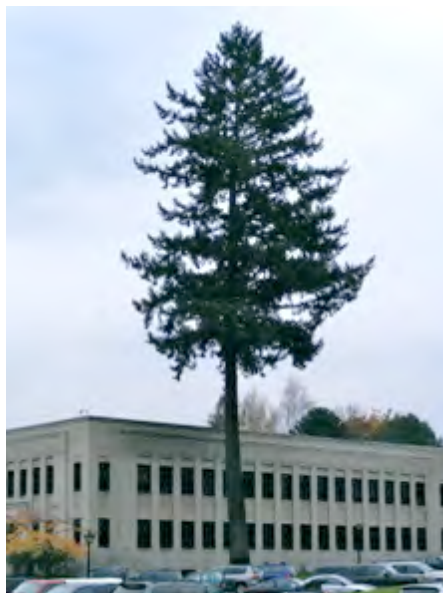
Many remnant native trees have been lost; some that remain pose a risk due to decay, defects & size.

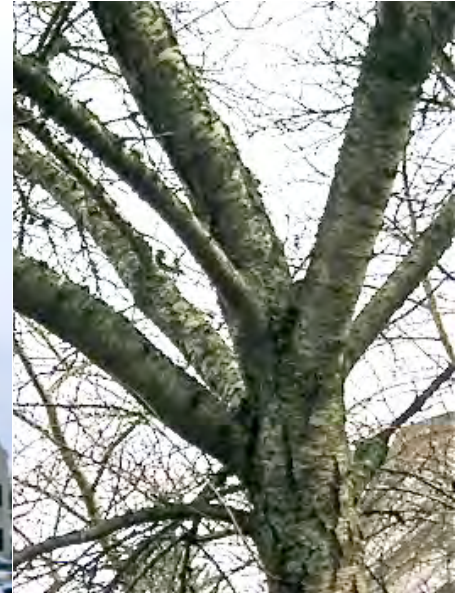
Mature cherry tree with congested, weak branch structure is too big to fix by pruning & prone to breakage.

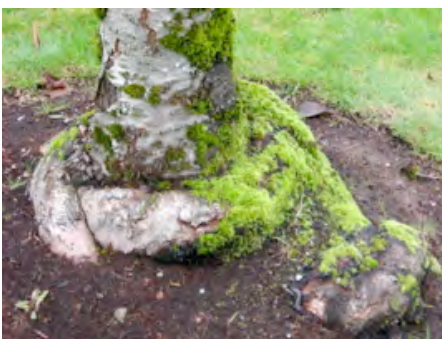
Poor drainage & compaction promote girdling & surface roots in lawn. If scalped, roots decay.

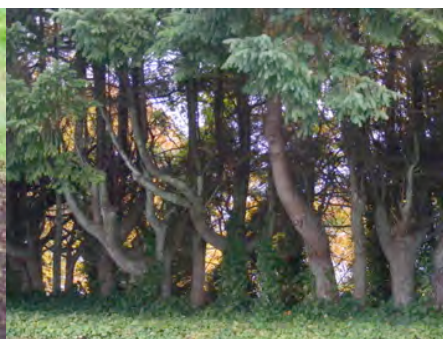
Topped, ivy-choked native firs on bluff edge are too damaged to restore; firs also block a key vista.

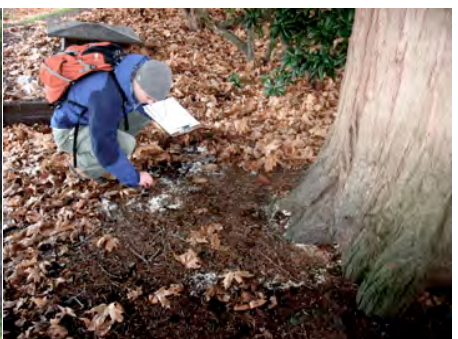
Fungi at tree base & rootzone suggest advanced decay. Many diseases affect trees on campus.

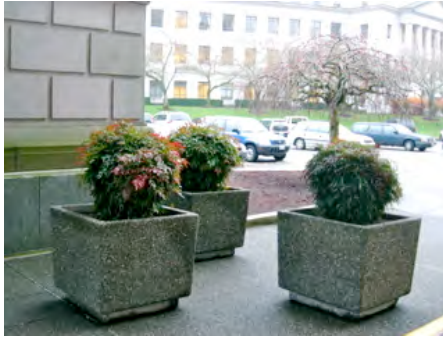
Nandina in planters has been sheared, although its natural habit & texture would work well here.

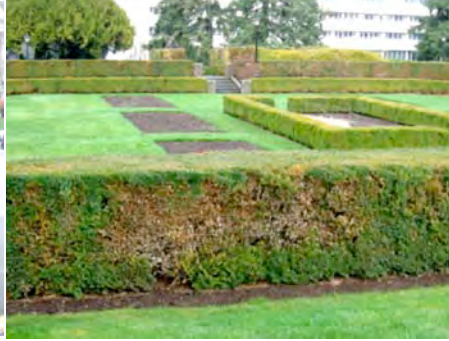
Boxwood hedge around sunken garden suffers disfiguring dieout probably due to root disease.

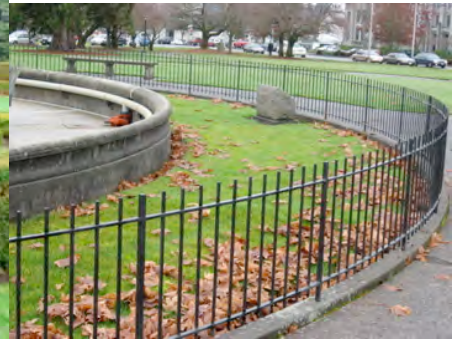
Turf within fence is inefficient to mow. Low flowering perennials & shrubs would enhance this feature.

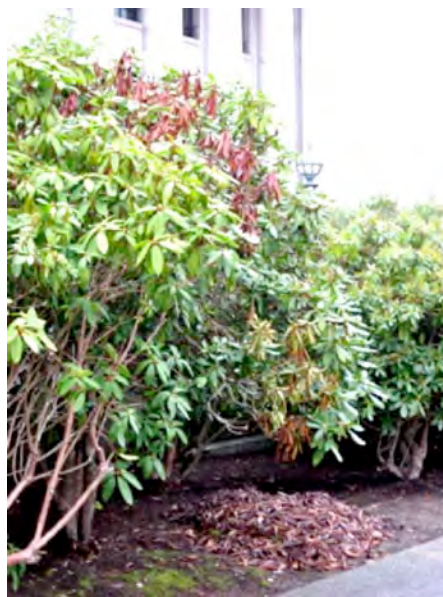
Leggy rhodies in mossy, bare soil; note leaf litter is being removed. Dying plant likely has fatal root rot.

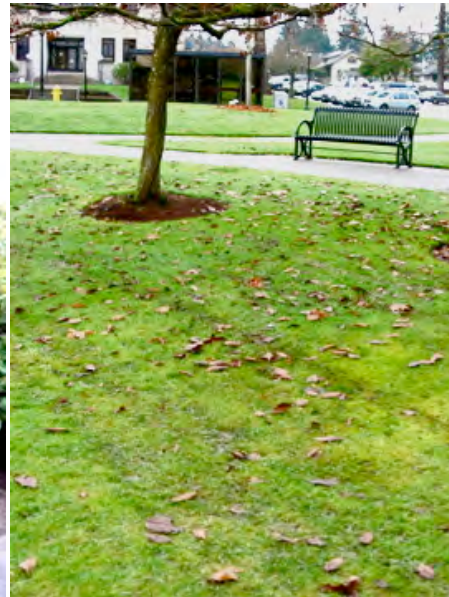
Mower tracks and moss in poorly-drained lawn area. Wet season mowing increases compaction.

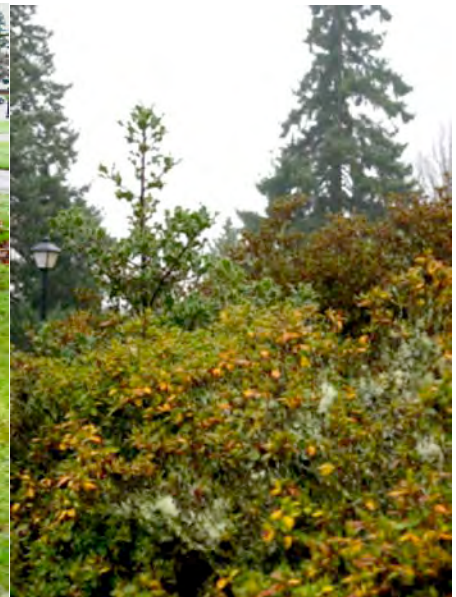
Old azaleas by Sunken Garden are lichen filled & need rejuvenation pruning. Note invasive holly (left).

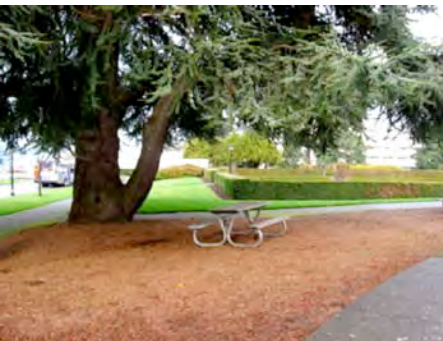
Lack of understory vegetation allows foot traffic under high value tree and compacts its rootzone.
