West Capitol Campus

Historic Landscape Preservation Master Plan

June 2009 | GA project # 08-099

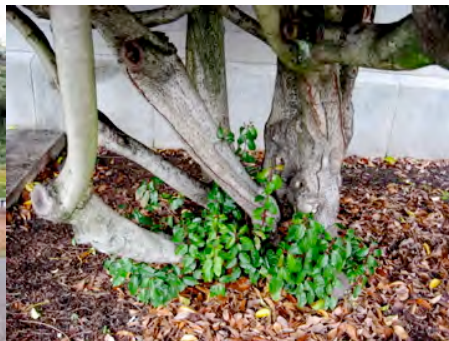
Treelike Portugal laurel is resprouting from base. REMoving decayed trunks above can renew it.

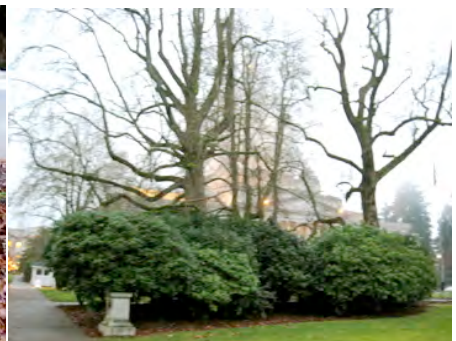
Large camellias & rhodies engulf trunks of historic tulip poplars & need deep regeneration pruning.

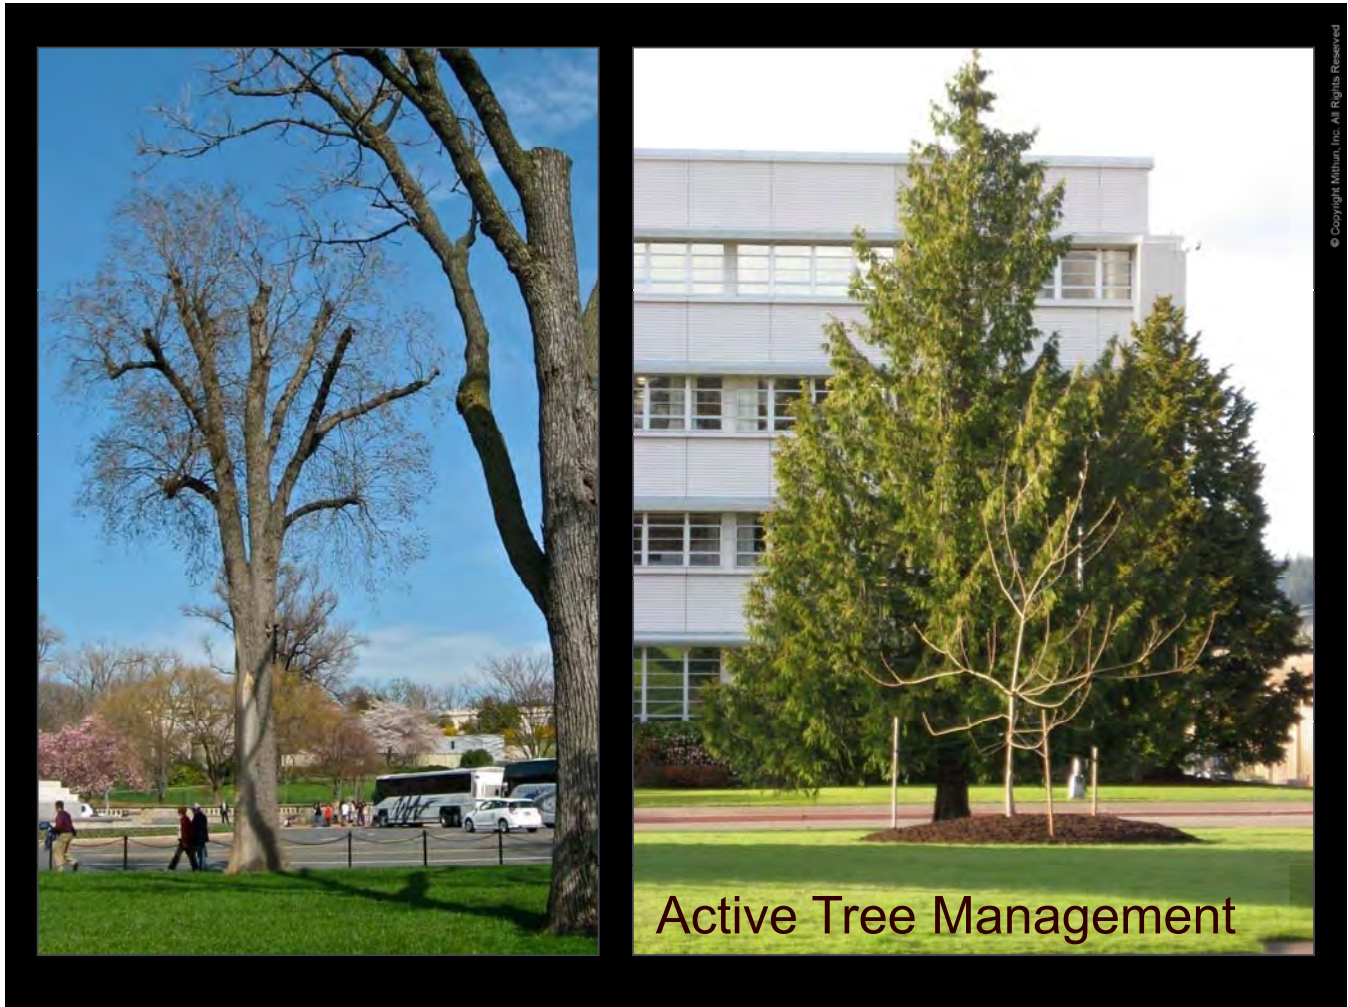
Fig. 10.5.1 Active Tree Management: Left: Mature trees on UW Capitol Campus pruned to safely extend their lives. Right: New memorial butternut tree planted on West Capitol Campus, spring 2009 (April 2009, Source: Arbutus Design)

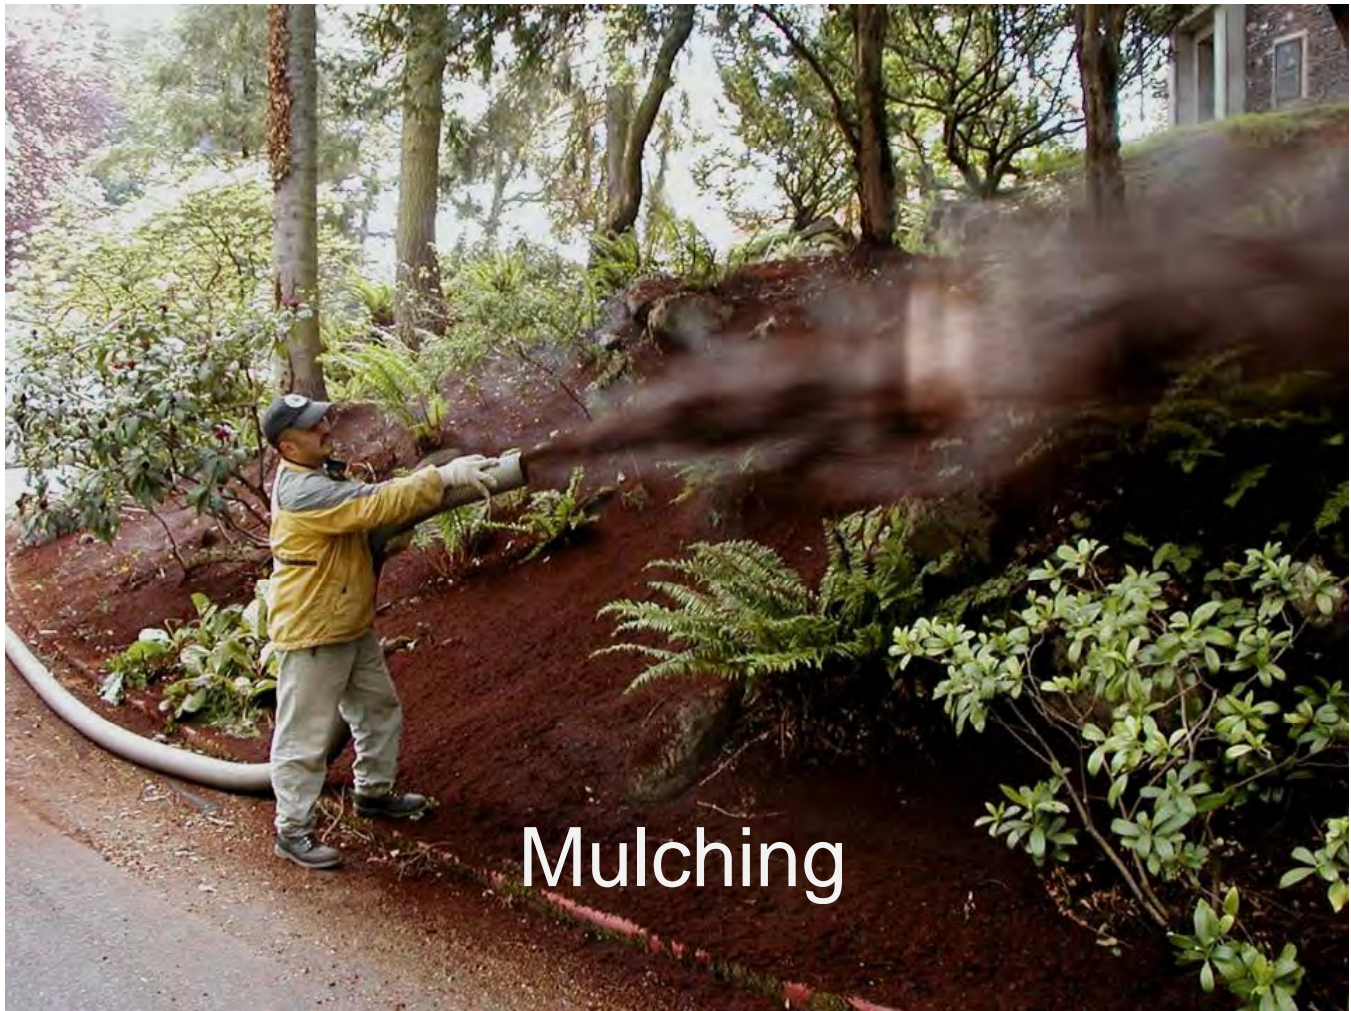
Fig. 10.5.2 Organic mulches improve soil health & fertility and reduces compaction. (2004, Source: Seattle Parks and Recreation)

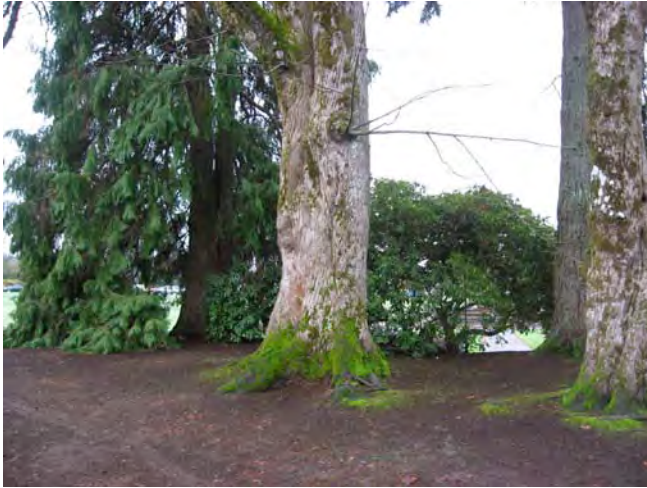
Fig. 10.5.4 Heavy foot traffic and bare soil under native trees in remnant grove contribute to compaction, poor drainage & root damage/decay. (December 2008, Source: Arbutus Design)

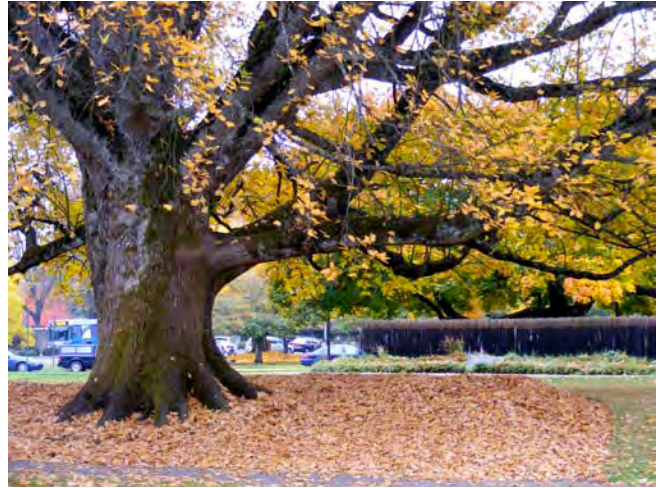
Fig. 10.5.5 Leaves collected under canopy of English oak provide root-protecting mulch (October 2008, Source: Arbutus Design)

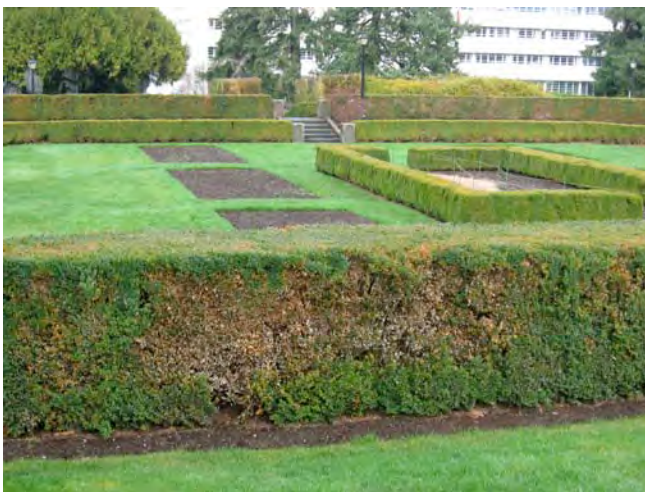
Fig. 10.5.8 Diseased, unattractive boxwood hedge. (Source: Arbutus Design)

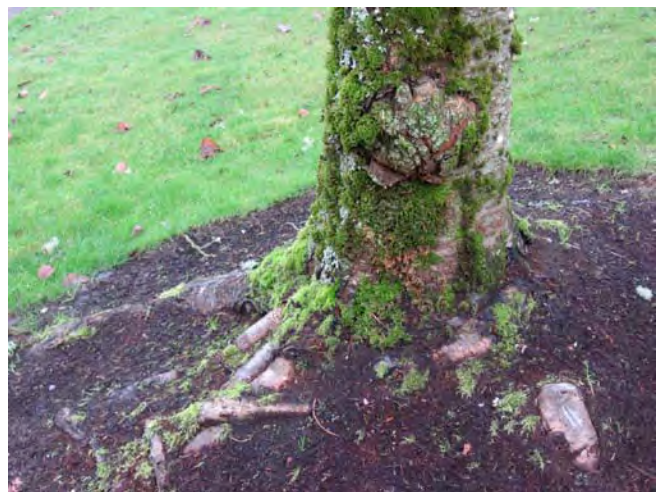
Fig. 10.5.9 Typical Yoshino cherry root condition. (Source: Arbutus Design)

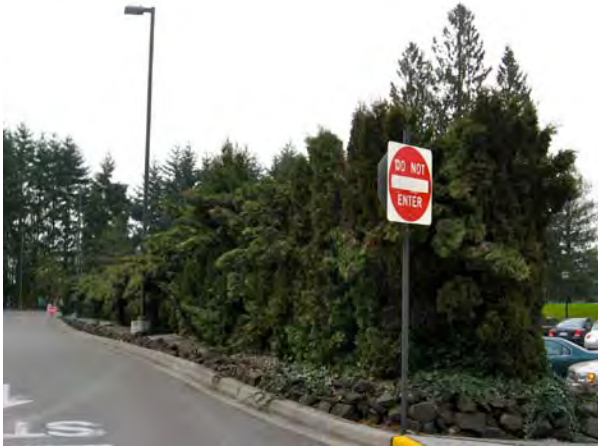
(top) Fig. 10.5.11 Last surviving red crabapple from Olmsted designed Pleasant Lane street tree allee (October 2008, Source: Arbutus Design).

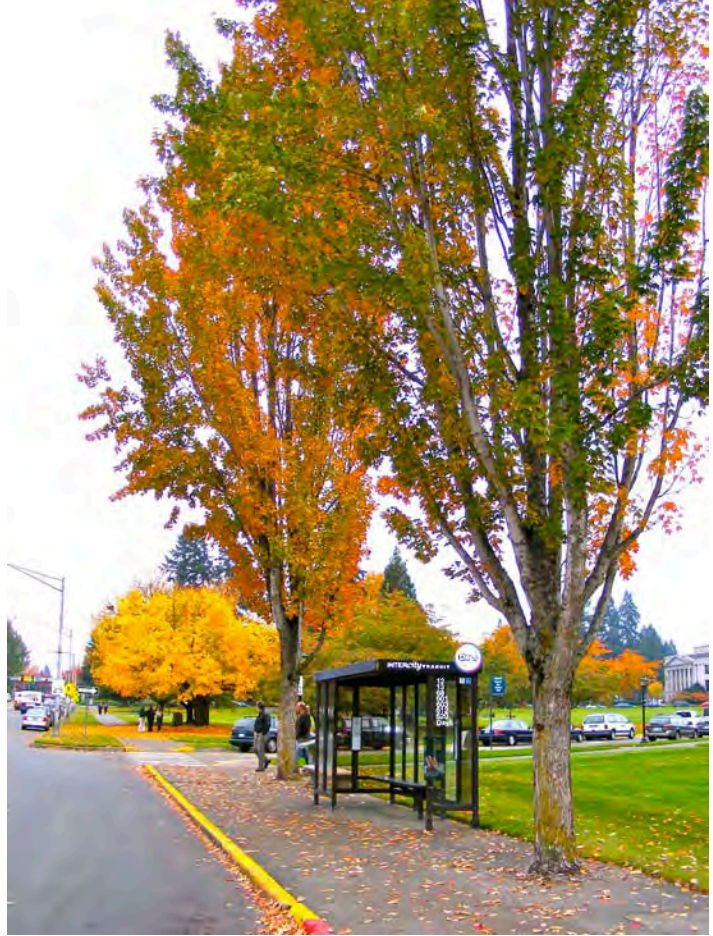
Fig. 10.5.13 Pair of columnar maples provide the only West Campus street trees along Capitol Way. They lack rooting space and the broad, arching form of Olmsted-intended elms. (October 2008, Source: Arbutus Design)

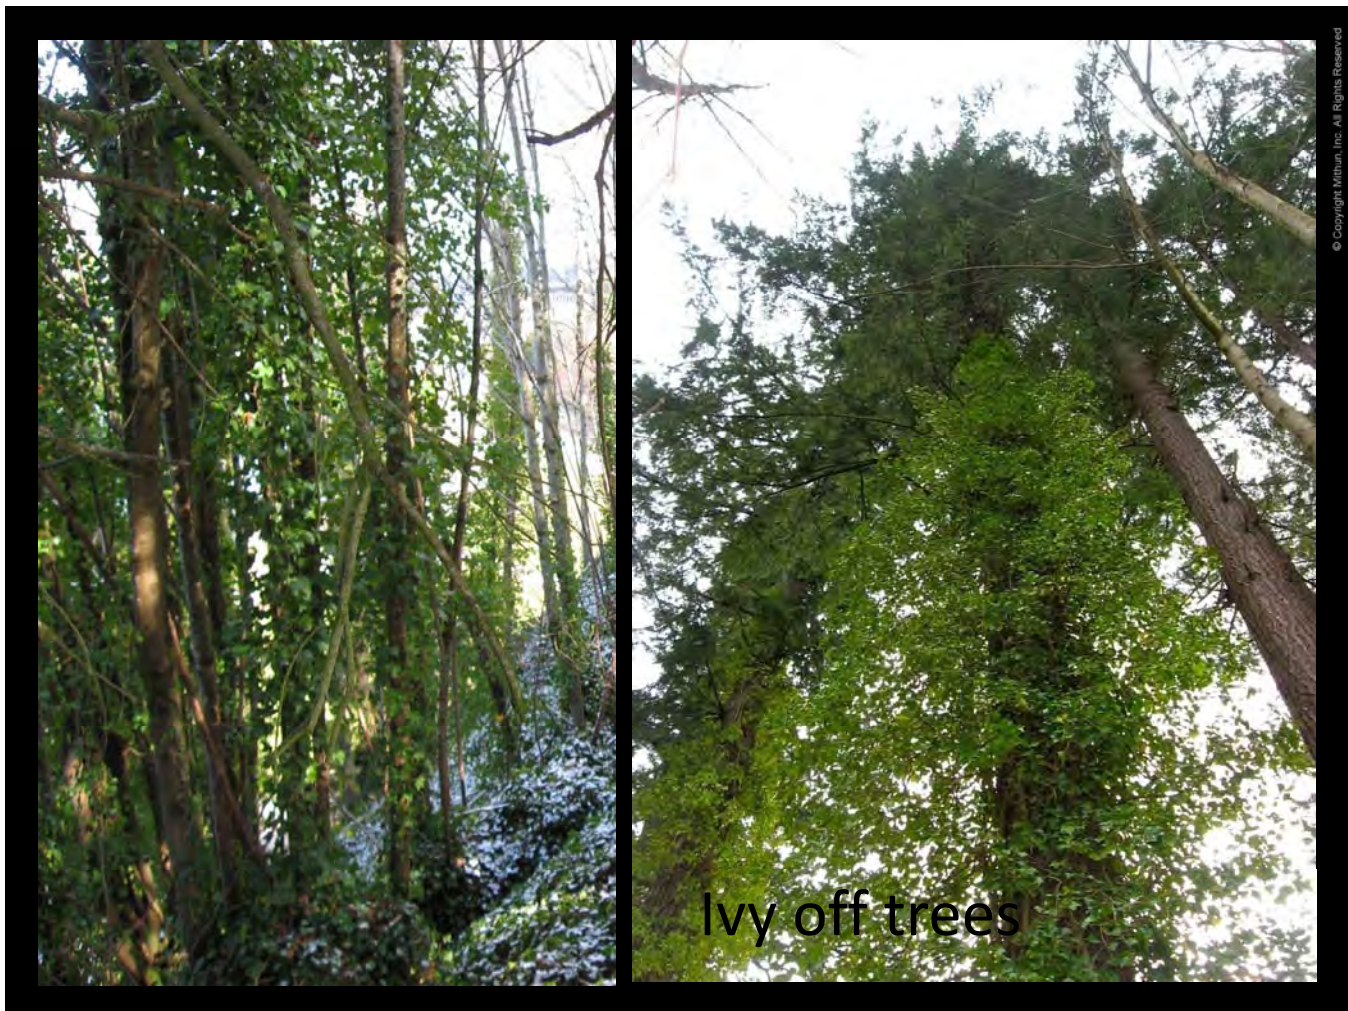
Fig. 10.5.16 Ivy on trees. (Source: Arbutus Design)

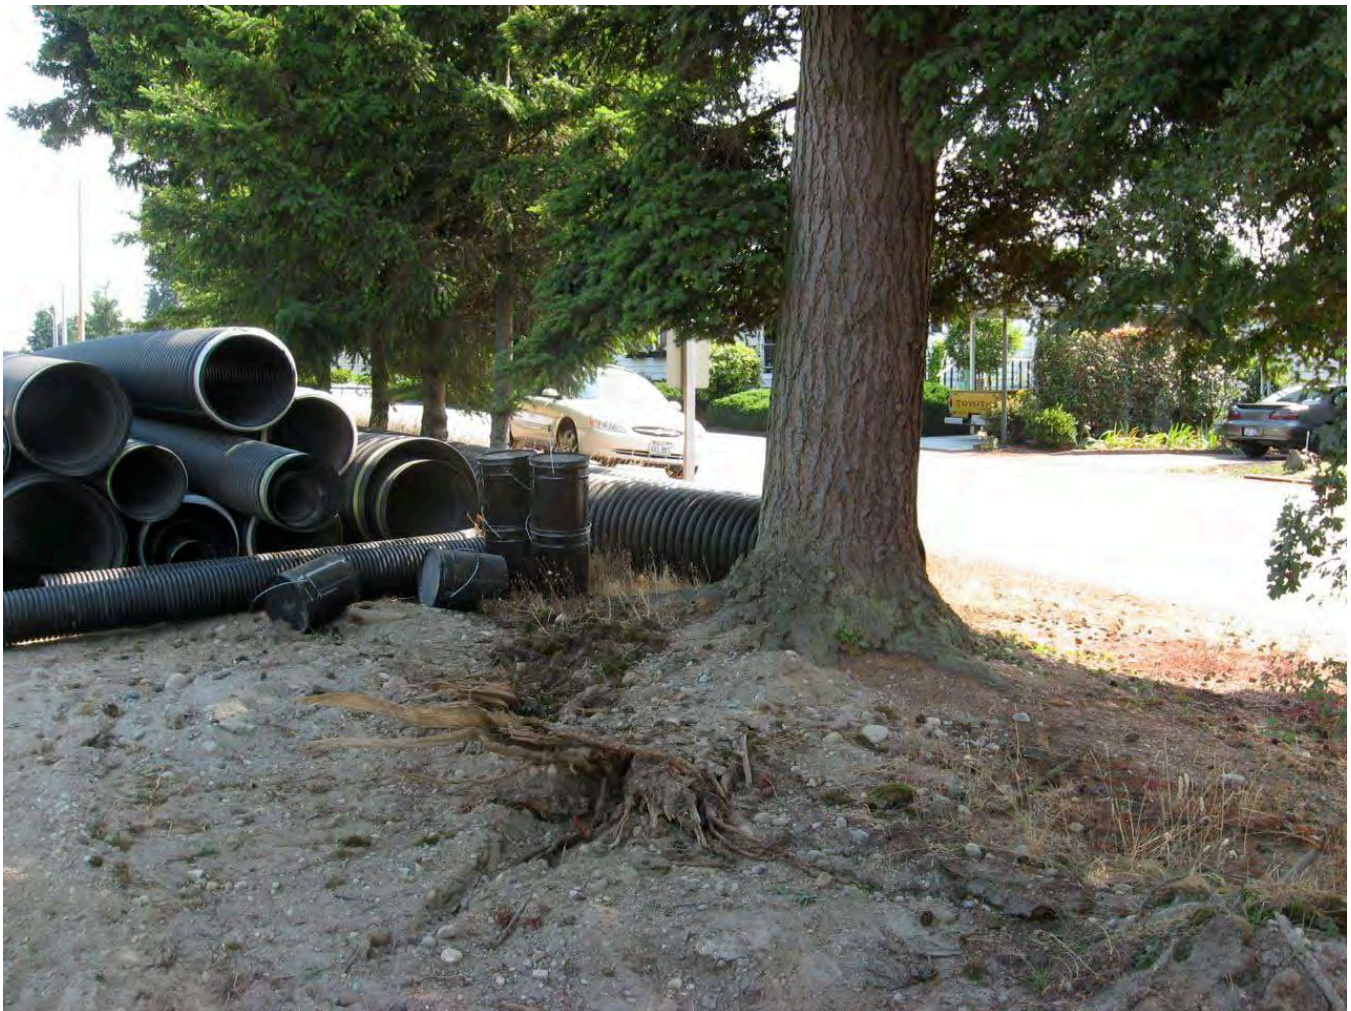
Fig. 10.6.1 Careful drainage system planting & installation could have prevented tree root damage. (August 2005, Source: Arbutus Design)

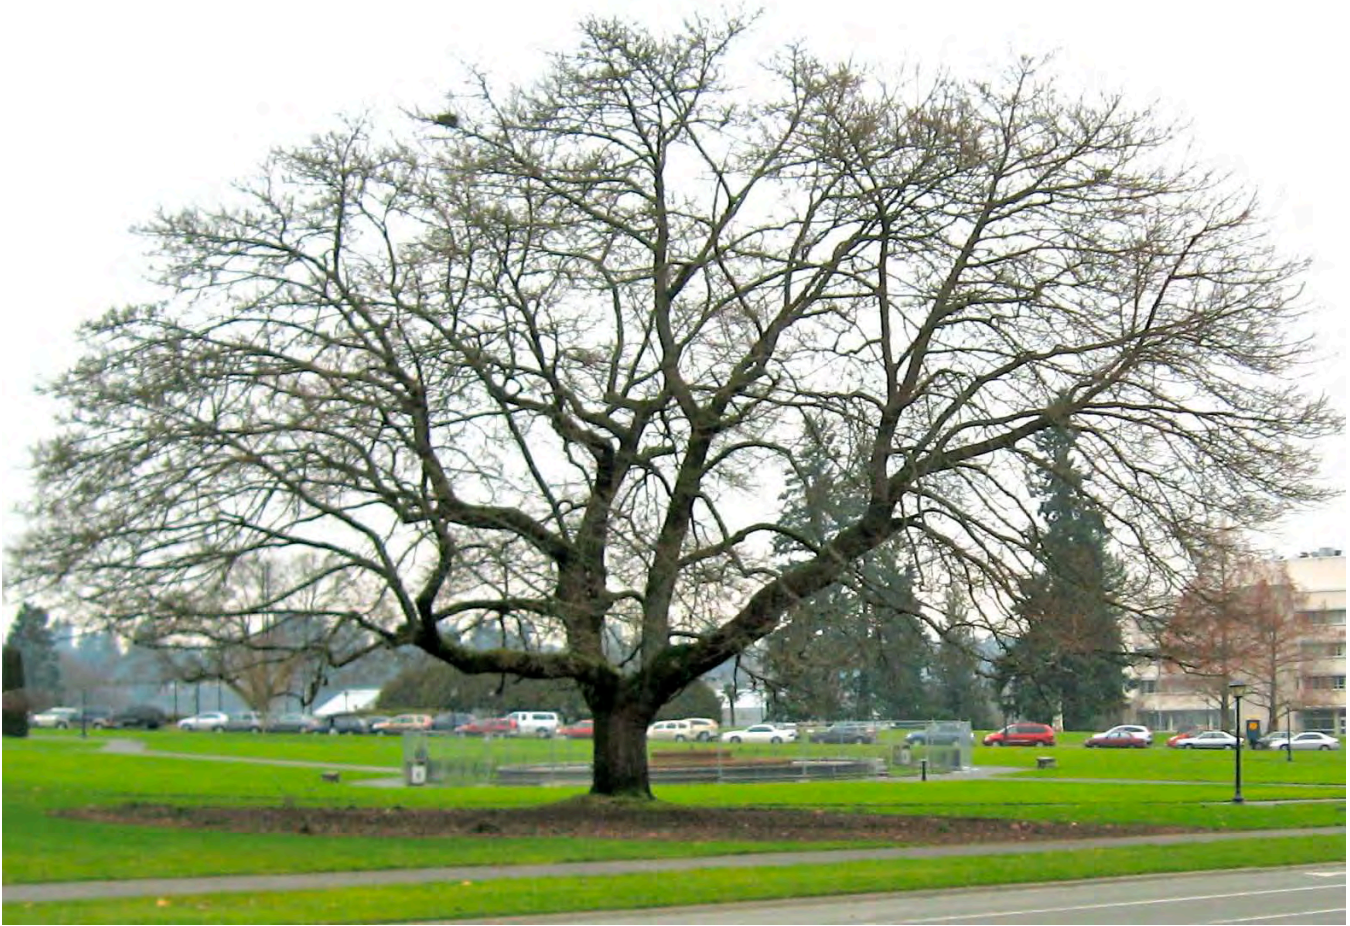
Fig. 10.6.2 Heritage Norway maple ‘miracle tree’ regained vigor after organic soil amendments & mulch were applied, along with air spade root treatment, pruning, & drainage work. (January 2005, Source: Arbutus Design)

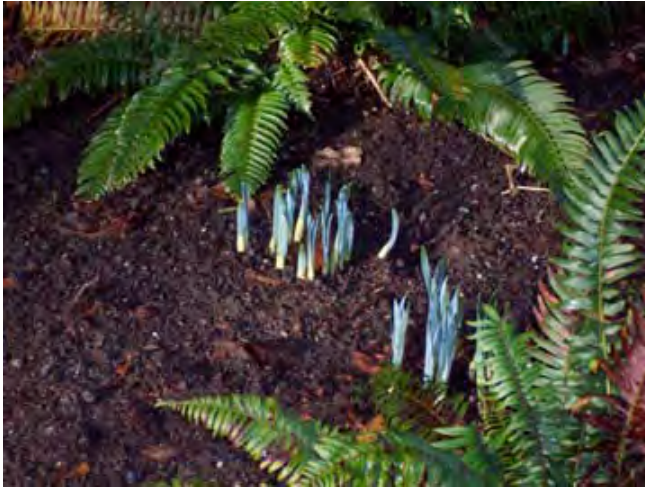
Fig. 10.6.5 Compost mulch improves plant establishment, appearance and health. (February 2006, Source: Arbutus Design)

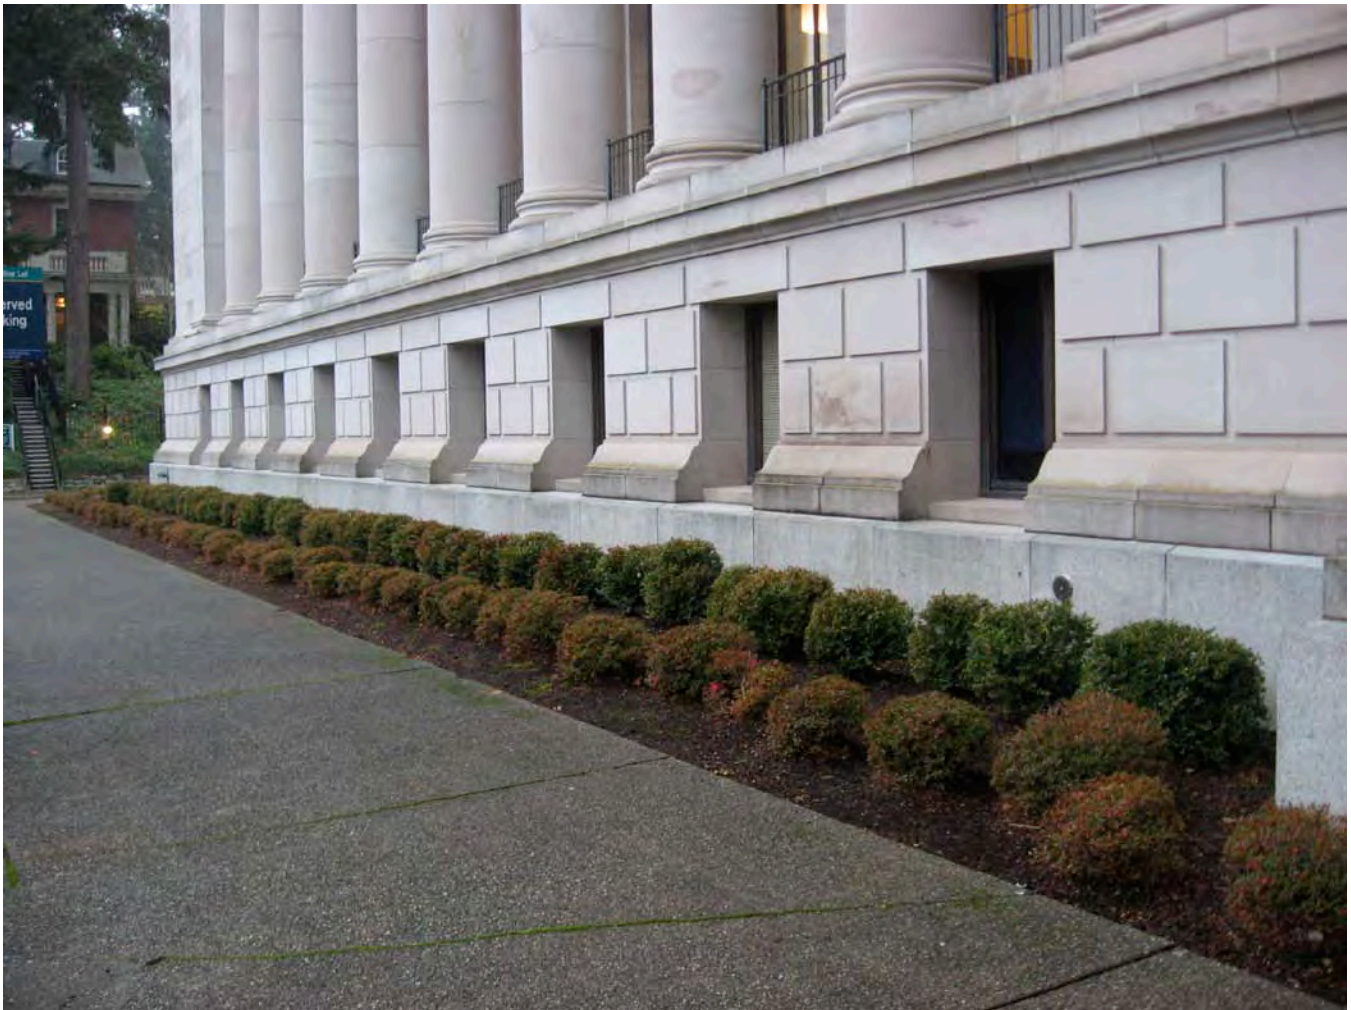
Fig. 10.6.8 Shrubs should be pruned only for hedging or topiary, not size control. Without pruning, these plants would have fit narrow planting beds at maturity. (December 2008, Source: Arbutus Design)

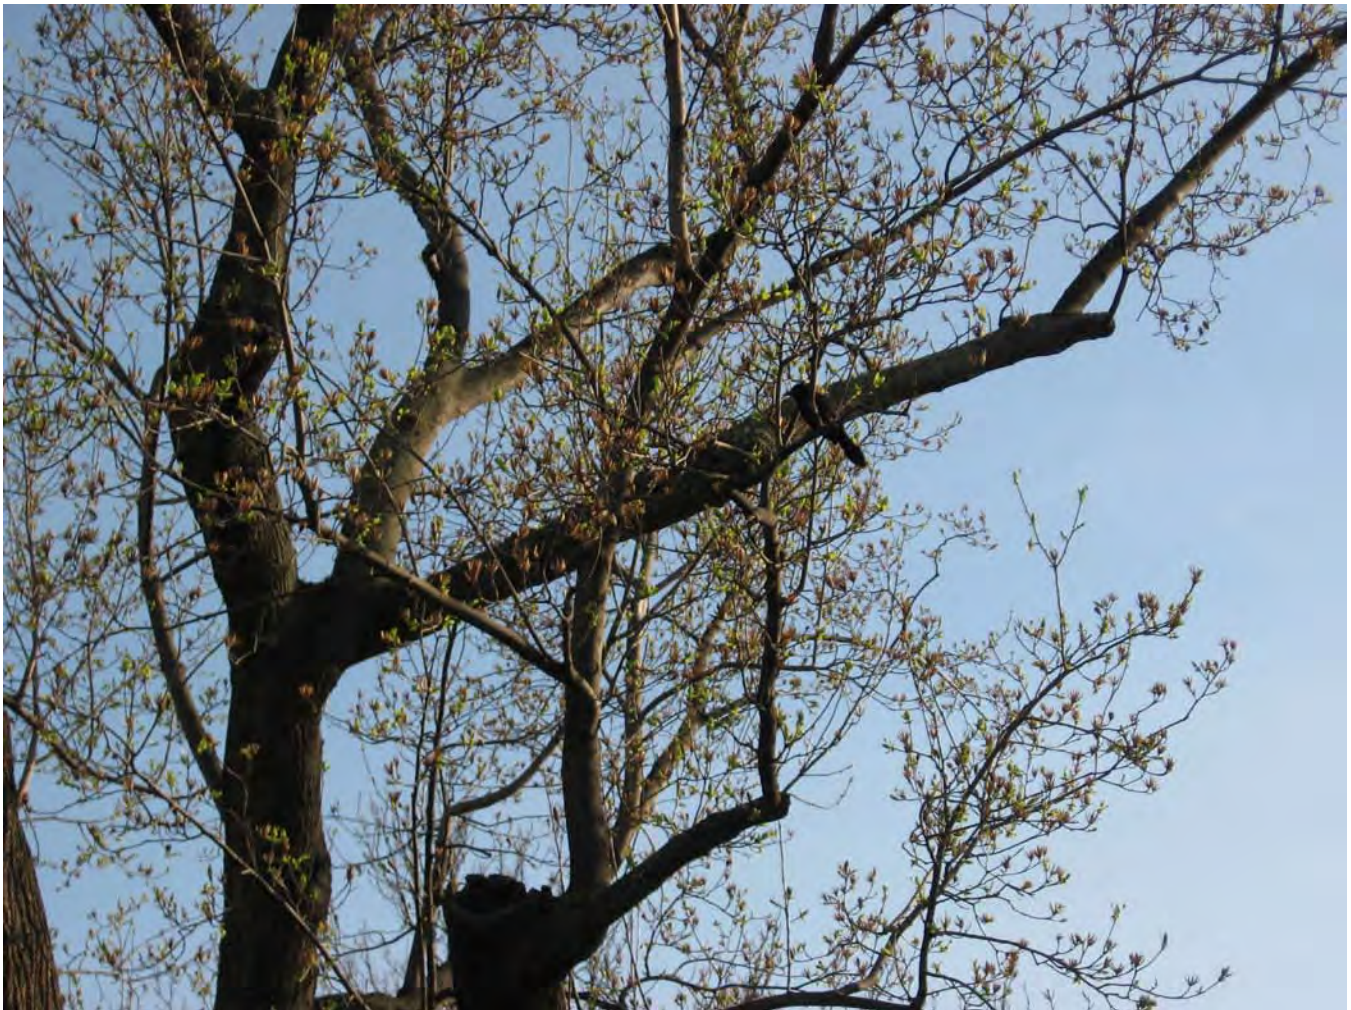
Fig. 10.6.9 Example of retrenchment pruning of veteran tree on US Capitol grounds. (March 2009, Source: Arbutus Design)

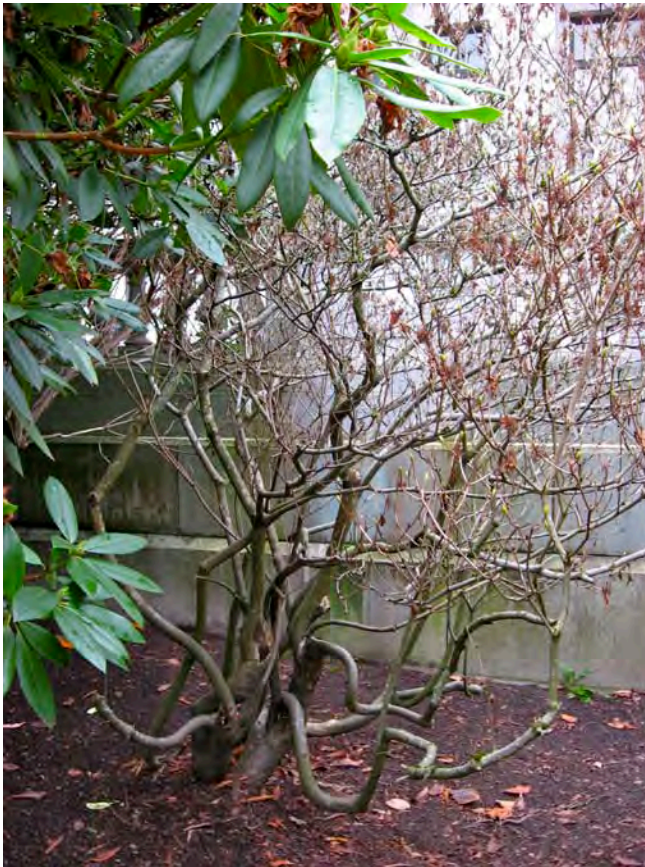
Fig. 10.6.10 Long unpruned deciduous azalea has large stems with severe decay cavities at base. (December 2008, Source: Arbutus Design)

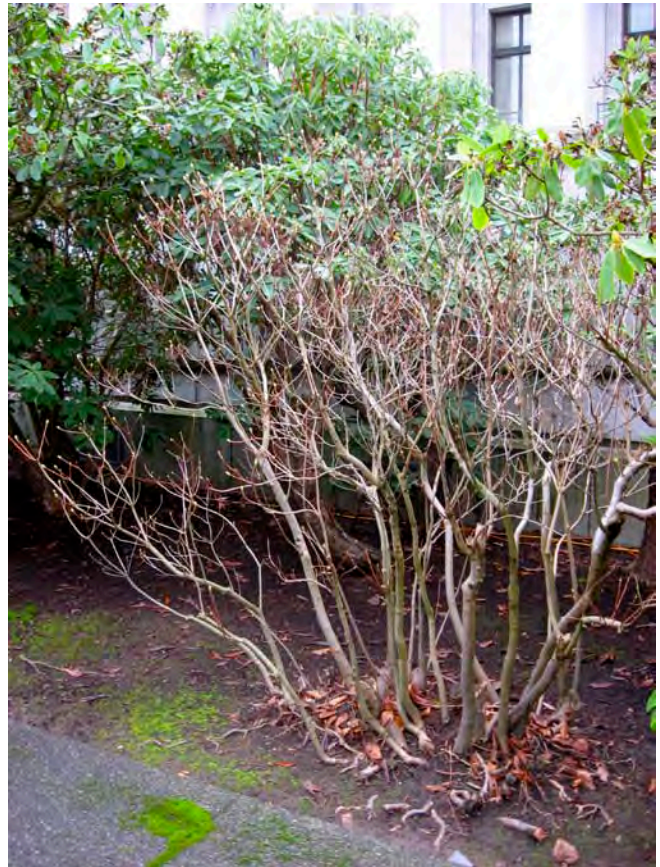
Fig. 10.6.11 Nearby azalea has well-spaced stems and nice form resulting from basal renovation pruning. (December 2008, Source: Arbutus Design)

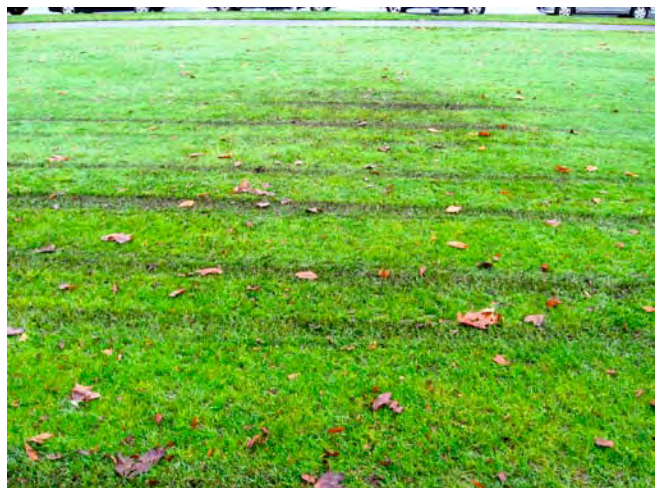
Fig. 10.6.15 (left) Increasing shade under cherry canopy and poor soil drainage make turf weak and seasonally muddy. Long-term, grass should be replaced with shade-adapted groundcovers. (December 2008, Source: Arbutus Design)

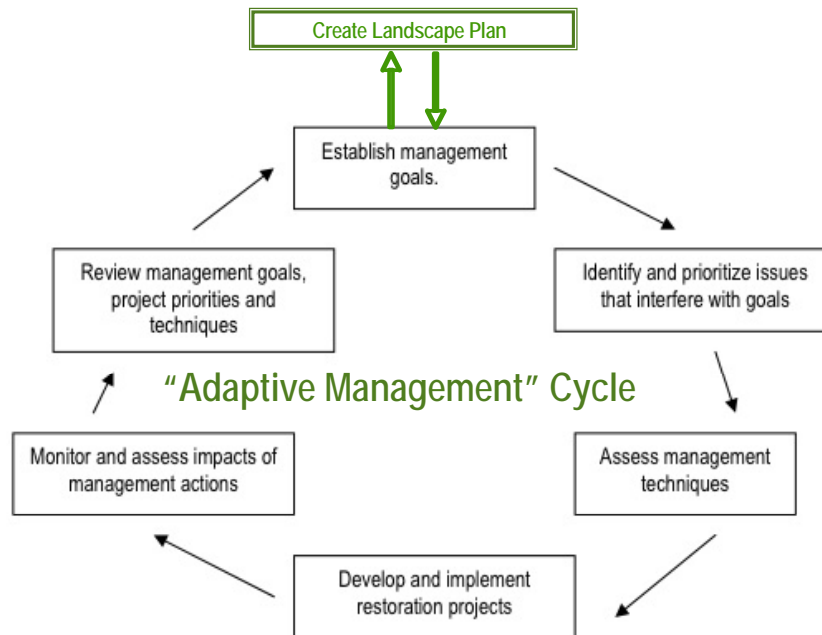
Fig. 10.8.1 Adaptive Management Cycle diagram (2009, Source: Arbutus Design)

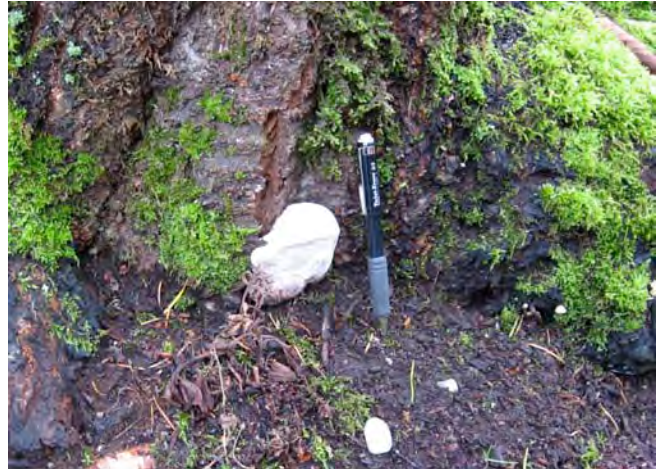
Fig. 10.8.3 Monitoring butt decay - pencil for scale (December 2008, Source: Arbutus Design)

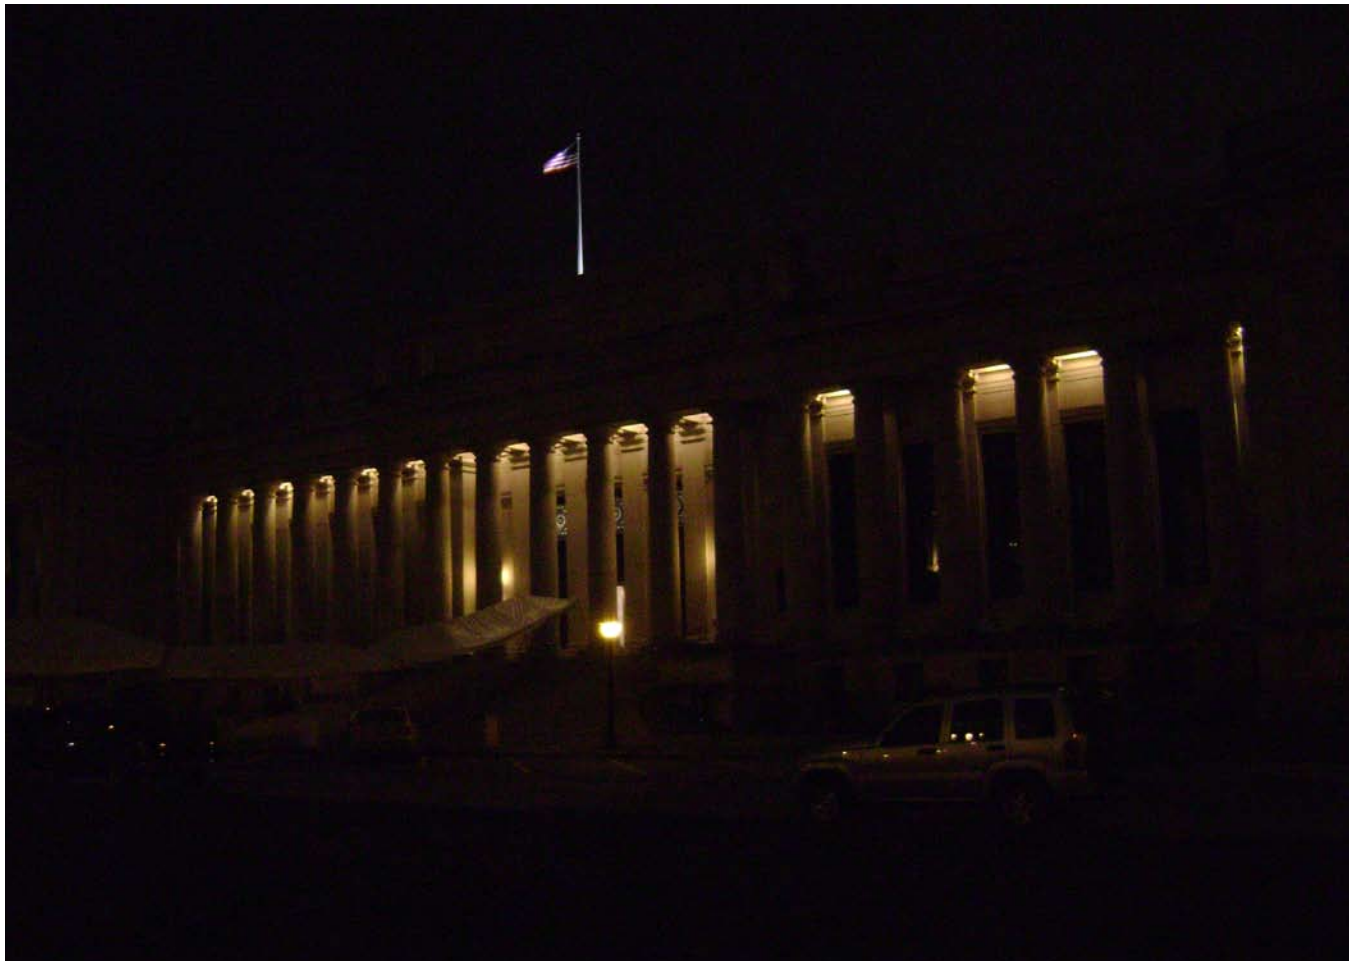
Figure 11.1 Lighting at porticos of Temple of Justice (source:Dark|Light Consulting, LLC, 2009)

Although there are a number of other light sources in use in more limited applications, including incandescent, fluorescent, and metal halide (MH), the main differentiator is that they provide “whiter” light than the HPS. These whiter sources are generally used at newer memorial sites, at decorative fixtures near building entries, and for architectural lighting at the Legislative Building and Temple of Justice entry porticos.

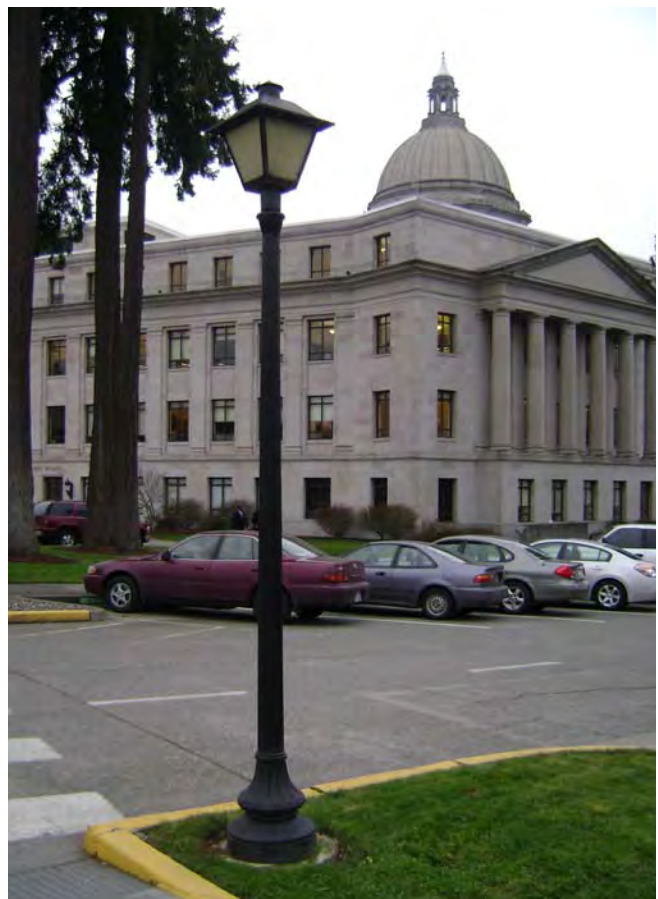
Illuminated pedestrian and vehicle circulation areas are lit with carriage-lantern style post-top luminaires with HPS lamping.

Figure 11.2 Carriage lantern style pole-mounted fixture (source: Dark|Light Consulting, LLC, 2009)

In other areas, the fixture design seems to be incongruent with patterns established elsewhere. The carriage lantern fixtures used for circulation areas are an example of this. They sharply depart from the globe typology used nearly everywhere else on the campus. Although there are historic photos showing a similar carriage-lantern type fixture, there is some design documentation to indicate that these were not the fixture type intended by the Olmsted Brothers for this application, and they may have been installed due to cost or availability issues.

Whether intended as the original design or not, the carriage lantern form was originally installed, but it is unlikely that the existing fixtures are original. First, the original fixtures would not be expected to have survived in the approximately 80 years since their installation. Second, comparing current and historic photos of the fixtures shows differences in fixture scale and detailing.

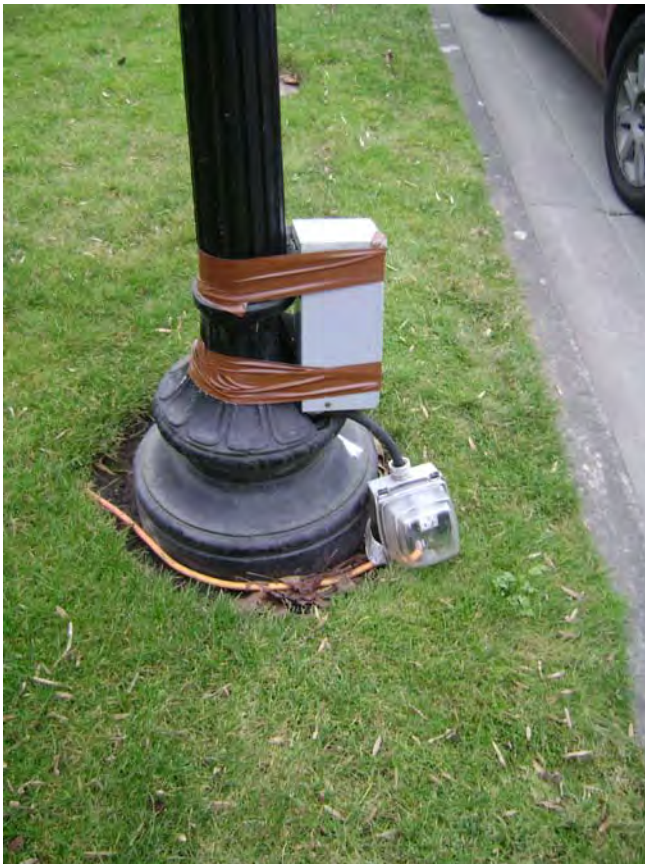
During the survey, it was noted that holiday string lights appear to be powered by outlets in enclosures attached to pole bases with duct or packing tape.

Figure 11.3 *Electrical outlet attached to light pole base as observed during site survey (source: Dark|Light Consulting, LLC, 2009)*

Should any replacement or rework of the post-top fixtures be undertaken, a parallel effort to provide safe and accessible receptacle power for holiday lights or other power needs should be undertaken, to avoid further use of the taped-on metal enclosures noted during the site survey.

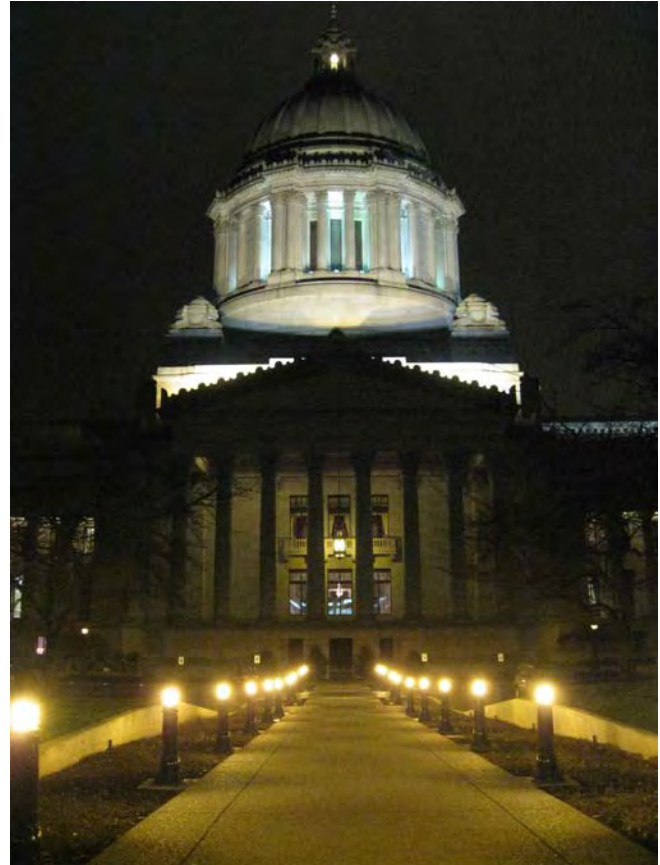
Figure 11.4 *Bollards at Sundial Circle (source: Dark|Light Consulting, LLC, 2009)*

- **Sundial Circle**
 The sundial circle itself is lit by carriage-lantern post-top fixtures located on 15th Avenue to the south, along with a substantial amount of spill light from HPS bollards on the walkway between the circle and the Legislative Building. These bollards are extremely bright, to the point of creating glare, and are the predominant nighttime element in this space because of their brightness and their sheer quantity, detracting from both the Sundial Circle and the Legislative Building.

The Sundial Circle currently suffers from a lack of focus on the circle itself, as the brightest objects in the field of view include the interior of the library, carriage-lantern fixtures on 15th Avenue, and, most notably, the high concentration of light bollards to the north leading to the Legislative Building. The quantity of bollards should be reduced, and if possible, the fixture type should be changed to one that shields direct view of the light source.

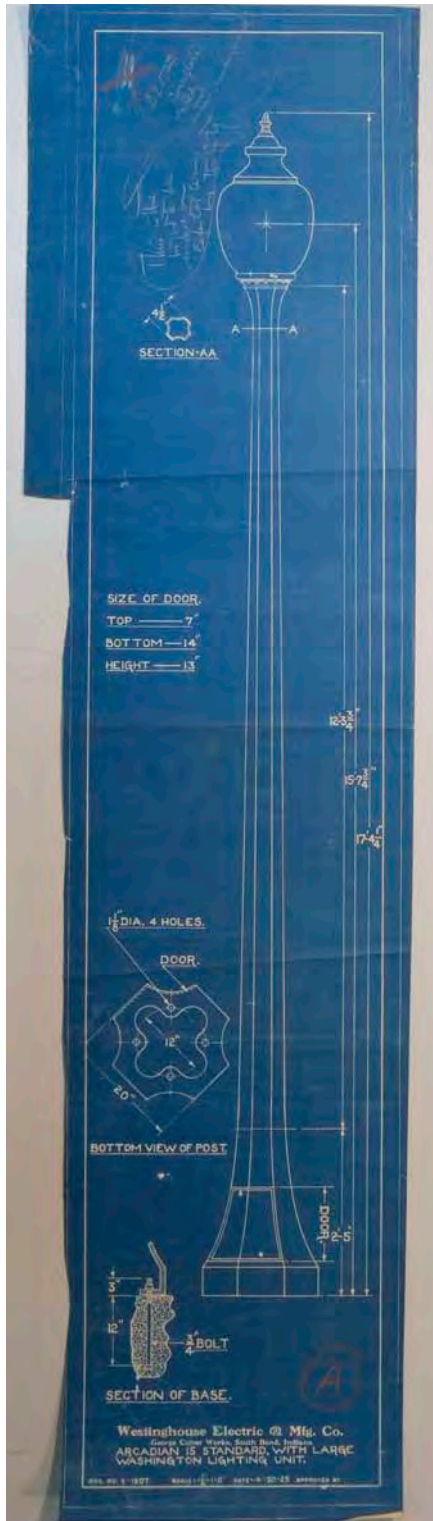
Historic design documentation shows that an “acorn” type fixture with a verdigris pole finish may have been

Figure 11.5 Historic documentation showing “acorn”-style pole-mounted lighting fixture (source: 5350_53A_TU, Frederick Law Olmsted National Historic Site, National Park Service)

intended for street lighting and pedestrian pathways. This would more closely align with the round language of the globe fixtures, as opposed to being the sole square fixture on campus, and strike a more coherent tone in keeping with the stature of the Campus architecture, instead of offering a discordant note.

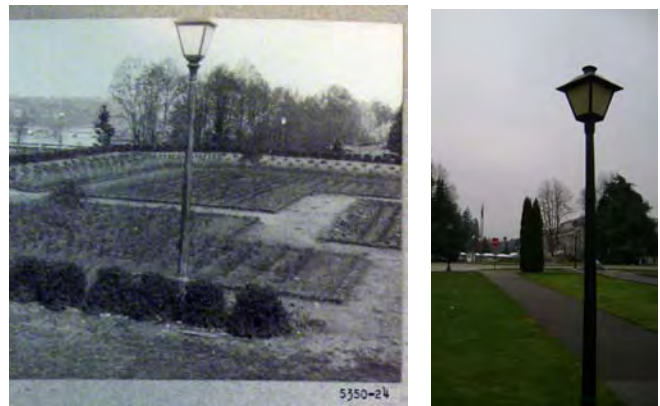
Figure 11.6 Comparison of historic and current carriage lantern lighting poles [source: Frederick Law Olmsted National Historic Site, National Park Service (historic photo), Dark|Light Consulting, LLC (2009 photo)]

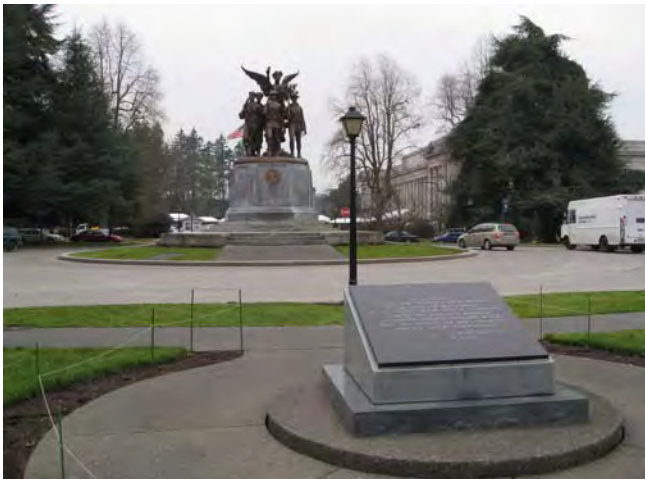
Figure 11.7 *Post-top fixture between Prisoner of War Monument and Winged Victory Monument (source: Dark|Light Consulting, LLC, 2009)*

There is one location where unfortunate fixture placement interrupts this view corridor, both during daytime and at night. Between the Prisoner of War Monument and the Winged Victory Monument, there is a post-top fixture. This fixture should be relocated if possible to correct this condition.

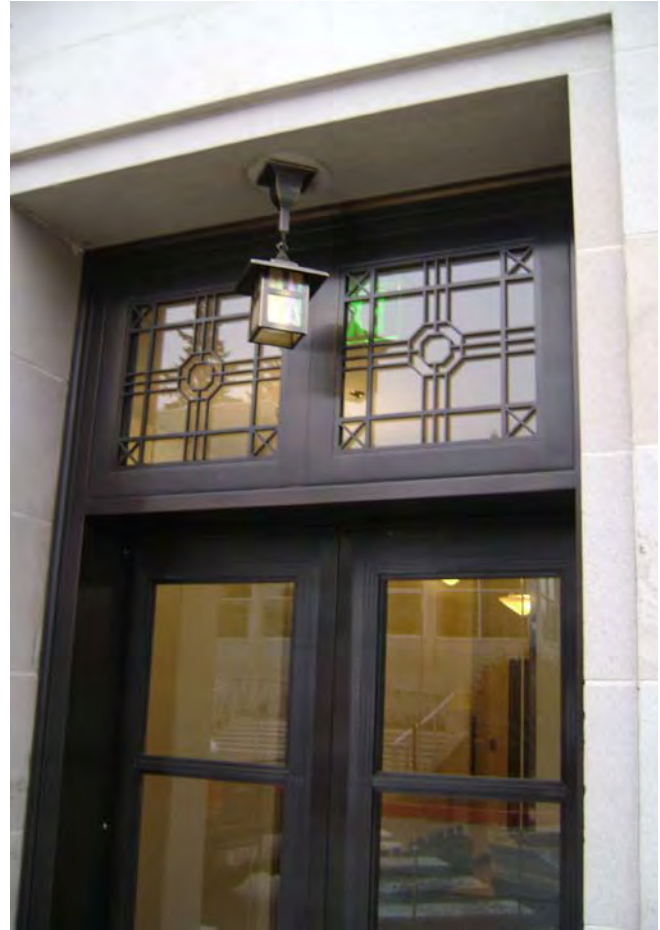
Figure 11.8 Craftsman-style light fixture (source: Dark|Light Consulting, LLC, 2009)

configuration and ornamentation is one that should continue to be used where decorative fixtures need to be added in the future. There are exceptions to this, especially where wall-mounted lanterns are attached to buildings. In these cases, Gothic fixture styles are found and are appropriate. One instance of a Craftsman-style fixture (believed to be a modern reproduction) was noted during the survey, care should be taken to ensure that as decorative fixtures need to be replaced, that forms and materials for new fixtures adhere as closely as possible to the original fixture.

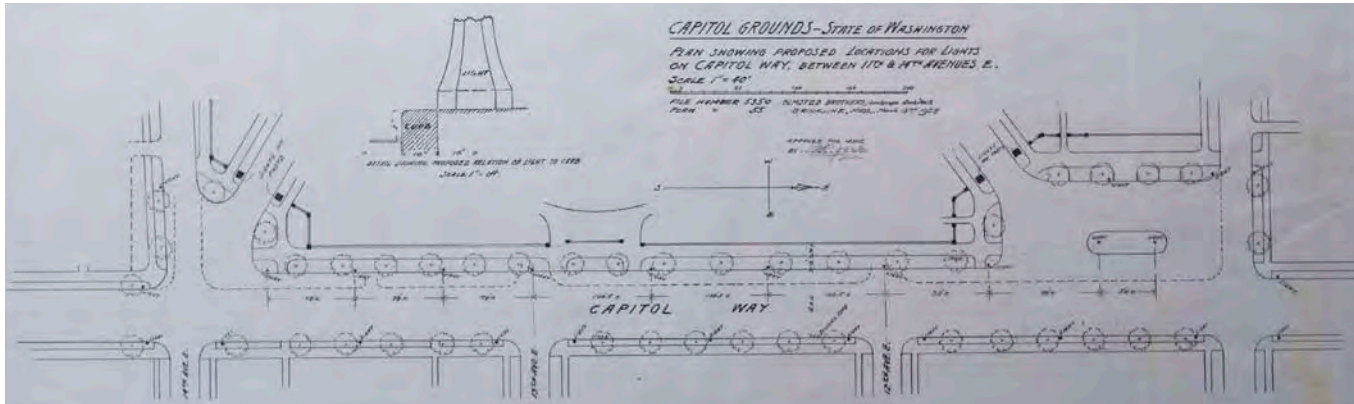
Figure 11.9 Historic documentation showing lighting along Capitol Way, and intended portal elements at entries to diagonal drives (source: 5350_55_TU, March 13, 1928, Frederick Law Olmsted National Historic Site, National Park Service)

well-delineated at night. A lighting study found in historical documentation indicates that some type of entry marker may have been intended at the entries to the diagonal drives. If such an element were incorporated into the landscape, integrating lighting through a luminous post-top element on the structure, and lighting of the structure itself, would provide nighttime cues to these entry points and further strengthen the diagonal axes at night.
