West Capitol Campus

Historic Landscape Preservation Master Plan

June 2009 | GA project # 08-099

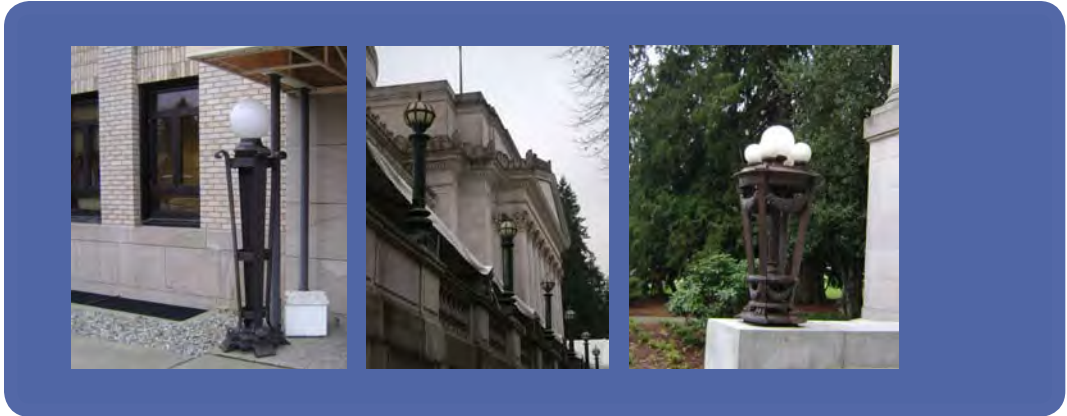
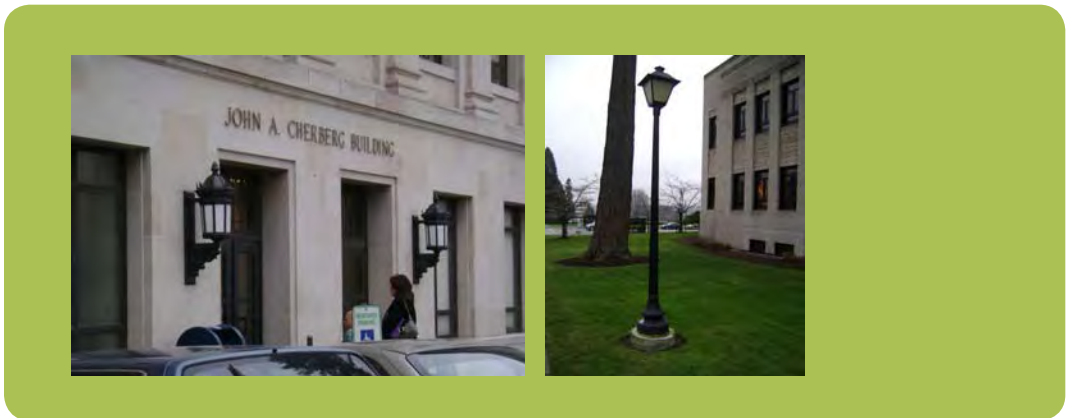
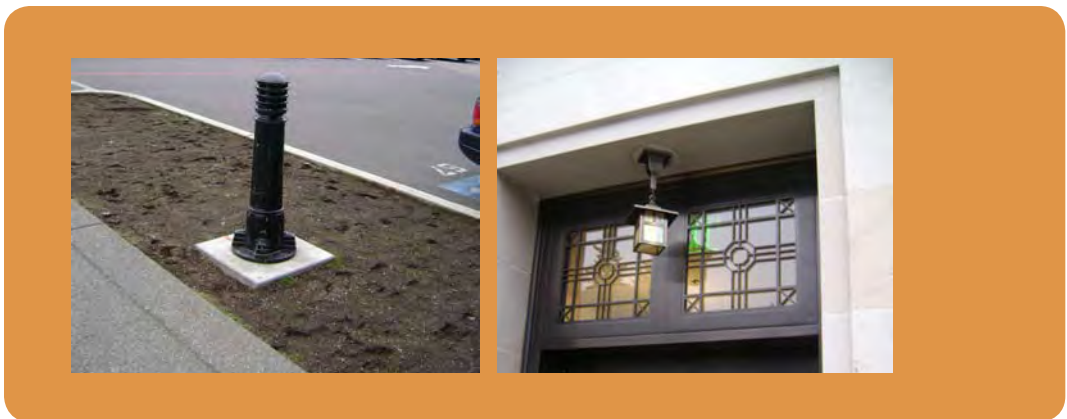
historic globe-style fixtures

other appropriate historically-styled fixtures

inappropriate historically-styled fixtures

Figure 11.10 Chart showing lighting fixture typologies for the existing campus (source: Dark|Light Consulting, LLC, 2009)

* Fixtures shown on the Cherberg building are originals that were refinished during the building rehabilitation project. The light standard shown in the adjacent photograph is original dating to the campus electrical work done in the late 1930s under supervision of Joseph Wohleb (information source: Artifacts Consulting).

This plan discusses the existing square carriage lantern pole fixtures elsewhere. While it may not have been the originally intended fixture and it may, after further research, be replaced with a different fixture, it does have a historic presence on the West Capitol Campus.

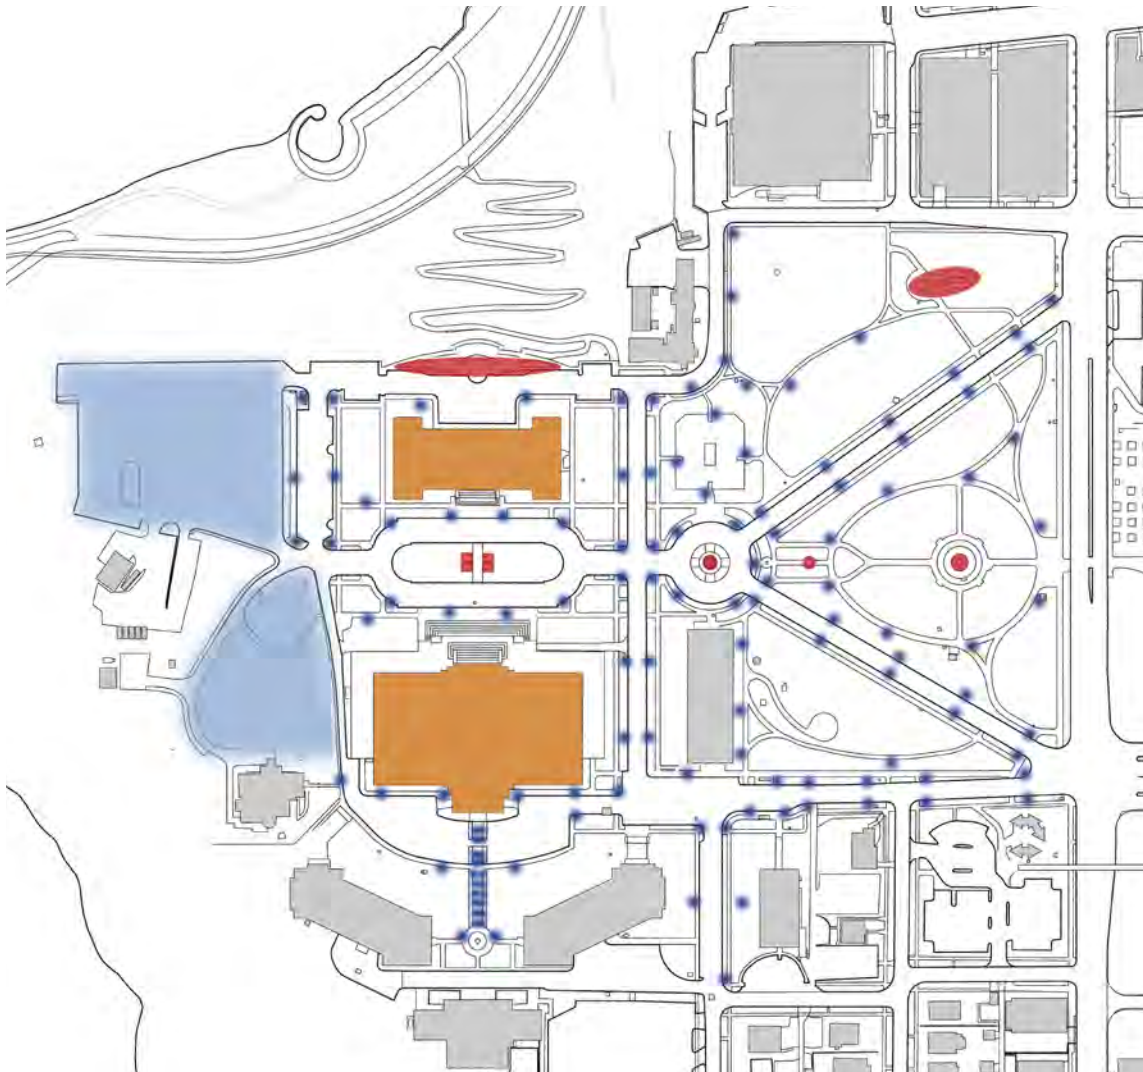
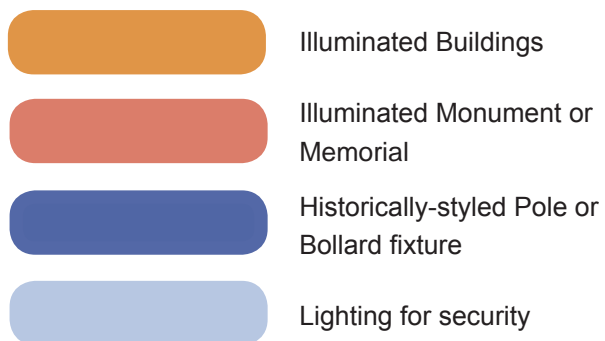
Figure 11.11 Diagram of schematic lighting types for the existing campus (source: Dark|Light Consulting, LLC)

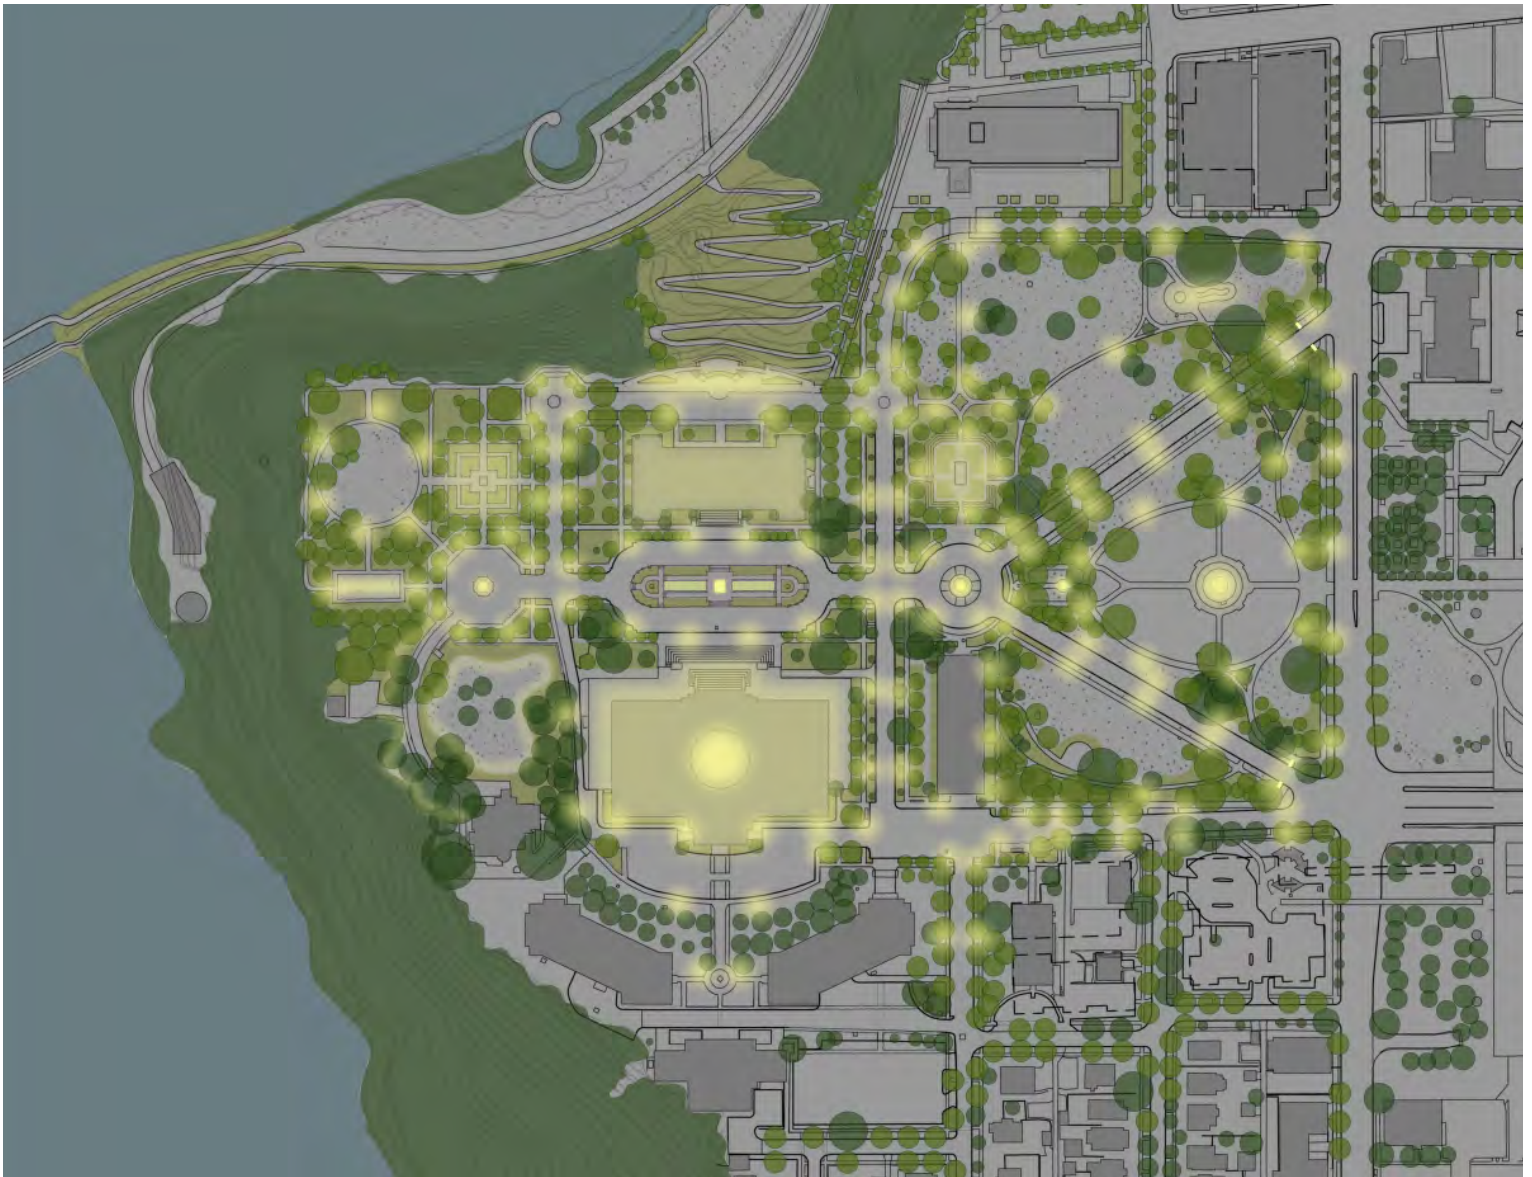
Figure 11.13 *Diagram showing luminous balance for a future campus (source: Dark|Light Consulting, LLC)*

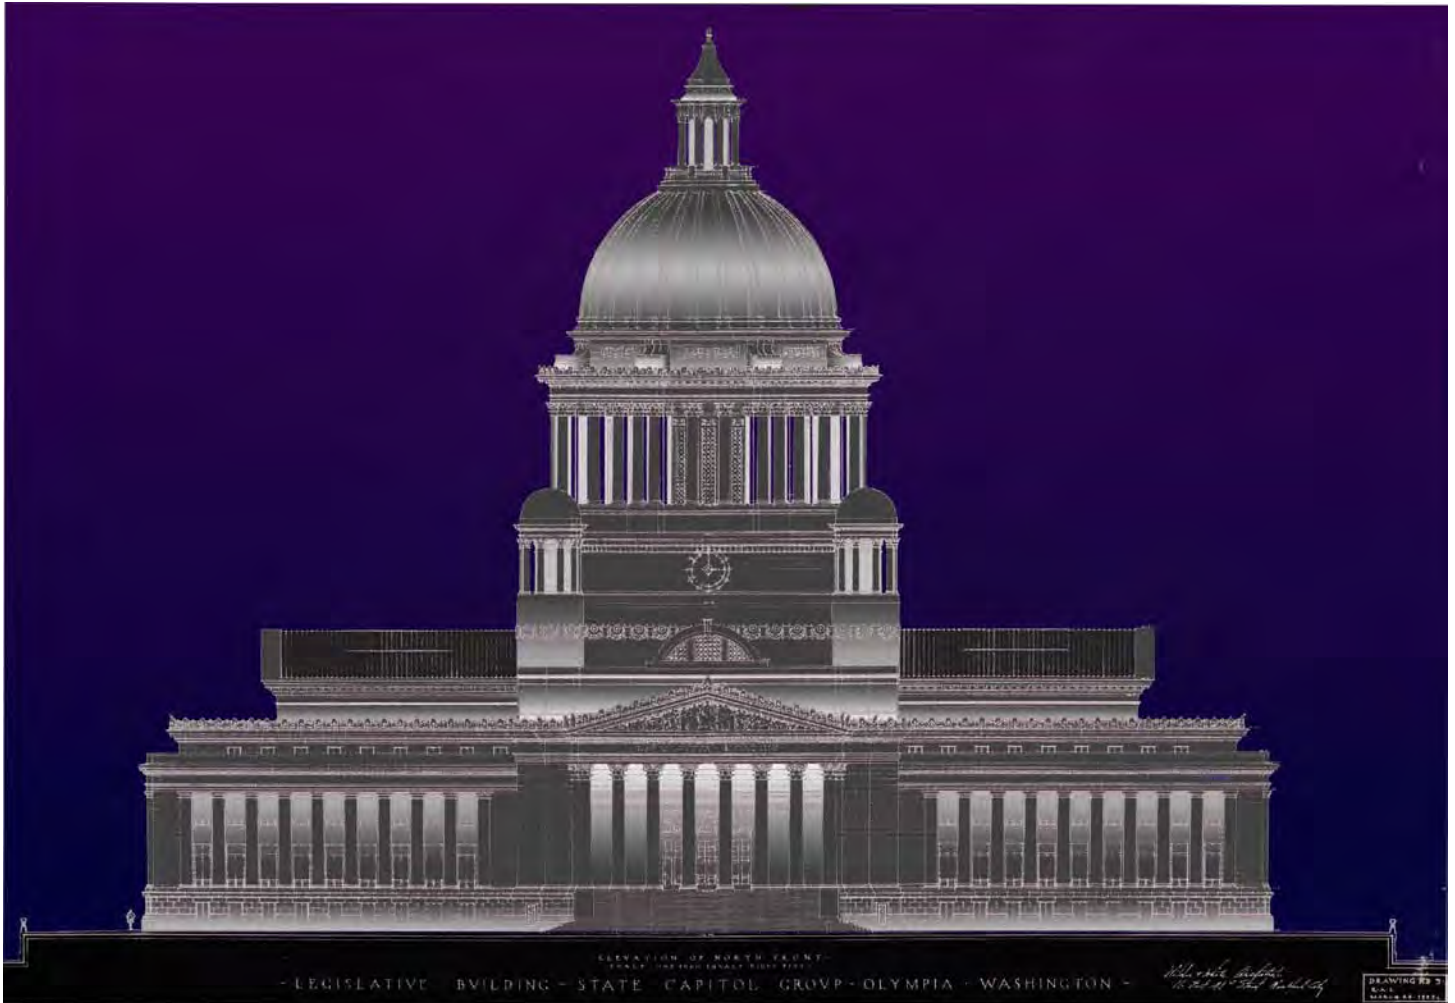
Figure 11.14 One possible alternative for lighting of the Legislative Building. In this alternative, a layered lighting approach is favored over general floodlighting of selected building elements. This layered lighting emphasizes detail, form, and the depth of the architecture. The podium base is uniformly lit to visually ground the building, while lighting within the porticos silhouettes the columns to highlight depth. The entry portico is illuminated to a higher level to aid in wayfinding and provide visual interest. A continuous band of light above reveals the filigree element in silhouette, rendering this element differently at night and providing the viewer with an understanding of the intricacy of these elements. Lighting within the cupolas above and below, along with the columns supporting the dome, provide a different type of layering, as the columns are seen in silhouette toward the viewer, while the inside is illuminated. Finally, the dome itself is softly lit to be seen both within the context of the West Capitol Campus and from distant viewpoints near and far. Together, these elements come together to form a cohesive lighting composition that creates a strong nighttime anchor for the Campus. (source: Dark|Light Consulting, LLC)

The Legislative Building should be relit with an eye towards a layered lighting approach that provides a base level of illumination but highlights selected elements to render the detail and form of the building and the dome structure.
